Testing of Innovative Pipe Renewal Liners for Renovation of Potable Water Distribution Pipelines

A thesis
presented to the University of Waterloo
in fulfillment of the
thesis requirement for the degree of
Master of Applied Science
in
Civil Engineering

Waterloo, Ontario, Canada, 2017

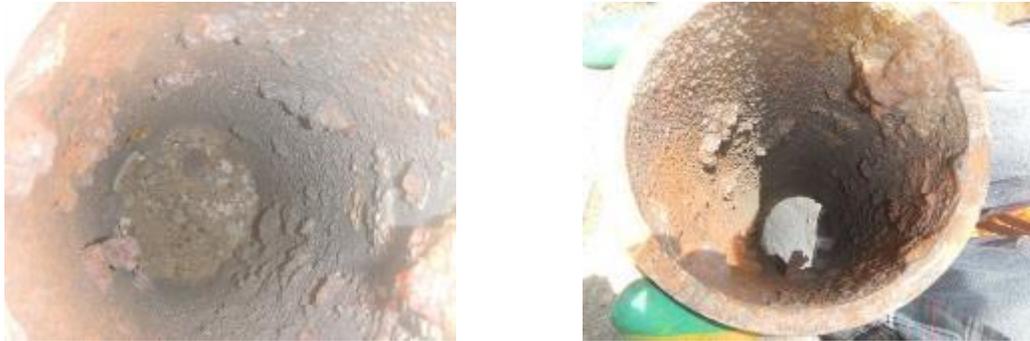
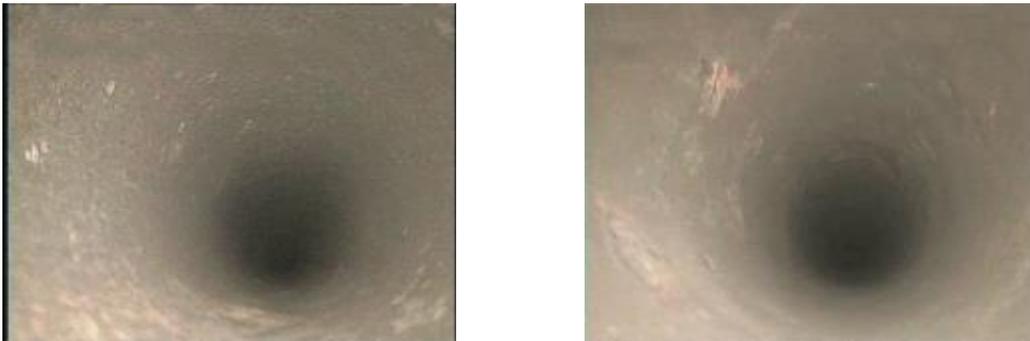
Figure 2.4 shows the initial condition of the pipe before cleaning and how it looked after cleaning using the Tomahawk™ cleaning System. Unlike other cleaning methods, this is a waterless cleaning technology, which allows linings to be applied to a dry pipe. The

resulting pipe surface finish is seen to surpass ASTM F2831 specified minimum requirement of SSPC-SP6/NACE. No. 3, as it is categorized to be near-white metal finish (SSPC-SP10/NACE. No. 2).

(a) Albert Street pipe before cleaning.

(b) Albert Street pipe after cleaning.

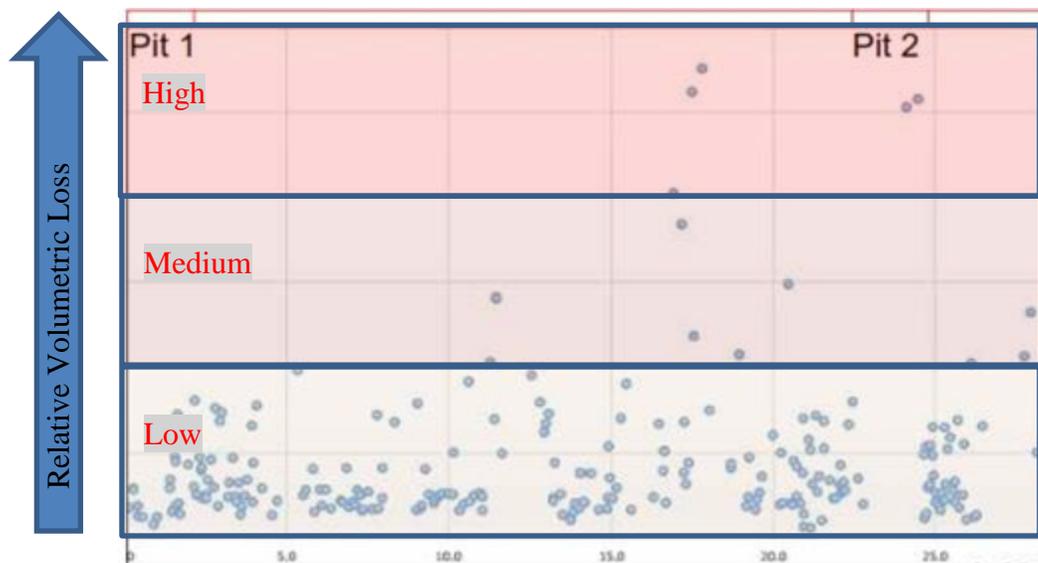
After lining, samples were exhumed from pit 1 and 2 for this assessment. Figure 2.5 below shows the results from the PICA test. For the samples taken from pit 1, none of them experienced high volumetric loss in pipe wall thickness. However, there were two instances of high volumetric loss in pit 2. Figure 2.6 shows the corresponding pipe samples where we can readily observe the high volumetric loss in pipe wall thickness.

Figure 2.5: Pipe Wall Assessment using PICA I-Pit Tool.

- 2) Sections in the test sites having a PICA tool rating of “High”, were verified as the samples experienced cracks. This may be due to graphitization, causing reduction in strength of the substrate.

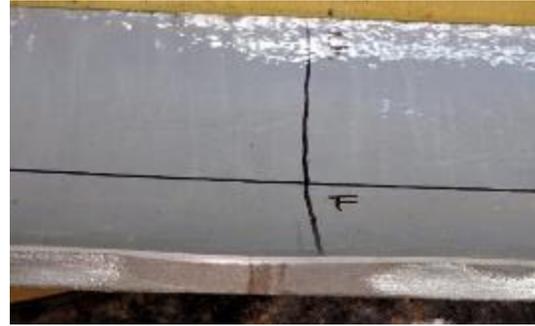
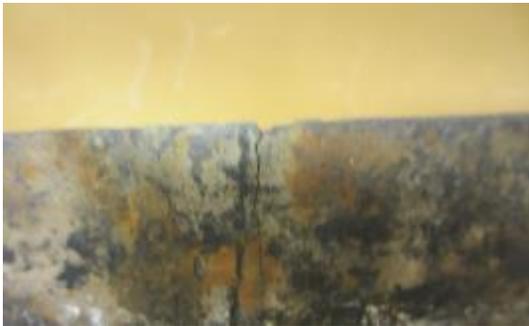
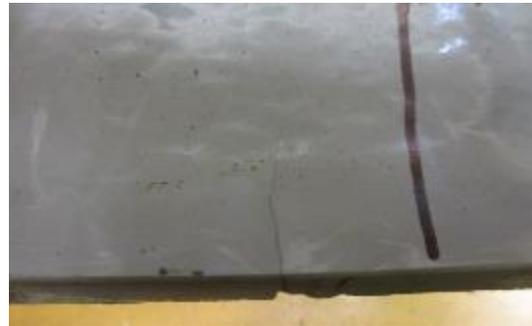
(a) Pipe wall appearance for Pit 2 sample.

(b) Exterior and Interior appearance of Pit 2 sample.

Figure 2.6: Pit samples showing cracks due to high volumetric loss in pipe wall thickness.

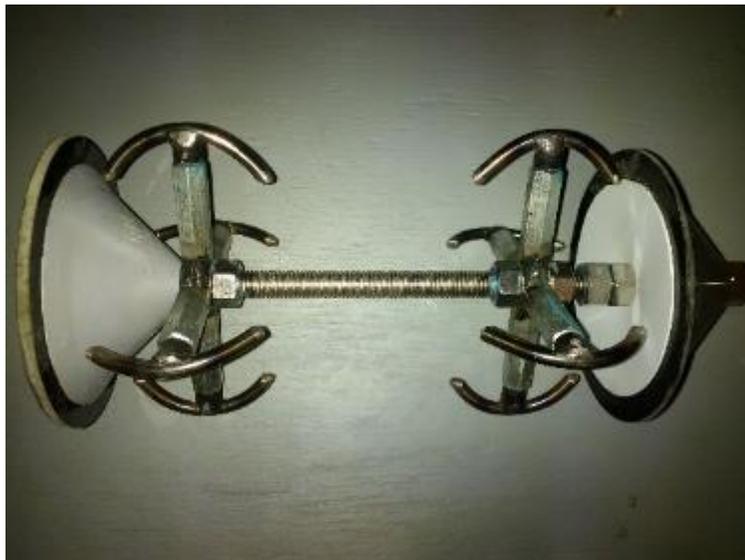
The MG-120 was mixed on site, then poured into the cleaned pipe. A spreading Distributive Body (DB) placed inside the pipe at the moment of the application of the lining product was pulled through the pipe to distribute the lining product around the pipe. The DB used for this pilot project has a front flex plate diameter of 12.2 cm and rear diameter of 12.7 cm. Linear travel speed of DB inbound and outbound is about 10.7 m/min. A winch controls the speed of the DB travel through the pipe. The DB travelled elevated, off the bottom of the pipe by about 8 mm, to allow air to flow around the full circumference of the DB, which helped substantially to improve lining consistency. Figure 2.7 shows an image of the DB used.

Figure 2.7: Distributive Body used for Albert Street Pilot Project.

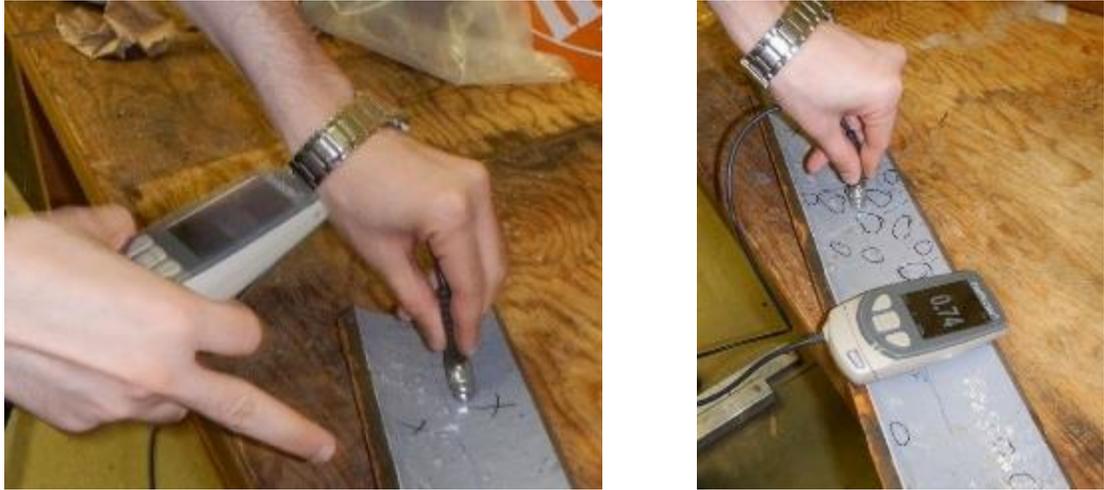
Liner thickness has been measured on selected panels and compared to the minimum thickness required by some relevant standards shown in Table 2.1. A Positector 6000 electronic magnetic gauge (see Figure 2.9) was used to take DFT readings along the length and across the circumference of the pipe sample, this was done to verify uniformity criterion throughout the entire pipe as differences in thickness can result in different permeability and strength of liner.

Figure 2.9: Thickness measurements using a Positector 6000 device.

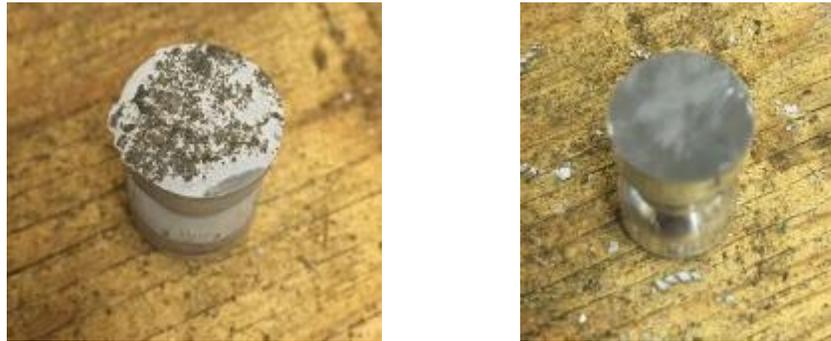
Figure 2.13: Images showing cohesive fracture and glue failure.

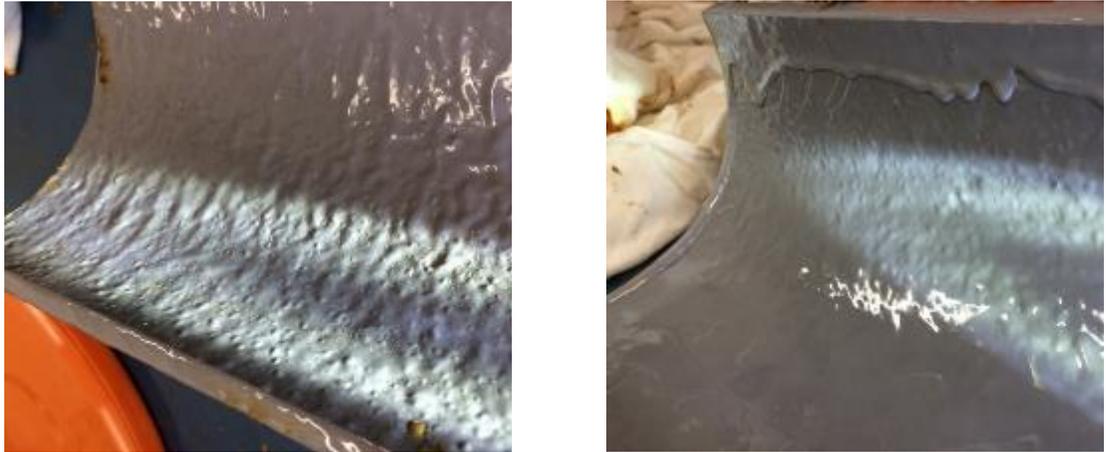
AWWA C210 specifies test panels (50mm x 150mm x 3.2mm) to be immersed in deionized water, weak acid, and weak base. The sample should be kept at 25°C for 30 days. The uncoated side was sealed with resistant materials, and then the samples (from top and bottom sections) were placed in containers and immersed for over 30 days. The samples were taken out, left to dry for 24 hours, then examined for presence of peels or liner disbondment. Figure 2.16 shows the samples after they were removed from the water and left to dry for 24 hours. At the end of this test, no peels or any liner disbondment was noticed.

Figure 2.16: Images of top and bottom of pipe sample after immersion testing.

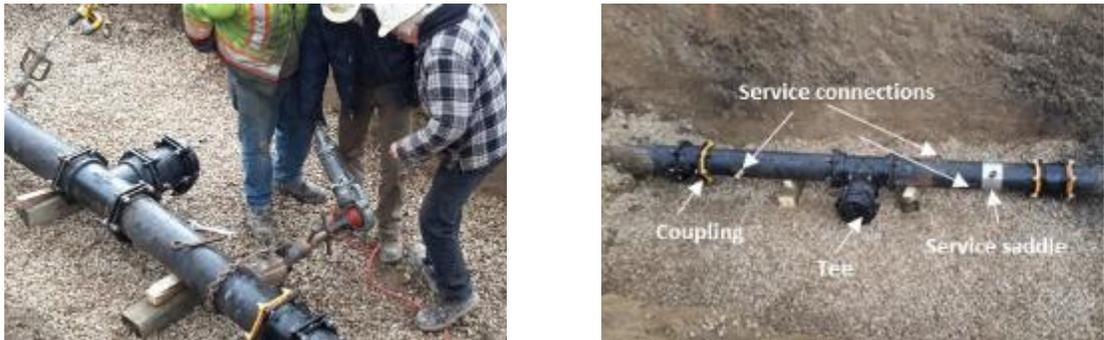
Three pre-fabricated test spools with service connections, saddle connections, tees, and couplings were installed at specific locations in Pits 2, 4, and 6. Figure 3.3 shows the spool and how it was being installed with the three sections on site.

Figure 3.3: Installation of pipe spools with connections, tees and couplings.

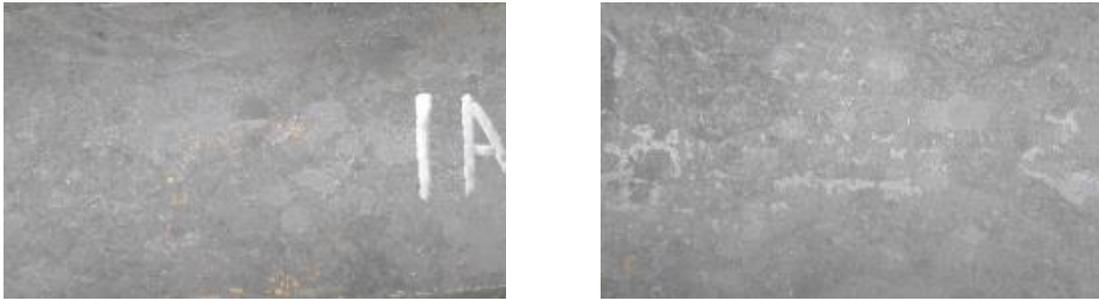
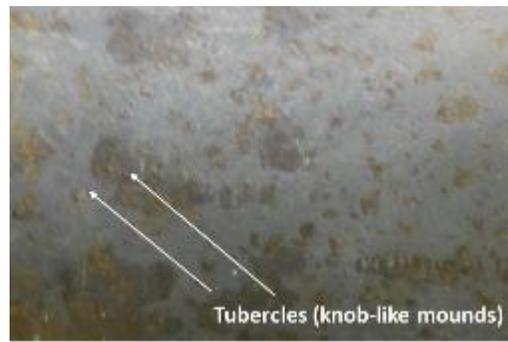
(a) Section 1 cleaned using Tomahawk System.

(b) Section 2 cleaned using ID-TEC SR-Series high pressure water jet tool.

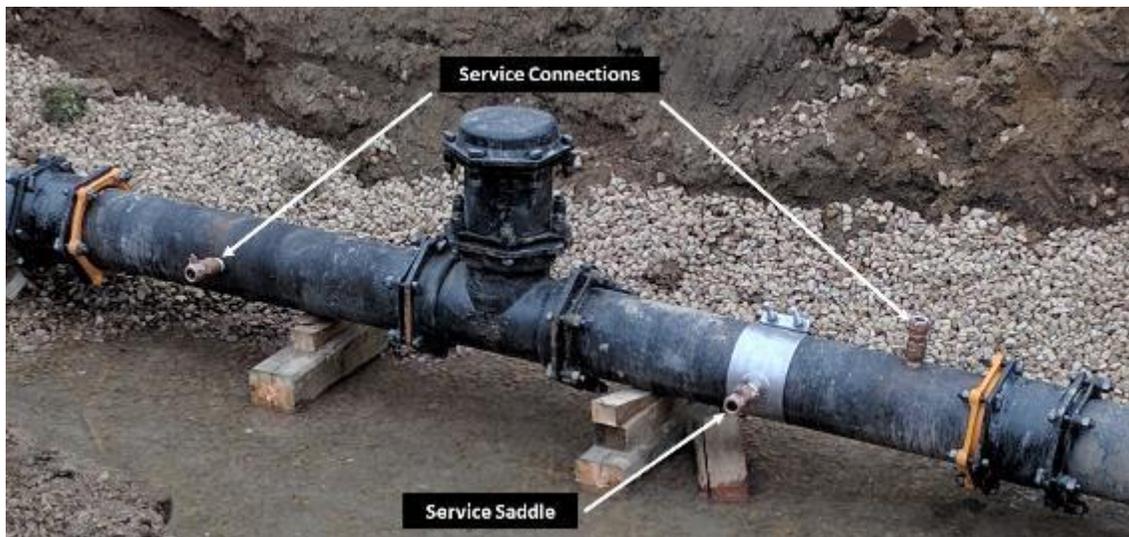
Two service connections and a service saddle were installed in each of the three spools in Pit 2, Pit 4, and Pit 6 for pipe Sections 1, 2, and 3. Figure 3.13 shows a typical spool fitted with two service connections and a service saddle. The service connections and service saddles were cut out of pipe and then split into quarters using waterjet cutting. Figure 3.14 to 3.23 show the lining condition around the service connections and service saddles. There was good lining coverage around the service connections and service saddles and no shadow effect was observed. However, lining partly encroached the service connections and service saddles, and therefore reduced the service size. Therefore, there was some lining adhesion around the service connections. One of the intruding service connections in pipe Section 1 spool (refer to Figure 3.15) was cut using remote controlled ID-TEC equipment. In that case the lining got separated from the host pipe around the service connection. There was little to no adhesion of lining for service saddle connections.

Figure 3.13: Spool with service connections and service saddle.

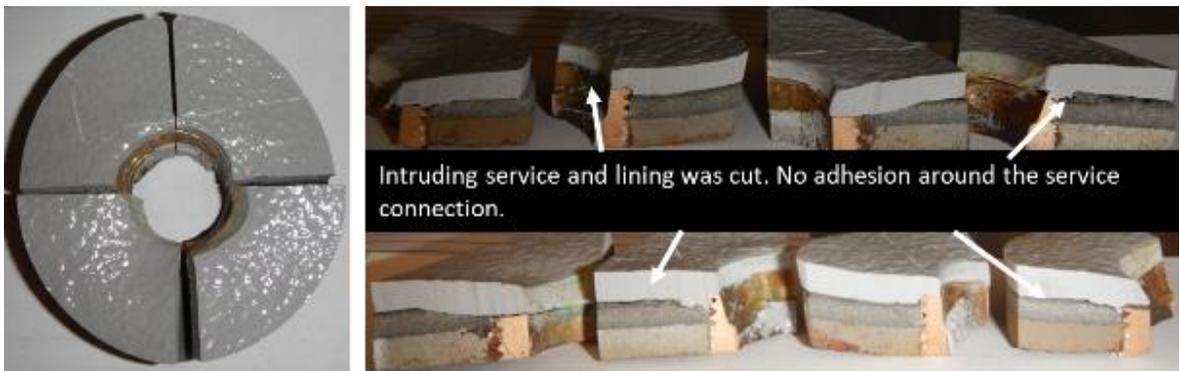
Figure 3.15: Service connection 1B3-1(1) for Tomahawk cleaned section.

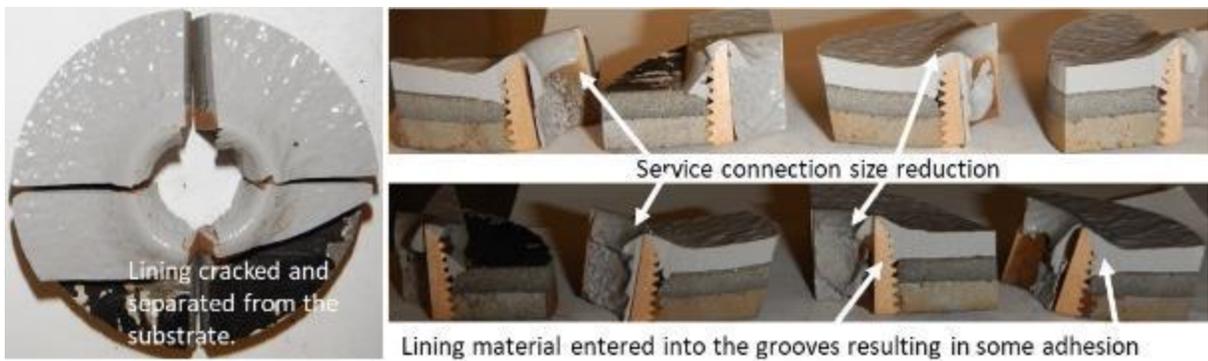
Figure 3.18: Service connection 2B6-2 for Rack bore cleaned section.

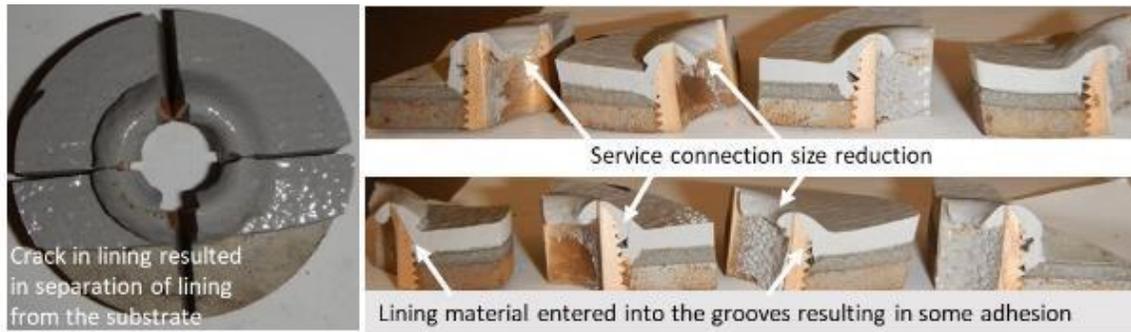
Figure 3.22: Service connection 3B6-2 for Water jet cleaned section.

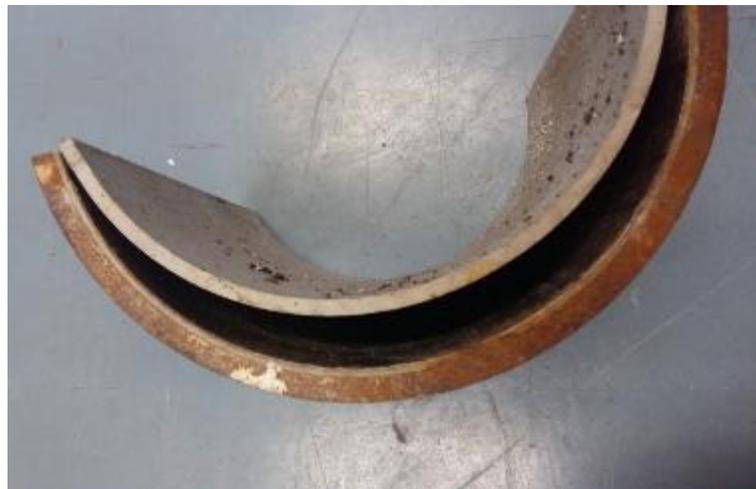
Figure 3.28: Pipe section with no lining adhesion with the host pipe as liner separated after jet cutting

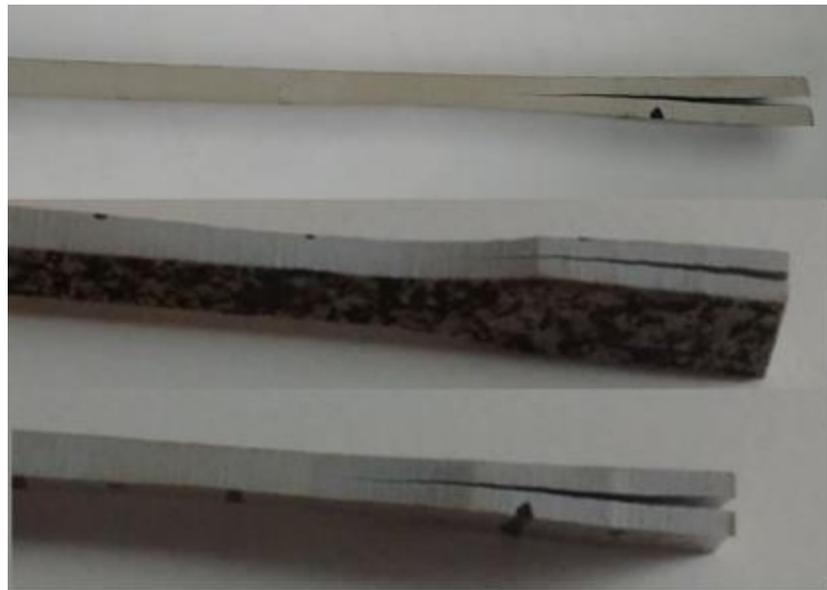
Figure 3.29: Separation of two lining layers in some tensile samples.

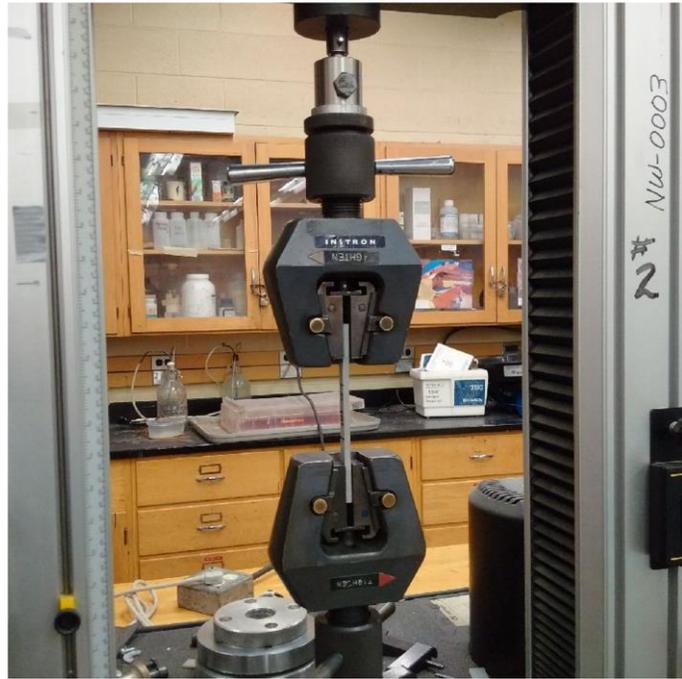
Figure 3.30: Specimens and tensile test setup.
