**Precast Concrete Inlay Panels:  
Rehabilitation Strategy for  
High-Volume Highways in Ontario**

A thesis  
presented to the University of Waterloo  
in fulfilment of the  
thesis requirement for the degree of  
Doctor of Philosophy  
in  
Civil Engineering

Waterloo, Ontario, Canada, 2018

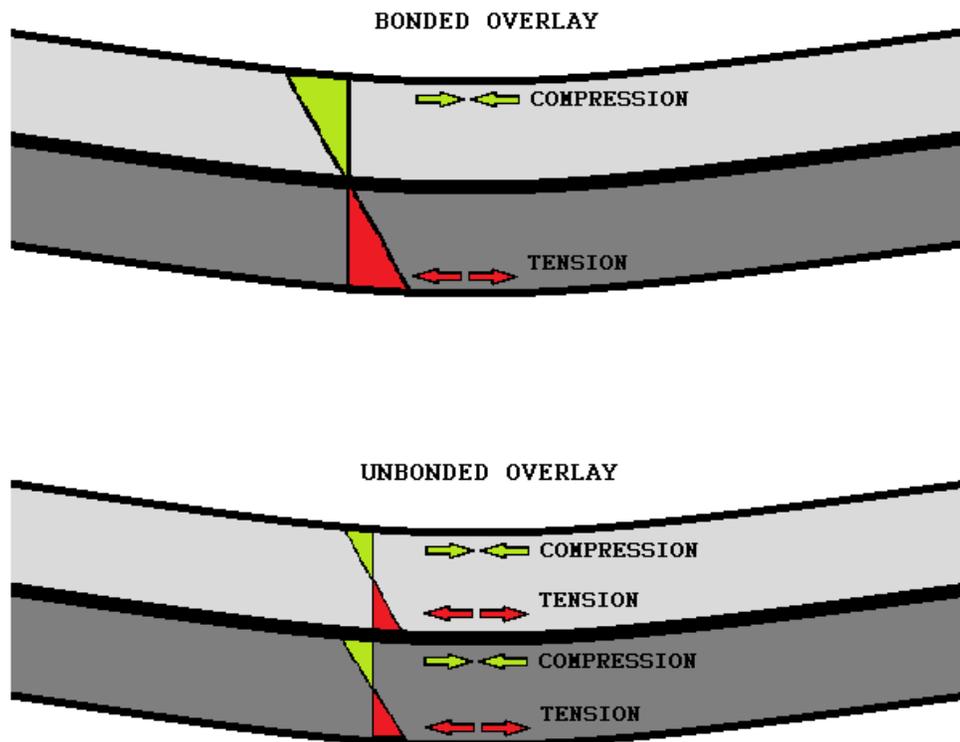
**Figure 2.1: Bonded and unbonded concrete overlay stress distributions**

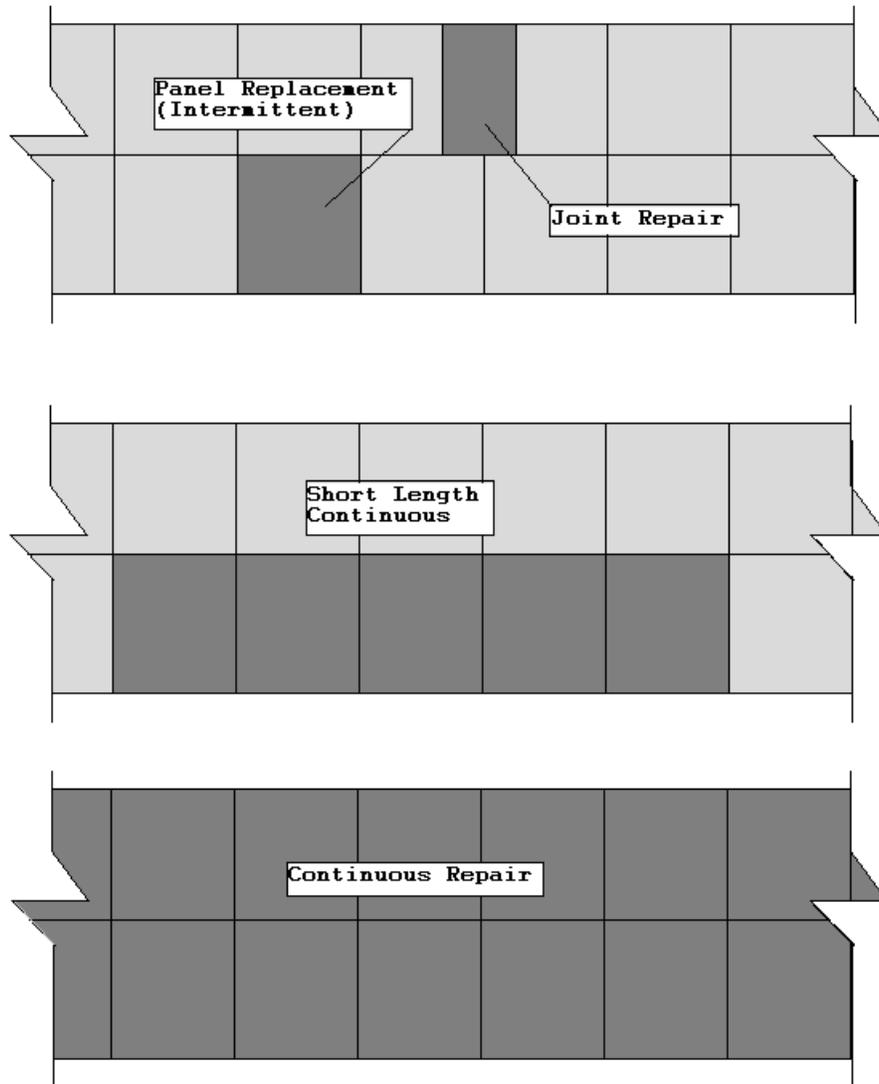
to repair deterioration that extended beyond the length of one panel, and continuous repair, in which an entire section of concrete pavement is replaced with PCP. In each PCP type, the width of the panels is the width of one traffic lane, and the length is either determined by the length of deterioration being repaired or by the maximum length that can be transported to site. In order to rehabilitate a rutted lane, a continuous placement of precast concrete panels will be necessary.

**Figure 2.4: Precast concrete panel repair types (adapted from (Tayabji, Ye, & Buch, 2012))**

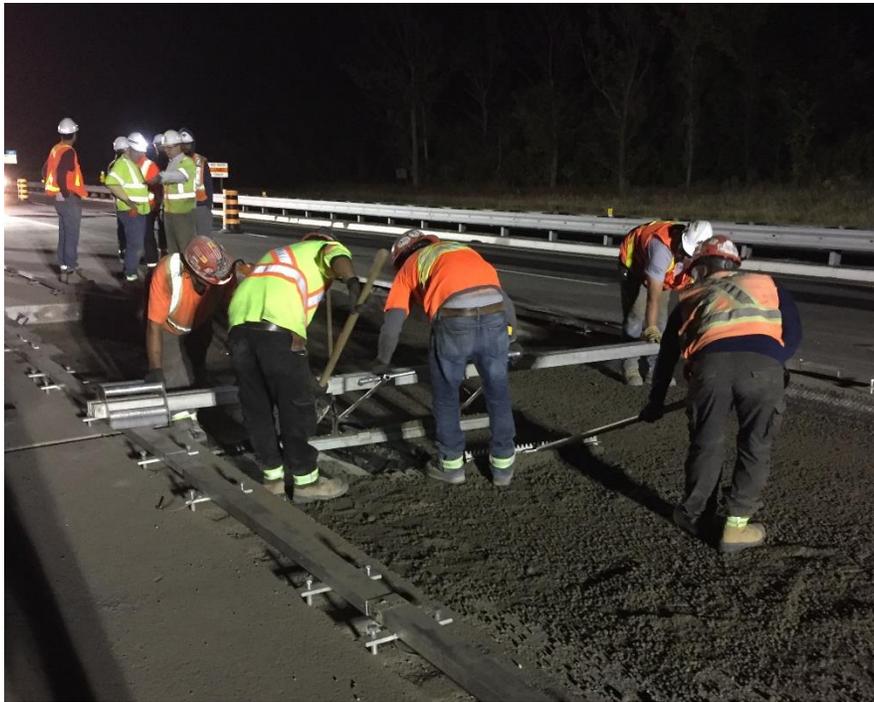
placed on the supporting HMA surface and levelled using a screed, such as the one pictured in Figure 4.2. The screed is positioned based on the elevation and cross slope information determined as part of the pre-construction surveying. After levelling, the material is compacted using plate tampers to a desired density, and this process is repeated until the required surface elevation of the compacted CTBM is met. The final surface of the CTBM must be within a  $\pm 3$  mm tolerance prior to placing the panels and thoroughly dampened with sprayed water.

**Figure 4.2: Large screed levelling base material**

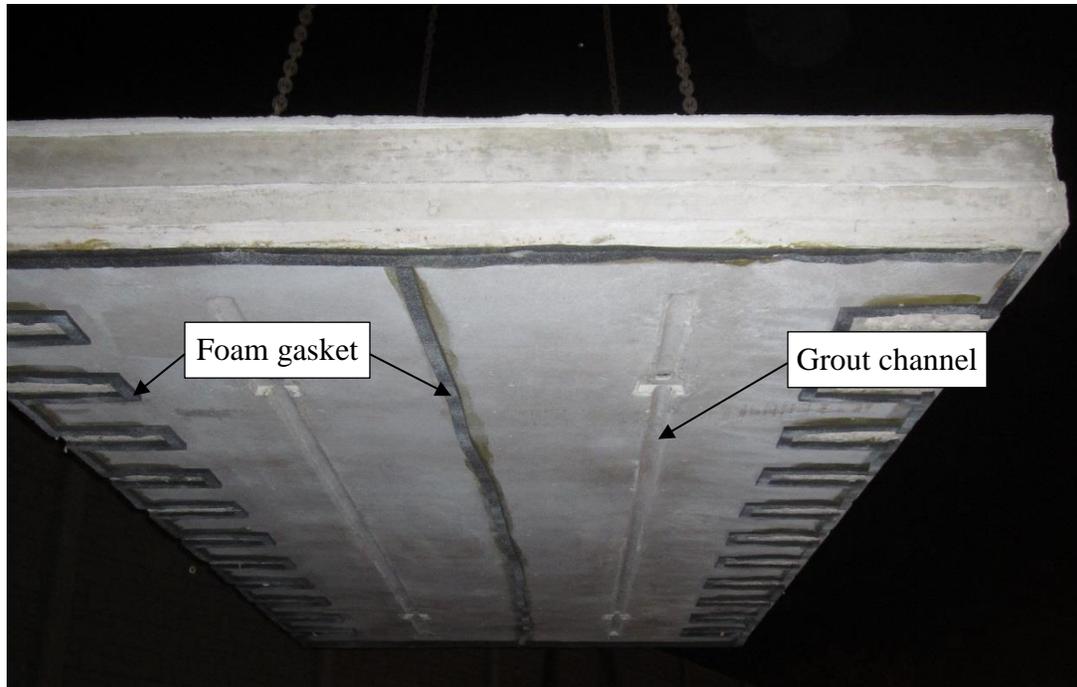
Foam gaskets are placed beneath the panel and form barriers between the dowel slots, edges, and the sub-panel voids. These gaskets prevent the grout types from blending that could reduce the effectiveness of the structural grouts. An example of this detail is shown in Figure 4.4.

**Figure 4.4: Typical sub-panel details**

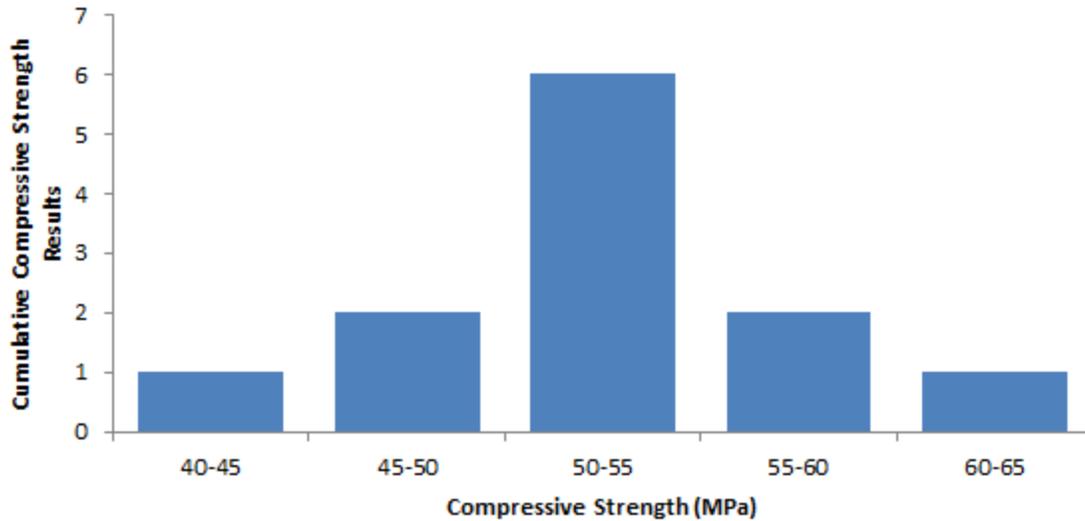
The actual concrete strength results were found 28 days after casting, and these results are summarized in Figure 4.6. The strength results represent average values based on all tests done on a single concrete batch. A concrete batch would typically produce enough concrete for two panels.

**Figure 4.6: 28-day concrete compressive strength results for PCIP**

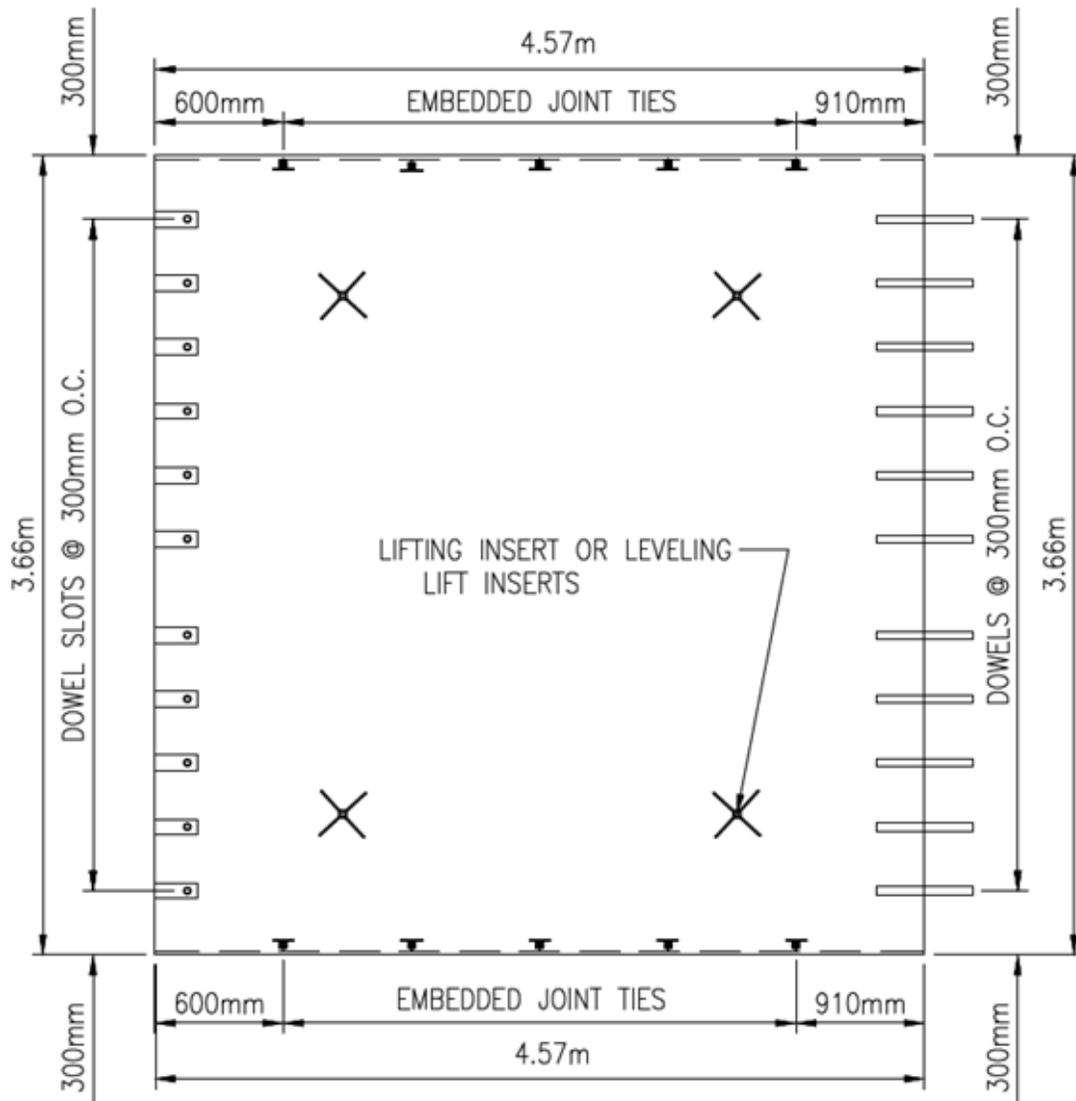
**Figure 4.9: Typical precast panel layout (The Fort Miller Co., Inc. 2015)**

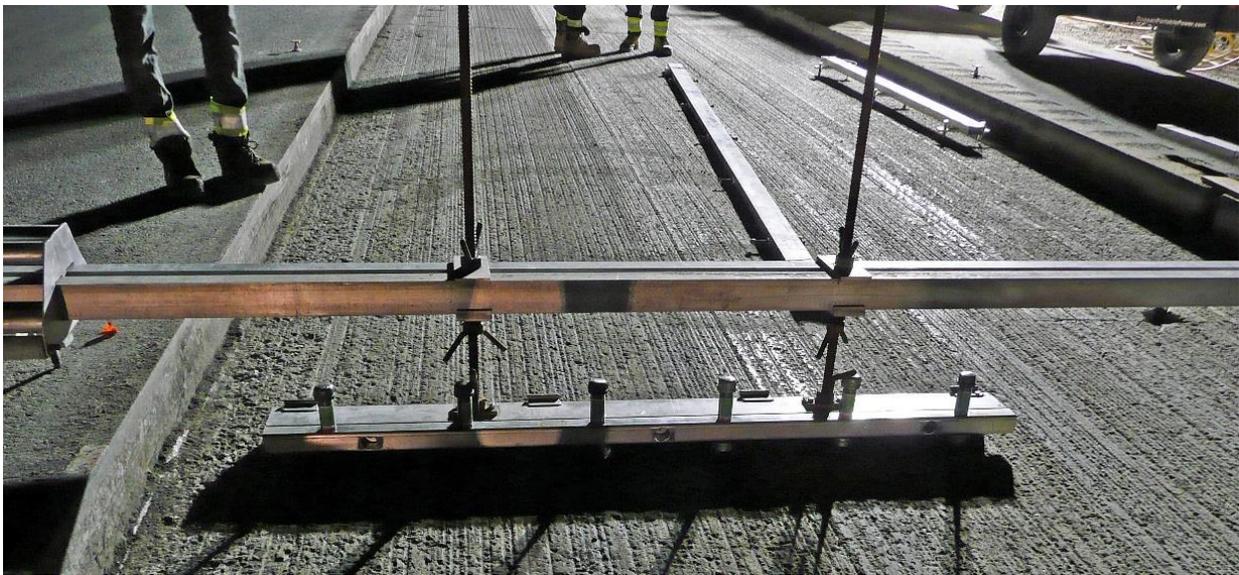
**Figure 5.13: Fort Miller's grade checking apparatus**

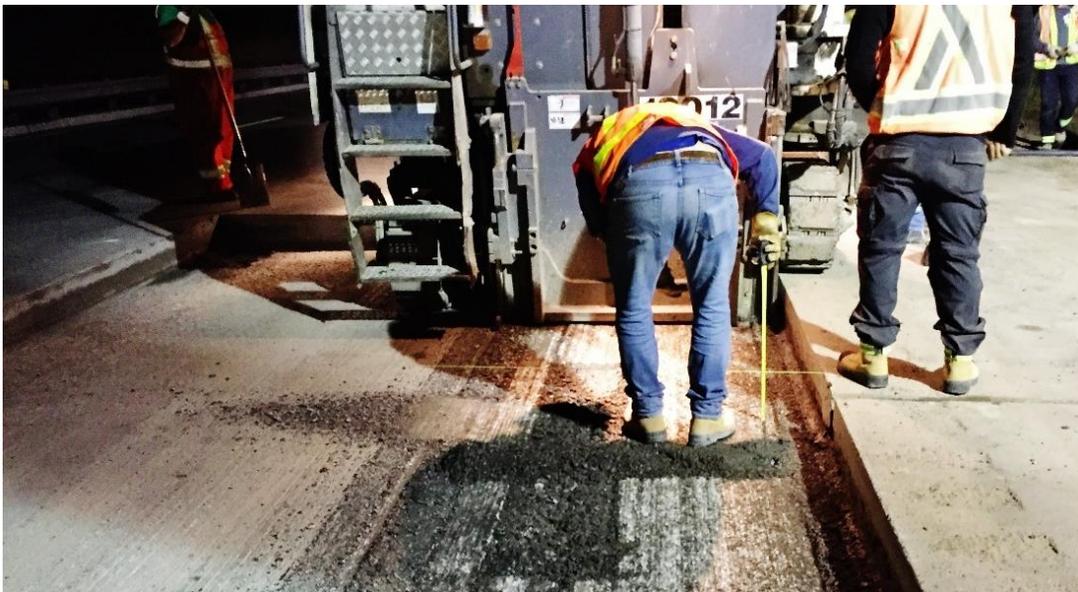
**Figure 5.15: Checking the re-milled surface with a stringline**

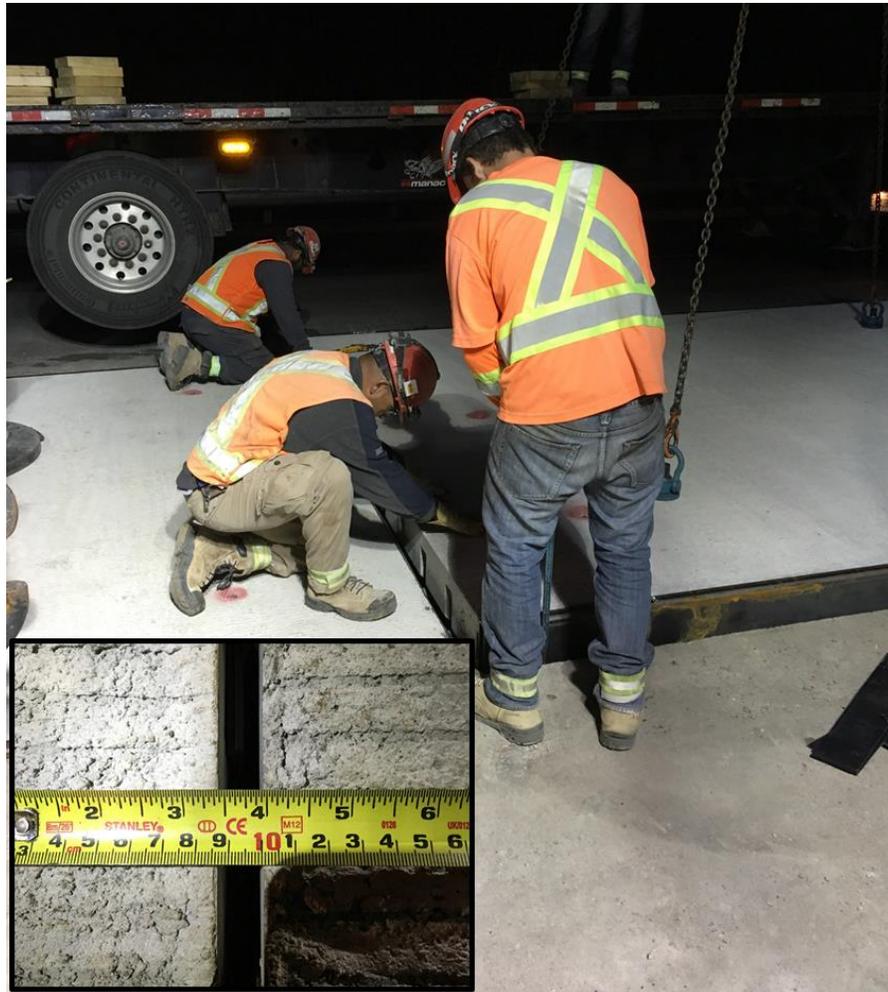
At the first transverse joint between the HMA and the precast panels, the panel was found to be approximately 9 mm high. There were also no surveyed marks to show where the panel should be placed, and when the second panel was placed, a gap of approximately 15 mm was observed. The placement of the second panel and the gap between the first two panels are shown in Figure 5.16. The vertical difference between adjacent panels was found to be within the 3 mm tolerance for the remainder of the panels.

**Figure 5.16: Placing panel #2; first gap (inset)**

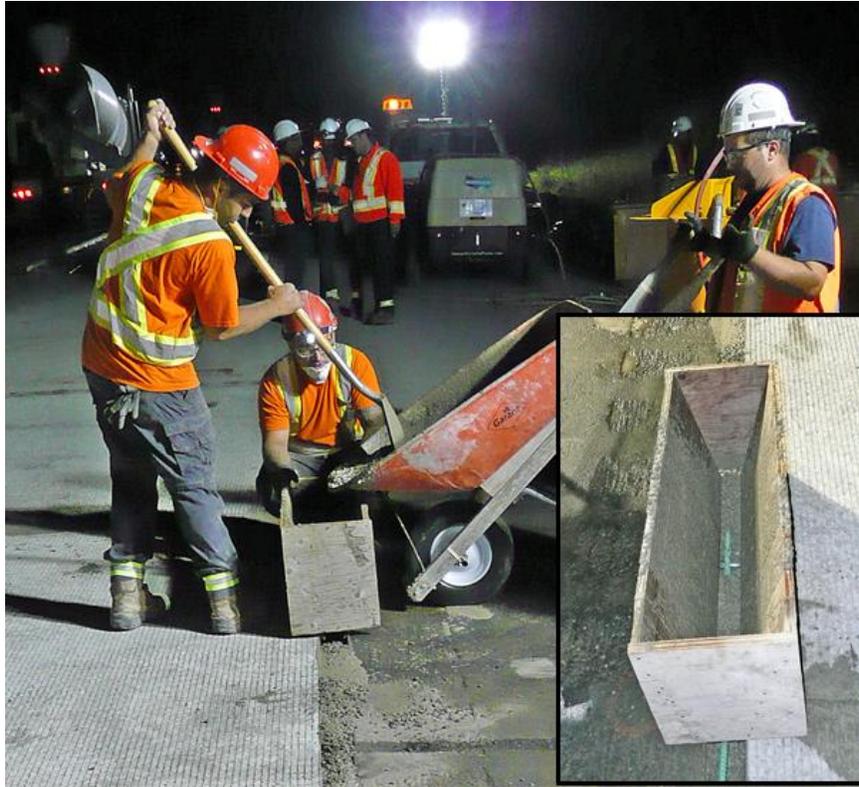
Following the dowel grouting procedure, the longitudinal joints were grouted using the same grout used for the dowels, extended with 60% pea-gravel by weight. The extended grout was made by adding four parts pea-gravel for every one part grout. This material was mixed on-site in a concrete drum mixer and then placed in the joints using a hopper constructed out of plywood, pictured in Figure 5.22.

**Figure 5.22: Edge grout being placed using small hopper; Inside view of hopper (inset)**

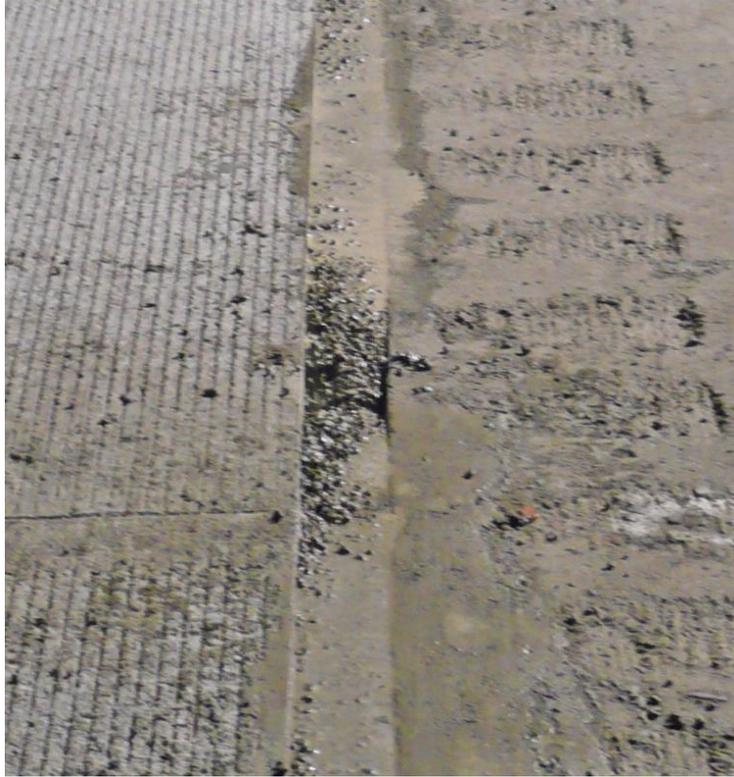
**Figure 5.23: Evidence of segregation in edge grout**

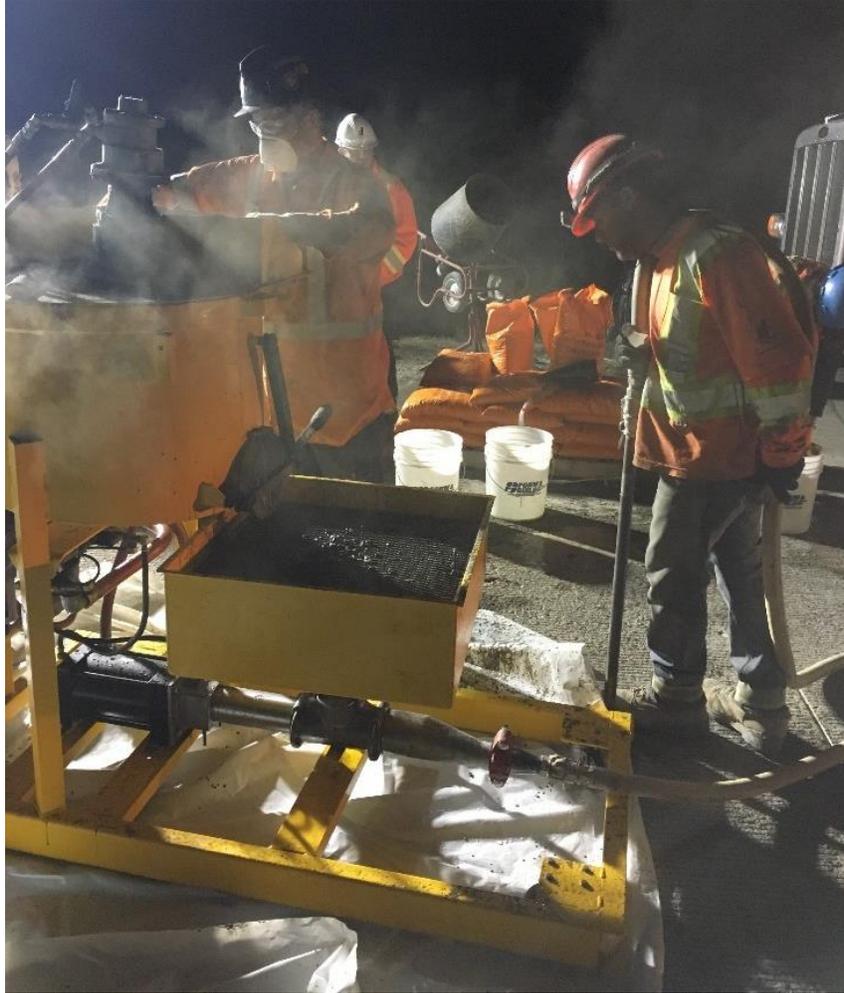
During the fifth batch, steam was observed coming out of the mixer. This is typically a sign that the material is hardening in the mixer. The mixer was promptly emptied and cleaned and no hardened grout was left in the mixer, however this indicated that mixer cleaning should take place every four batches to prevent the machine from seizing up. Figure 5.28 shows the steam as observed coming from the mixer.

**Figure 5.28: Grout mixer steaming**

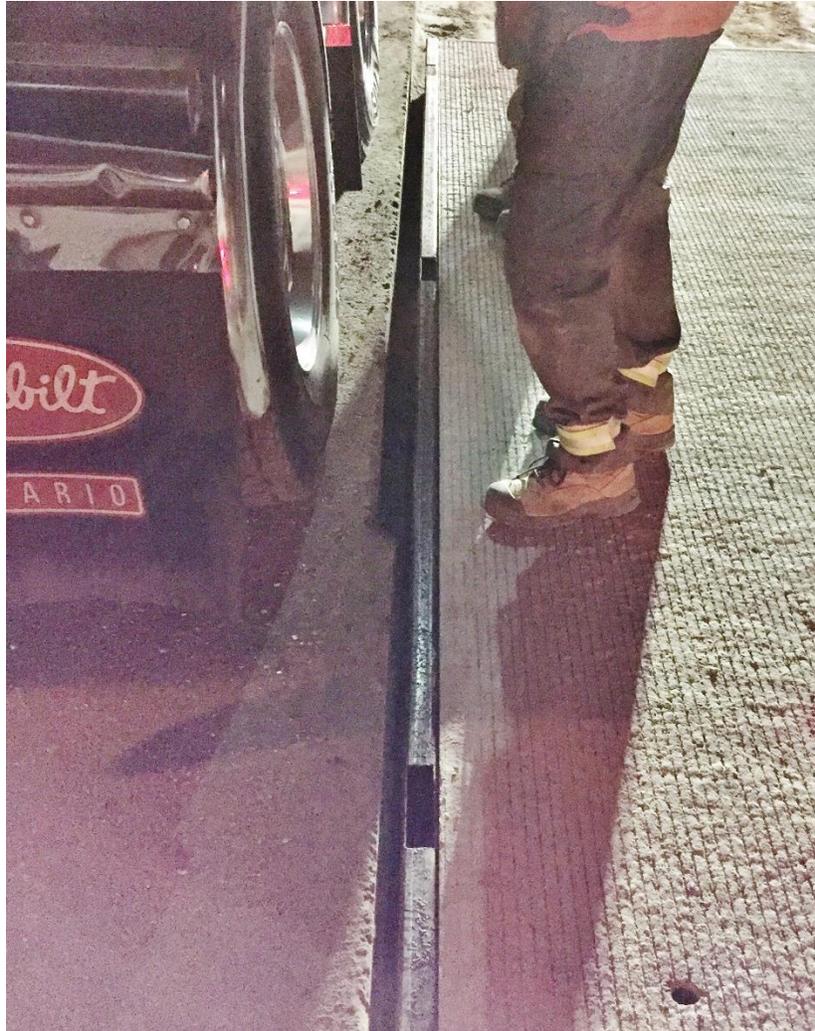
As the CTBM was being placed and compacted, the panels were being placed on the compacted material. The final panel was placed at approximately 4:40 am. During the placement of panels, it became apparent that the milling operation had milled wider than was specified, leaving a large gap on both longitudinal edges of the panels. This was found to be a milling mistake rather than a layout or saw-cut mistake at the point shown in Figure 5.29. The saw-cut edge was over-milled by approximately 30 - 40 mm.

**Figure 5.29: Location where milled portion was widened**

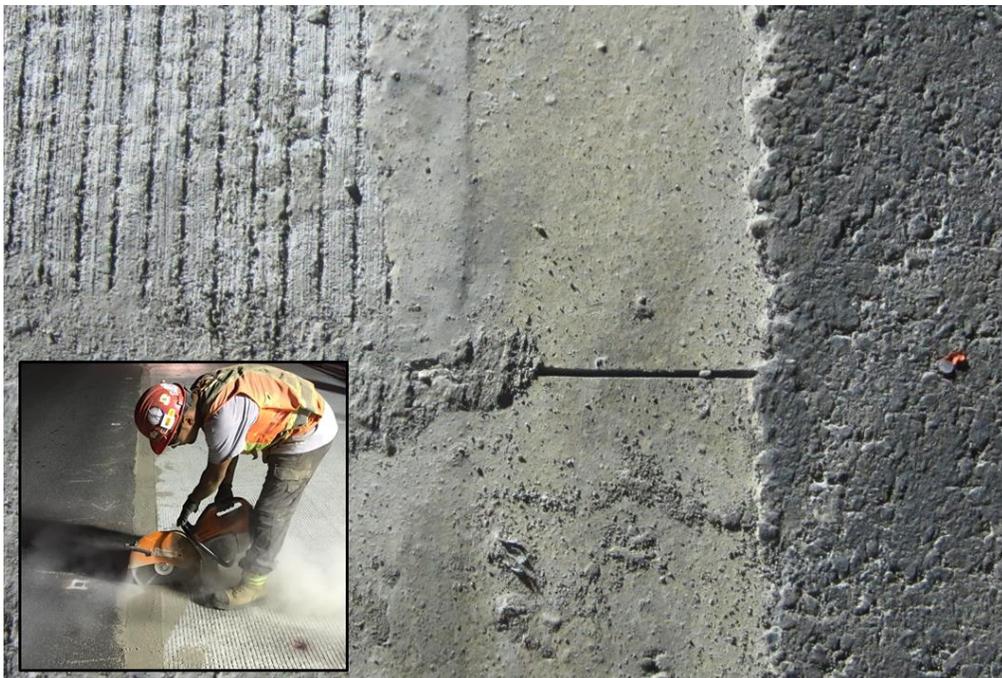
**Figure 5.30: Edge grout saw-cut at transverse joint; Saw-cutting (Inset)**

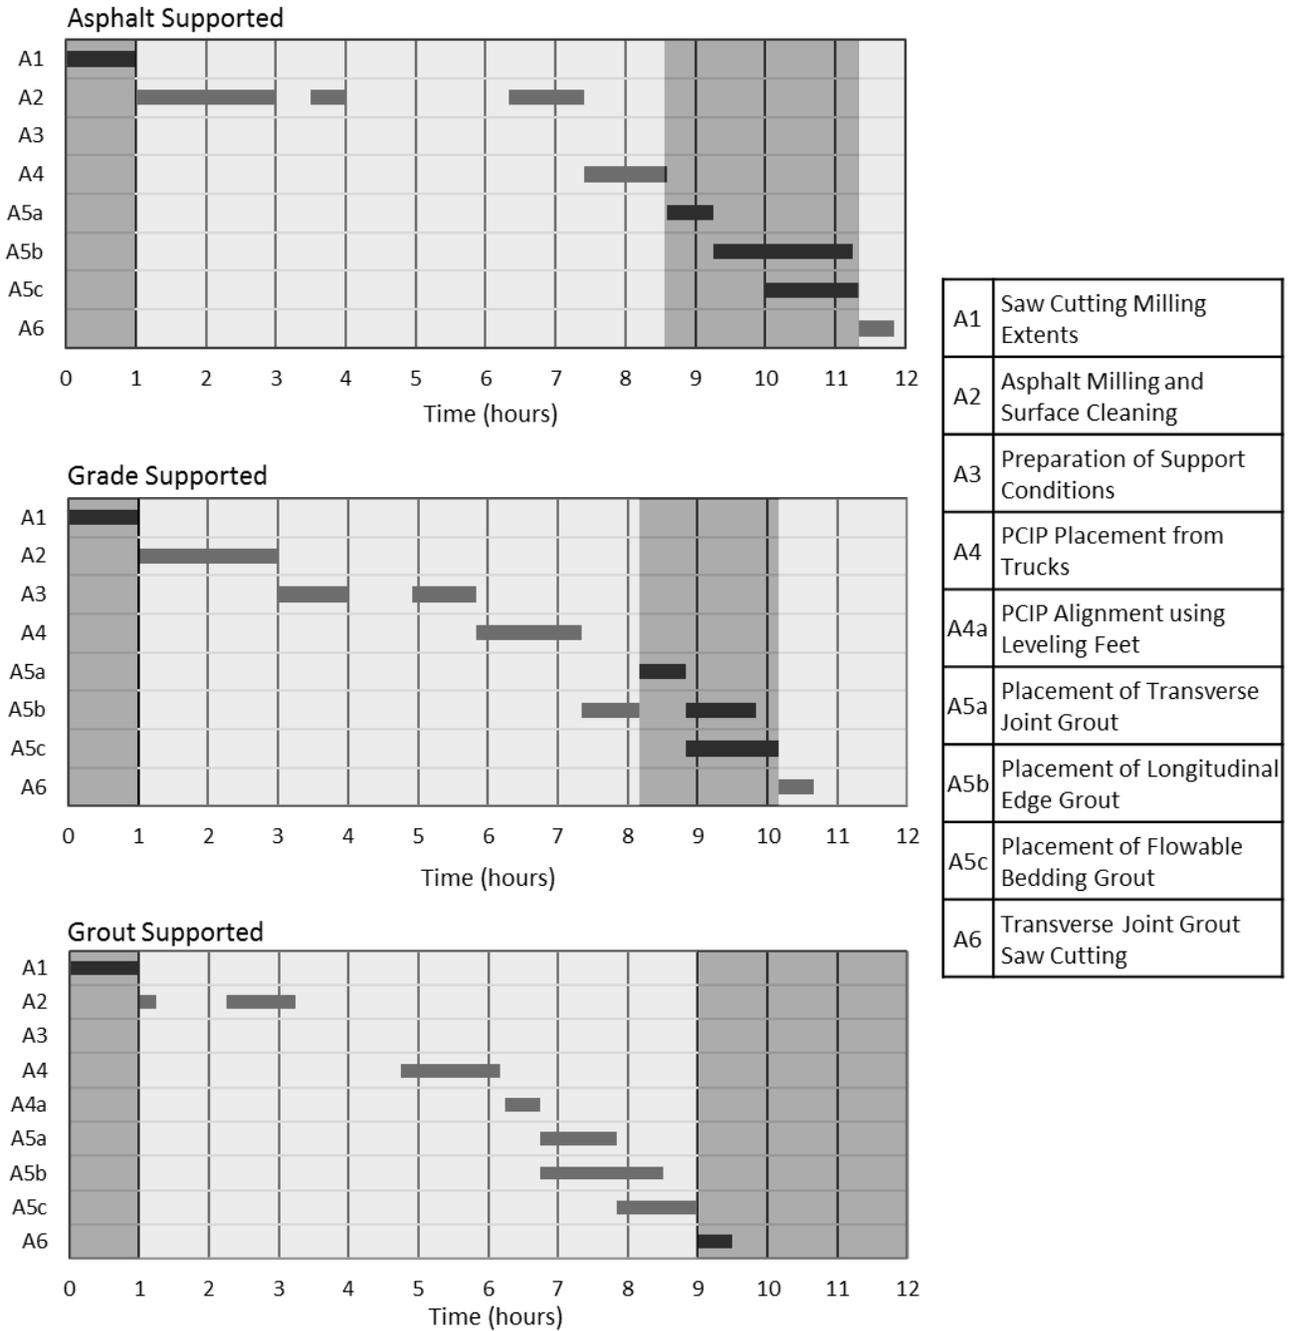
**Figure 5.36: Construction activity timing for each support condition**

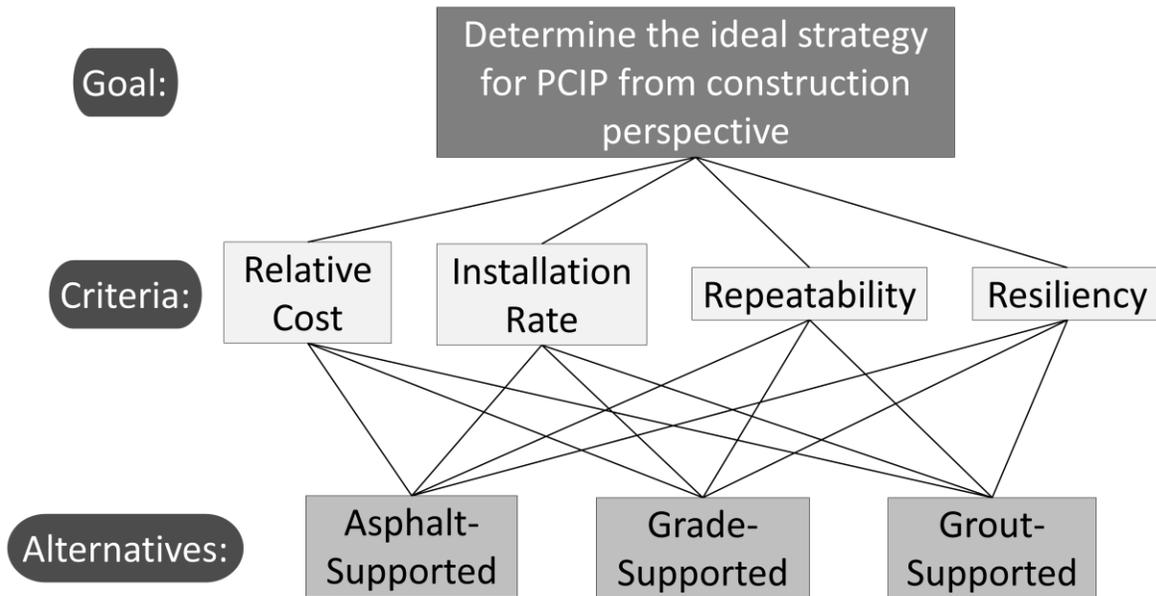
An AHP was implemented to rank the three support condition alternatives (AS, GraS, and GroS) based on four constructability criteria: relative cost, installation rate, repeatability, and resiliency. The AHP organizes the problem into a hierarchy that includes the goal, criteria, and alternatives, illustrated by Figure 5.37.

**Figure 5.37: AHP hierarchy for the PCIP evaluation**

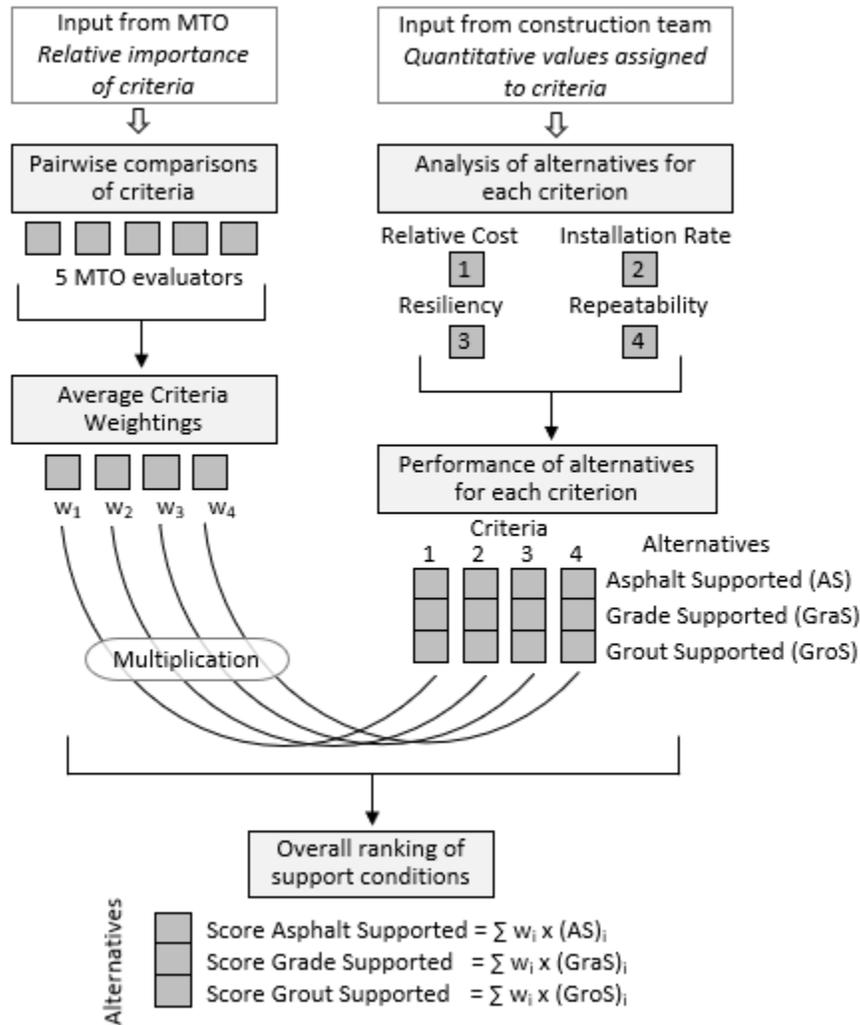
**Figure 5.38: Flow chart of AHP steps for ranking support conditions**

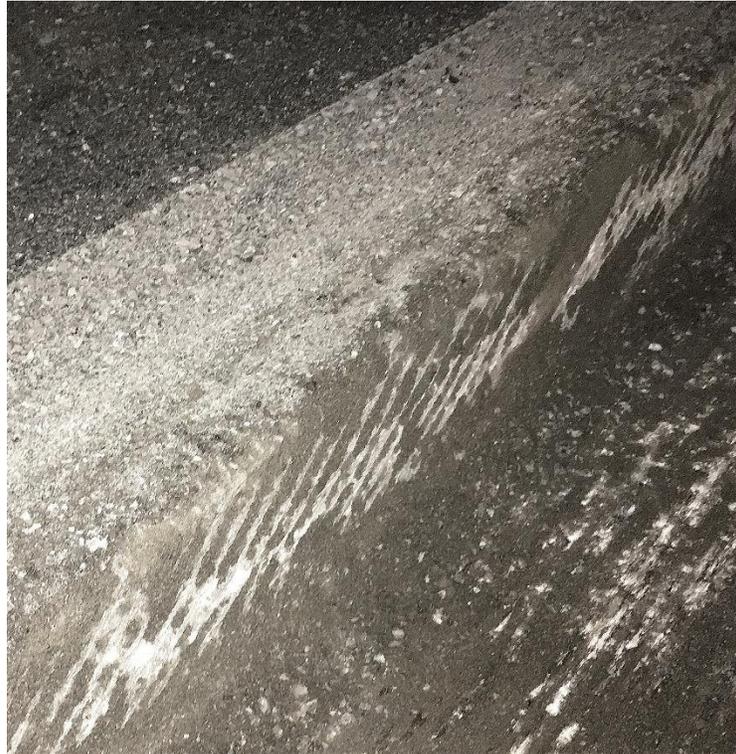
going forward. If the milling machine is not remotely guided using survey data, then at least a highly visible line denoting the extents of milling may be necessary.

**Figure 5.40: Vertical milled surface**

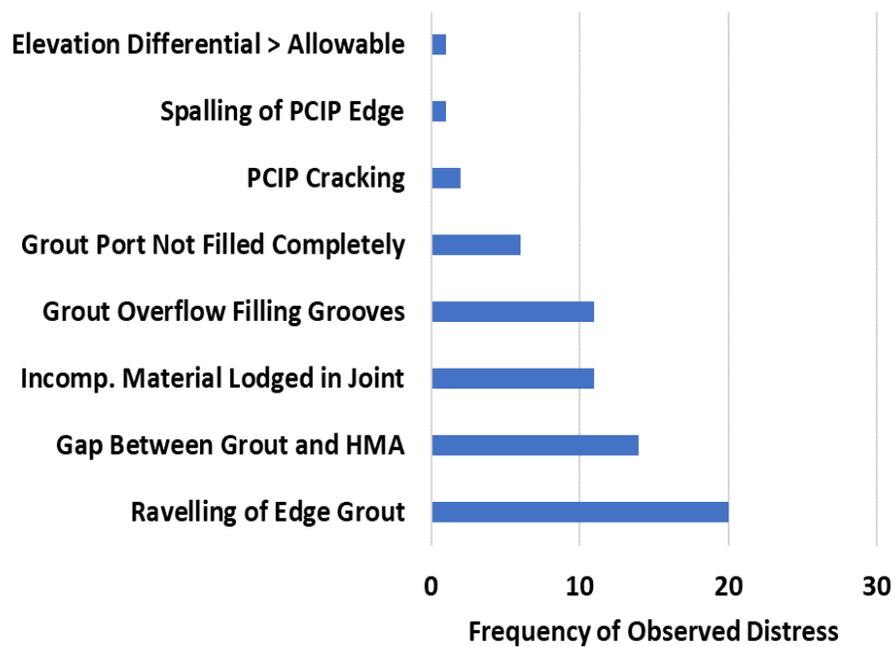
Figure 6.1 summarizes the distresses and issues that were observed on site and the frequency at which they were observed. In each case, the frequency represents the number of panels that showed the given concern out of the total 22 panels of the trial. The frequency does not represent the total number of instances of a given distress or issue.

**Figure 6.1: Frequency of observed distresses and issues on PCIP Trial Section (Sept. 6, 2017)**

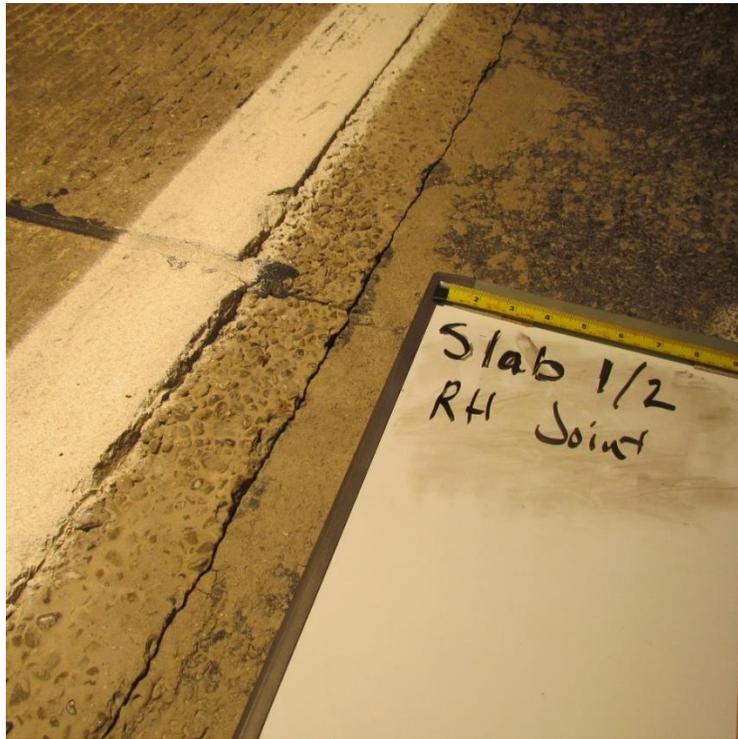
**Figure 6.3:** Edge grout/asphalt interface gap

Gaps between the grout and the adjacent asphalt were observed in 14 of the 22 panels of the project. This was probably due to the considerably different material behaviour characteristics under both temperature and traffic-related loading. Differential thermal strains along the interface could result in stresses larger than the shear capacity of the grout/asphalt interface. In areas where both ravelling and this gap were found, they appeared to compound, resulting in more severe material loss, as shown in Figure 6.4. This was commonly found where the transverse saw-cut, which was made as part of the joint-sealant application, extended through the edge grout.

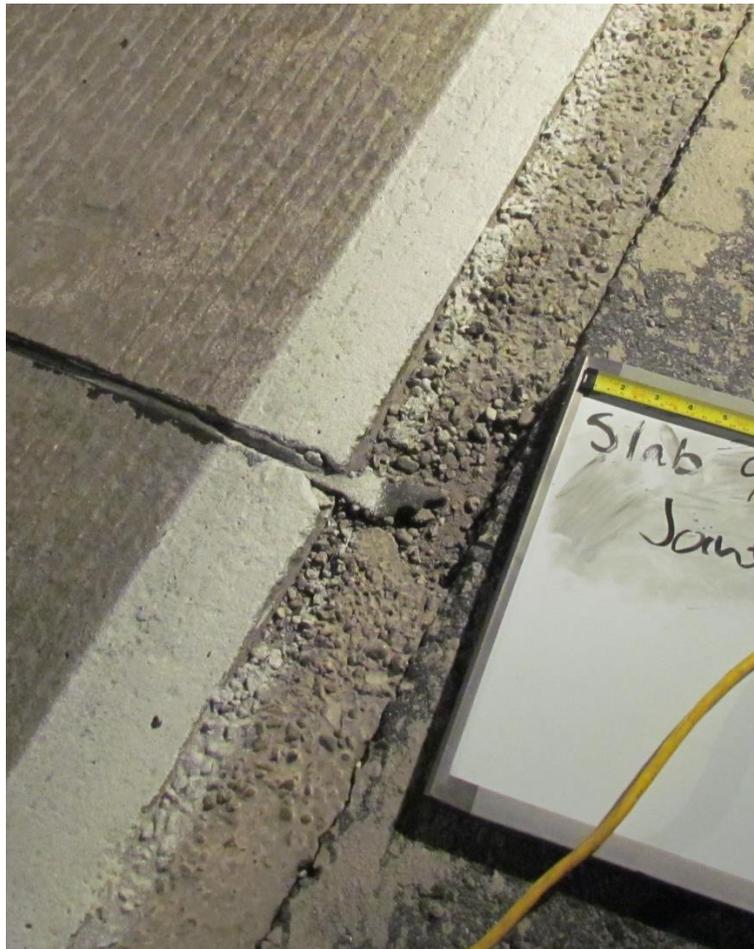
**Figure 6.4: PCIP/HMA gap and severe ravelling**

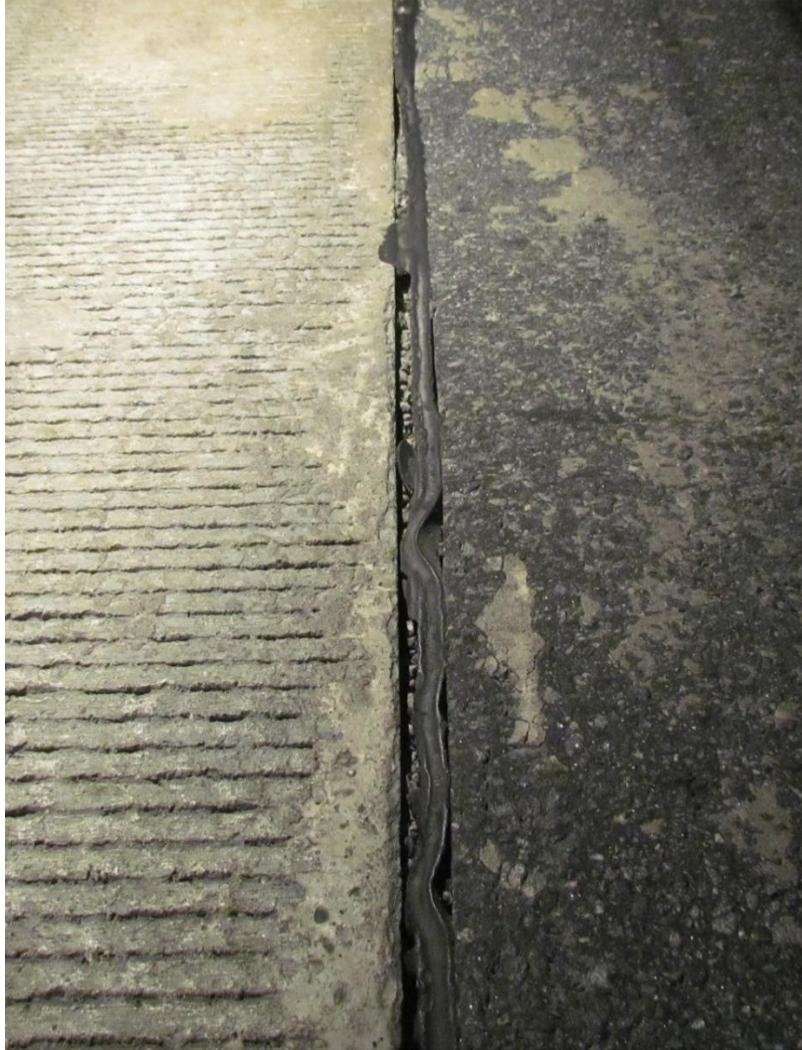
This deterioration results in the sealant becoming effectively useless and a substantial means of ingress for surface water to reach the bottom of the panels. If the deterioration continues, it will eventually effect the ride quality of the pavement; a wider gap will result in an impact as the vehicle's tires hit the corner of the HMA pavement. The presence of water and increased impact forces from vehicle wheels hitting the HMA corner could lead to accelerated deterioration of the HMA in the area.

**Figure 6.5: Final transverse joint between PCIP and HMA (right wheel path)**

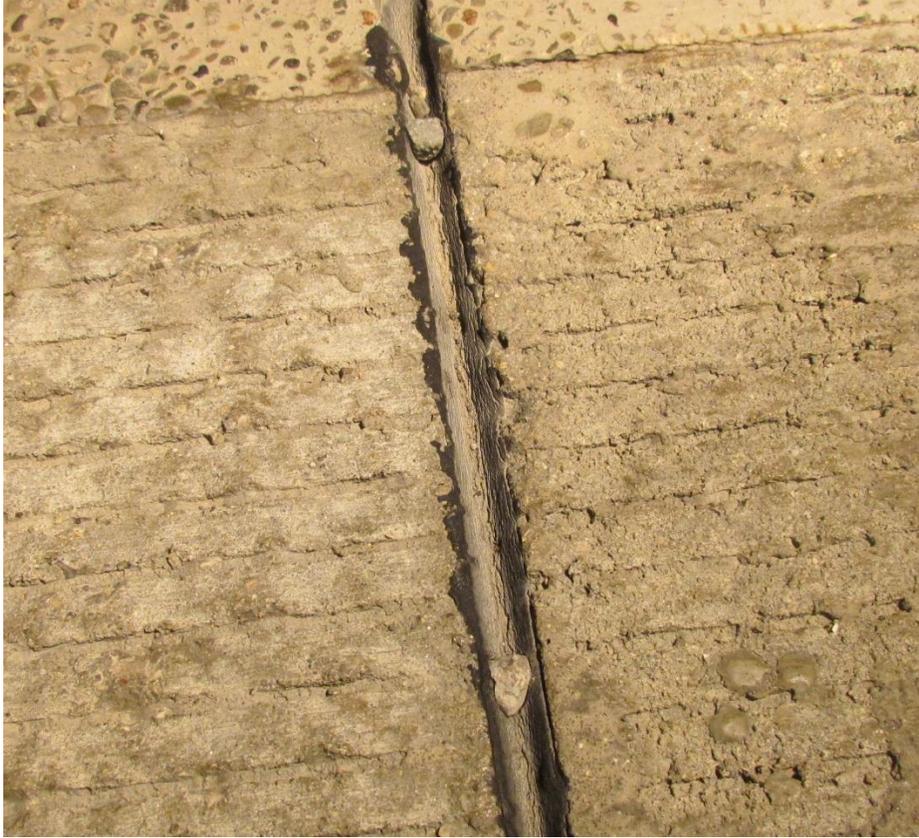
**Figure 6.6: Incompressible materials lodged in transverse joint**

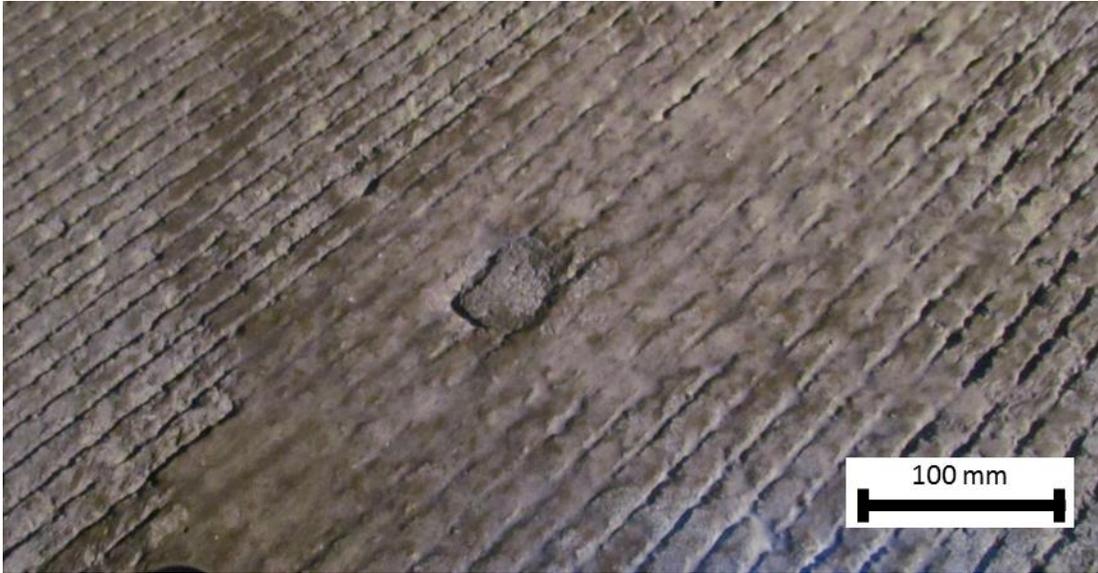
Throughout the trial, there was evidence of overflows during sub-surface grout injection. Grout was observed to fill the tined surface texture in the areas surrounding grout ports and at panel edges. Generally the affected areas surrounding grout ports were quite small, with diameters of

**Figure 6.7: Grout overflow at injection port**

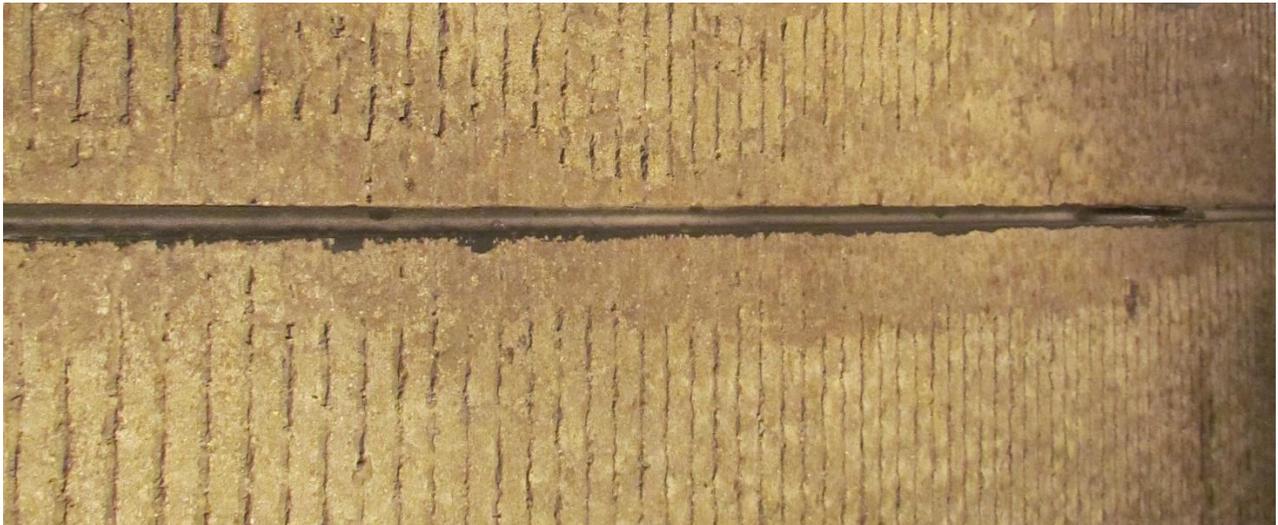
**Figure 6.8: Grout overflow at transverse joint**

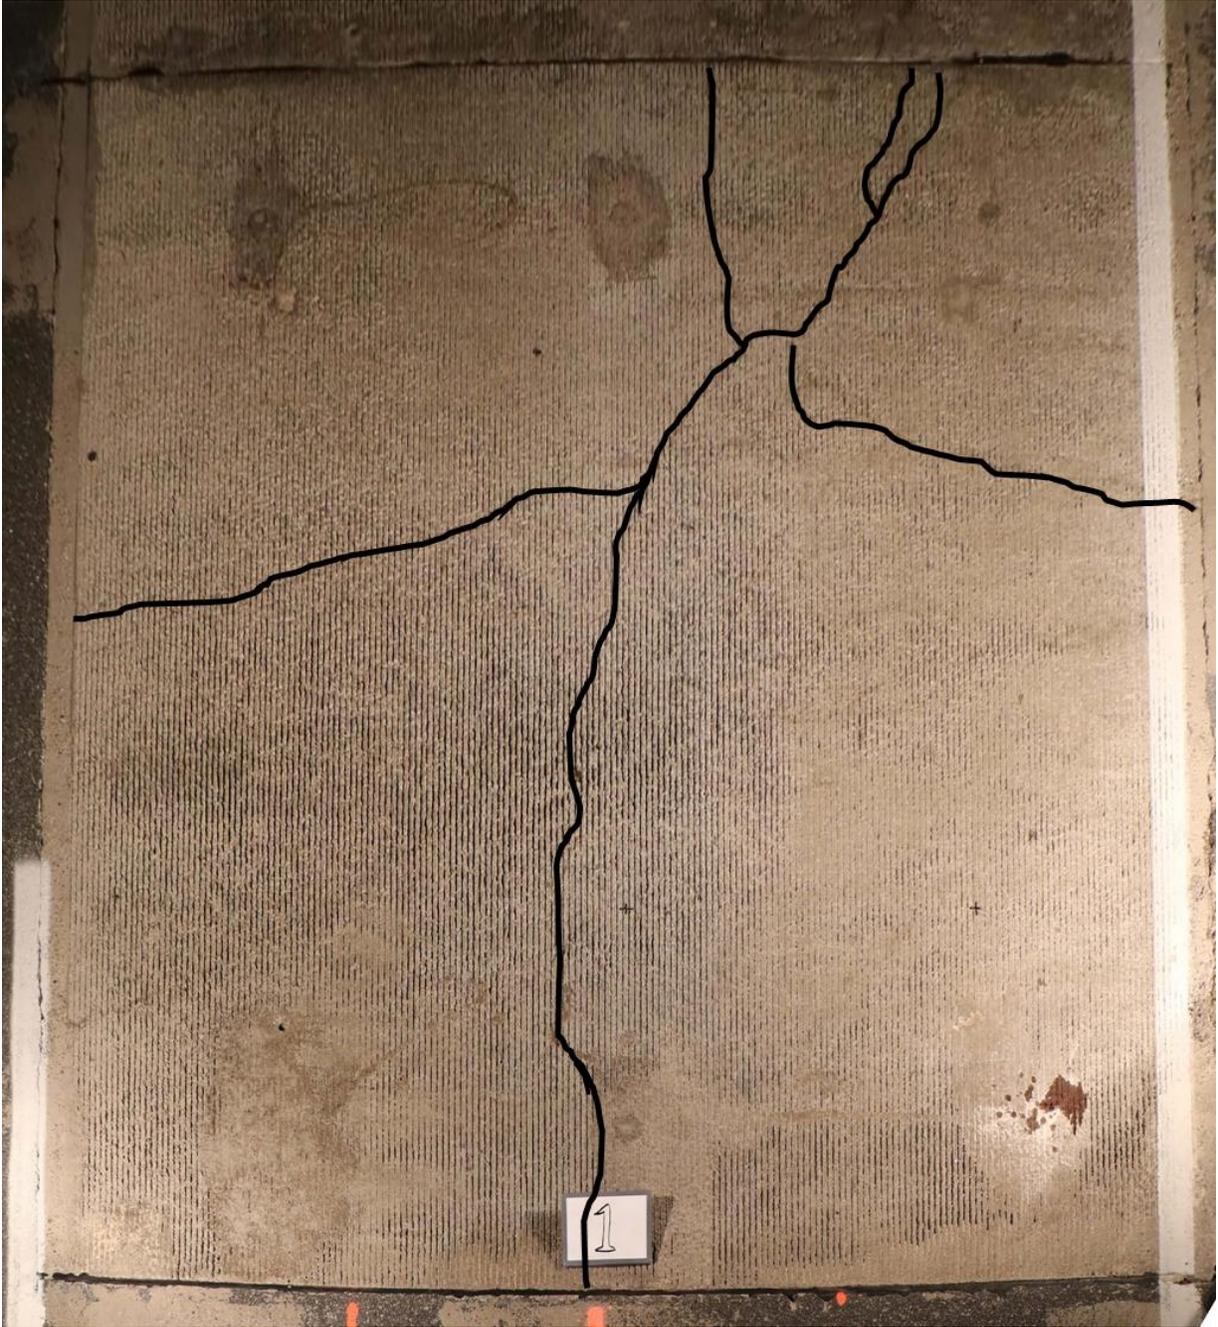
**Figure 6.9:** Cracking observed in Panel #1 (cracks highlighted for clarity)
