**Precast Concrete Inlay Panels:  
Rehabilitation Strategy for  
High-Volume Highways in Ontario**

A thesis  
presented to the University of Waterloo  
in fulfilment of the  
thesis requirement for the degree of  
Doctor of Philosophy  
in  
Civil Engineering

Waterloo, Ontario, Canada, 2018

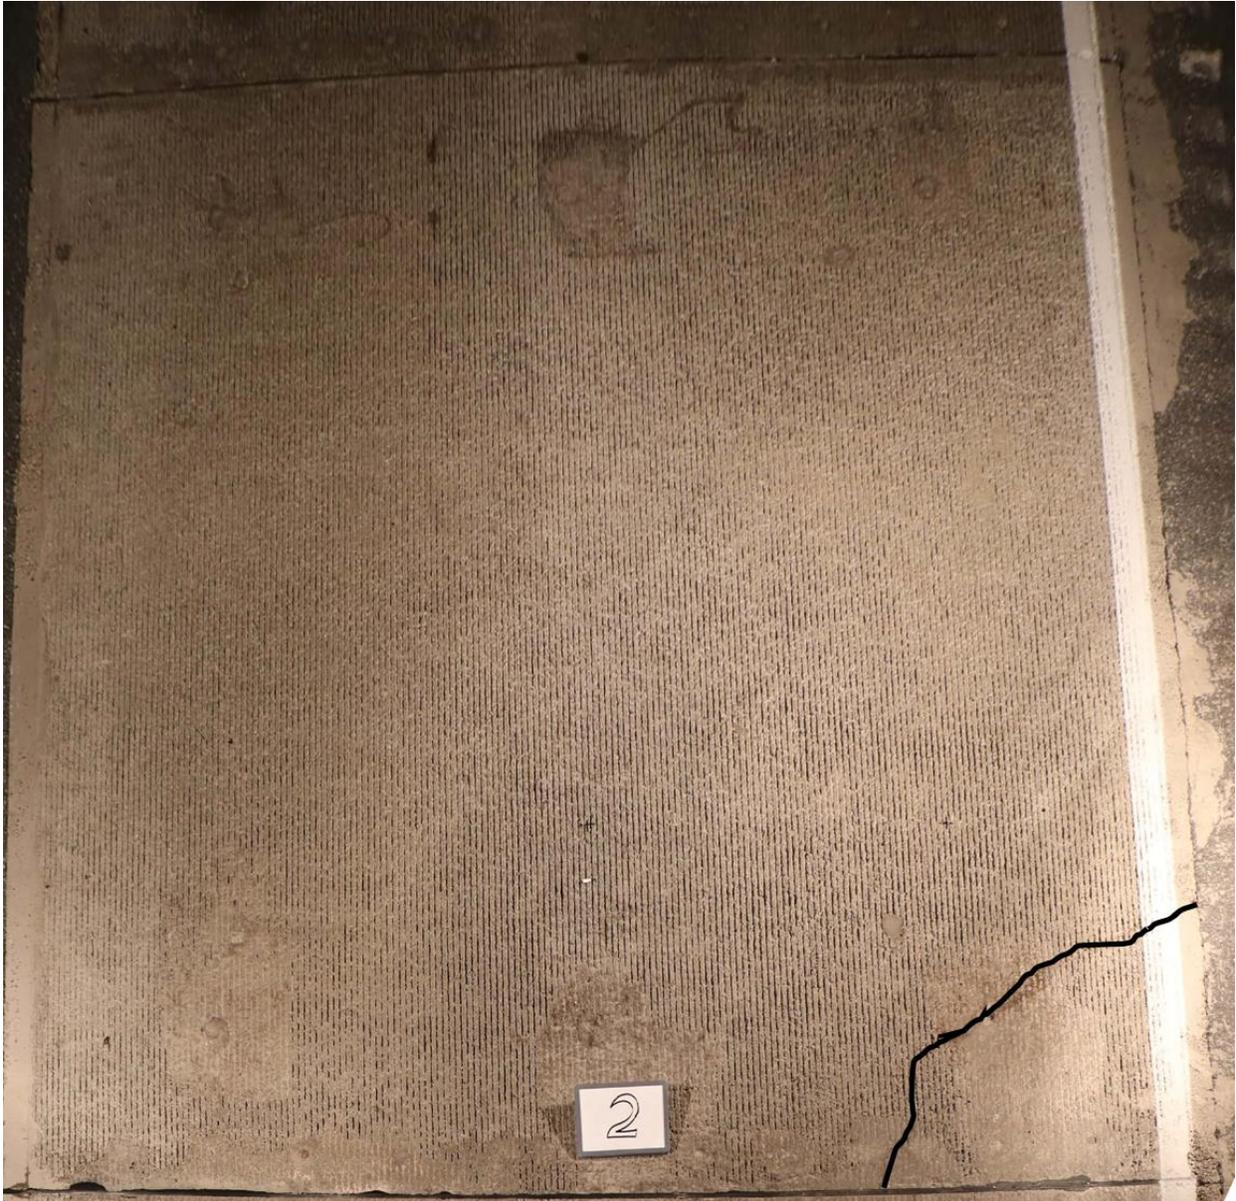
**Figure 6.10: Cracking observed in Panel #2 (crack highlighted for clarity)**

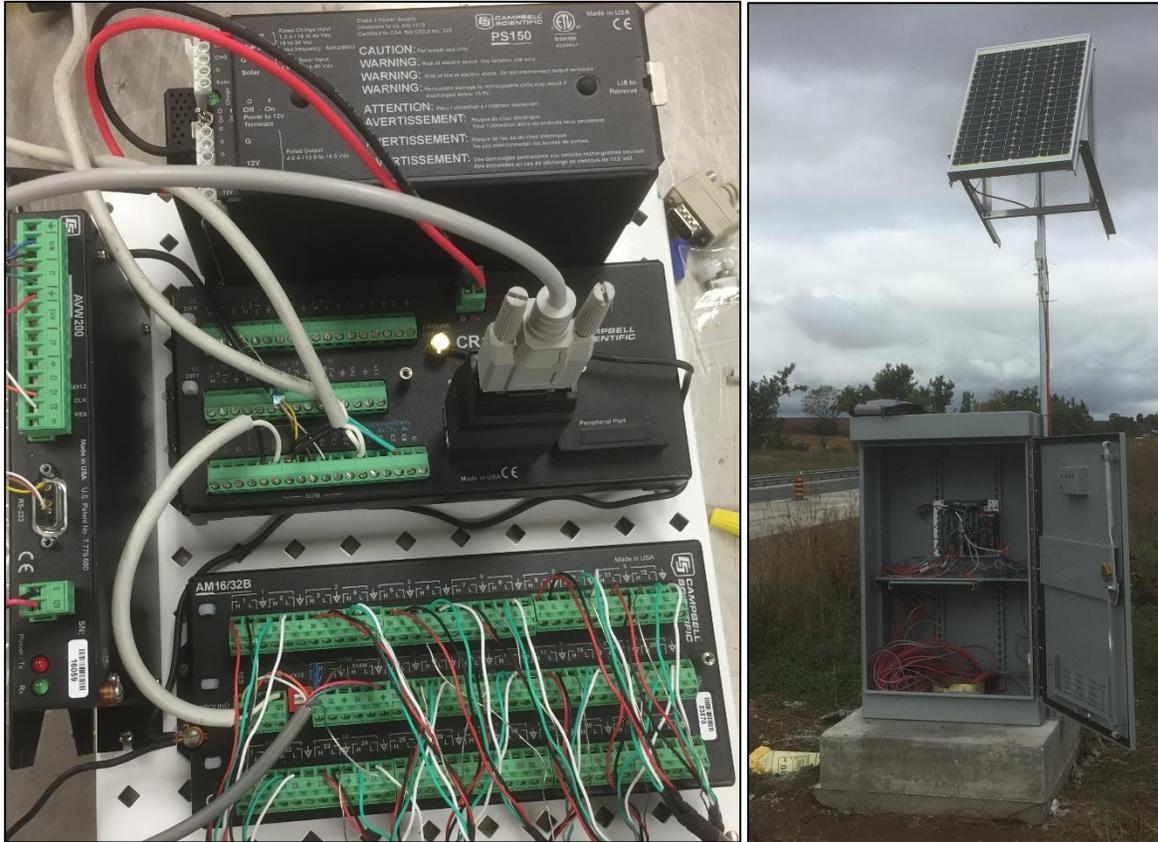
**Figure 6.13: Data logging equipment setup (left), installation on site (right)**

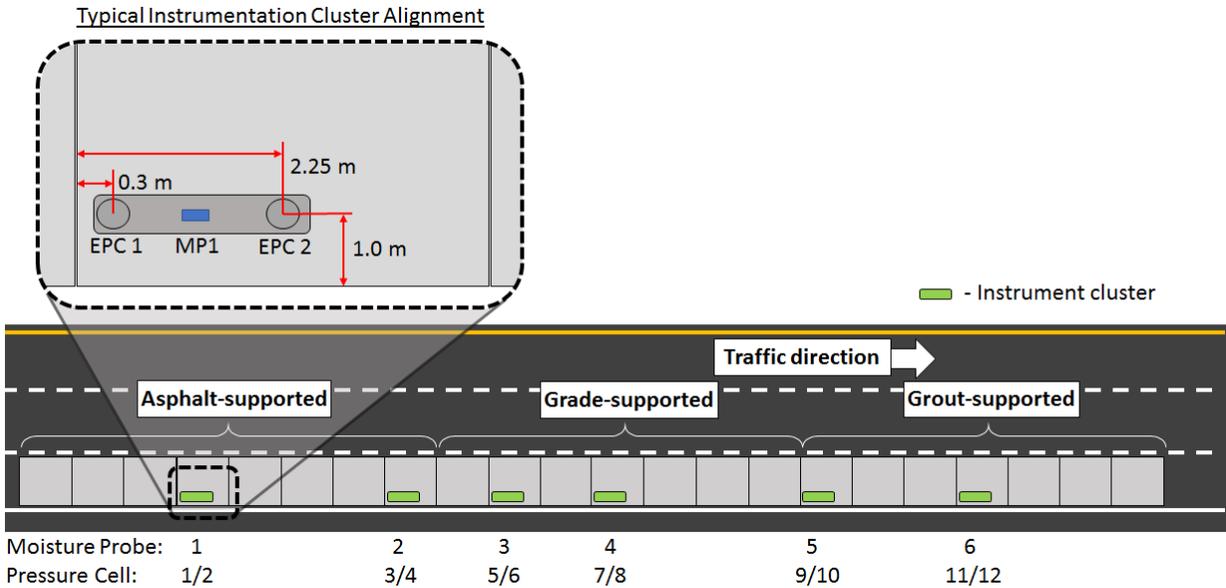
**Figure 6.14: Project instrumentation schematic**

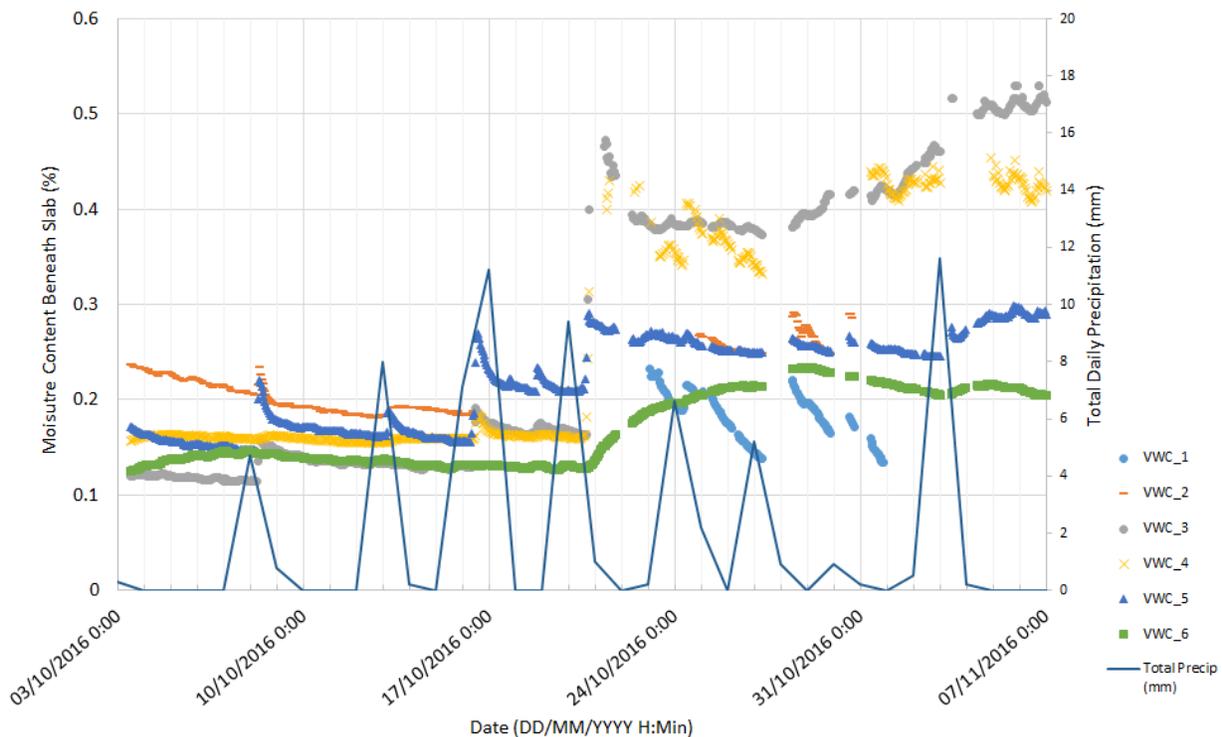
**Figure 6.17: Volumetric water content October 3 – November 7, 2016**

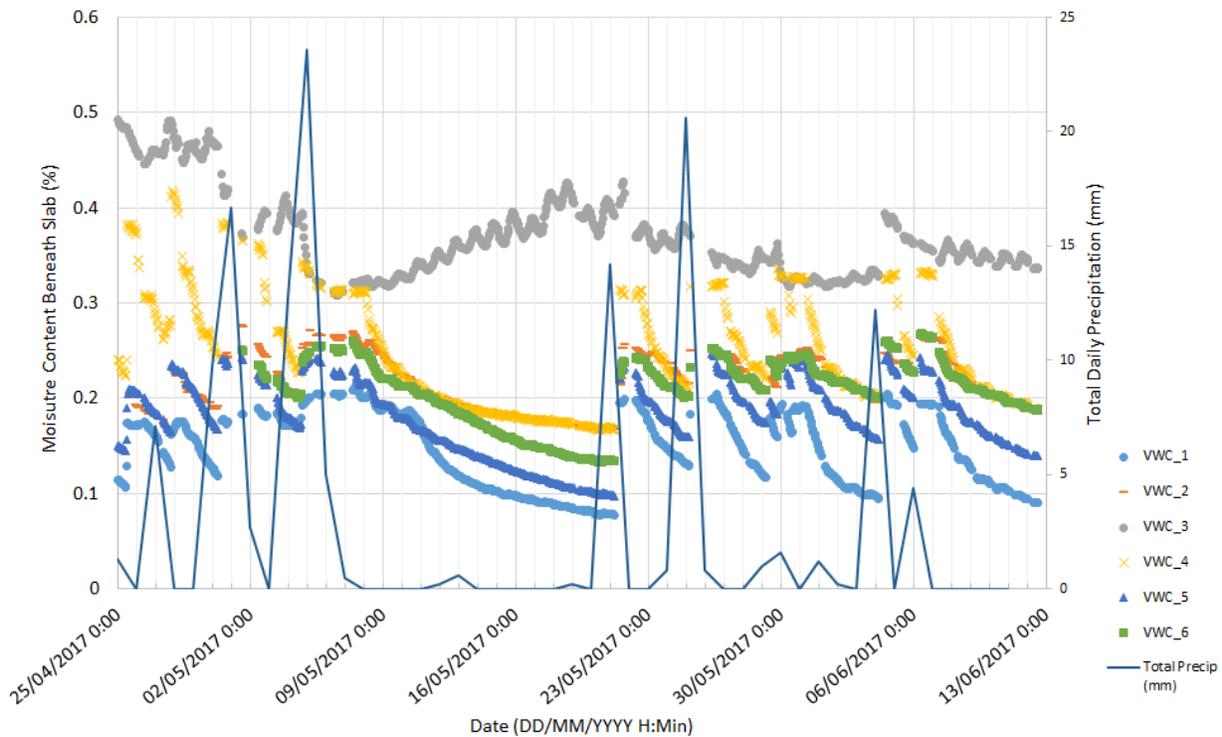
**Figure 6.18: Volumetric water content April 25 to June 13, 2017**

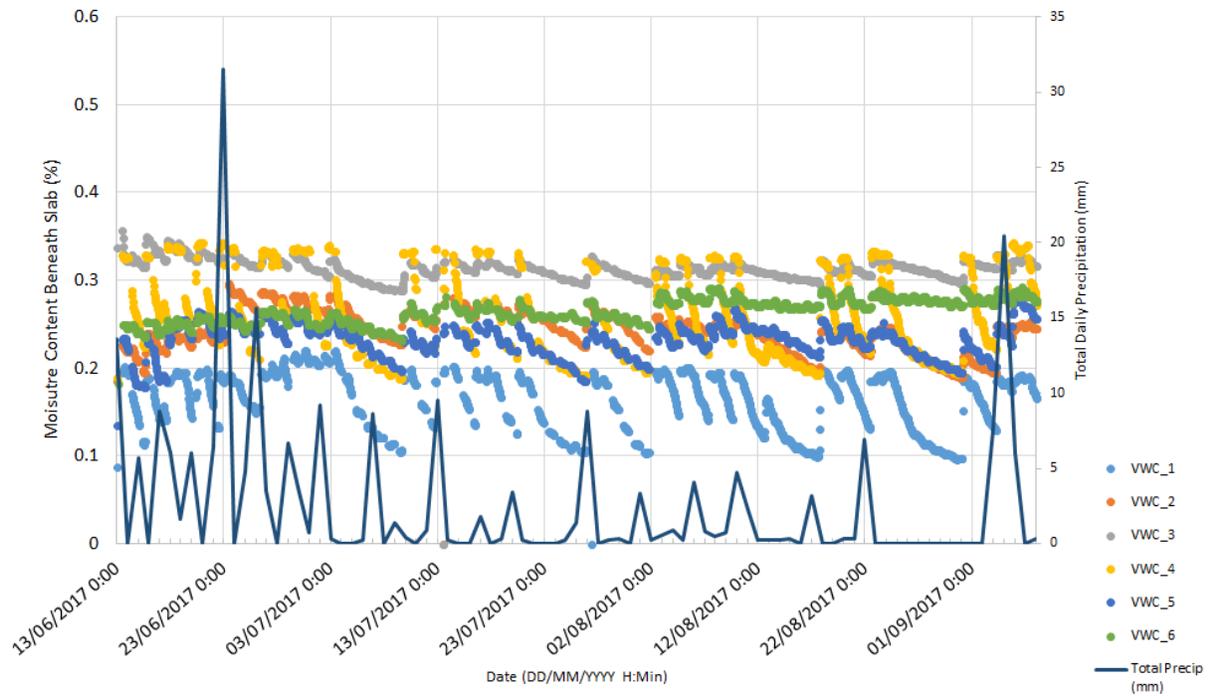
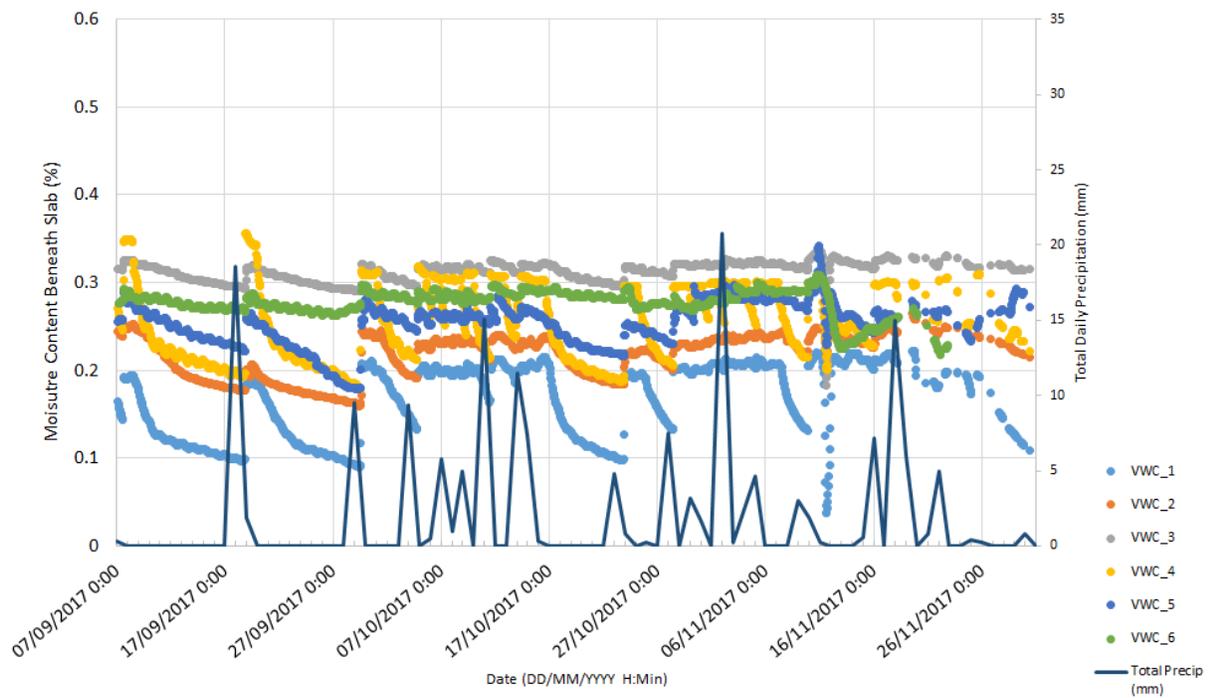
**Figure 6.19: Volumetric water content June 13, 2017 to November 30, 2017**

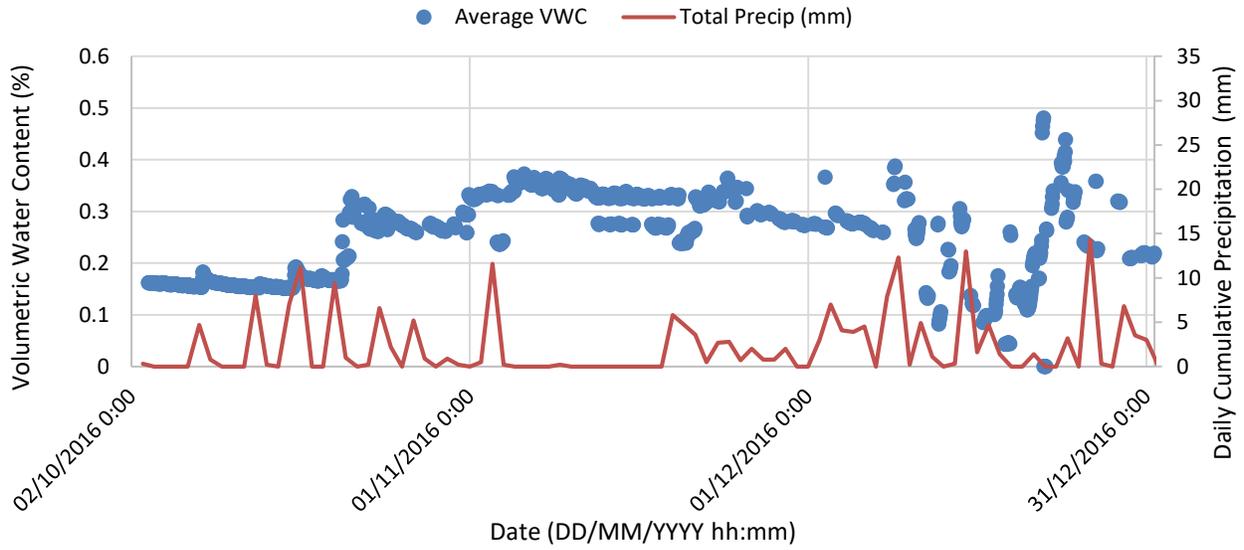
**Figure 6.20: Average volumetric moisture content and daily precipitation for 2016**

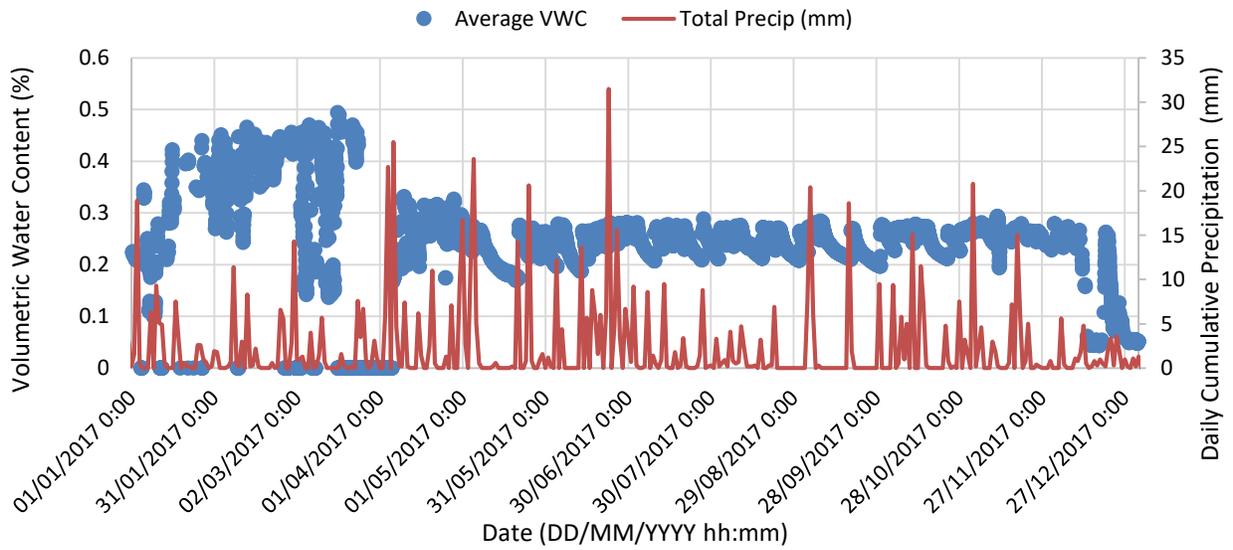
**Figure 6.21: Average volumetric moisture content and daily precipitation for 2017**

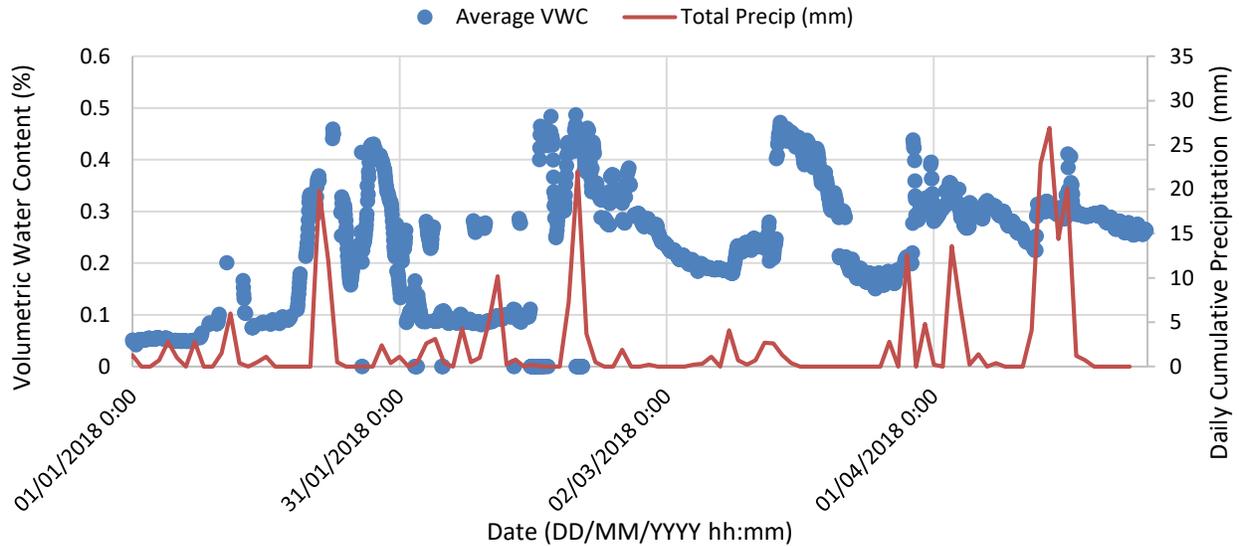
**Figure 6.22: Average volumetric moisture content and daily precipitation for 2018**

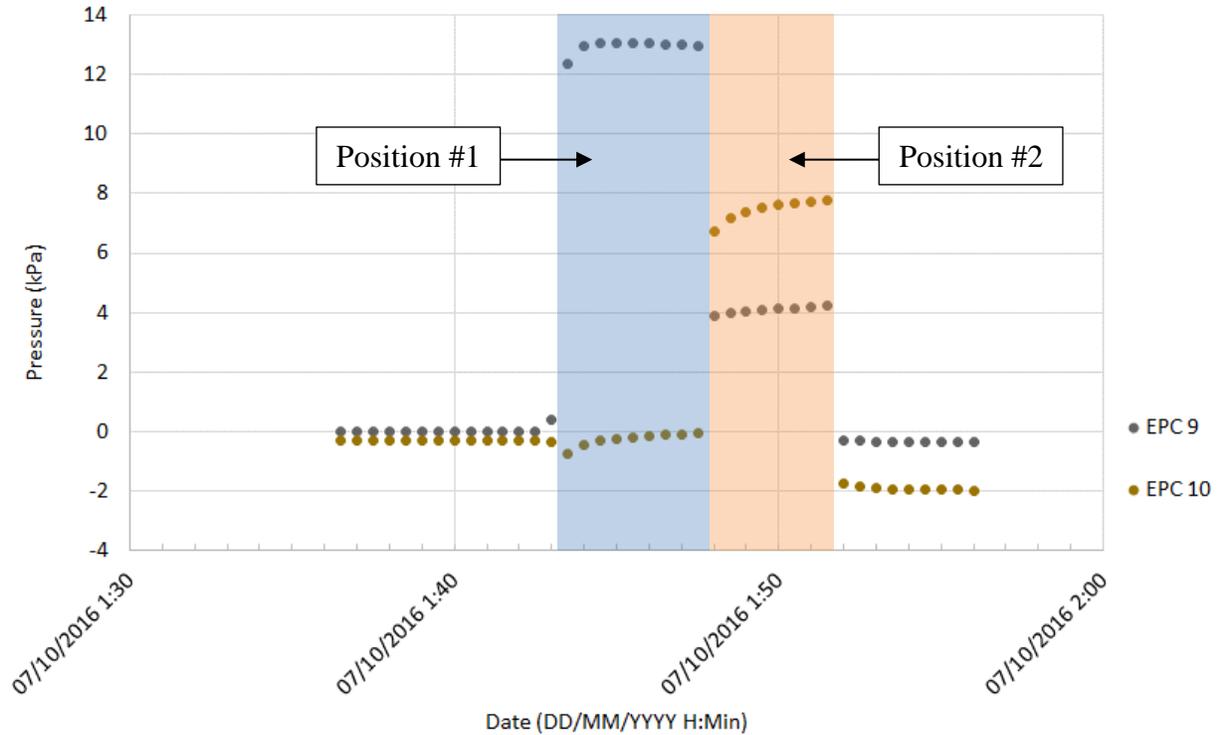
**Figure 6.23: Static load test results for panel instrumented with EPC 9/10**

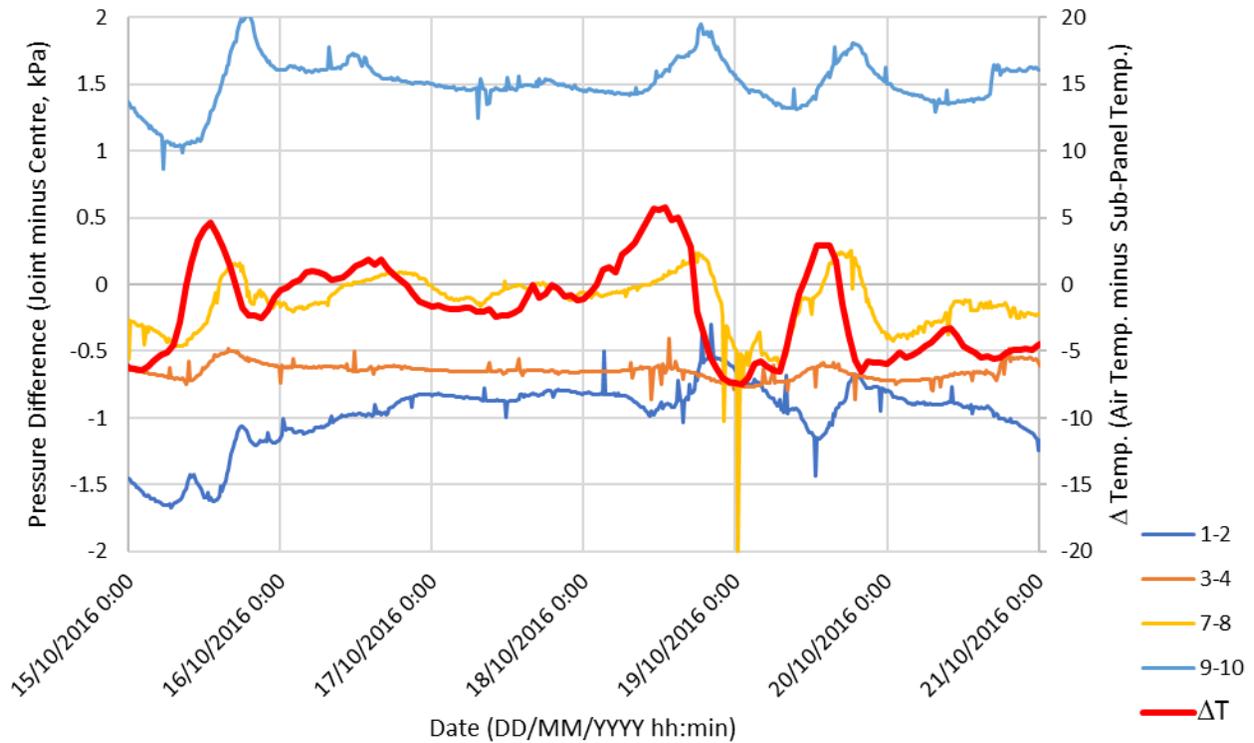
**Figure 6.25: Instrument cluster pressure differences and temperature differential (Oct 2016)**

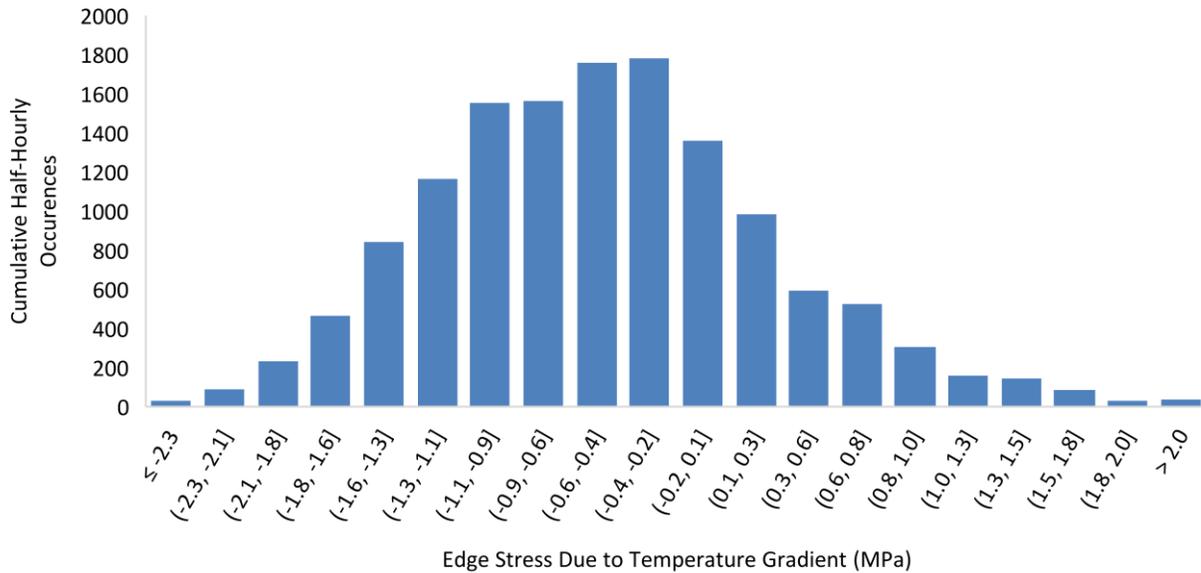
**Figure 6.29: Edge stress distribution 24/04/2017 to 24/04/2018 (half hour intervals)**

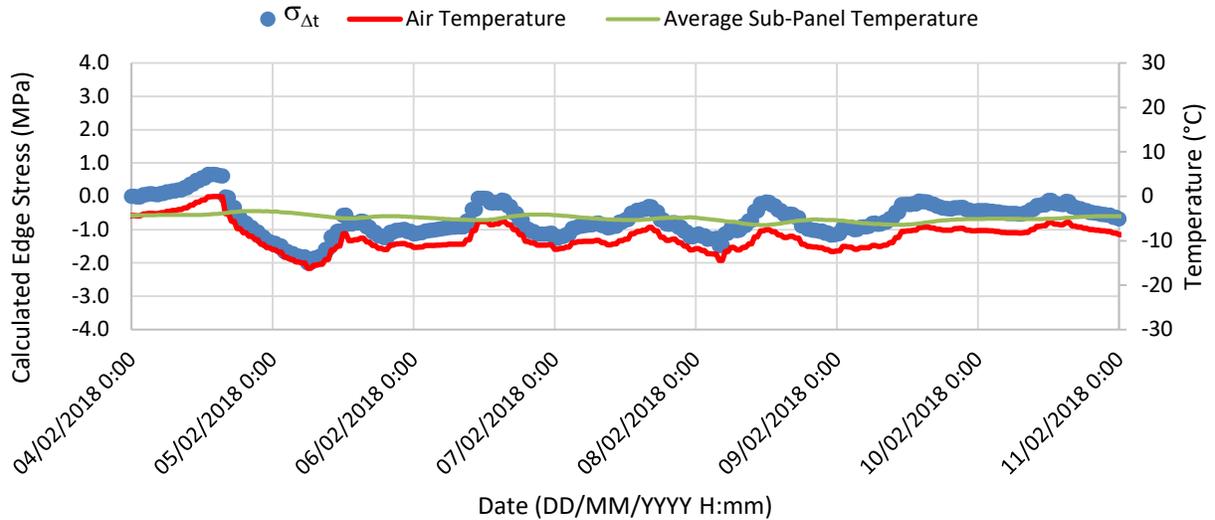
**Figure 6.32: Calculated edge stress during cold weather period (04/02/2018 – 11/02/2018)**

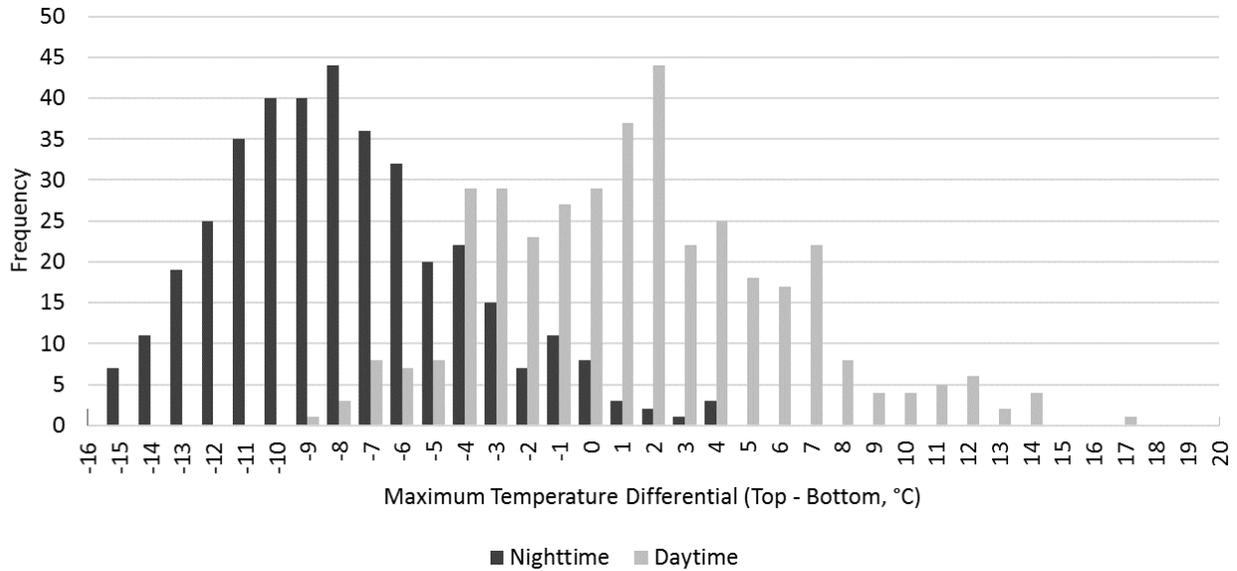
**Figure 6.33: Daily maximum and minimum temperature differentials, October 3, 2016 – October 3, 2017**

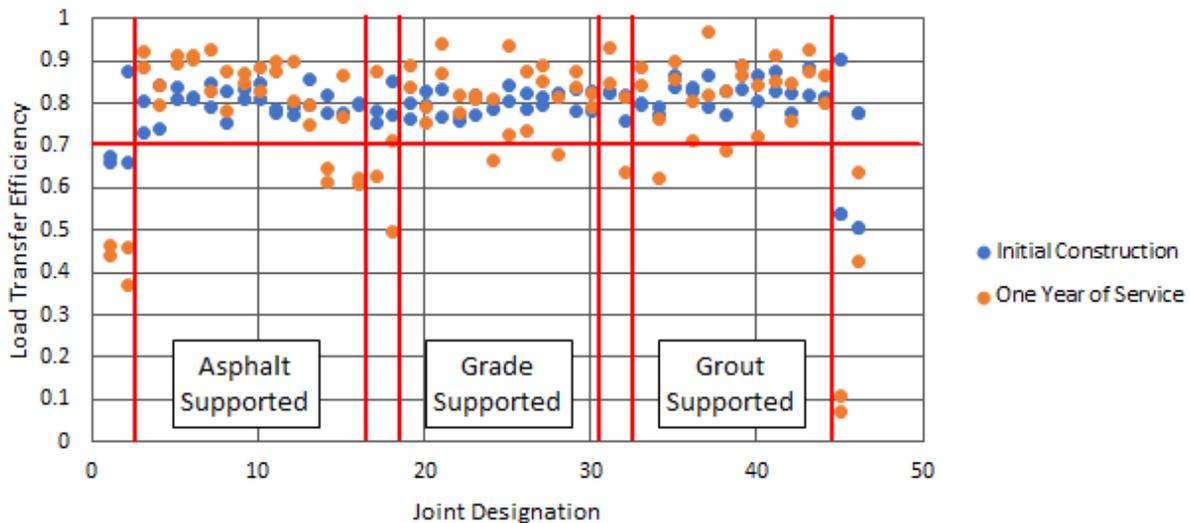
**Figure 6.35:  $LTE_{\delta}$  results for Oct. 6, 2016 (Initial Construction) and Sept. 19, 2017 (One Year of Service)**

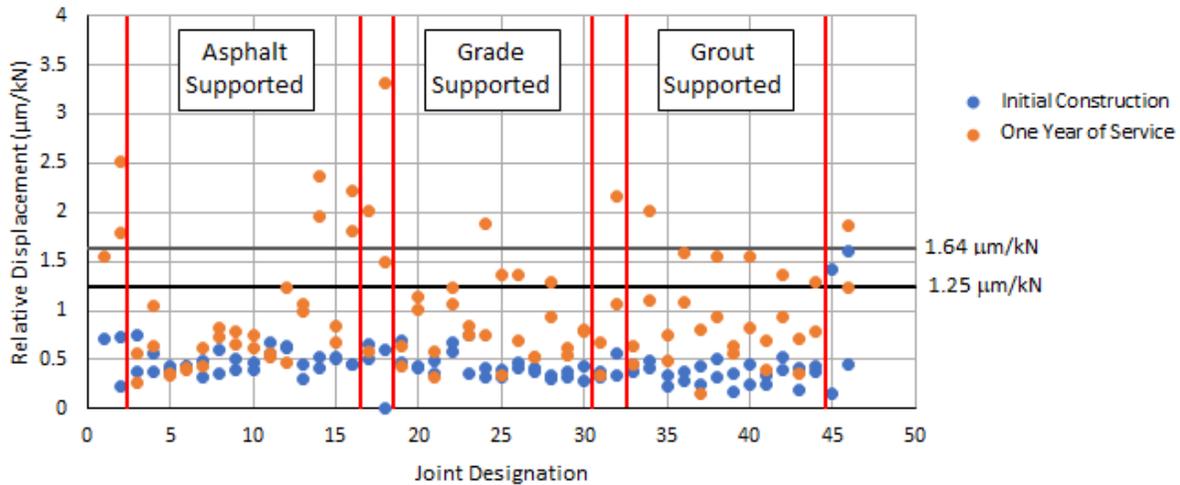
**Figure 6.37: RD<sub>75</sub> Results for Oct. 6, 2016 (Initial Construction) and Sept. 19, 2017 (One Year of Service)**

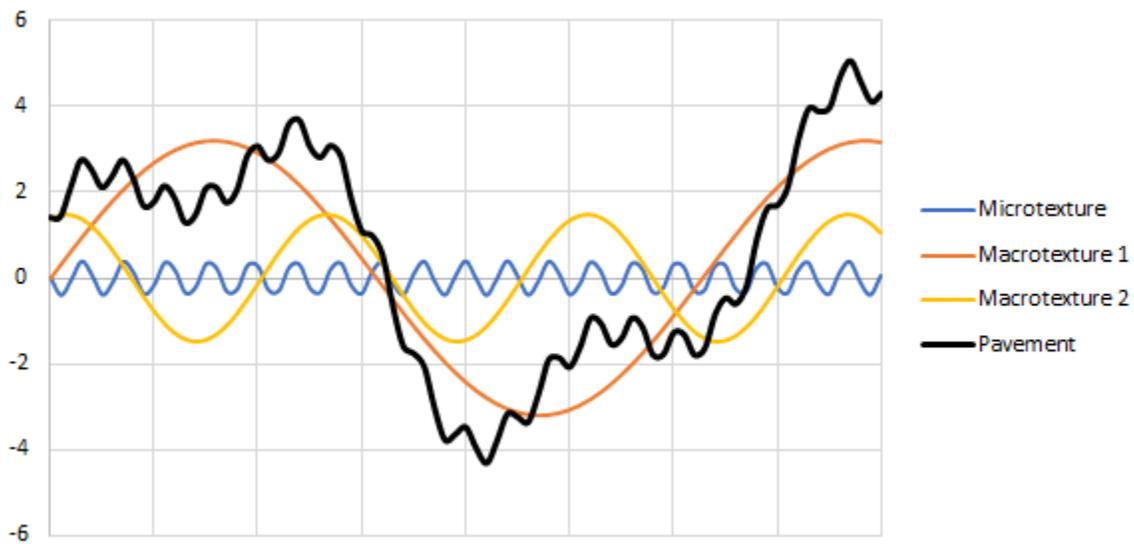
**Figure 6.41: Simplified pavement surface as combination of different sine waves**

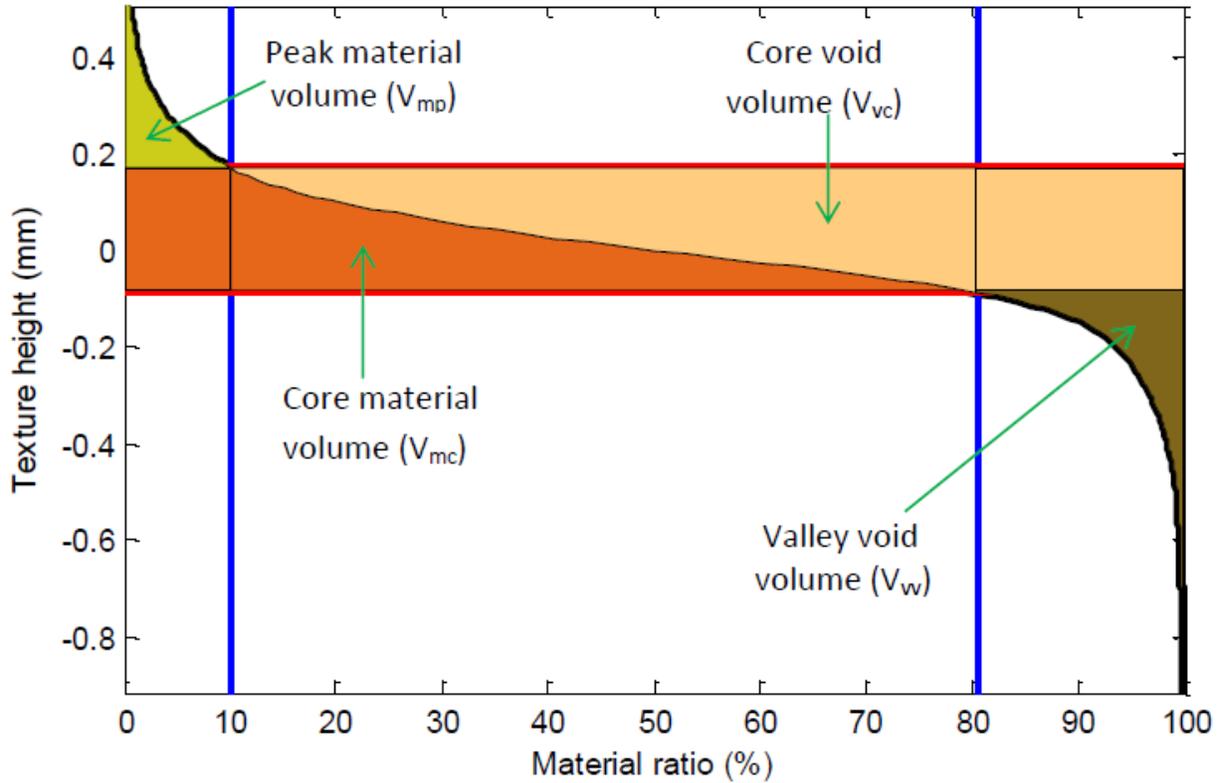
**Figure 6.42: Material bearing area curve for pavement texture (Liu, 2015)**

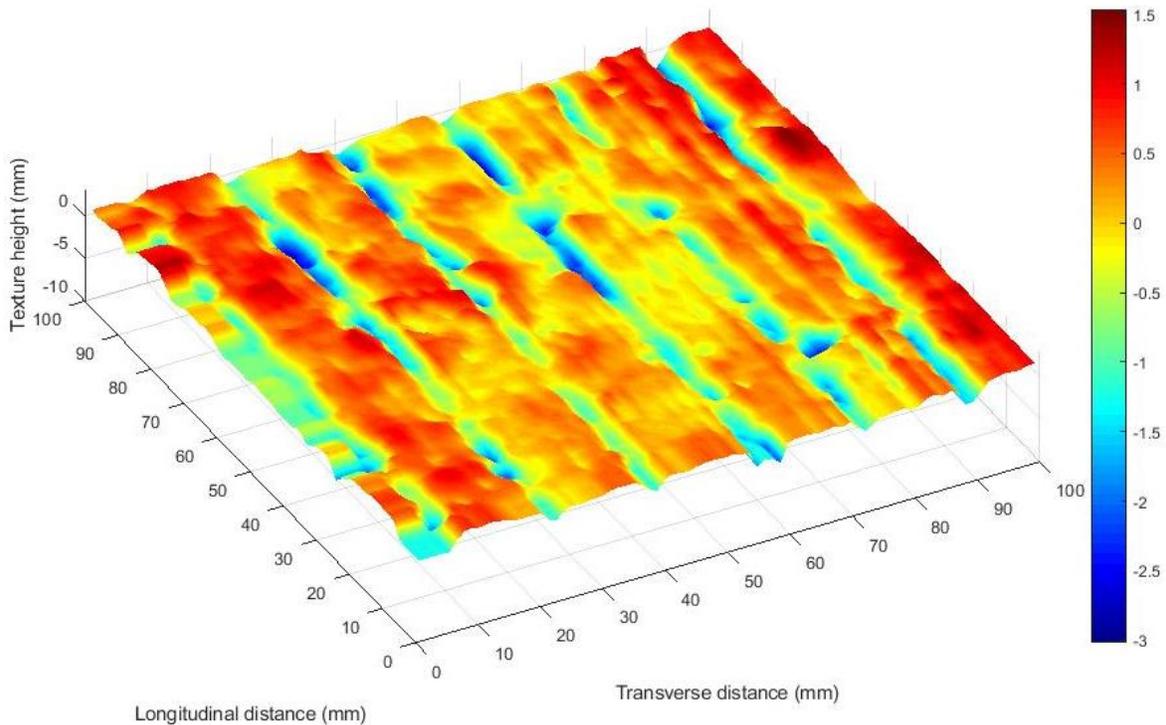
**Figure 6.44: Recovered 3-D surface texture height map of right wheel path on Panel #1**

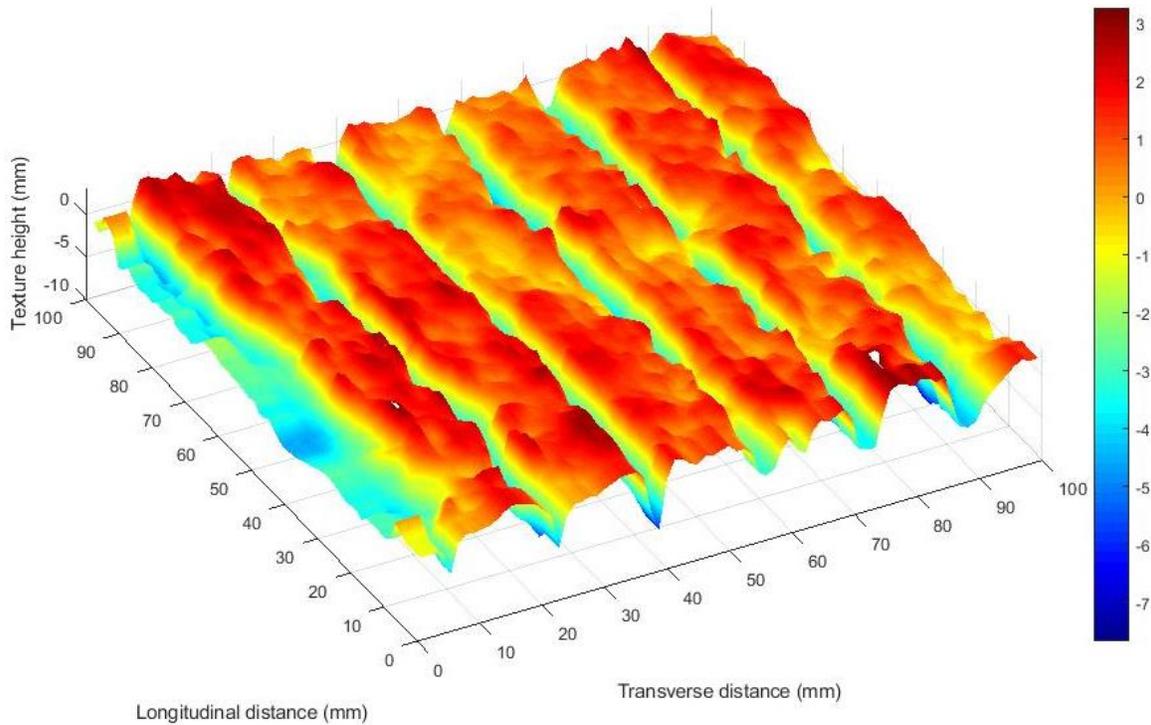
**Figure 6.45: Recovered 3-D surface texture height map of centre of Panel #1**

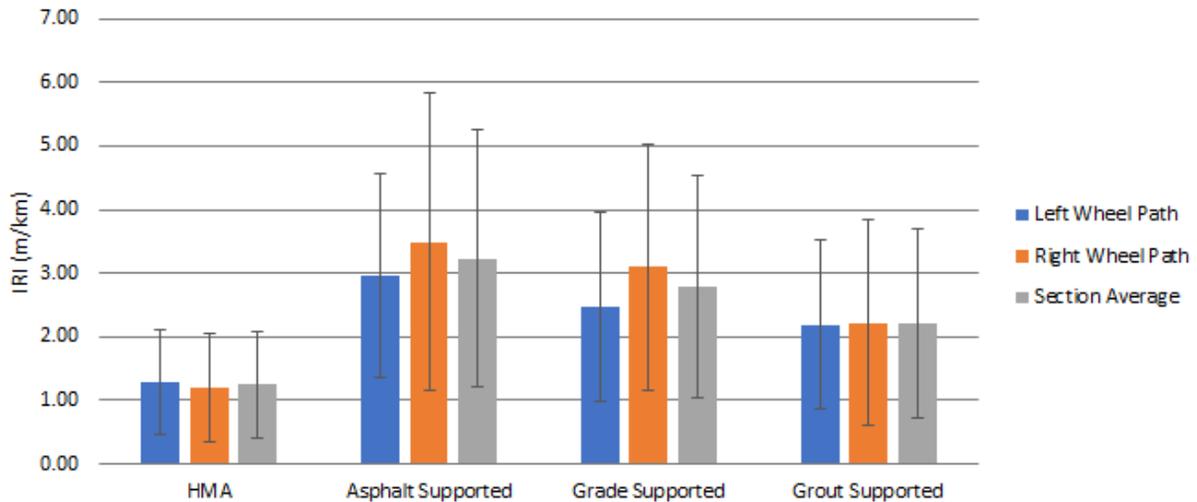
**Figure 6.55: Average IRI values for each section of the trial section**

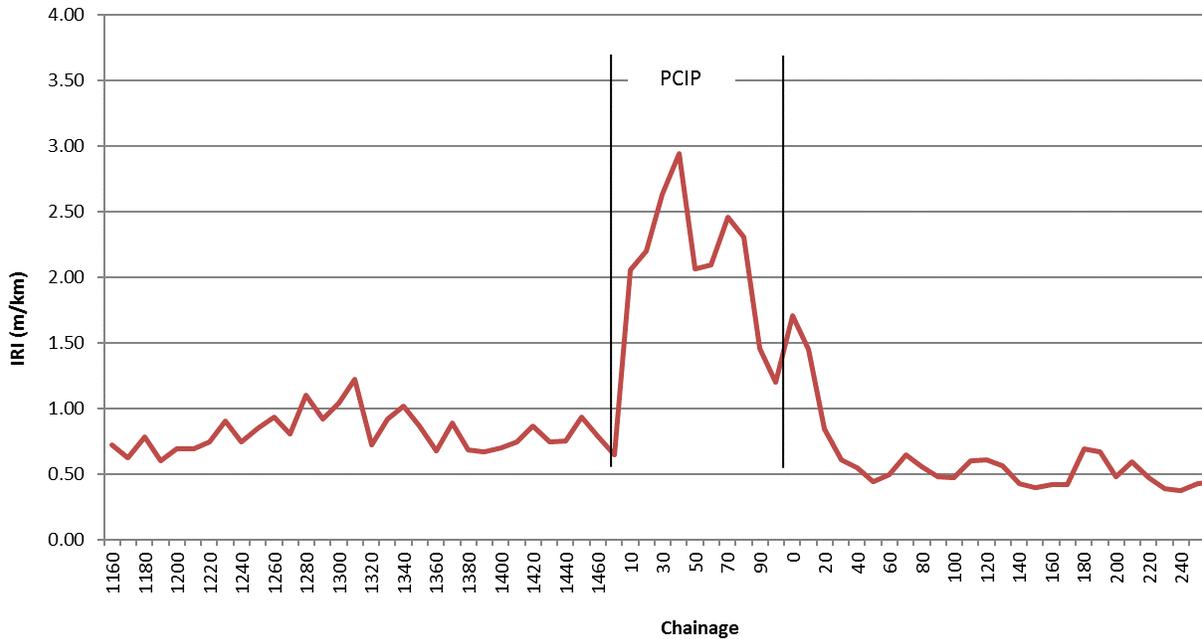
**Figure 6.56: IRI values on 10 m intervals for one data collection pass (ARAN)**

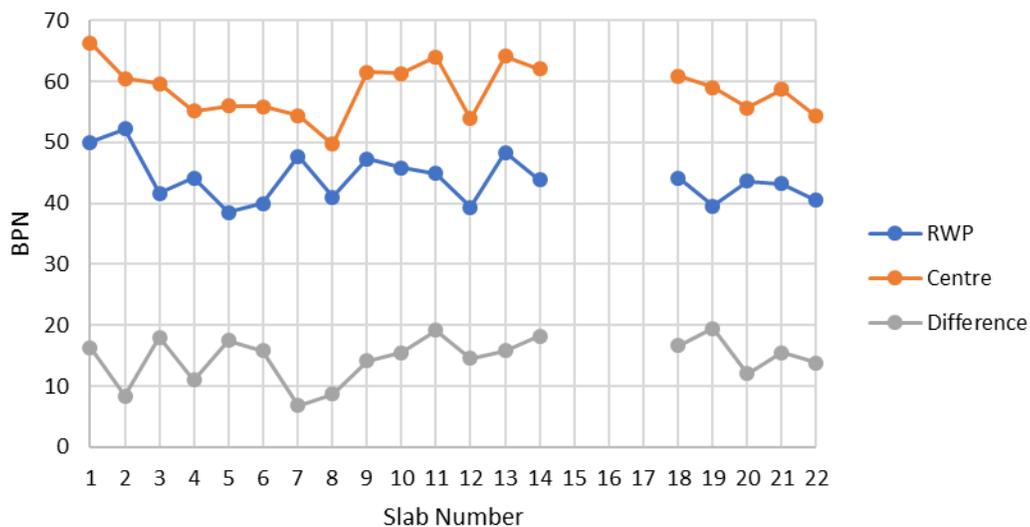
**Figure 6.61: British Pendulum Results for In-Situ Testing (Sept. 6, 2017)**

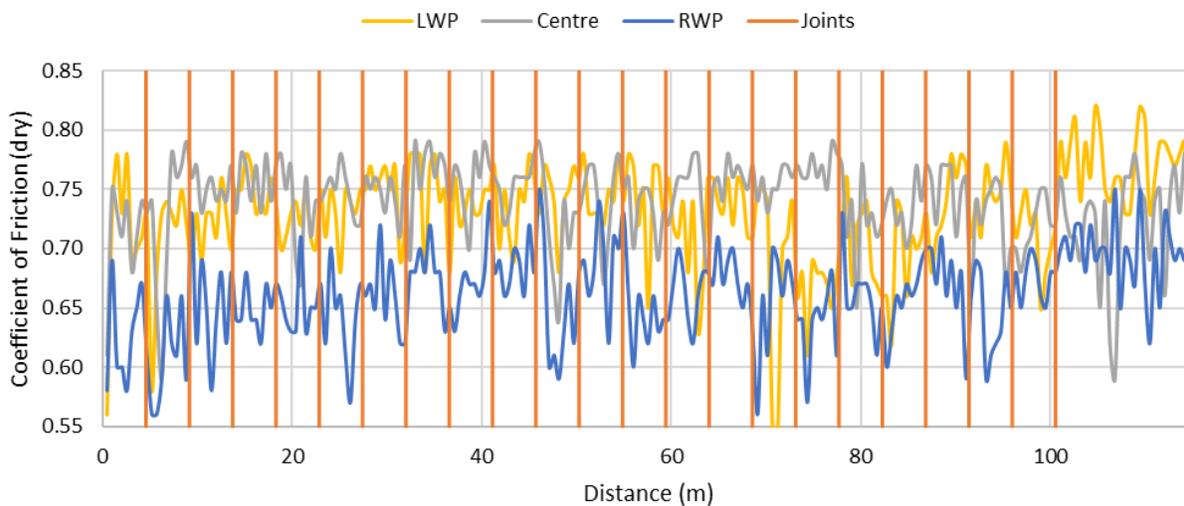
**Figure 6.63: Coefficient of Friction (dry) for PCIP Trial (Sept. 6, 2017)**

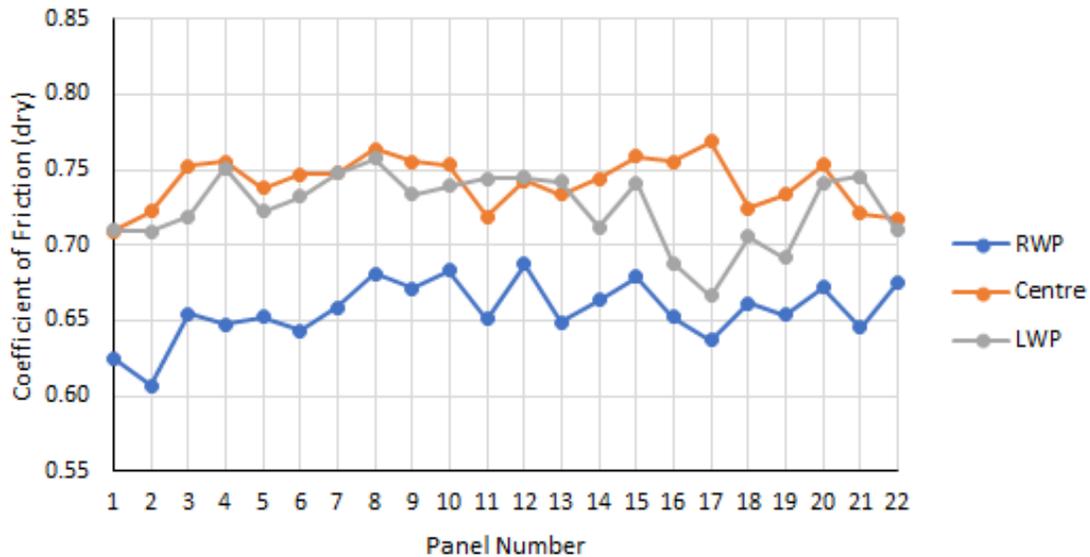
**Figure 6.64: Average coefficient of friction (dry) per panel for PCIP Trial (Sept. 6, 2017)**

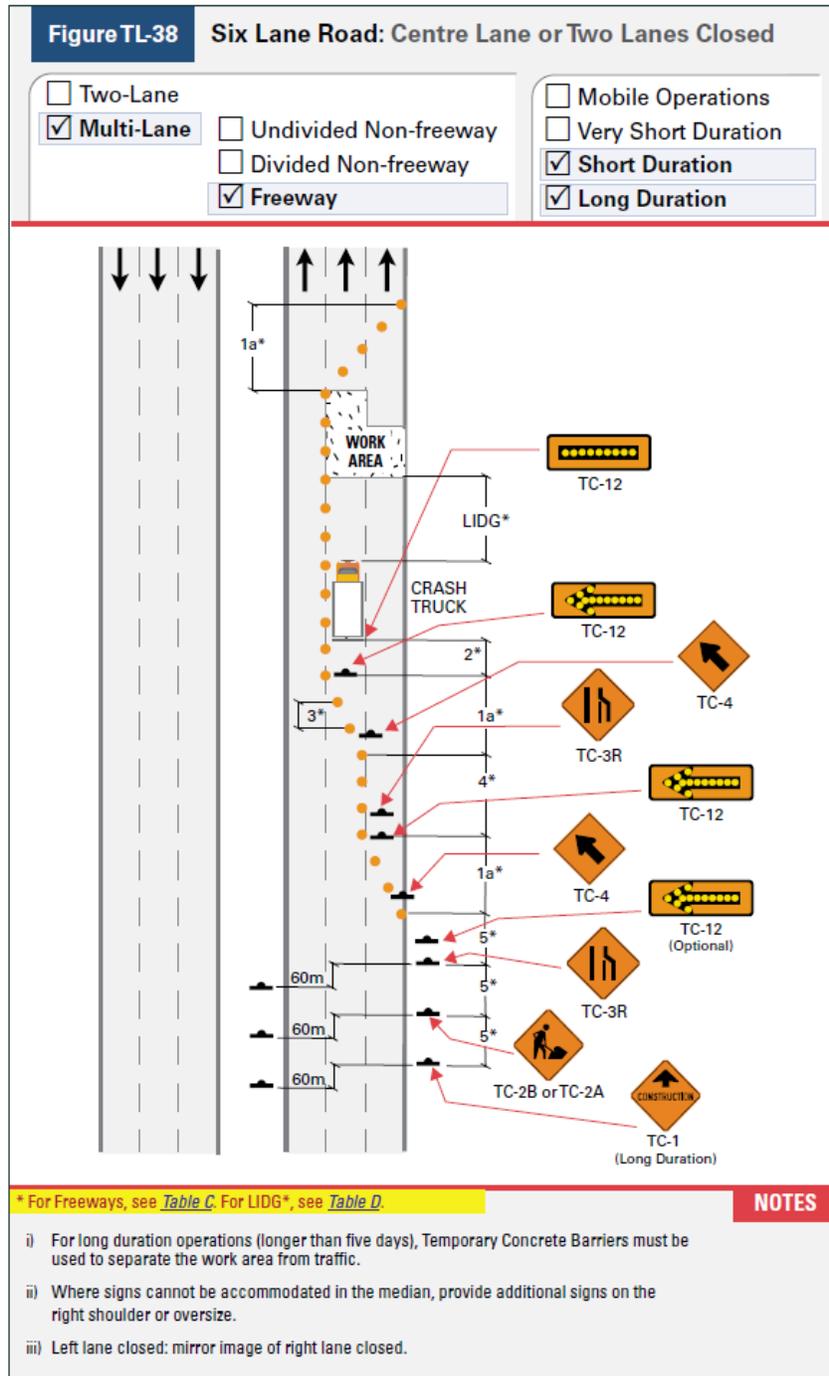
**Figure 7.3: Temporary closure layout for M/O and PCIP rehabilitations (Ministry of Transportation of Ontario, 2014)**

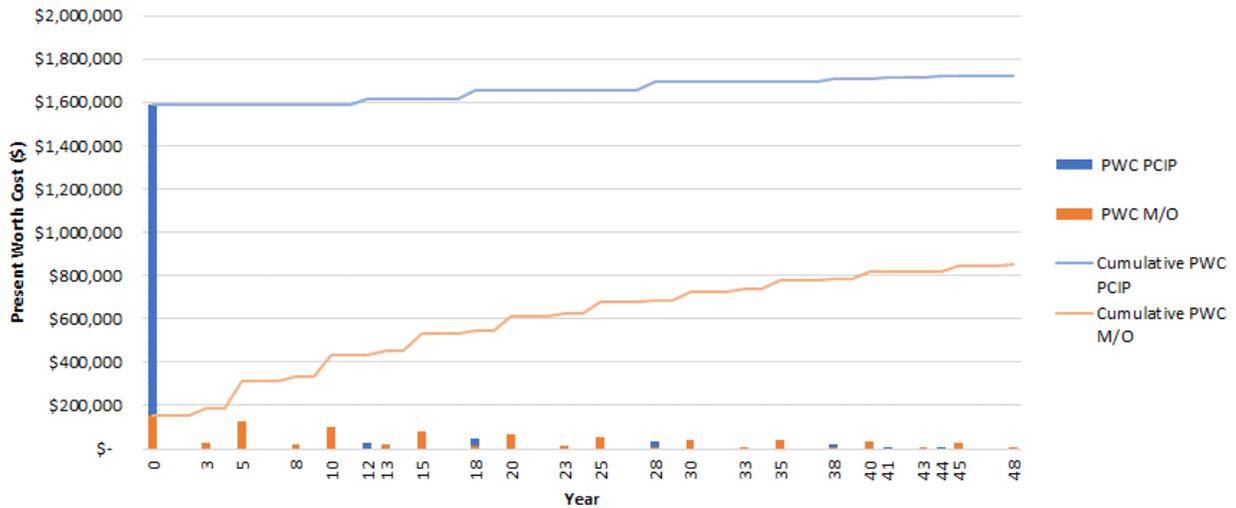
**Figure 7.5: Present worth costs for PCIP and M/O rehabilitation techniques**
