**Precast Concrete Inlay Panels:  
Rehabilitation Strategy for  
High-Volume Highways in Ontario**

A thesis  
presented to the University of Waterloo  
in fulfilment of the  
thesis requirement for the degree of  
Doctor of Philosophy  
in  
Civil Engineering

Waterloo, Ontario, Canada, 2018

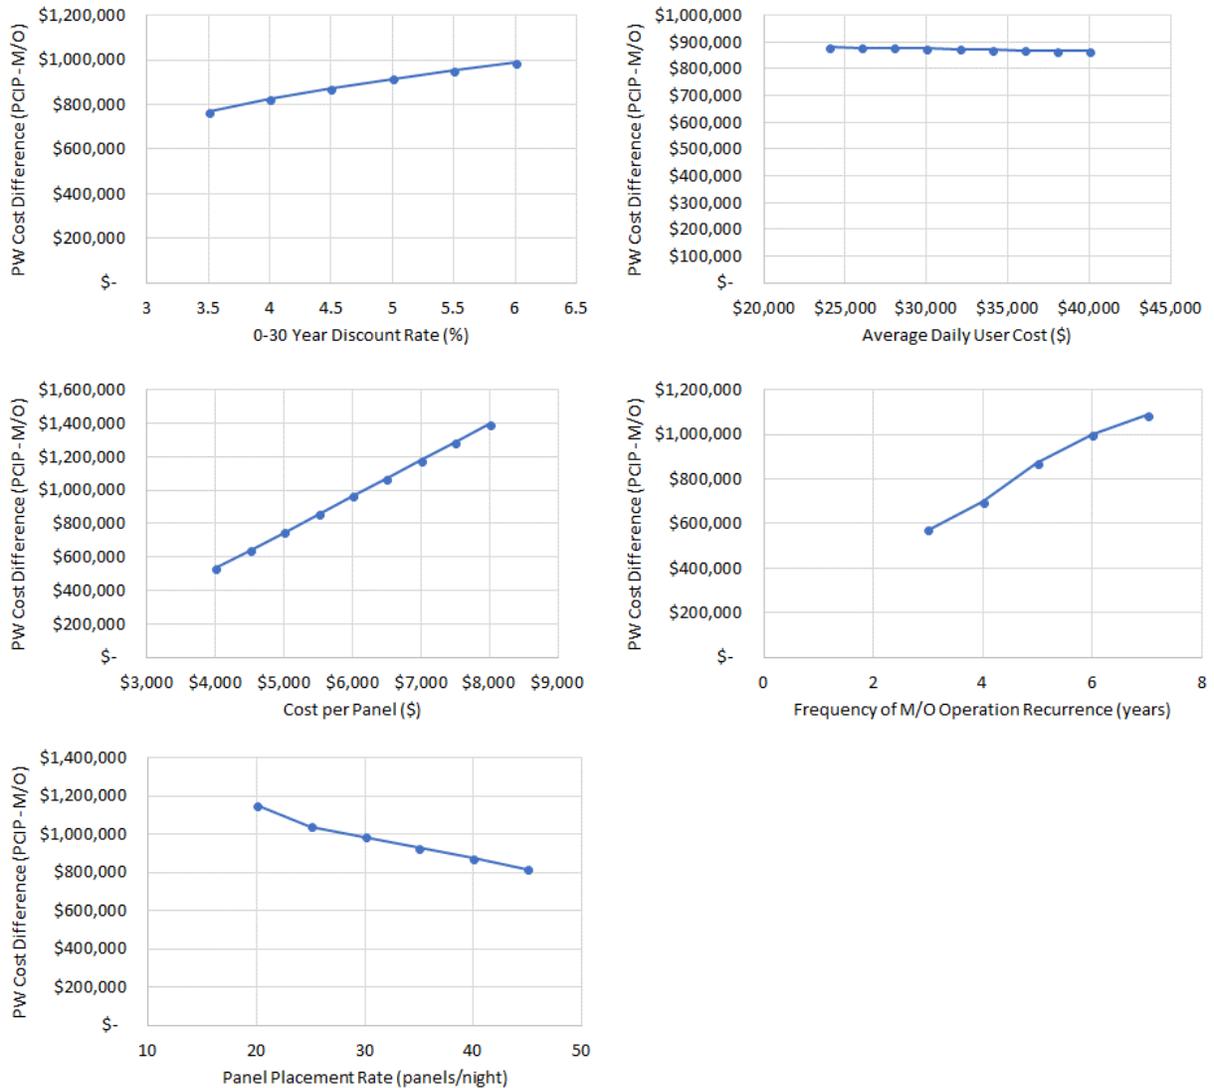
**Figure 7.6: Sensitivity Analyses for Discount Rate (upper left), Average Daily User Cost (upper right), Cost per Panel (centre left), Frequency of M/O Operation (centre right), and Panel Placement Rate (lower left)**

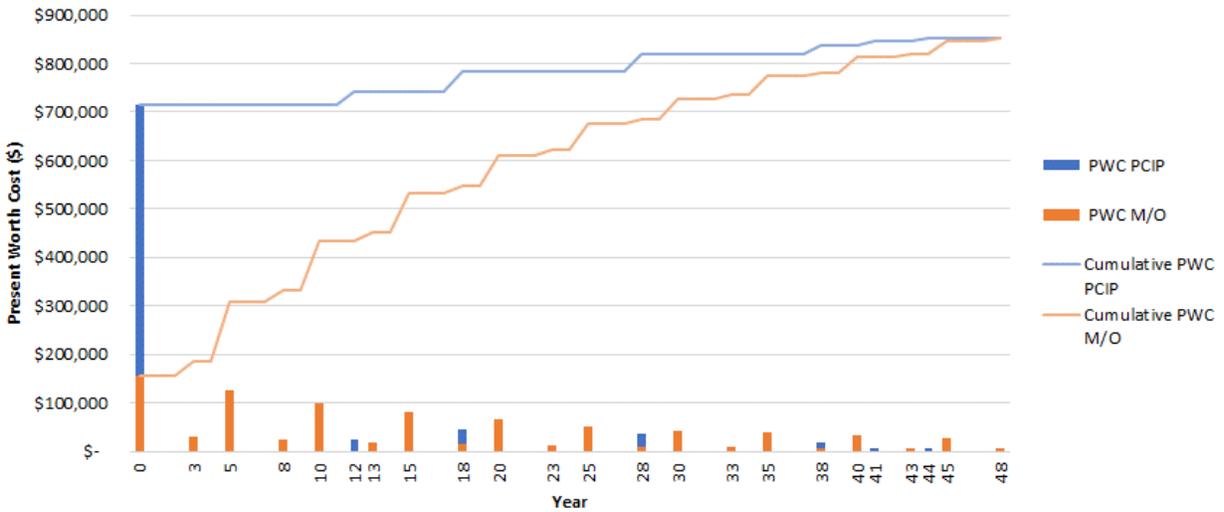
**Figure 7.8: Life cycle costs of PCIP and M/O strategies at “tipping point”**

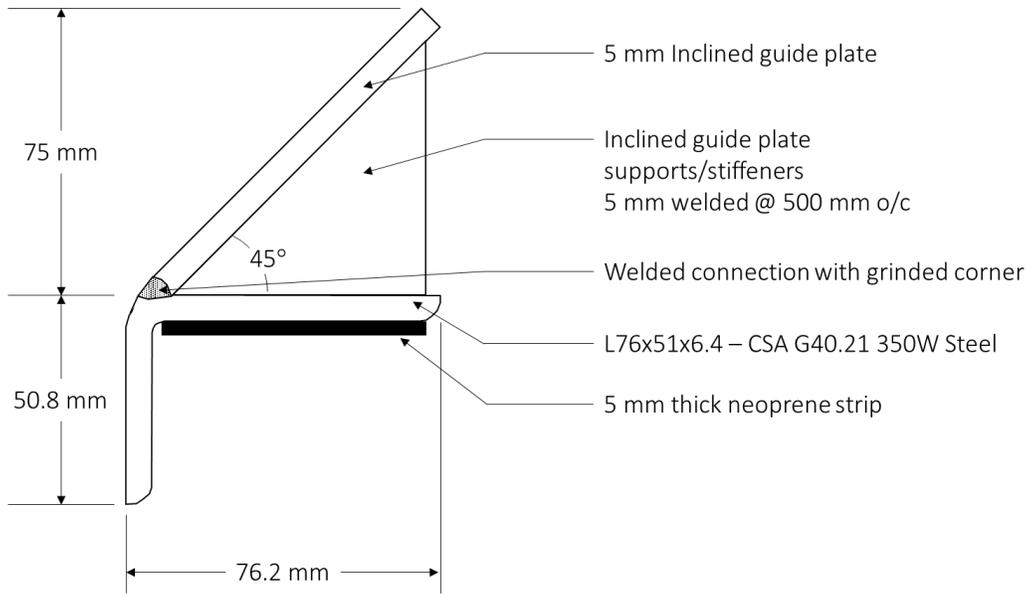
**Figure 9.1: Cross-section of HMA corner protection detail**

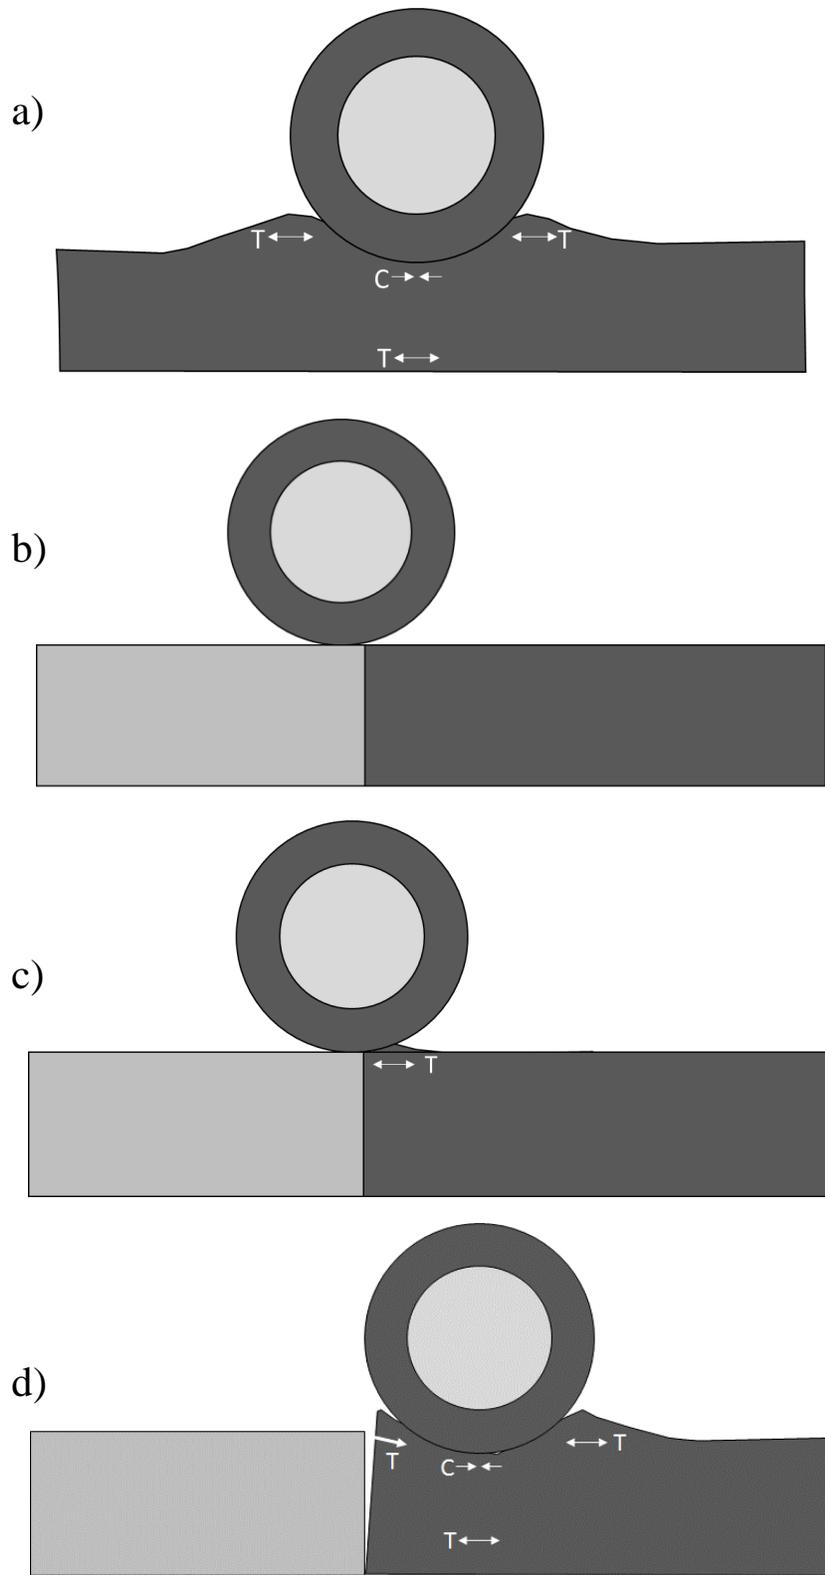
**Figure 9.3: Simplified longitudinal HMA stresses under tire load**

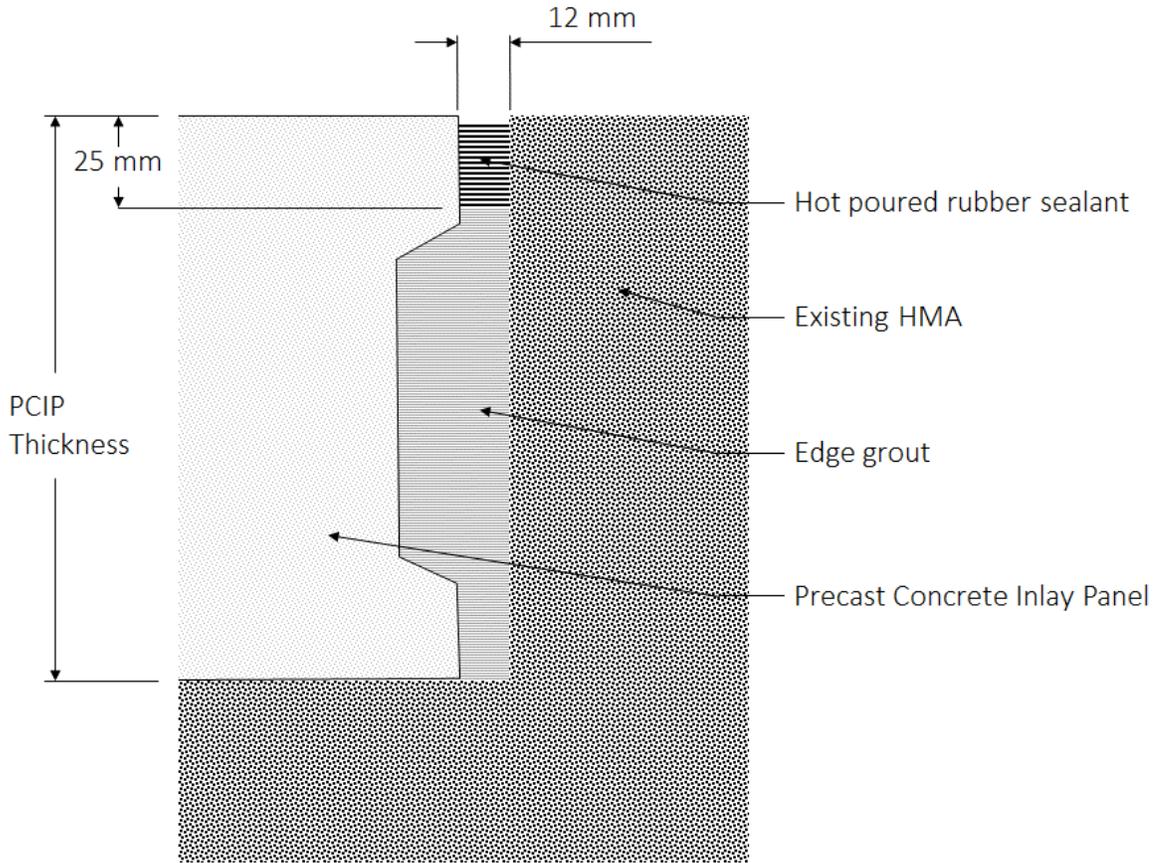
**Figure 9.5: PCIP trial transverse edge design detail**

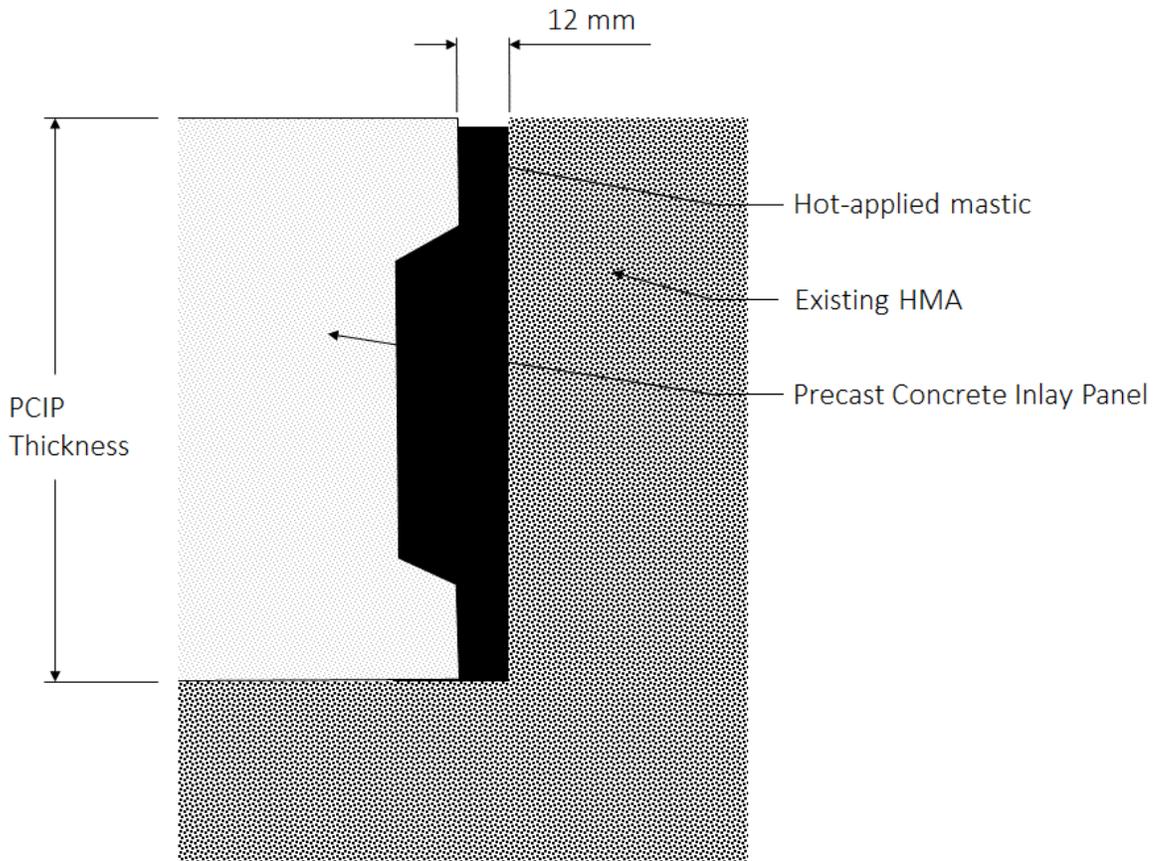
**Figure 9.6: Proposed PCIP transverse edge detail**

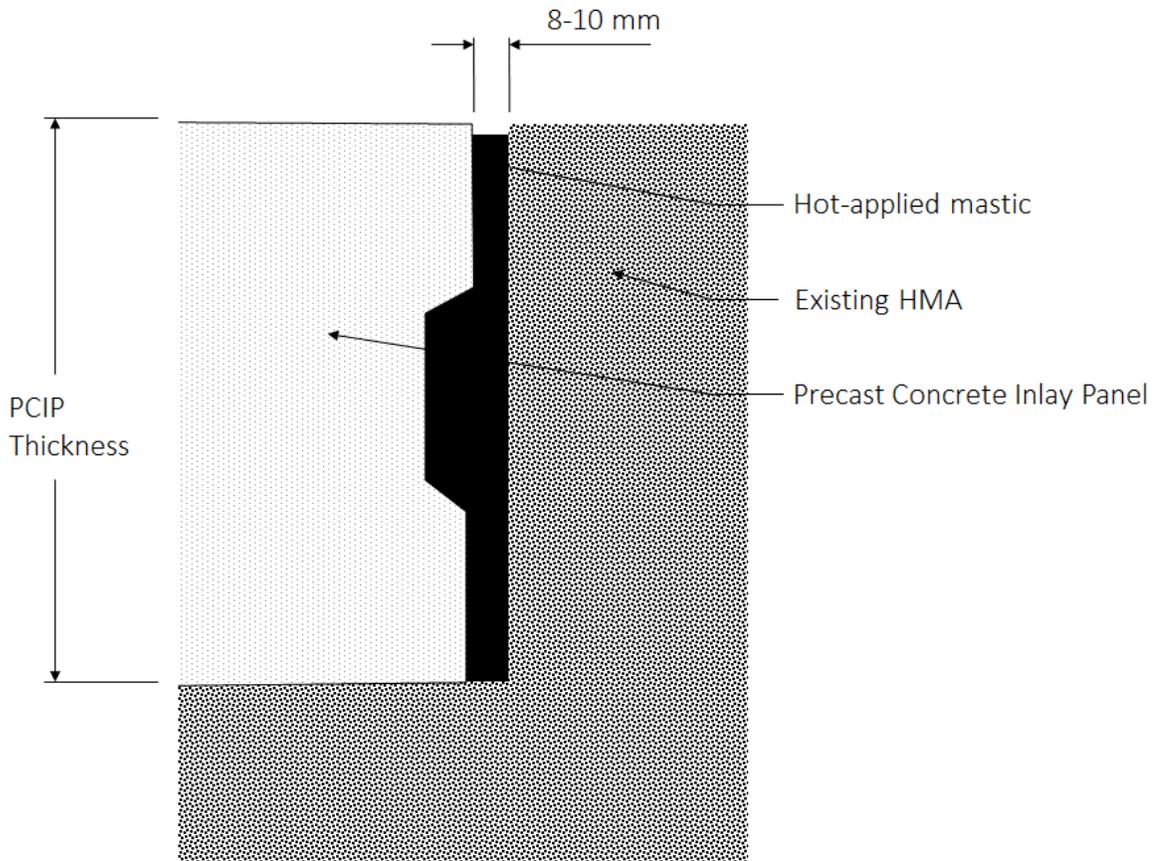
**Figure 9.7: Proposed PCIP longitudinal joint detail**

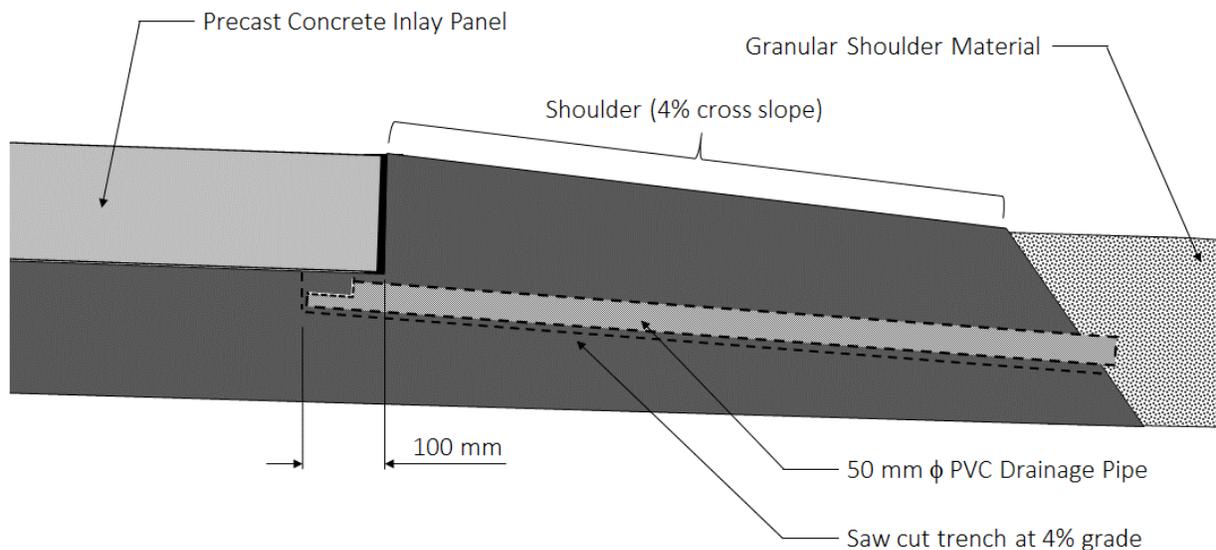
**Figure 9.8: Proposed drainage detail for PCIP rehabilitations**

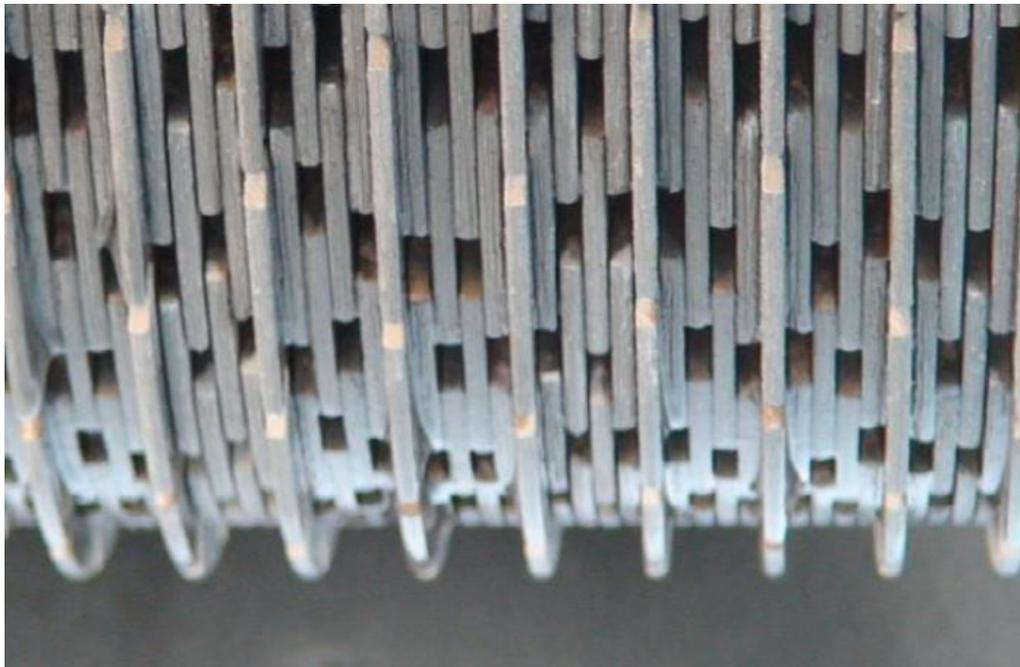
**Figure 9.10: Diamond grinding head for Next Generation Concrete Surface (adapted from (Scofield, 2017))**

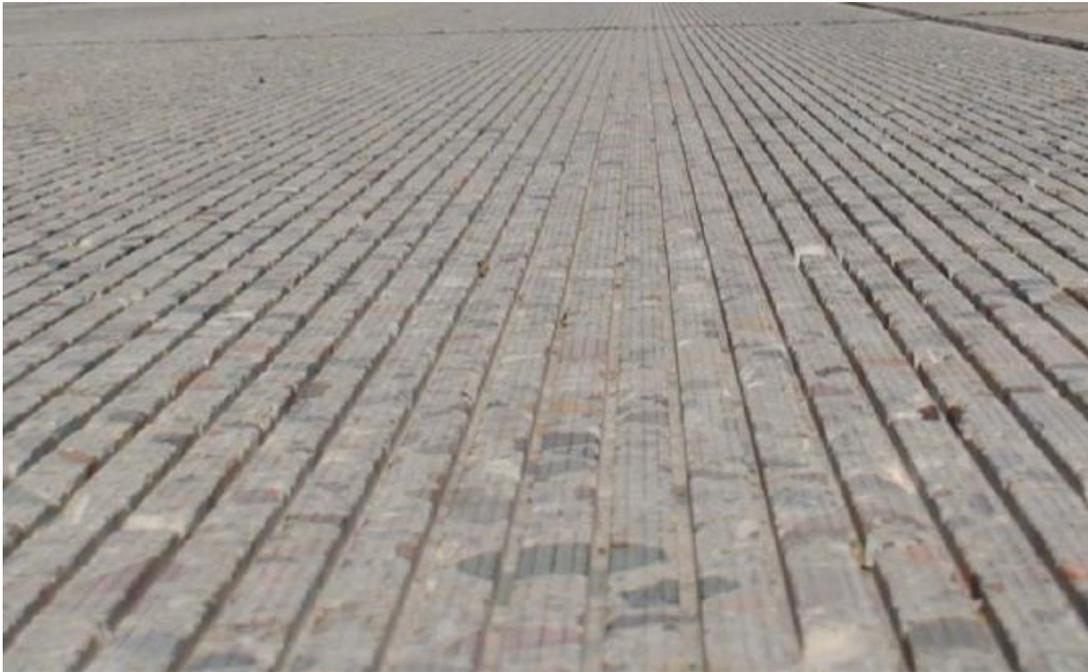
**Figure 9.11: Next Generation Concrete Surface texture (adapted from (Scofield, 2017))**

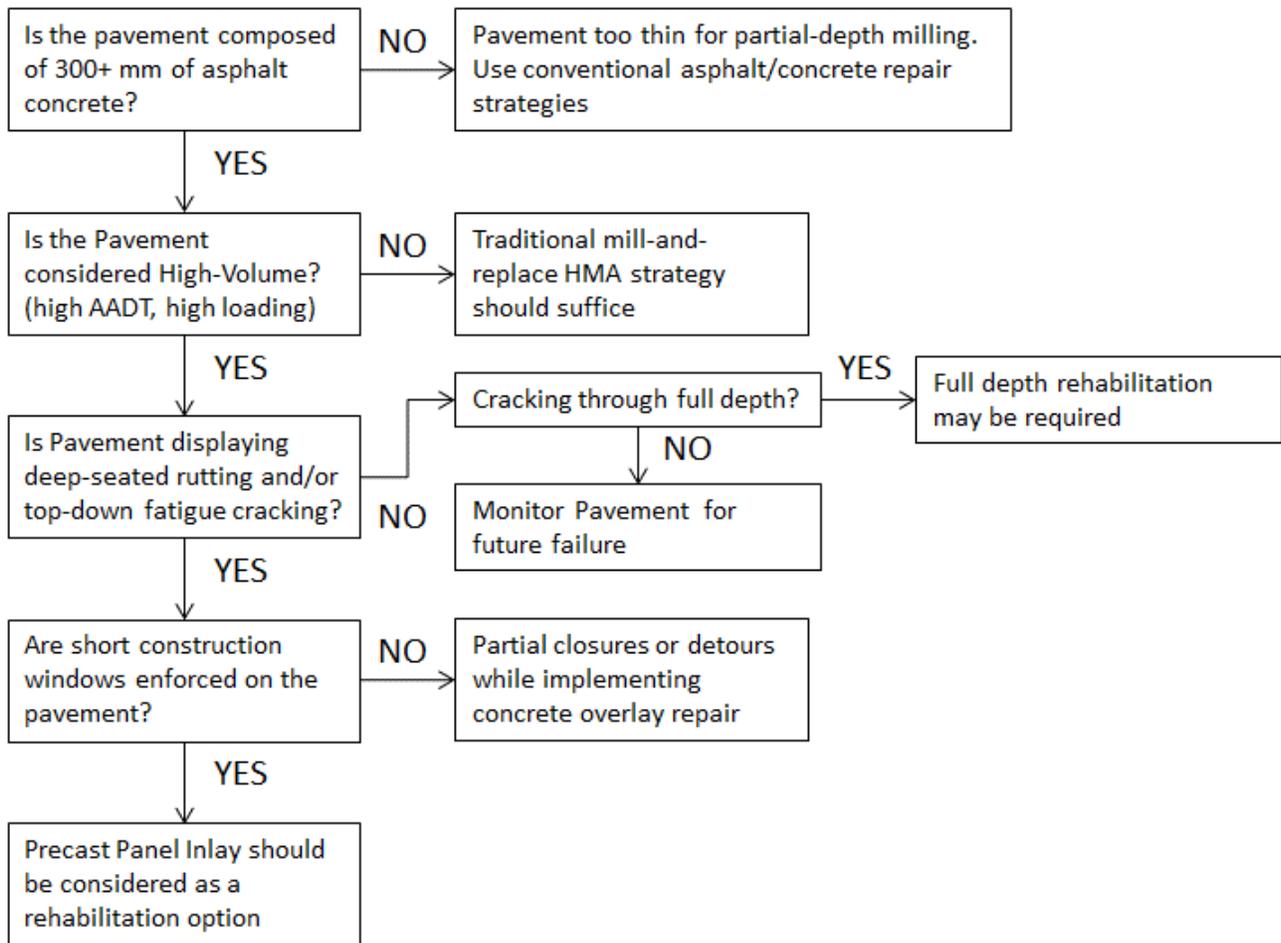
**Figure 9.13: Selection tree for Precast Concrete Inlay Panel use**
