The effect of Electro Spark Deposition on the microstructure
and mechanical properties of IN718

A thesis
presented to the University of Waterloo
in fulfillment of the
thesis requirement for the degree of
Master of Applied Science
in
Mechanical and Mechatronics Engineering

Abstract

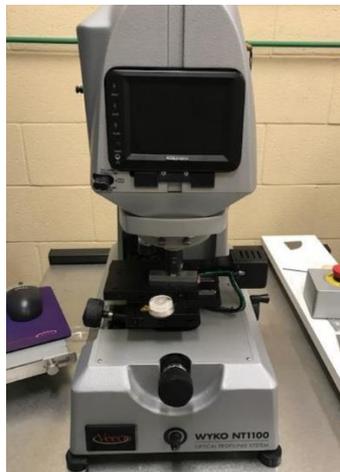
Figure 3.3: WYKO NT1100 optical profiler.

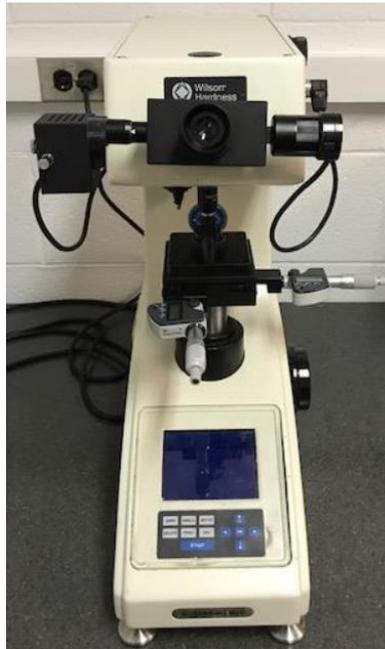
Figure 3.4: Microhardness tester.

Microhardness tests were performed using a Wilson Vickers 402MVD automated hardness tester, with 10 g load and dwell time of 15 s. All the microhardness tests were carried out following the procedures of the standard ASTM E384-16. The samples were prepared accordingly to the usual metallographic preparation of grinding and polishing followed by etching with inverted glyceridea. Figure 3.4 shows a picture of the microhardness tester.

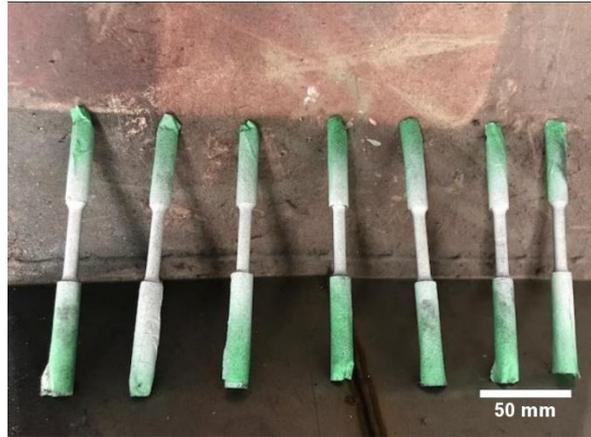
Figure 3.5: Tensile samples after the application of the two layers of painting.

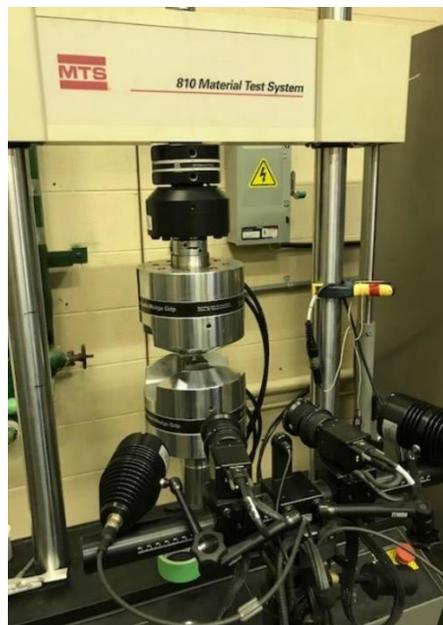
Figure 3.6: Setup of the MTS frame with the cameras for tensile tests using the DIC technique.
