**Three-Dimensional CT Imaging and Microstructural
Mechanical Modeling of Corrosion and Freeze-Thaw
Damage of Concrete**

A thesis

presented to the University of Waterloo

Doctor of Philosophy

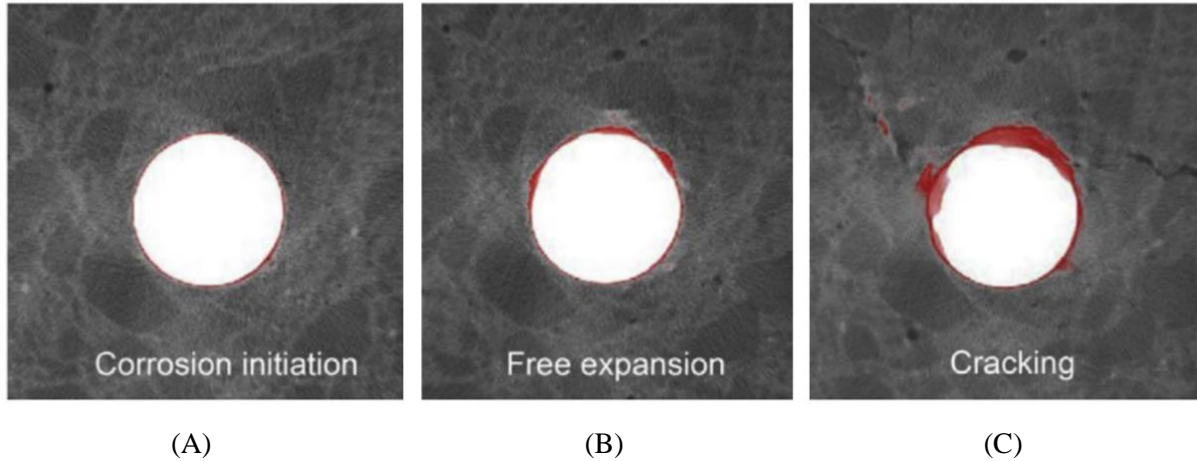
Figure 2.5. CT Imaging of a 2.5 mm Rebar (White), Rust (Red), and a $10 \times 10 \times 10 \text{ mm}^3$ Concrete at Different Phases of Corrosion. Reproduced from Dong et al. [55] with Permission from Elsevier.

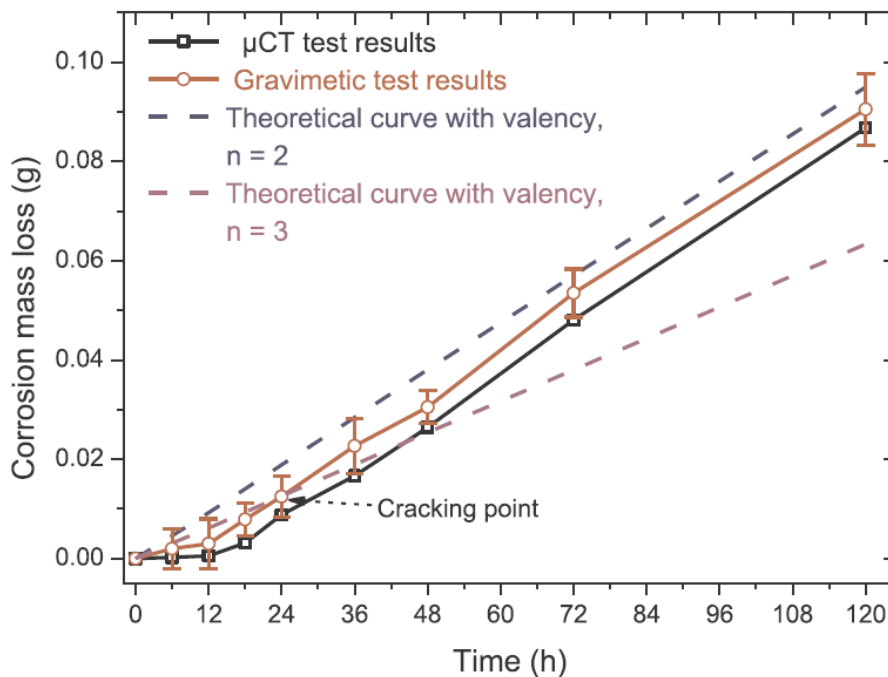
Figure 2.8. Reinforcement Mass Loss Data Attained Using CT Imaging, Gravimetric Test, and Faraday's Law. Reproduced from Hong et al. [94] with Permission from Elsevier.

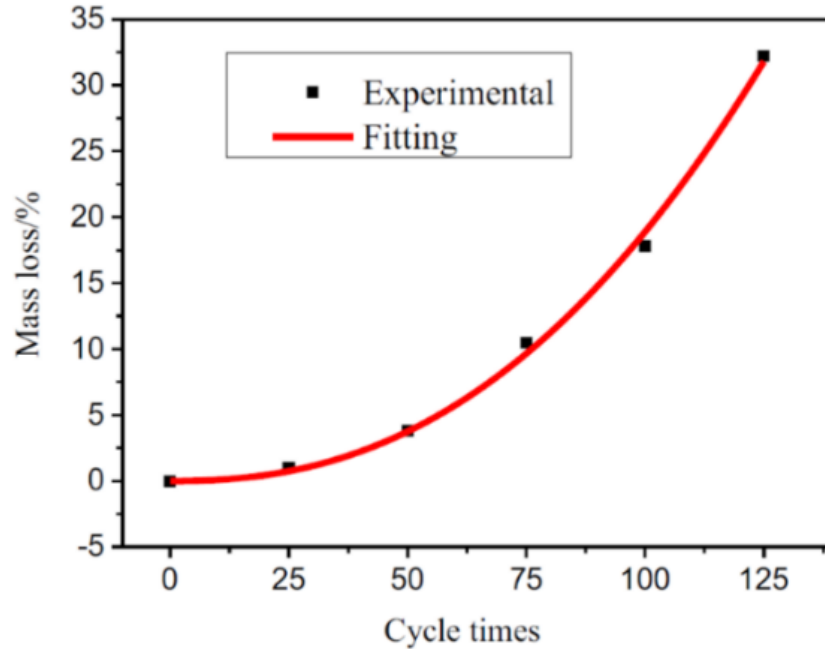
Figure 2.18. Mass Loss Resulted from Exposure to Freeze-Thaw Cycles. Reproduced from Li et al. [154] with Permission from Elsevier.

The frost damage propagates on a layer-by-layer basis, as shown in Figure 2.17, starting from the exterior surface, due to its direct exposure to the freezing water [58,153,154]. Thus, concrete scaling can occur as surface cracks grow and connect [59,61,72]. Also, cracks tend to appear within the aggregate-mortar interface, as illustrated in Figure 2.17 (F), ascribed to its low bonding strength and rough surface, which can lead to stress concentration [29,57,58]. Moreover, the frost damage rate can accelerate over time since surface cracks increase water ingress and deteriorate the concrete cover, causing exponential growth of mass loss as shown in Figure 2.18 [154].

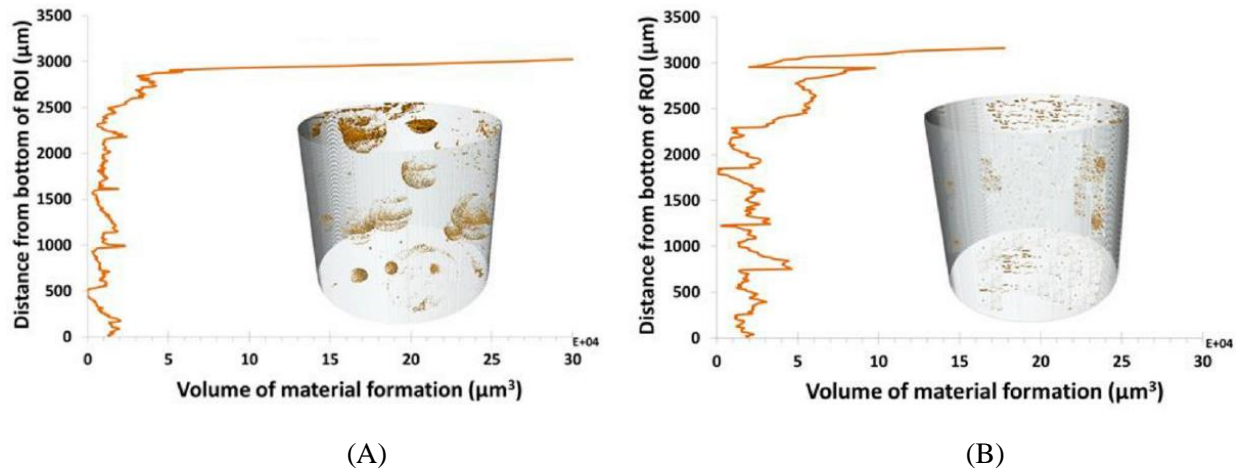
Figure 2.20. Material Formation within (A) nAE, and (B) AE Mortar Specimens after Freeze-Thaw Testing. Reproduced from Sokhansefat et al. [29] with Permission from Elsevier.

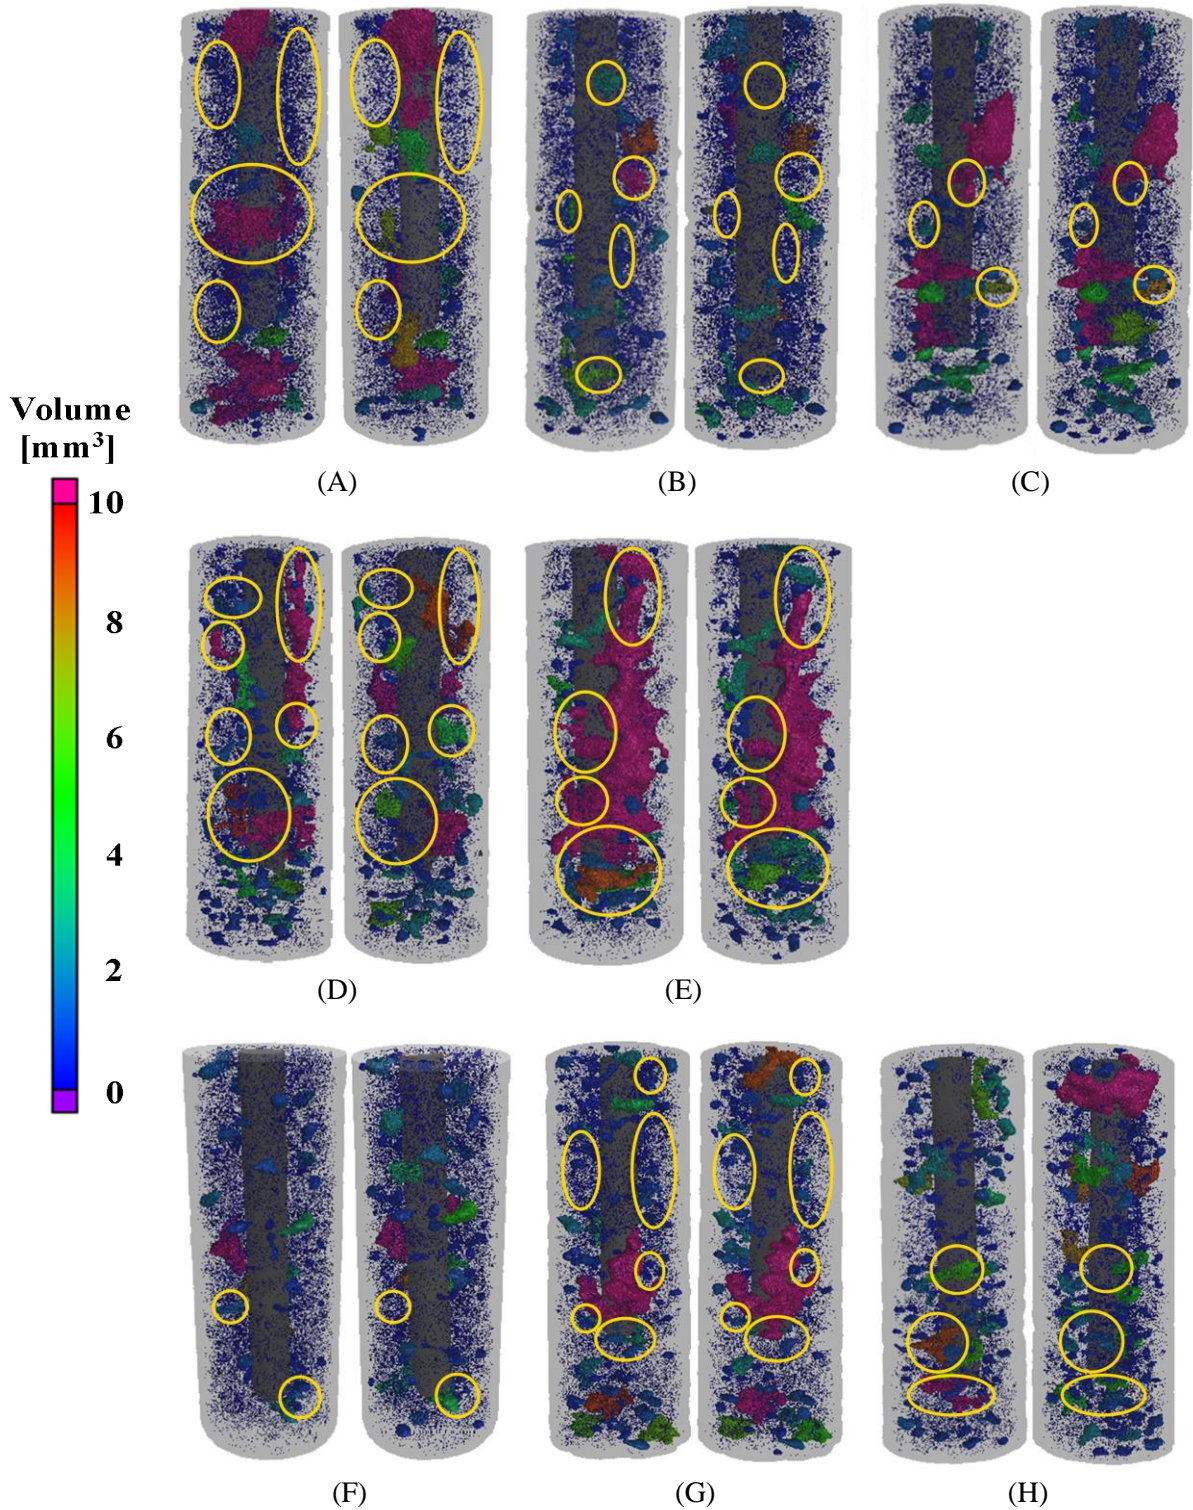
Figure 3.9. 3D Reconstructions of Pore Structures of Specimens (A) CW4, (B) CW5/CS10, (C) CW6, (D) CW7, (E) CW8, (F) CS5, (G) CS20, and (H) CS30 before (Left) and after (Right) 120 Wet-Dry Cycles

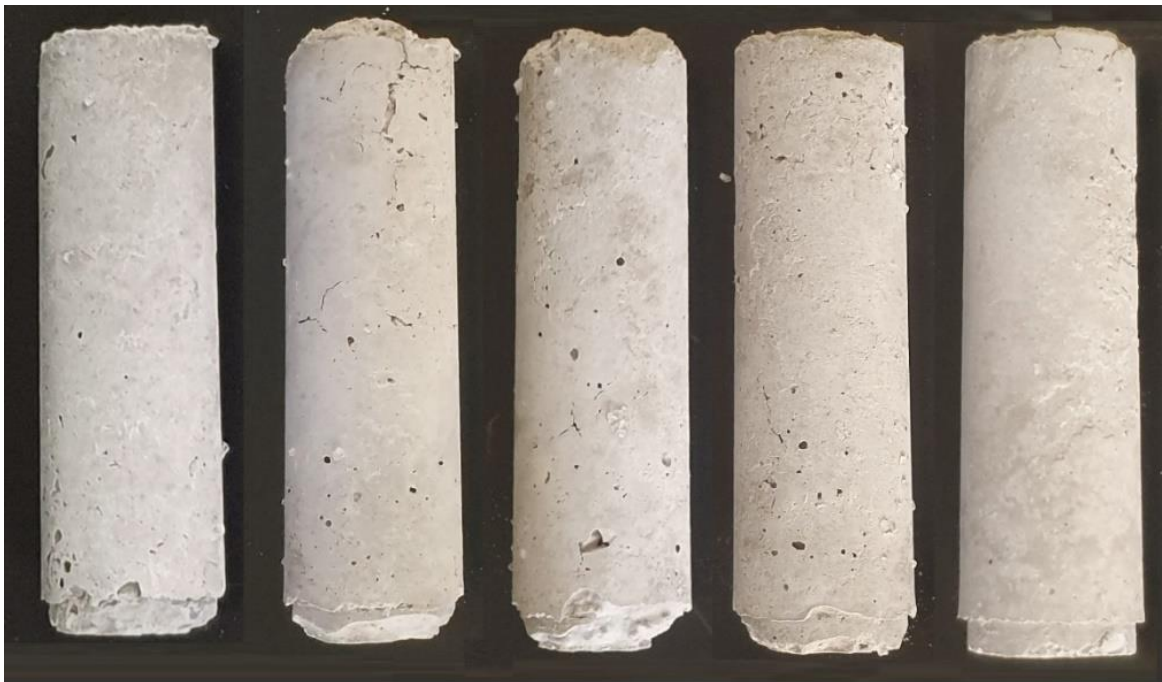
Figure 5.1. (A) Control, (B) PS-5%, (C) PS-10%, (D) MS-5%, and (E) MS-10% Concrete Specimens

Five concrete specimens of the same mixture proportions were prepared using small aggregates (<5 mm), fine sand, and ordinary Portland cement, which has the chemical composition listed in Table 5.1. The utilized concrete mixture had water-to-cement, sand-to-cement, and aggregate-to-cement ratios of 0.5, 1, and 1.5, respectively. The samples, shown in Figure 5.1, were 40 mm long and 15 mm in diameter. The specimens were de-molded 24 hours after casting and water cured for 28 days at a temperature of 20 °C before μ CT imaging and frost testing. The specimens were labeled based on the freeze-thaw environment. For example, specimens PS-10% and MS-10% were subjected to frost cycles in potassium sulfate and magnesium sulfate solutions, respectively, with a concentration of 10%. As discussed in the following sections, the specimens have similar pore properties, mitigating the need for duplicate samples.

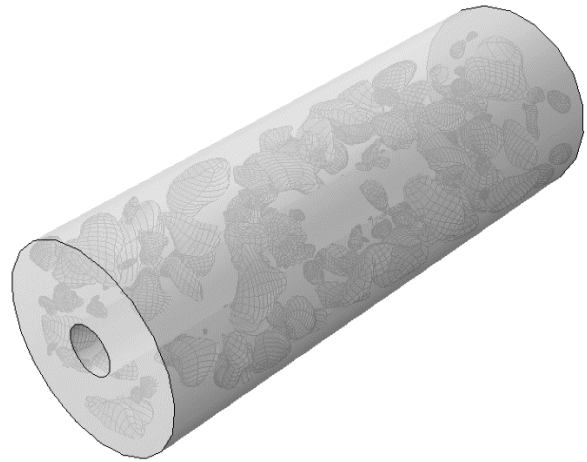
Figure 6.2. 3D Models of (A) Aggregates, (B) Air Voids, (C) Steel Reinforcement, and (D) Cement Mortar

Three-dimensional mesh elements of the aggregates, voids, and mortar were generated, cleaned, and converted into solid 3D models. Different software packages were used to create the 3D configuration of the FE models, namely, Image J, Geomagic Design X, and Autodesk Fusion 360. The 3D reconstructions of the corrosion FE model's elements, including the steel reinforcement, are illustrated in Figure 6.2. In terms of the freeze-thaw FE model, the detected air pores were filled with ice since concrete is fully saturated throughout the freeze-thaw cycles. The 3D reconstructions of the two concrete specimens of the freeze-thaw FE model are demonstrated in Figure 6.3. Due to the complex configurations of the 3D components, tetrahedral mesh elements (C3D4) were used. The mesh sizes of ice (e.g., 0.46 – 4.6 μm), aggregates (e.g., 0.58 – 5.8 μm), and cement mortar (e.g., 9.2 – 92 μm) were automatically selected by ABAQUS (Dassault Systems version 2019), resulting a total number of mesh elements of over 4.3 million elements. The mechanical properties, surface-contact conditions, applied corrosion expansion for the corrosion FE model, and applied frost cycles for the freeze-thaw FE model are discussed in the following sections. It is important to note the morphology of the modeled components can be enhanced by using higher-resolution CT images.

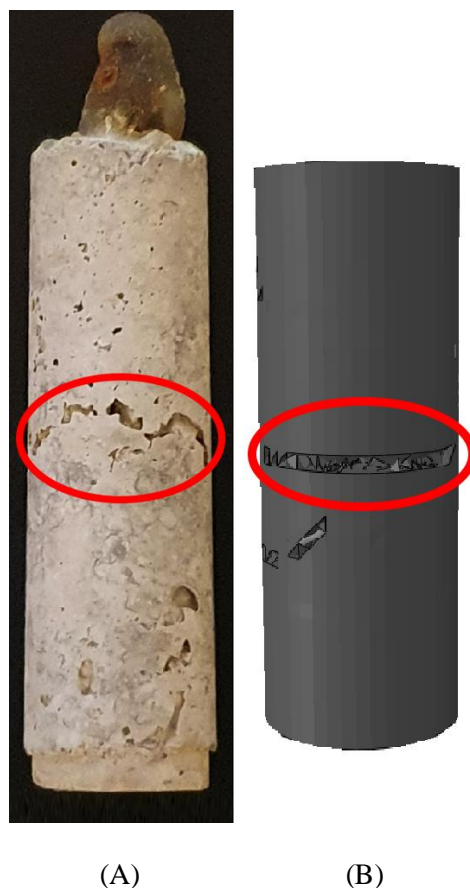
Figure 6.10. Comparison between (A) the Actual Concrete Damage and (B) the Simulated Concrete Damage at 1.5% of Reinforcement Expansion
