Fatigue Bond Behaviour of Corroded Reinforcement and CFRP Confined Concrete

A thesis
presented to the University of Waterloo
in fulfillment of the
thesis requirement for the degree of
Doctor of Philosophy
in
Civil Engineering

Waterloo, Ontario, Canada, 2007

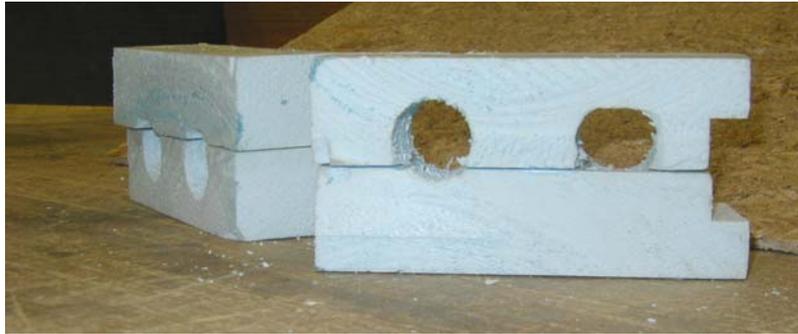
Figure 2.3: High-density foam used to create the pocket at the end of the bonded zone

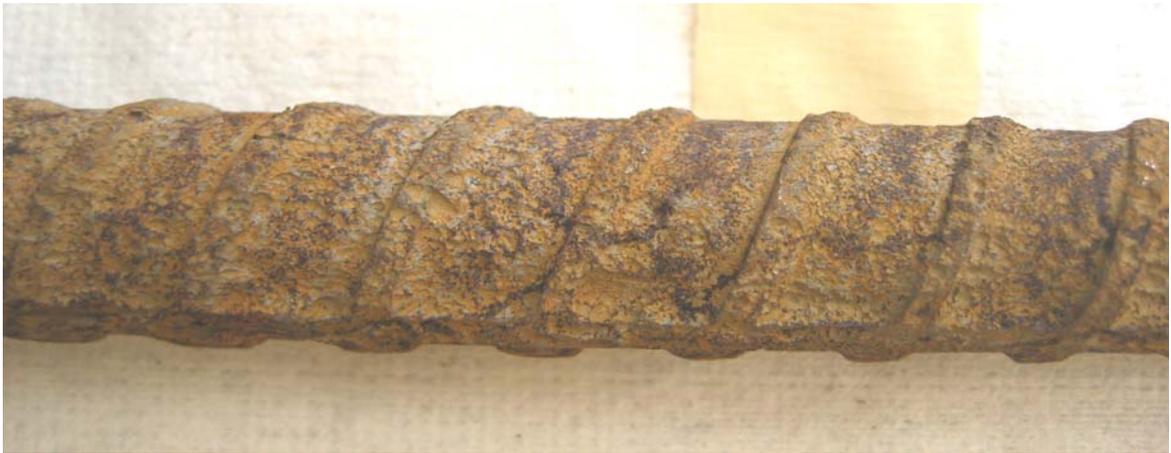
Figure 3.1: Uniform corrosion for steel bars corroded for 50 days

For beams corroded for 50 days, the measured mass loss per coupon ranged from 3.5% to 8.0%. The average mass loss per beam (4 coupons) ranged from 4.4% to 6.5%. The overall average for all the beams was 5.6%, close to the 5% predicted using Faraday's law.

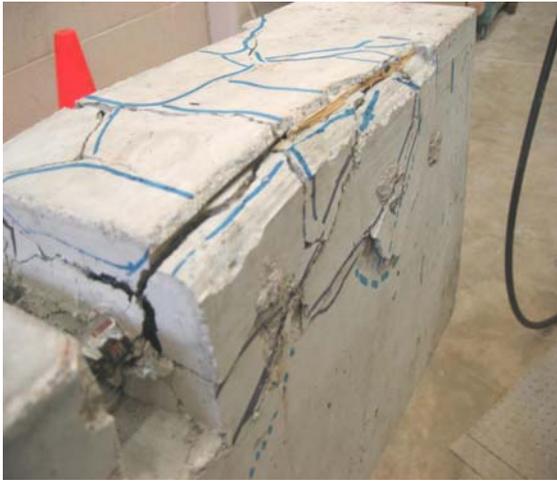
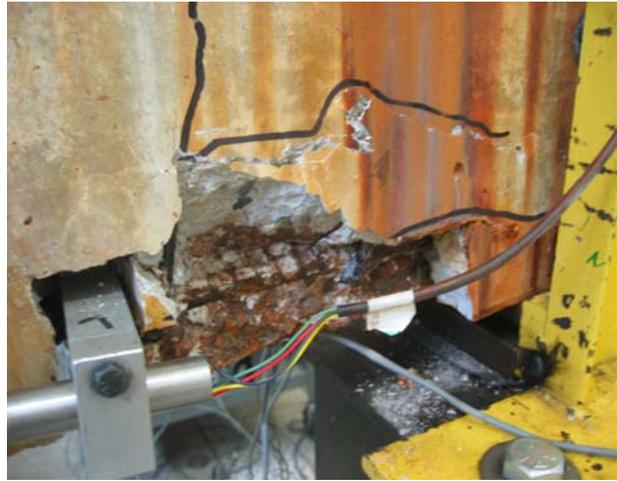
a) Concrete splitting for uncorroded beams

b) Concrete cover spalled for corroded beams

Figure 3.9 Typical failure cracks for unwrapped beams

After each test was halted, the failure surface was inspected. It was observed that for the unwrapped uncorroded beams, the lower concrete cover was cracked into two or three pieces (Figure 3.9a). The concrete above the steel bar in the vicinity of the bar lugs was cracked and crushed (Figure 3.10a) while the concrete in the bottom cover was intact (Figure 3.10b). This suggests that the concrete above the steel bars resisted the bond forces, and therefore was cracked and crushed while the bottom cover was pushing away and did not participate in bond resistance. For the unwrapped corroded beams, a similar observation was noted; except that the bottom concrete cover had more cracks and the depth of the concrete keys (concrete between the steel and bar lugs) was less than for the ones in the uncorroded beams (Figure 3.11). This was noted for both sides of the beam (failed and sound sides), which suggests that the increase in the number of cracks and decrease in concrete key depth is due to the corrosion.

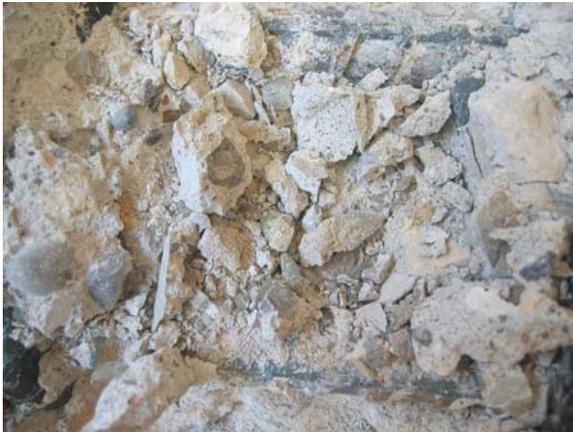
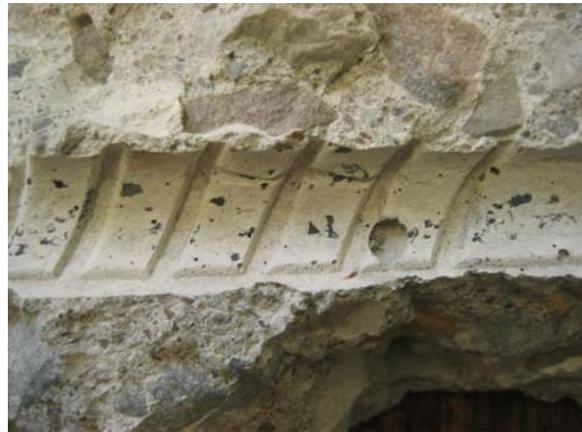
a) Concrete above the steel bar

b) Concrete below steel bar (bottom cover)

Figure 3.10 Failure plane for unwrapped uncorroded beams

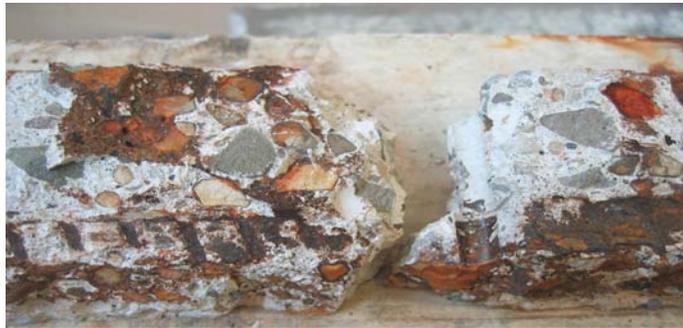
Figure 3.11 Failure plane for unwrapped corroded beams

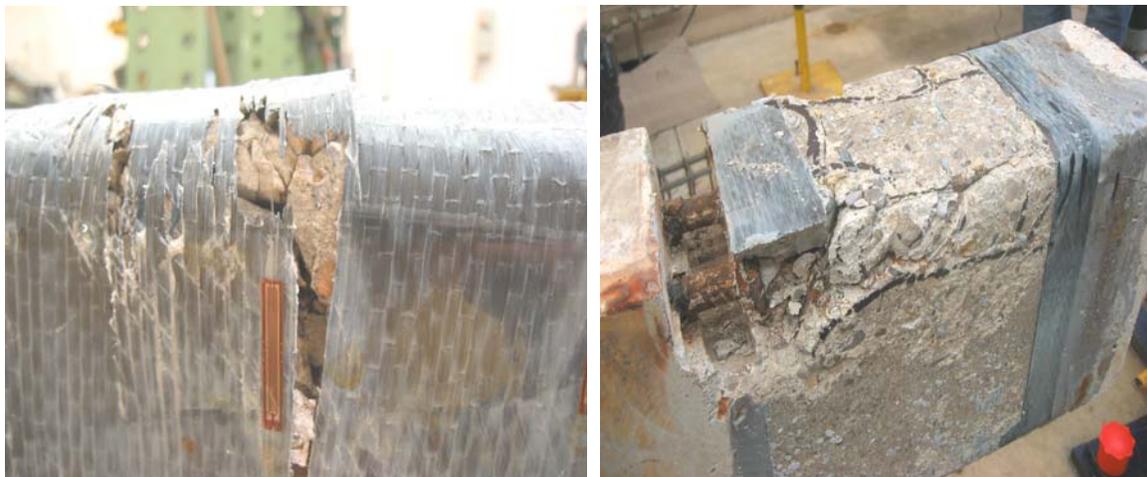
a) Rupture of CFRP sheets

Figure 3.12 Typical bond failure for wrapped beams

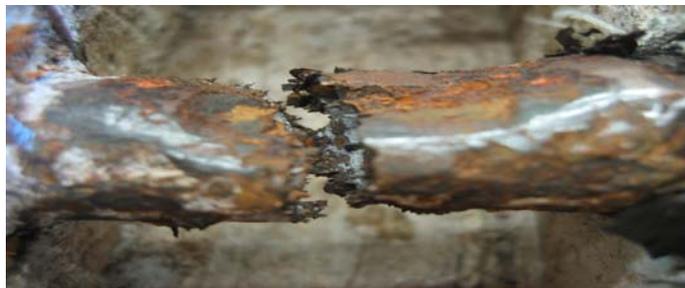
Figure 3.15 Flexural fatigue failure by steel rupture

On the other hand, for the ten (10) specimens (2 with 0% corrosion, 1 with 5% corrosion, 3 with 9% corrosion and 4 post repaired after 9% corrosion) that failed by steel rupture (Table 3.1), it was noted that the concrete in the middle of the beam was crushed. In addition, it was realized that the unfractured steel bar had slipped much more than the other fractured bar. Also, the CFRP sheets ruptured only from one side at both ends of the beam where the steel bar had slipped (rather than rupturing from both sides at one end of the beam as in the case for the specimens that failed by bond splitting). After the tests were halted, the sheets were removed and the cracks and the failure plane were inspected. There were splitting cracks at both ends for one side of the beam (where the CFRP sheets ruptured and bar slipped), while the other side was almost intact (where the steel bar ruptured). Further investigation revealed that these beams failed by flexural fatigue (indicated by one of the steel bars rupturing either in the middle of the beam or in the pocket) (Figure 3.15). In specimens F55-W0-T0 and F60-W0-T0 (uncorroded), the steel ruptured in the middle region of the beam where the stress was highest. For the other corroded specimens, one with 5% corrosion, three with 9% corrosion and four post-repaired with 9% corrosion, the steel ruptured in the pocket. The rupture of one steel bar resulted in a sudden increase of the stress in the other bar in the beam. This increased stress in the unruptured bar resulted in higher bond stresses and a large increase in bar slip and rupture of the CFRP sheet. The increase in the slip in the un-fractured bar started immediately after the other bar ruptured.

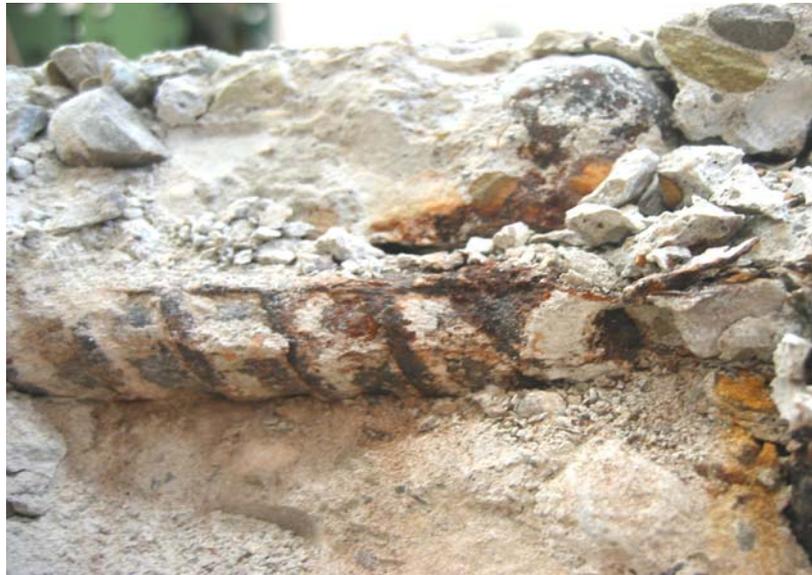
Figure 3.20 Traces of the condensed concrete in front of the steel bar lugs

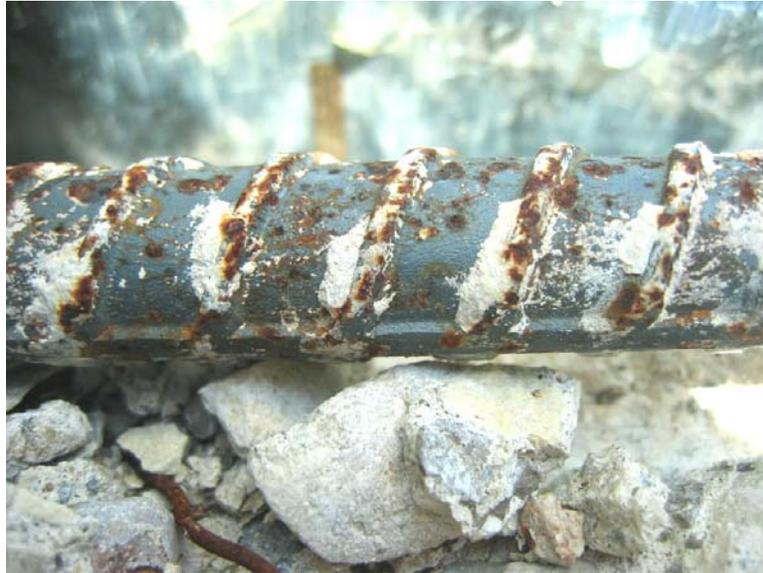
Figure 4.7 Condensed crushed concrete in front of the steel bar lugs for wrapped beams
