# Construction of Horizontal Wells in Municipal Solid Waste Using A Directional Drill

A thesis  
presented to the University of Waterloo  
in fulfillment of the  
thesis requirement for the degree of  
Master of Applied Science  
in  
Civil Engineering

Waterloo, Ontario, Canada, 2007

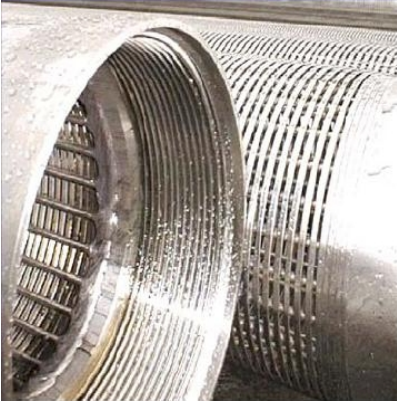
Figure 4-2: Stainless Steel Well Screen for the 2<sup>nd</sup> Field Trial (Cox et al 2000)

remained free of cuttings. Drill pipes were removed when the pilot bore path was completed and a 114 mm diameter stainless steel well screen, (Figure 4-3) was pushed into the overwash casing. The casing was removed once the well screen was installed.

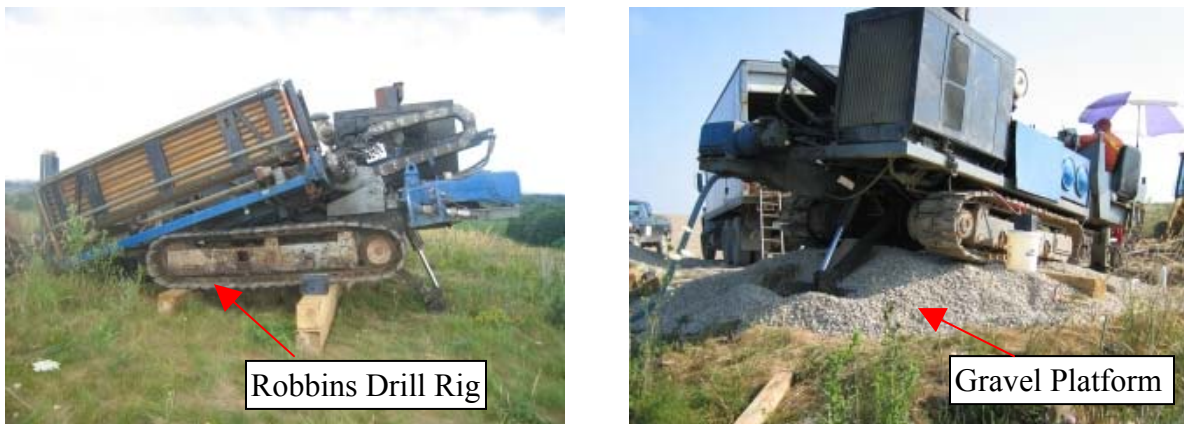
Figure 6-2: The Addition of Gravel Platform for Drill Rig Stability

A Robbins 4515TM-MSD drill rig operated by Earth Boring Inc. was used for the well construction. This rig is rated for 214 kN (48,000 lb) pullback and 7.1 kNm (5,200 ft-lbs) of torque. Earth Boring customized the drill rig to have 302 kN (68,000 lbs) pullback. Initially, the rig was setup on top of the covered waste pile. Following heavy rains, the ground anchoring the rig became unstable. To correct this problem, a gravel pad was constructed to set the rig on (Figure 6.2). The drill rig was set up to enter the ground at an angle of 21° (38% pitch).

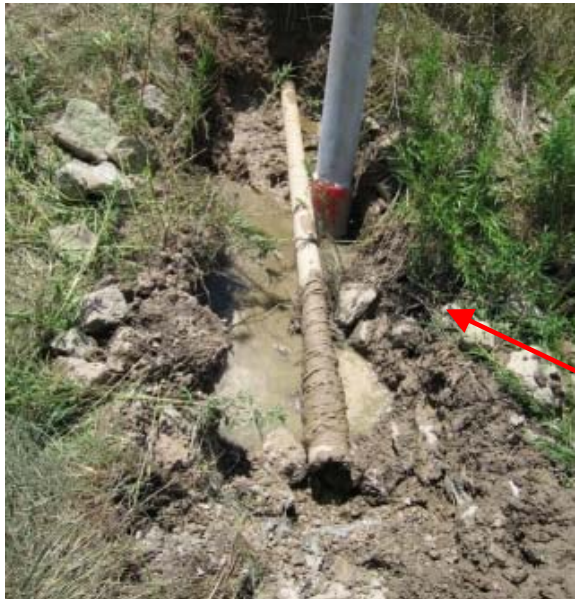
Very little leachate coming out of bore

The leachate mound at the Landfill suggested that the leachate elevation was at an elevation significantly greater than the pilot bore exit location. This high estimated leachate head led to the concern that large volume of leachate would be drained from the OLA when the pilot bore exited the toe berm. On-site pumps and vacuum extraction equipment were used to collect and discharge leachate to an adjacent manhole when the drill head broke through the berm. However, very little leachate was observed when drill head broke through. Figure 6-5 shows the condition of the bore after exit of the drill bit.

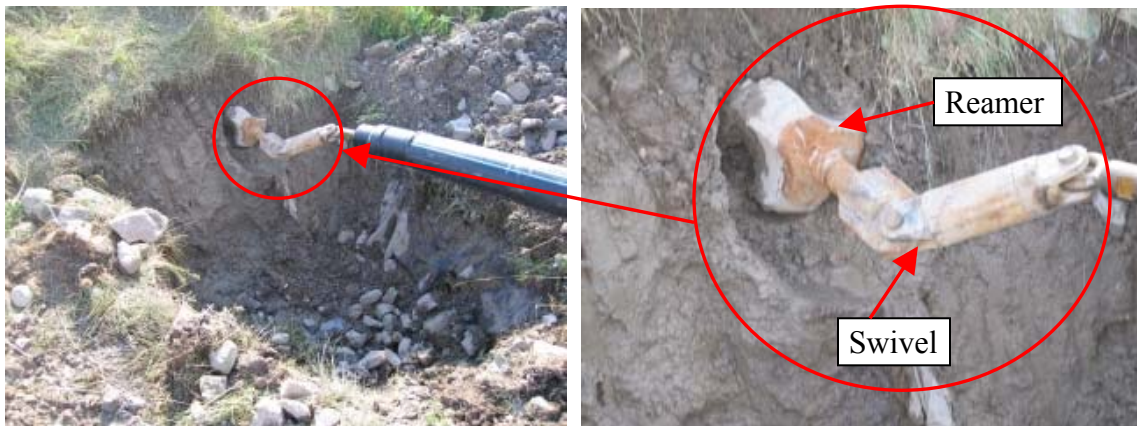
Figure 6-7: The entering of the 305 mm Reamer into the Bore during Pullback

The 200-mm HDPE carrier casing was connected to the Dub swivel that was connected to a 305 mm (12-inch) fluted reamer. Figure 6-7 shows the reamer entering into the bore at 10:00 a.m. on July 18, 2005.

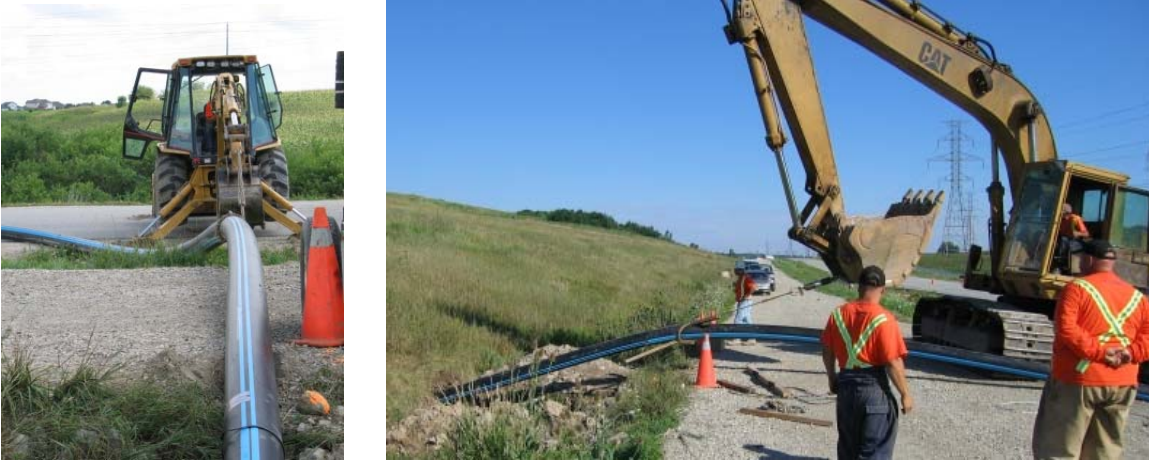
Figure 6-8: Pullout of Carrier Casing during 1<sup>st</sup> Pullback Attempt by Backhoe & Excavator

To retrieve the reamer and the pipe, several attempts were made to pull the carrier casing out of the bore using a rubber tired backhoe. These attempts were not successful and thus a CAT 235 excavator was brought to the site on July 29, 2005 to remove the pipe. Using a choker, as shown in Figure 6-8, the pipe was pulled out of the bore.

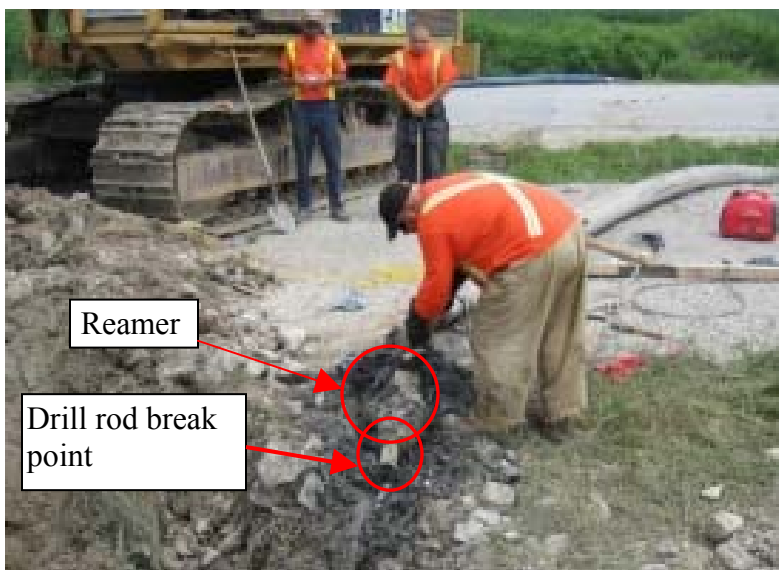
Figure 6-9: The Removal of Reamer after 1<sup>st</sup> Pullback Attempt (July 28, 2005)

The pipe pullback rate was controlled so that drill rods could be pushed at the same rate as the reamer being pulled back. The pipe pullout load was recorded using the external load cell connected to the choke. Inspection of the equipment after the removal from the bore found that failure occurred where the drill rod threaded into the reamer. The reamer and swivel were also found to be wrapped with ropes, cables, and carpet fragments, forming a ball. A grinder was used to cut this material wrapped around the reamer. Figure 6-9 shows the condition of the reamer and swivel upon removal from the bore.

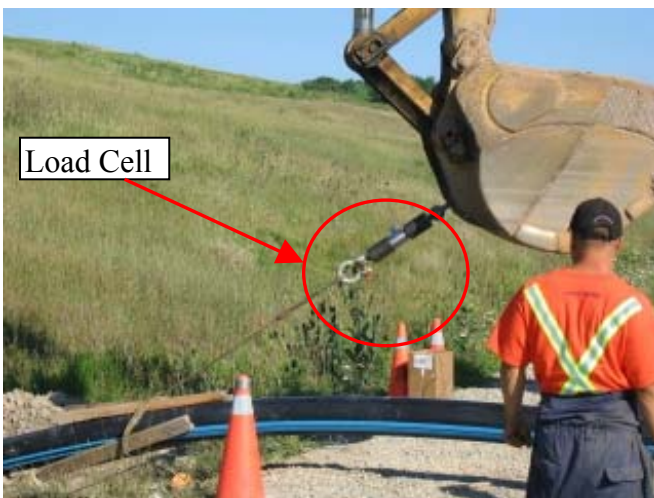
Figure 6-12: Load Cell Connected to the Excavator during 2<sup>nd</sup> Pullout of Carrier Casing.

The CAT 235 excavator was used to pull the pipe out of the bore. When the pipe was removed from the bore, leachate mixed with drilling fluid flowed into the exit pit as shown in Figure 6-11. The pullout load was recorded using the load cell shown in Figure 6-12. As with the 1<sup>st</sup> Attempt, drill rods and the pipe pulling were co-ordinated so that they occurred together.

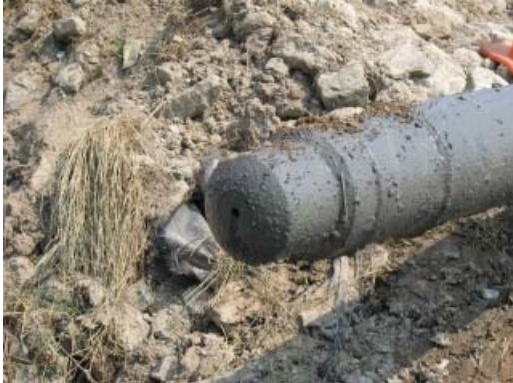
Figure 6-13: Condition of Carrier Casing After 2<sup>nd</sup> Pullout.

Upon pipe exit, it was found that the carrier casing was no longer connected to the swivel and that the load bolt placed through the HDPE butt cap was not present. The steel adapter that connected the load bolt to the swivel was found to be intact. Figure 6-13 shows the condition of the carrier casing upon the removal from the bore.

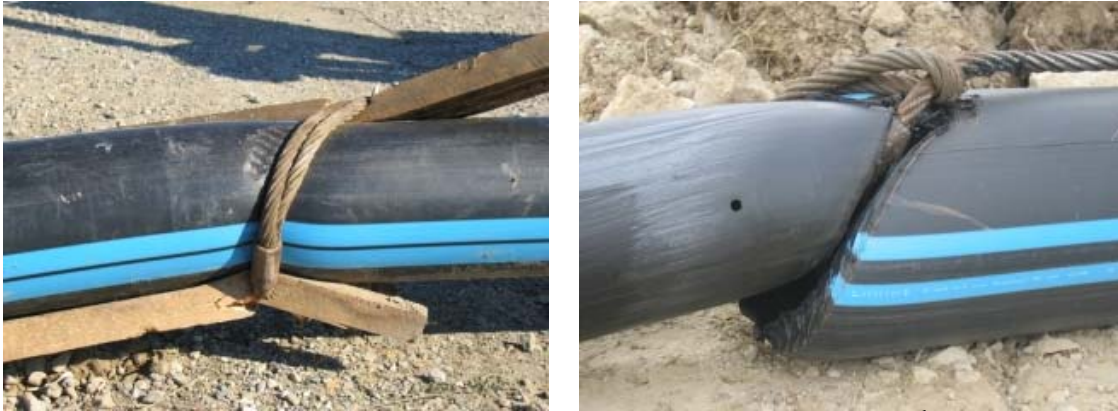
Figure 6-16: Damages on the 200-mm and 150-mm HDPE pipe after 3<sup>rd</sup> Pullback Attempt.

(236 ft) of the pipe was installed. While attempting to pull back the casing, the choker severed the pipe, shown in Figure 6-16.

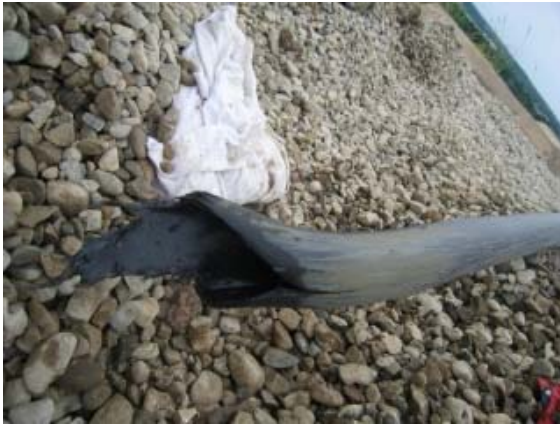
Figure 6-17: Failure of 100-mm OD HDPE Well Pipe during 4<sup>th</sup> Attempt

drilled length. This discrepancy in length led to the conclusion that the HDPE pipe was yielding in the bore. At this point, approximately 167 m of the 212 m (550 ft of the 695 ft) total length of well was installed. Pulling the HDPE well pipe out of the bore was not considered possible. Thus, it was decided to complete the pullback of the HDPE well pipe. With approximately 6 m (20 ft) of well pipe to install, the perforated HDPE pipe broke within the bore. Figure 6-17 shows the condition of the pipe when it came out of the bore.

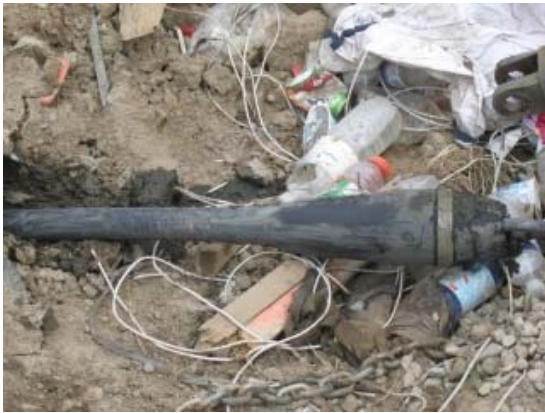
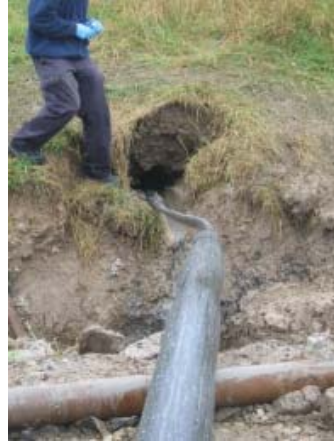
Figure 6-18: Reduced Diameter in 100-mm Perforated Pipe after Last Attempt

Stretched segments of the HDPE pipe were taken back to the University of Waterloo lab for inspection and analysis. After weighing and measuring the segmented pieces, it was found that the 23 m (76 ft) of HDPE well had strained approximately 223% or approximately 10 m.

A total of 23 m (76 ft) was pulled out from the bore at the entry point where the drill rig was sitting and a rubber tire backhoe was used to assist pulling the pipe. Because the pipe was stretched, the location of the broken pipe was unclear. The HDPE pipe yielded through most of this length and had "necked" down to approximately 38 mm to 51 mm (1.5-inch to 2-inch) diameter as shown in Figure 6-18. It was also observed that the pipe had been crushed flat and kinked in several locations.

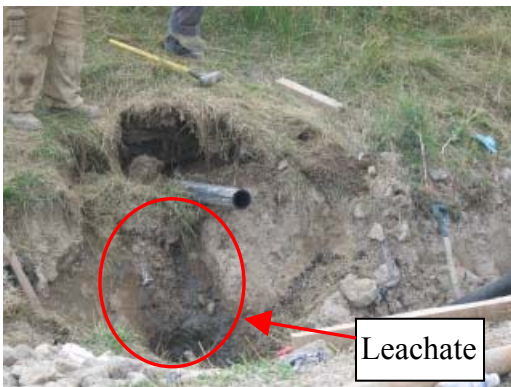
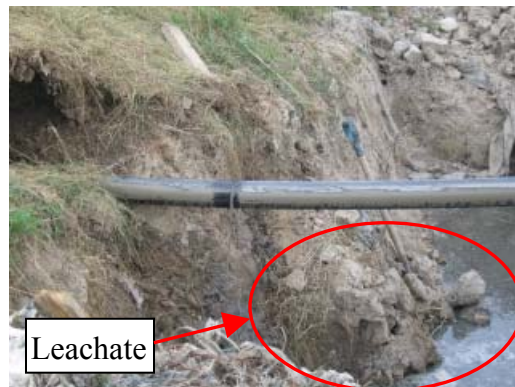
Figure 6-19: Leachate Flow during Pullout of 100-mm HDPE Pipe in the 4<sup>th</sup> Attempt

Leachate flow was observed coming out of the bore and within the 100-mm (4-inch) pipe from the perforated slots. Upon removing the pipe from the bore at the location of the drill rig, landfill gas was detected and it was emanating from the open bore. The volume of gas was significant enough that the bore had to be plugged.

Figure 6-19 illustrates the leachate flow from the bore and within the pipe at the pipe entrance location.

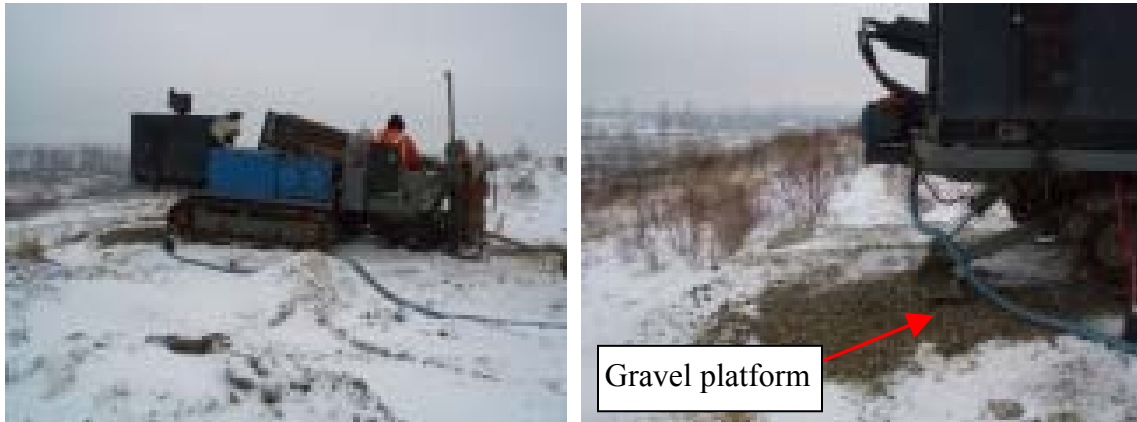
Figure 6-21: Drill Rig Sitting for West Well Installation

The placement of drill rig on the side of the east slope required the construction of a gravel drill pad as shown in Figure 6-21. Concrete anchors were also installed into the waste to ensure that the drill rig had sufficient resistance to thrust and pull.

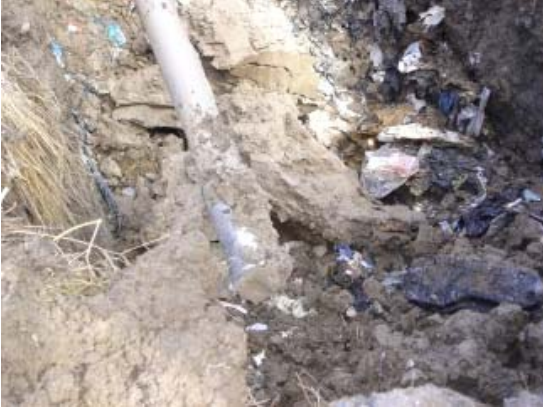
Figure 6-22: Drill Head Breakthrough Condition Upon From West Well Pilot Bore

The Hogs head drill bit used for the construction of the East Well was also used for the West Well. Pilot bore drilling commenced on January 26, 2006 and was completed on July 19, 2006. Due to waste obstructions, the pilot bore was abandoned twice before it was successfully completed. The time to complete the bore was approximately eight weeks. Figure 6-22 shows the condition of the drill head upon exiting from the pilot bore.

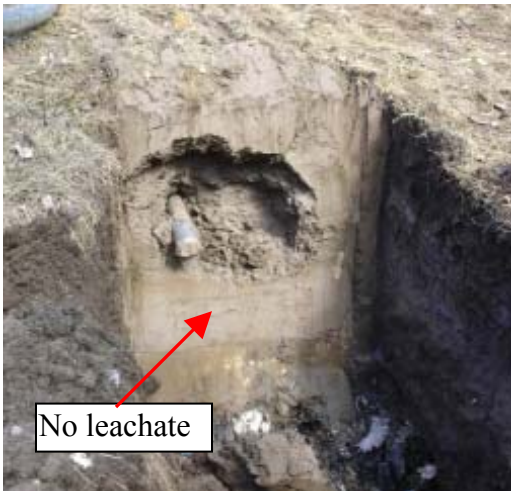
Figure 6-23: West Well Pilot Bore Breakthrough

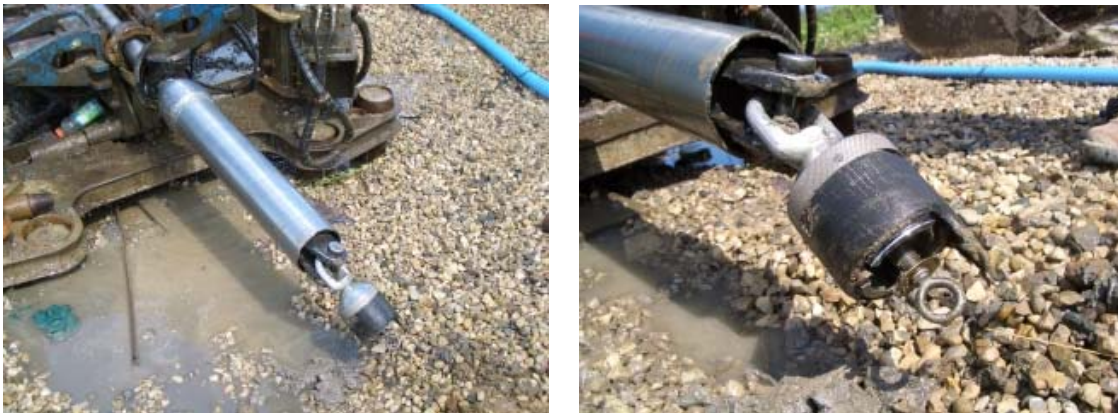
Figure 6-25: The Broken 100-mm Pipe after the Second Pullback Attempt for West Well

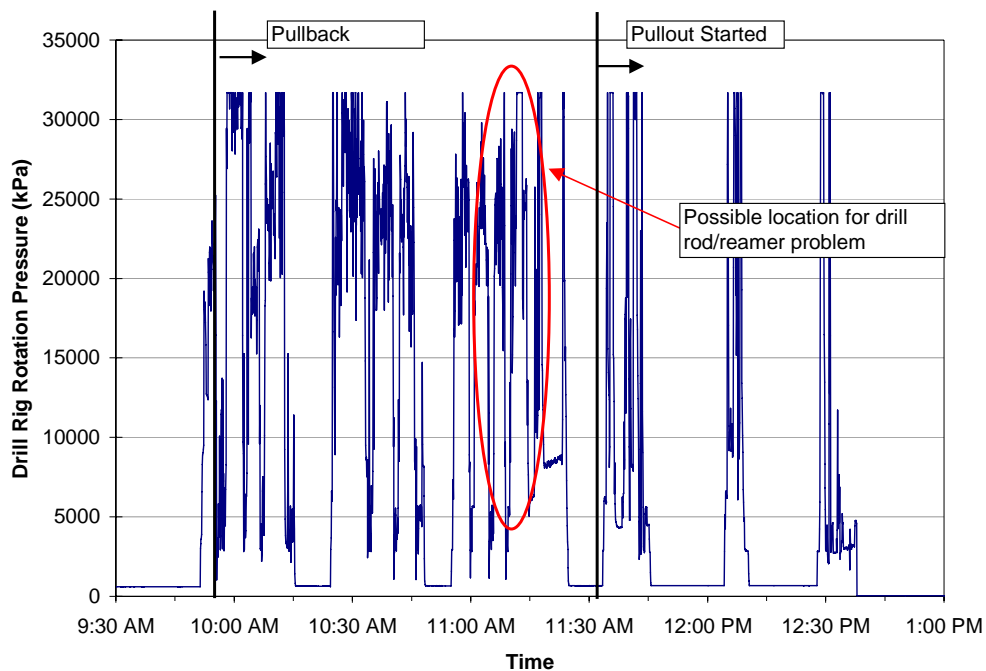
Figure 7-2: Drill Rig's Rotational Pressures during 200-mm HDPE Installation (July 28, 2005)

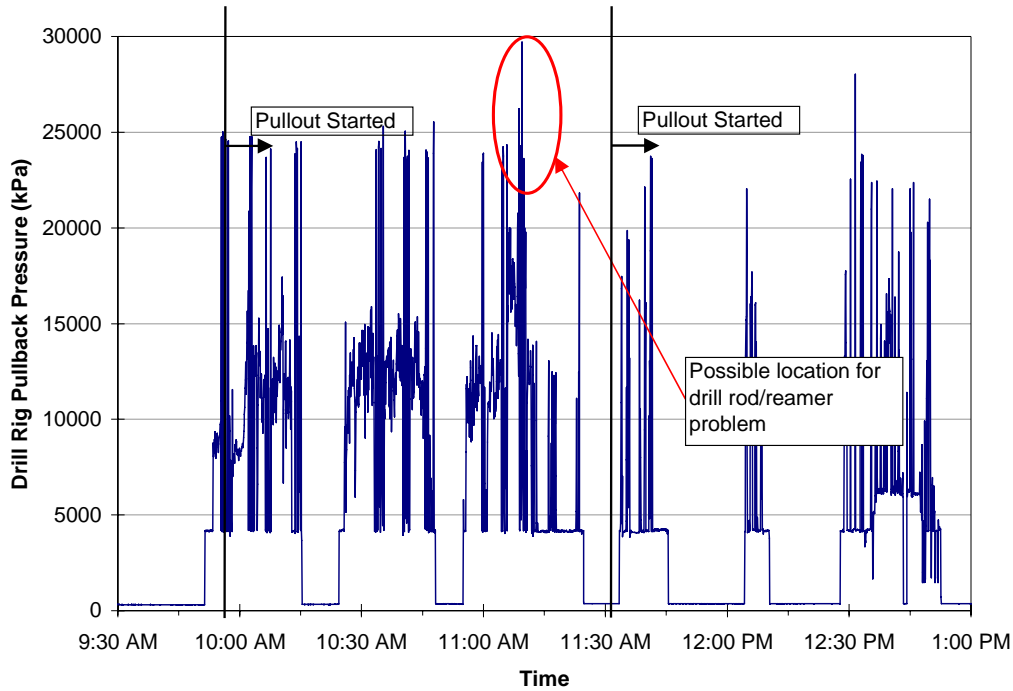
Figure 7-4: Drill Rig’s Pullback Pressures During 200-mm HDPE Installation (July 28, 2005)

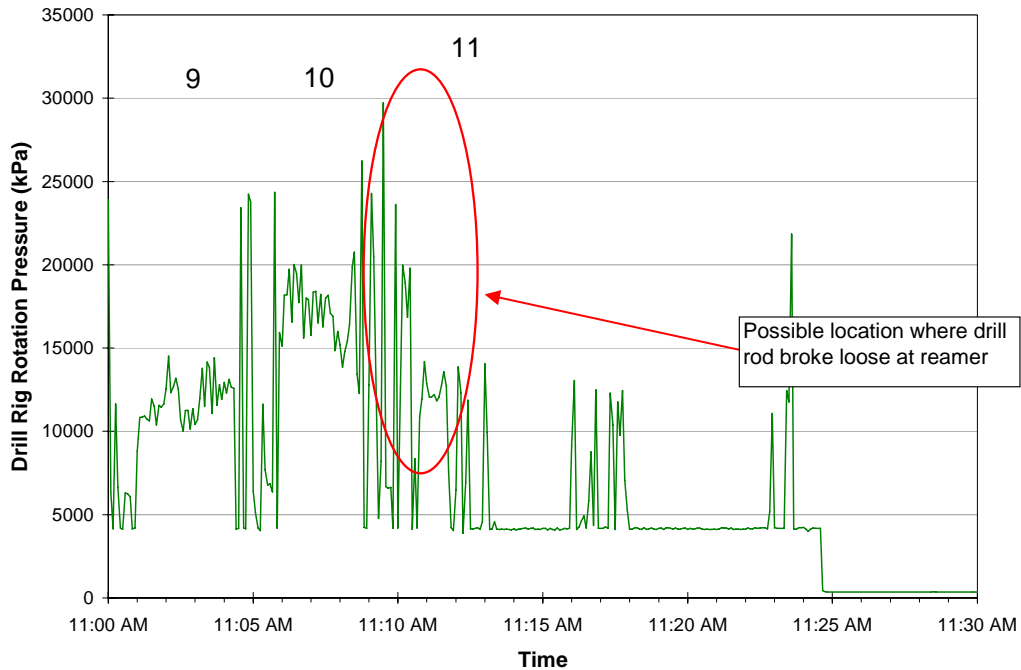
Figure 7-5: Drill Rig Pullback Hydraulic Pressures for Drill Rods 9 to 11 on July 28, 2005.

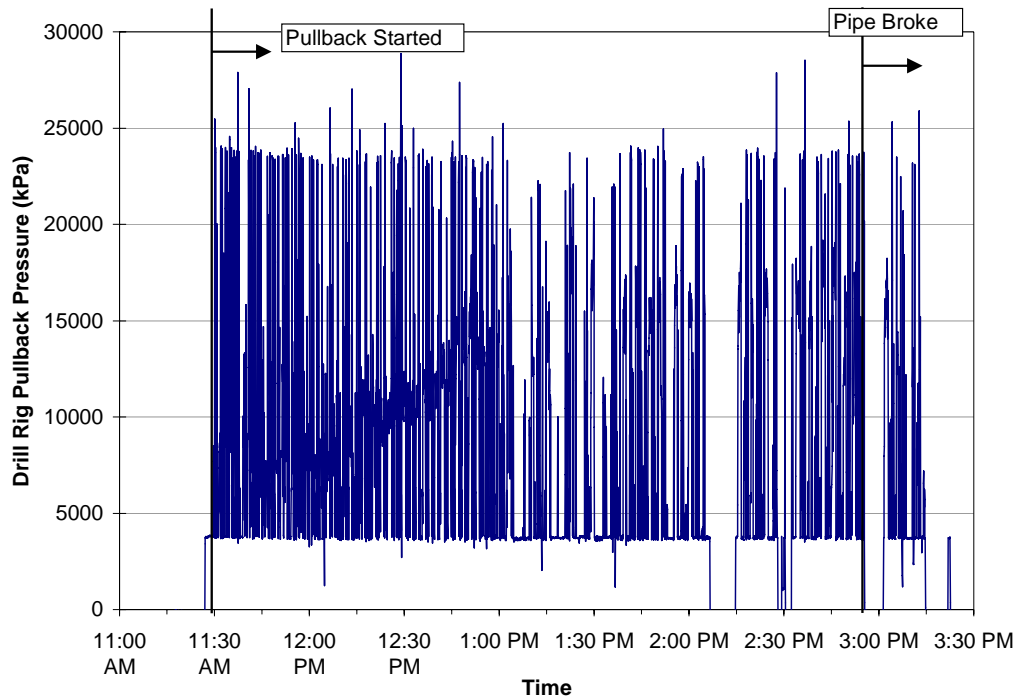
Figure 7-20: Drill Rig's Pullback Pressures for HDPE Well Installation on August 11, 2005.

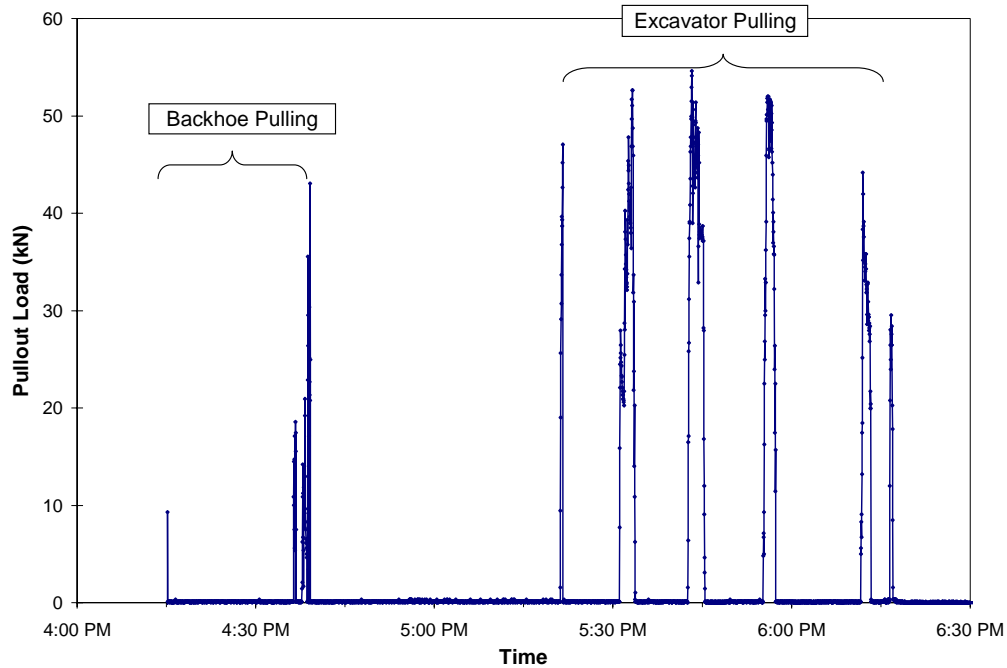
Figure 7-21: Pullout Load of 100-mm HDPE Pipe (August 11, 2005)

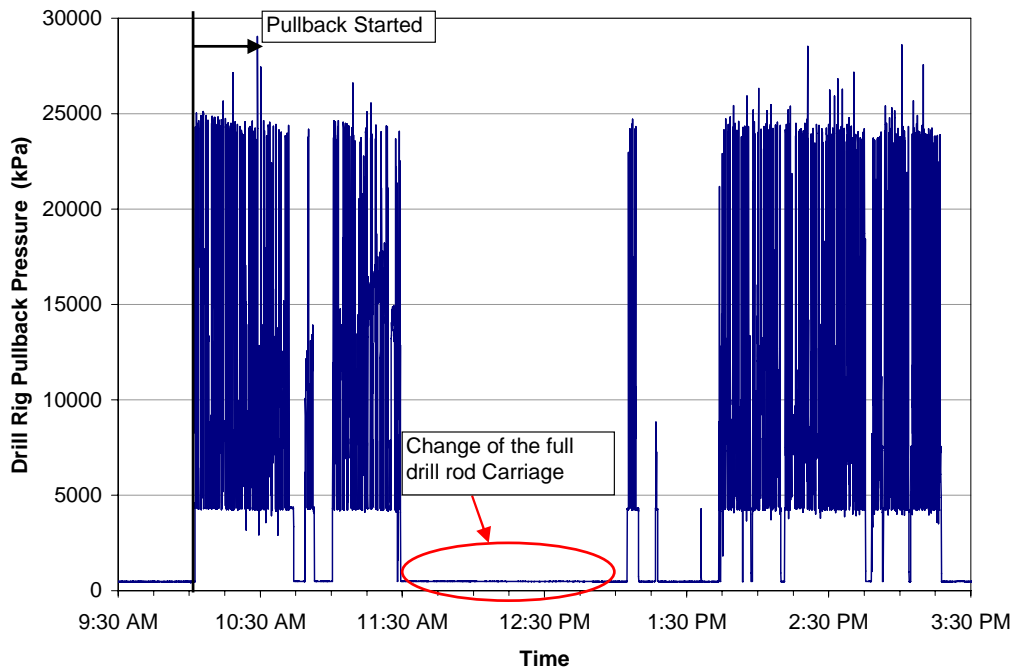
Figure 7-31: Drill Rig's Pullback Pressure on 100-mm HDPE Pipe (July 19, 2005)

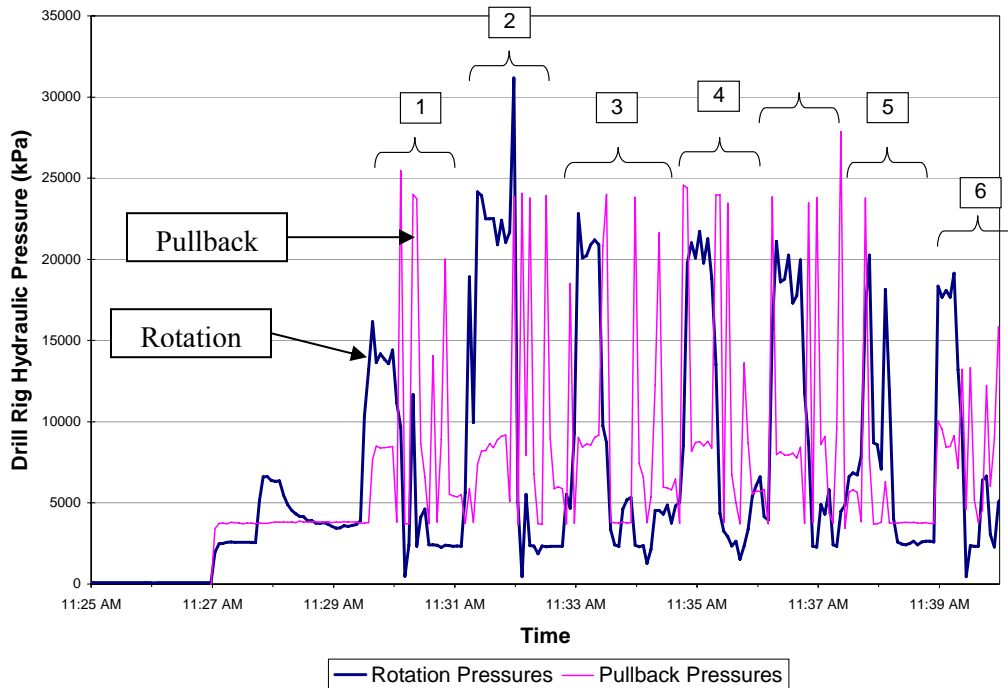
Figure 8-7: Close Scrutiny of Drill Rig Hydraulic Pressures of 100-mm HDPE Pipe
