# **THE DURABILITY OF AIRFIELD CONCRETE EXPOSED TO AIRCRAFT DE-ICERS**

A thesis

presented to the University of Waterloo

Master of Applied Science

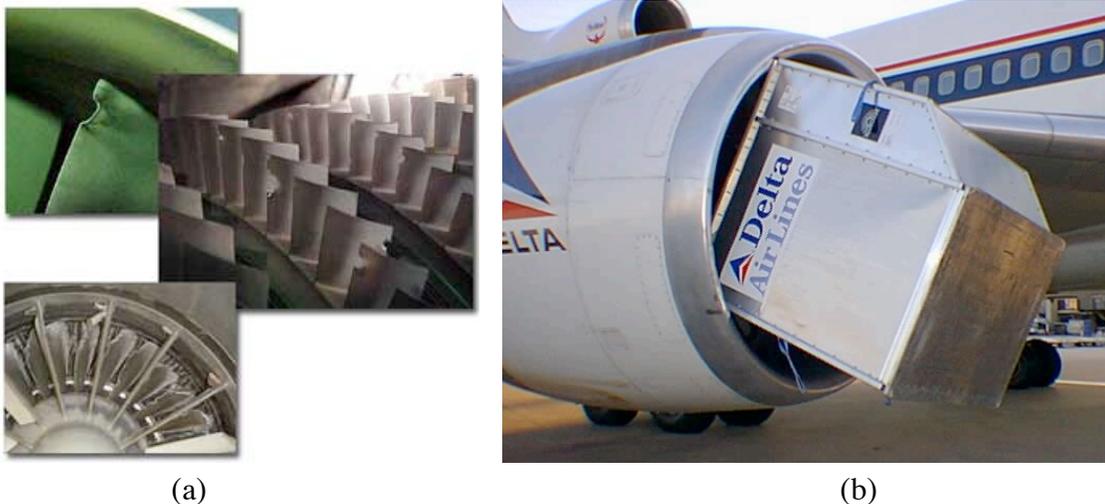
Figure 1.1 (a) Jet engine turbine blade damages [FODNews]; (b) Example of a cargo box being a large FOD hazard [Unusual Aviation Pictures].

FOD can range in size from nuts and bolts to large luggage carts. The term even includes wildlife and people on the airfield. Anything that is out of place on an airfield and can cause damage to the engine or flight control mechanisms is considered FOD. In addition to the passenger injuries and plane damage, potentially caused by FOD, a great deal of money can be lost in terms of flight delays, minor repairs, and lost productivity. An estimated 4 billion dollars is spent annually because of FOD, with the majority of it spent on engine repairs [FODNews].

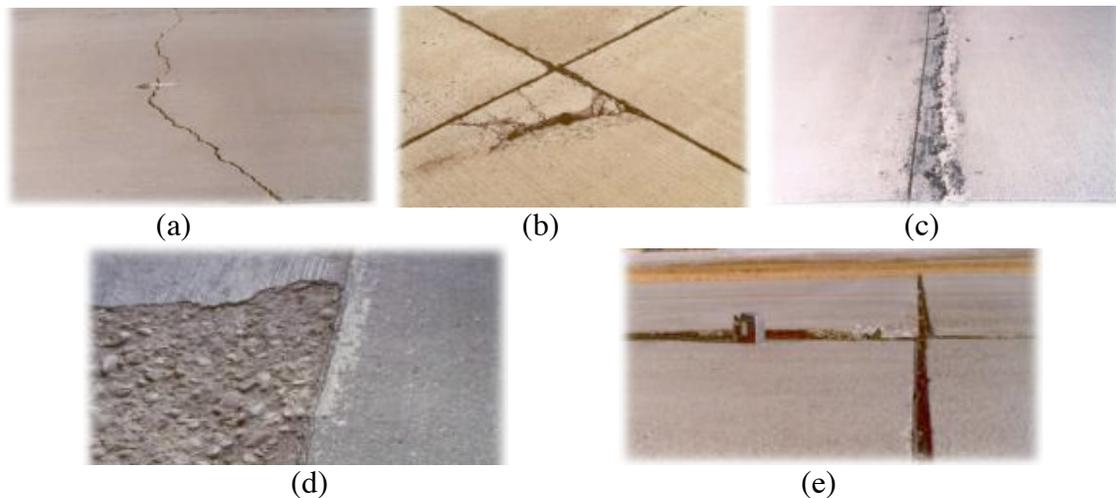
Figure 1.2 Common structural defects found in PCC airfields: (a) slab cracking, (b) corner cracking, (c) edge cracking (d) scaling/spalling, and (e) stepping [Transport Canada Civil Aviation].

All these defects can eventually result in loose pieces of concrete and popouts, which can pose a danger to the aircraft. In addition to the physical impact and load caused by the immense weight of the airplanes when at rest and upon landing, they could also be caused by a variety of chemical reasons. For example, the use of large amounts of de-icing and anti-icing chemicals used at airports located in cold regions may play a part in accelerating the deterioration of the airfield.

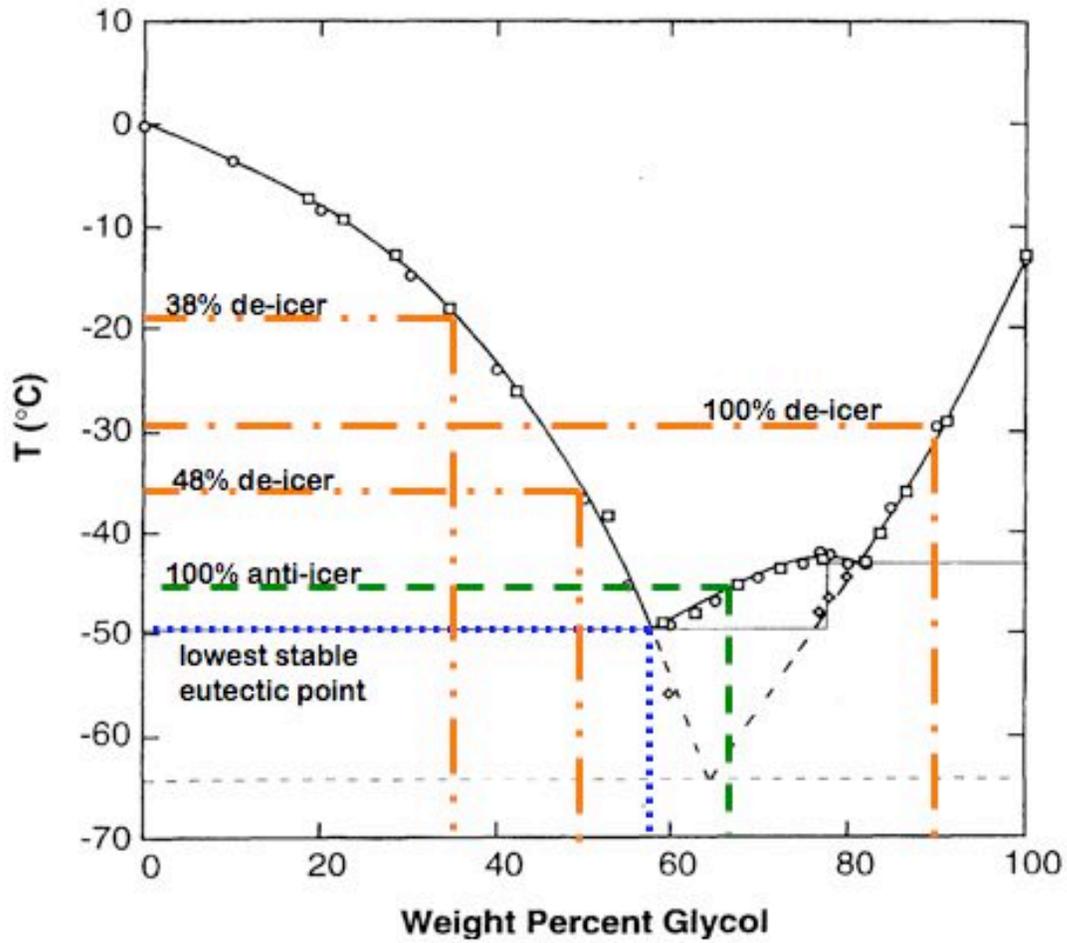
Figure 2.1 Ethylene glycol and water phase diagram [Cordray, 1996].

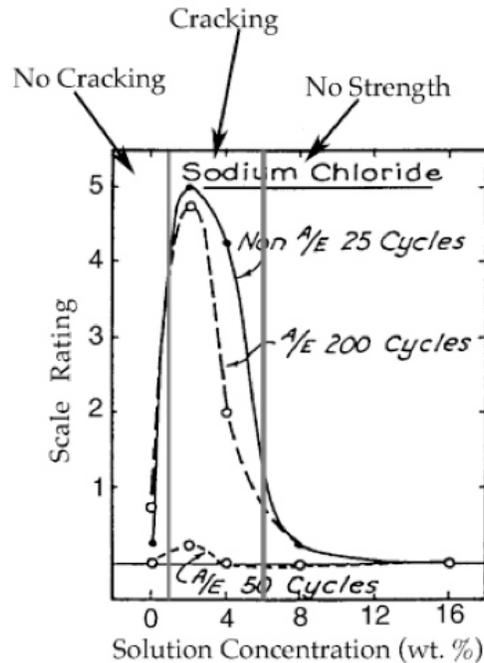
Figure 2.3 Effect of varying NaCl solution concentration on concrete scaling [Verbeck and Klieger, 1957].

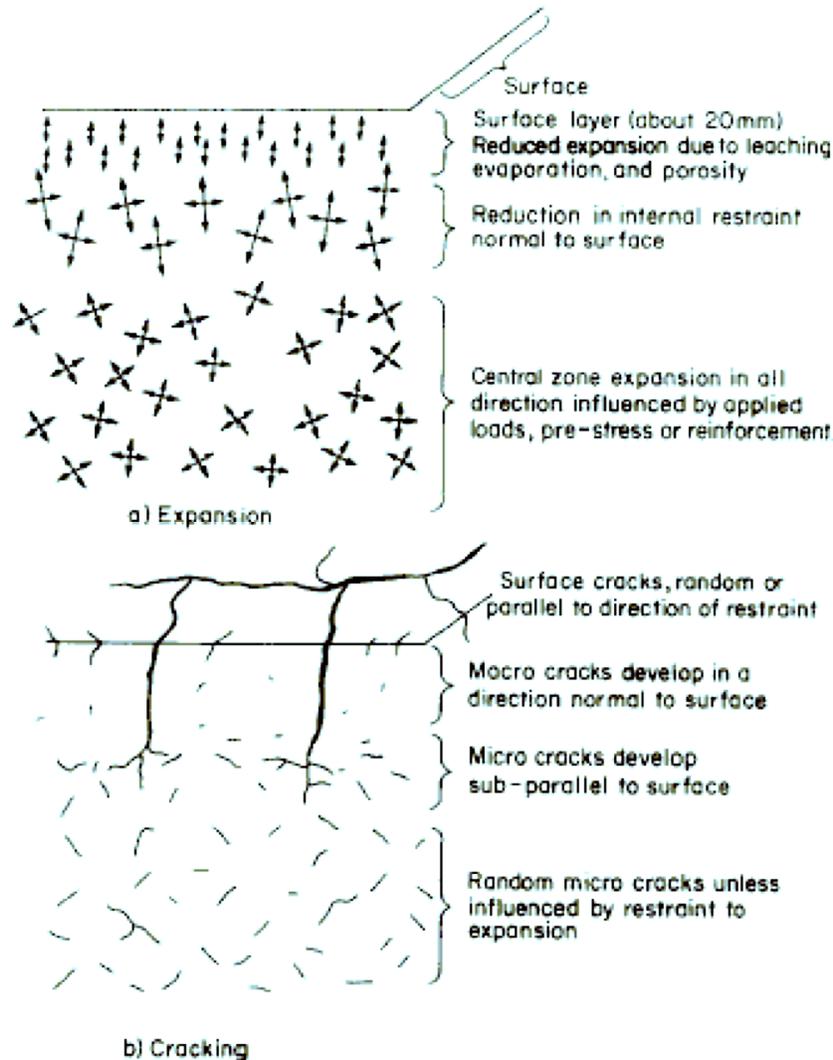
Figure 2.6 ASR crack zones: (a) expansion mechanism; (b) cracking mechanism [Courtier, 1990].

Courtier [Courtier, 1990] suggests the concept of dividing the concrete depth into three zones to discuss the mechanics of surface crack formation due to ASR. The zones are classified as zone three for the concrete far enough from the surface that it is not influenced by surface conditions, while zone one refers to the topmost layer up to a depth of approximately 20 mm. Figure 2.6 shows the expansion and cracking mechanisms affecting each zone.

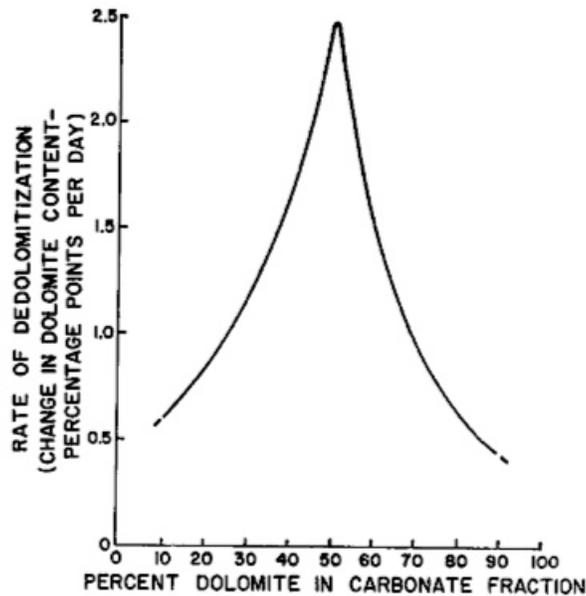
Figure 2.7 Rate of dedolomitization versus percent dolomite in carbonate fraction [Hadley, 1961].

There are differences of opinion regarding the expansion mechanisms of ACR that result in concrete deterioration. However, the greatest amount of expansion appears to occur when there are approximately equal amounts of calcite and dolomite content in the aggregate, as shown in Figure 2.7 [Hadley, 1961; Rogers et al., 2000].

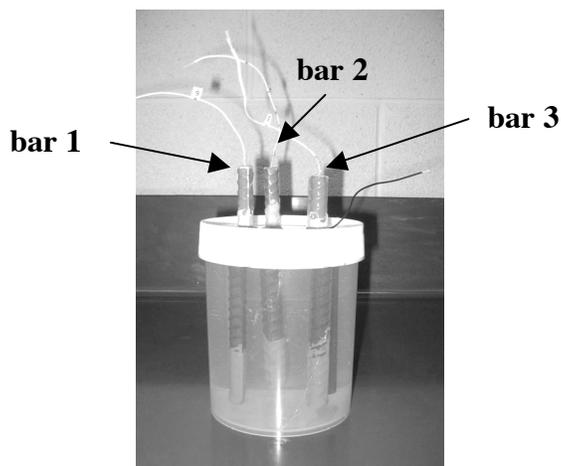
Figure 3.1 Water corrosion cell with white-wired working electrodes and a black-wired counter electrode.

All three working electrodes were inserted into the container through holes drilled through the plastic container lid. They were subsequently hot glued to the lid to hold them in place and prevent them from shifting around and touching the bottom of the container. The layout of the corrosion cell positioned the three reinforcement bars at equal distances away from the centre of the lid, which was the location of the reference electrode during measurement testing. The counter electrode was placed away from the working electrodes, but at an equal distance away from the reference electrode. The corrosion cell setup can be seen in Figure 3.1.

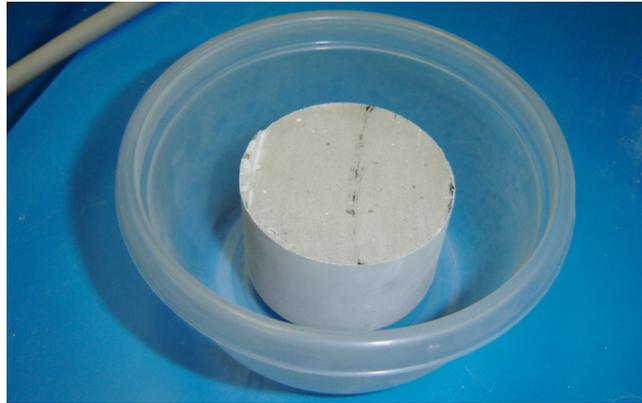
Figure 3.2. Setup of a 50mm  $\varnothing$  x 200 mm cement paste specimen in a container for the submersion test.

The cement paste specimens were placed in separate small plastic containers with the ground side facing the bottom of the container, as shown in Figure 3.2. Nylon tubing was used to support the specimens and provide access to the bottom surface of the specimen, allowing free fluid movement beneath the disks. Five different fluids were tested: 100% ethylene glycol, 38% ethylene glycol mixed with water, 48% ethylene glycol mixed with water, de-icing fluid, and anti-icing fluid. The fluids were used to half-fill two containers each, in order to fully submerge one ground end of the specimen while leaving the opposite ground end exposed to air.

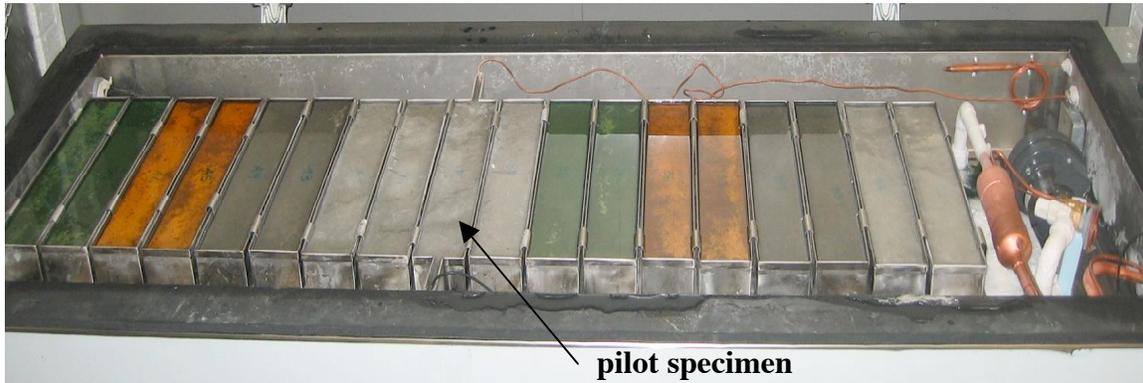
Figure 3.3 Interior of the freeze-thaw chamber, with specimens and test fluids in place.

The freeze-thaw equipment used for this test, manufactured by Humboldt Mfg. Ltd, can hold seventeen test specimens and one pilot specimen, as shown in Figure 3.3. The pilot specimen is required by the equipment to control the temperature cycling and to obtain continuous temperature readings.

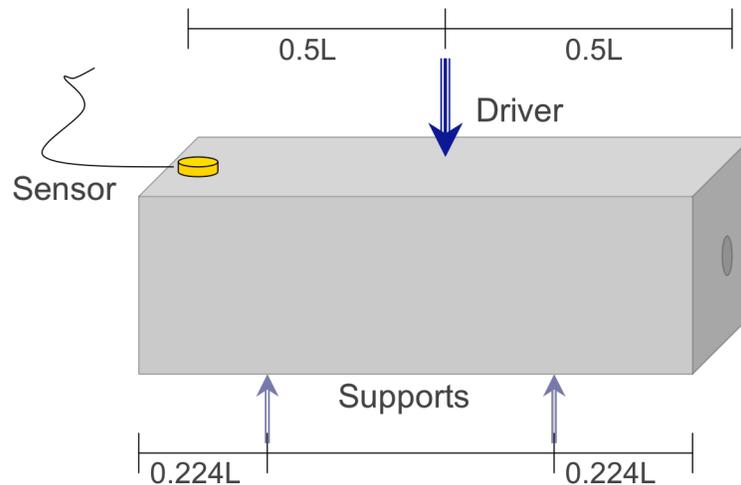
Figure 3.5 Transverse mode resonant frequency setup.

The fundamental frequency was obtained for each concrete prism using the standard Test for Fundamental Transverse Resonant Frequency of Concrete Specimens [ASTM C 215]. There are two methods listed in the standard that can be used: impact resonance method and forced resonance method. The equipment used in the lab is the Erudite MKIV by CNS Farnell Limited, which uses the forced resonance method, as shown in Figure 3.5. The driving force is created by an electromechanical input device, which can be controlled to oscillate at a set frequency or sweep through a range of frequencies. The driver is placed at the centre of the prism to cause resonance in its transverse mode. The output frequency is then acquired through a sensor that is placed at either end of the prism. It is lightweight so it does not interfere with the oscillation of the prism.

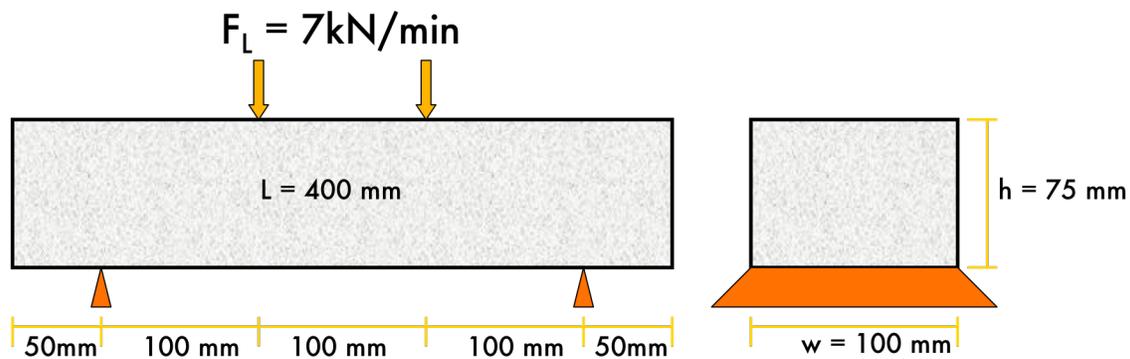
Figure 3.6 Four-point bending test setup.

An upper and lower fixture was attached to a MTS 810 Universal Testing Machine to create a four-point bending condition. The lower fixture has two supports for the specimen to rest on while the upper fixture is used to apply the load at two central loading points. It can be used to determine the rupture strength of a concrete prism. This setup can be seen in Figure 3.6. The loading rate used was 7 kN/min and loading was applied until failure.

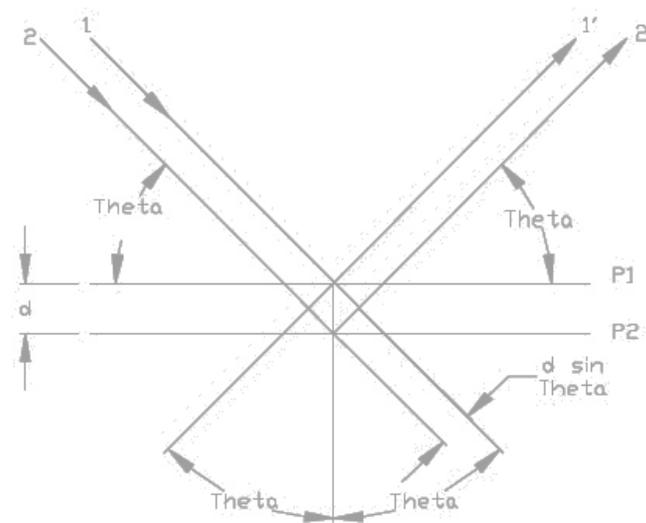
Figure 3.8 Diffraction of two x-rays by parallel planes of a crystal [Scintag].

When incident x-rays encounter a crystalline material, each x-ray may interact with parallel atomic planes, as shown in Figure 3.8.

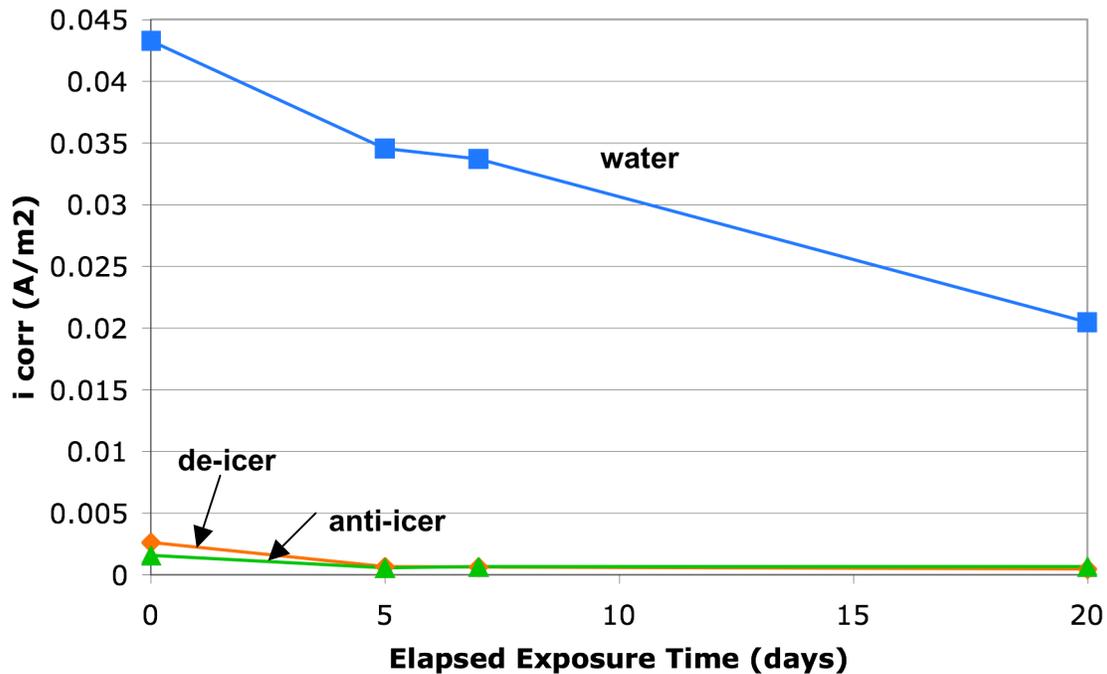
Figure 4.1 Corrosion results for steel reinforcement bars submerged in various fluids.

Corrosion testing was carried out over a 3-week time period, with measurements being taken immediately upon exposure and after 5, 7, and 28 days. The results are shown in Figure 4.1 below.

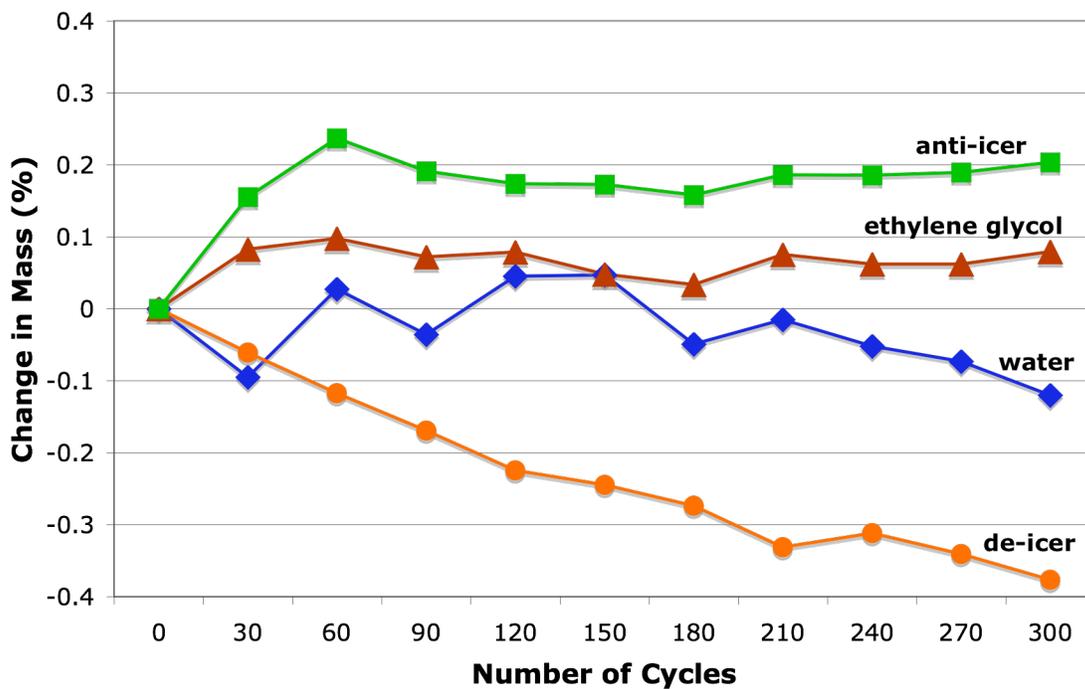
Figure 4.2 Average change in mass versus number of freeze-thaw cycles.

Throughout the duration of the test, none of the specimens fell below the modulus limit, thus all prisms were put through 300 cycles. Weight measurements were taken with a scale that had a resolution of 0.1 g. Prisms from batch A weighed more than prisms from batch B. This is expected because batch B had a higher air content, which resulted in lower density concrete. There was one specimen in each batch that was noticeably outside their respective weight ranges, at initial weights of 7675 g for batch A and 7790 g for batch B. When these two specimens were removed from the average specimen weight calculations, batch A had an average weight of 7821 g  $\pm$  1.2%, while batch B had an average weight of 7693 g  $\pm$  1%. This shows a weight difference of 1.7% between batch A and batch B, which corresponds well with the air content measured during batching. Average percentage change in mass values for each set of prisms are shown in Figure 4.2.

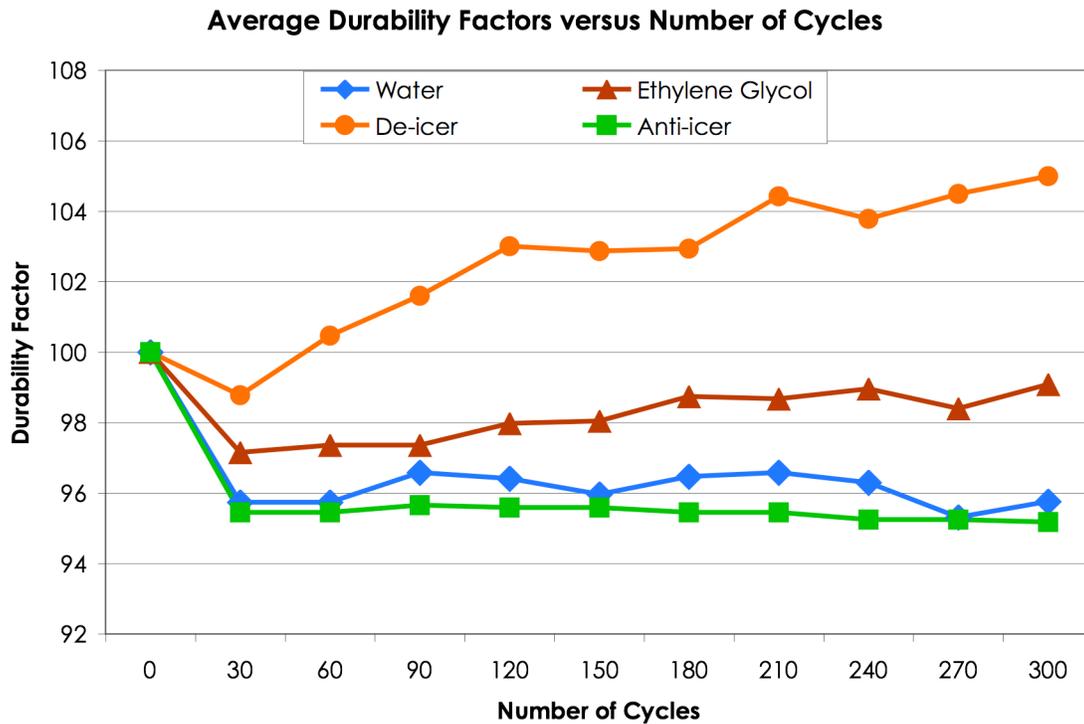
Figure 4.3 Freeze-thaw prism durability factors over 300 cycles.

The durability factors for all specimens are shown in Figure 4.3.

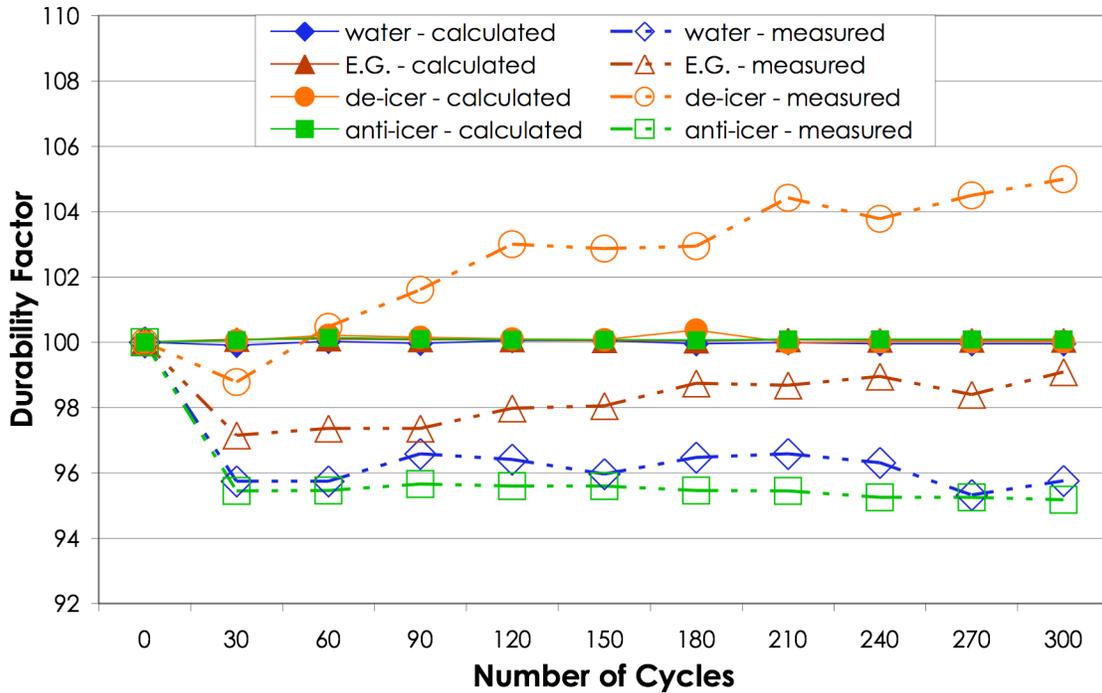
Figure 4.4 Average mass-based and average measured durability factors.

Where  $(f_r)_0$  is initial resonant frequency,  $m_0$  is initial mass,  $m_r$  is current mass, and  $f_r$  is frequency after a mass change from  $m_0$  to  $m_r$ . This equation was used to calculate a theoretical resonant frequency for the prisms at each 30-cycle interval based on the measured weights, which was in turn used to calculate a durability factor for each prism. A comparison of the calculated versus measured values can be seen in Figure 4.4.

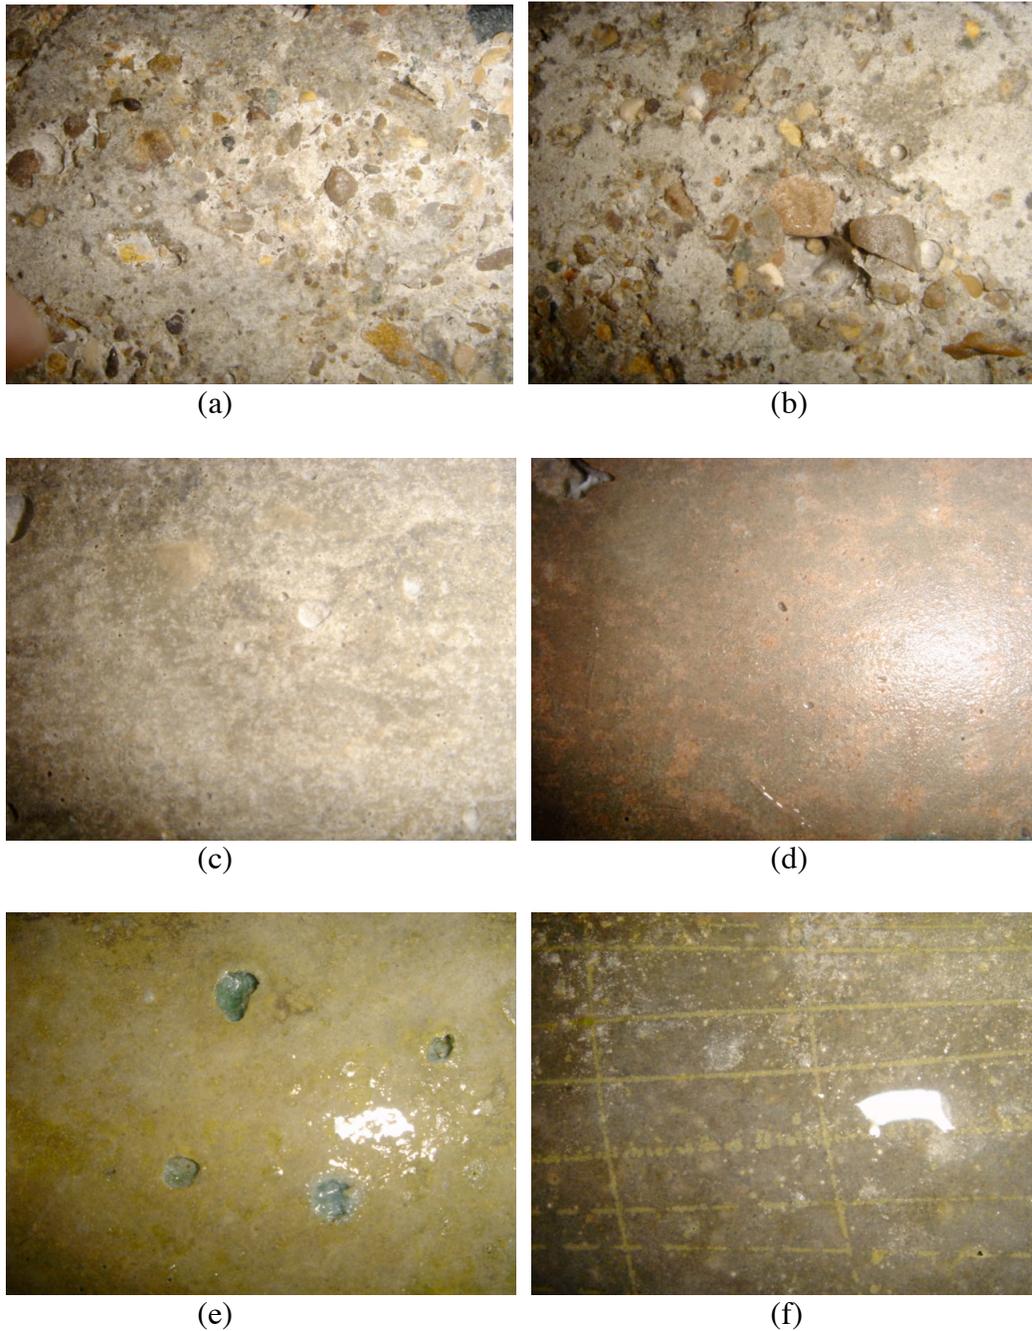
Figure 4.5 Surface conditions of freeze-thaw prisms submerged in (a) & (b) water, (c) ethylene glycol, (d) de-icer, (e) and (f) anti-icer.

Photographs of the test specimens surfaces after 300 cycles are shown in Figure 4.5.

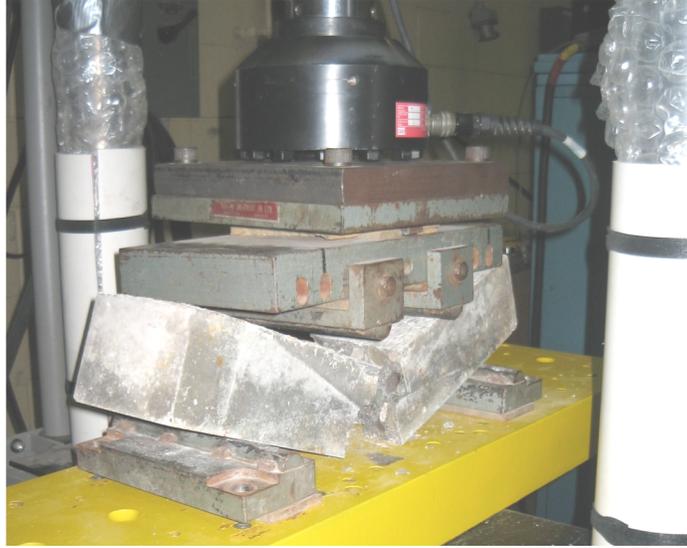
Figure 4.6 Prism after failure under four-point bending conditions.

Two specimens of each set from the freeze-thaw test were subjected to a four-point bending test, illustrated in Figure 4.6. Prisms that were cast at the same time as the freeze-thaw prisms, but were not exposed to freeze-thaw conditions, were used as controls.

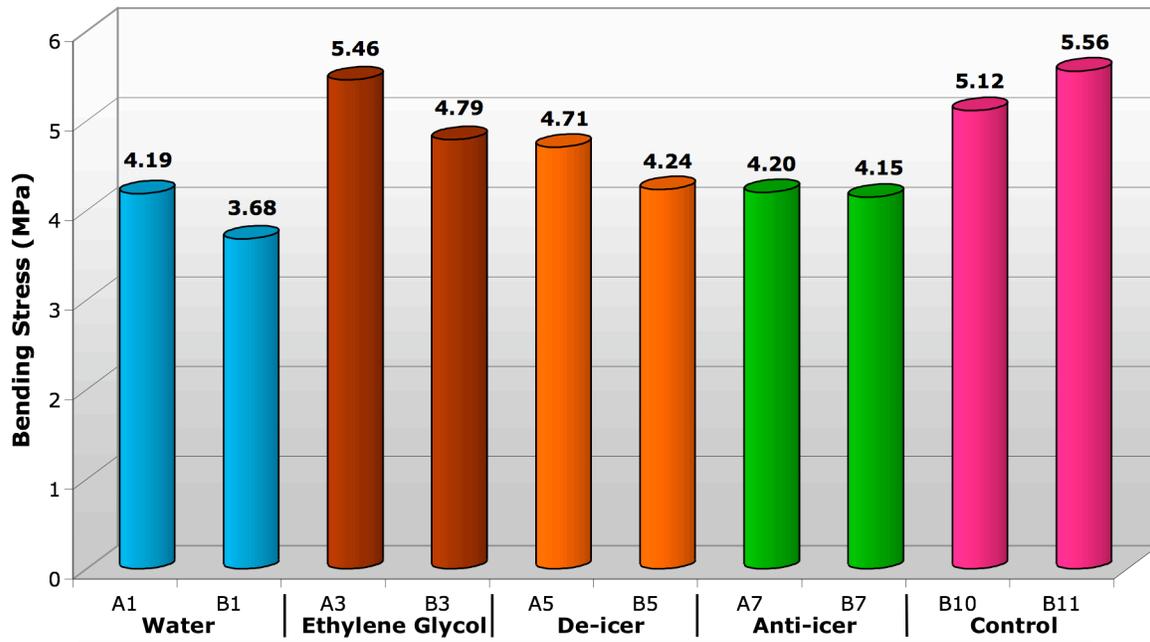
Figure 4.7 Four-point bending rupture strength results for the freeze-thaw specimens.

The results for all rupture strengths calculated from Equation 3.4 (Section 3.6) are given below in Figure 4.7.

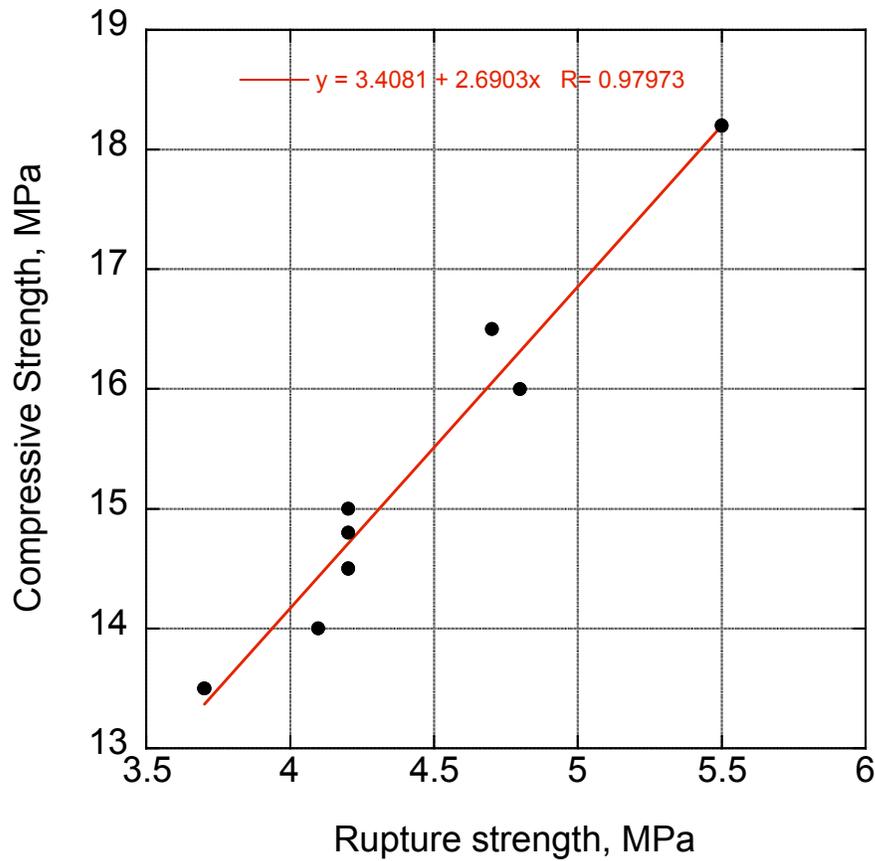
Figure 4.8 Plot of compressive strengths versus 4-point bending rupture strengths.

Section 4.8 to 4.10 below. As shown in Figure 4.8, these results correlate very well with freeze-thaw durability results.

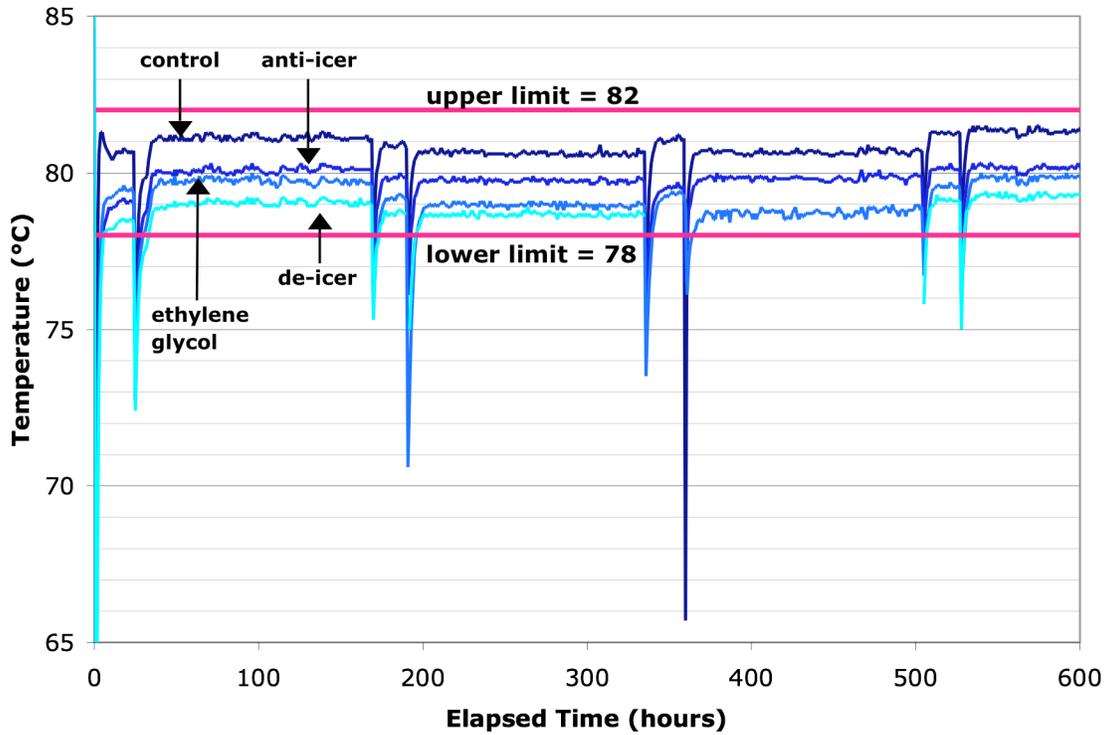
Figure 4.9 Thermocouple temperatures from each of the four test containers.

Test temperatures, which had to be tightly regulated at 80°C with a  $\pm 2^\circ\text{C}$  variance, were measured using thermocouples placed within each of the four specimen containers, consisting of ethylene glycol, de-icer, anti-icer, and a 1 M NaOH solution as a control.

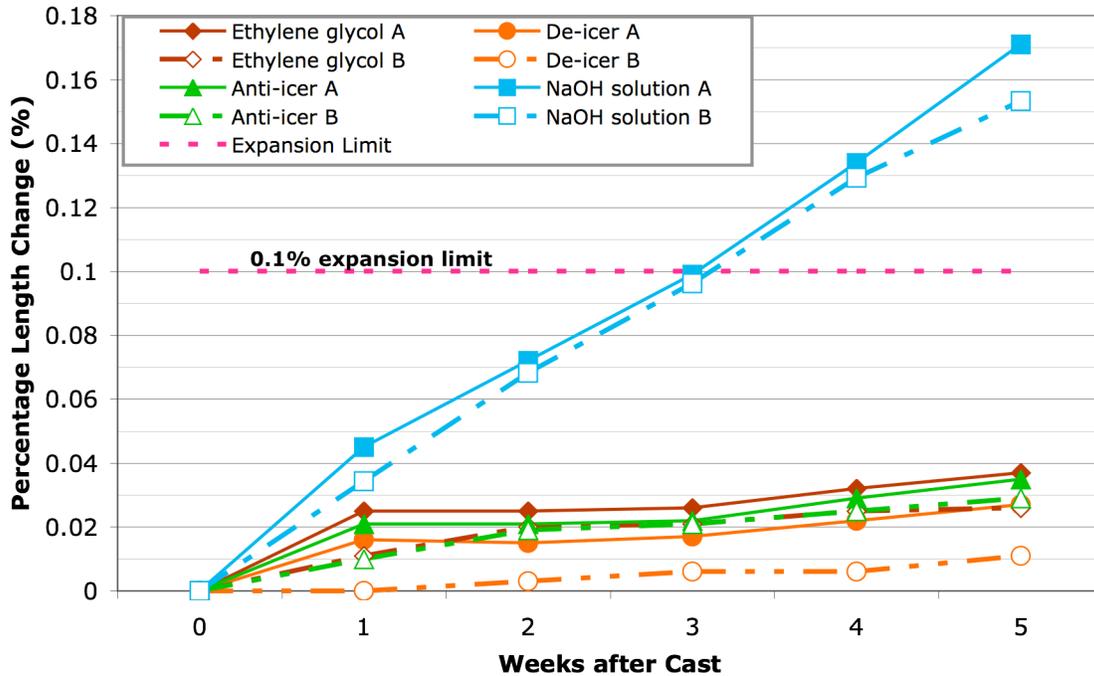
Figure 4.10 Accelerated expansion test results for concrete prisms in various media.

Expansion measurements were taken each week for a total of five weeks. The results are shown in Figure 4.10.

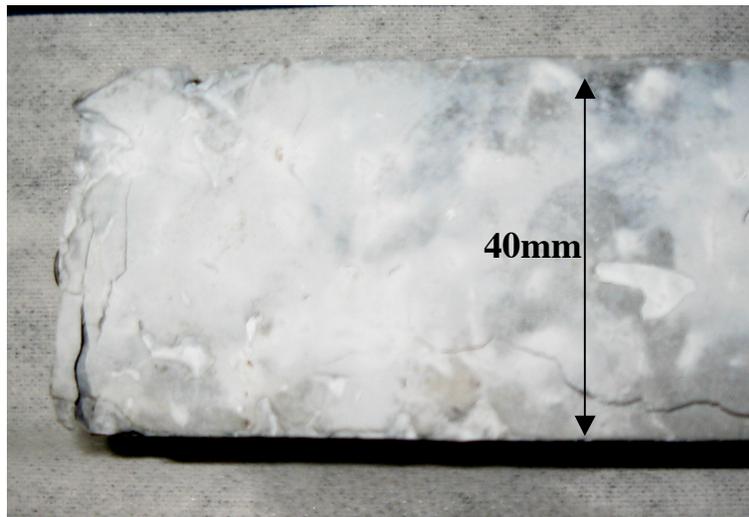
Figure 4.11 Expansion of alkali-reactive aggregates in concrete placed in NaOH solution causes visible cracking.

Visual inspections of the prisms afterward show the harmful nature of alkali-aggregate reaction within concrete prisms exposed to NaOH solution. As shown in Figure 4.11, there are visible cracks at various places along the length of the control prisms. On the other hand, prisms in ethylene glycol, de-icer, and anti-icer did not have any visible deterioration on the surface, which is expected since overall expansions were very low.

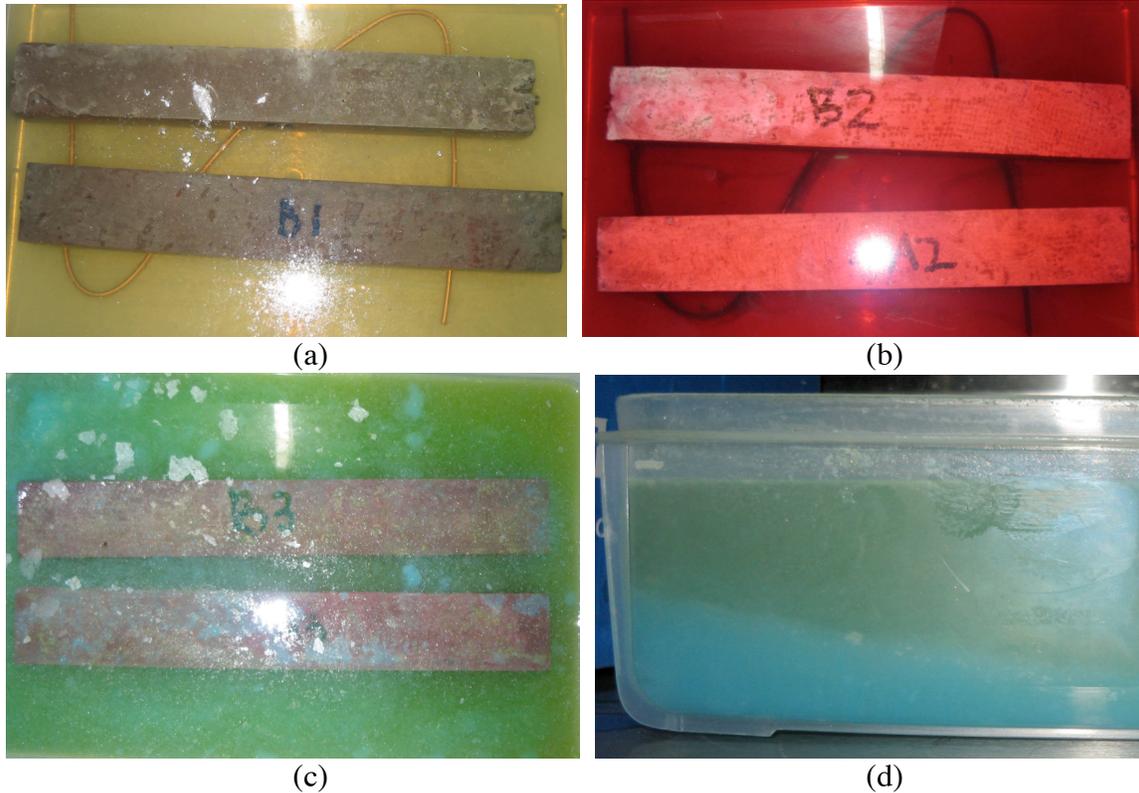
Figure 4.12 Various fluid changes were noted after one week exposure: (a) Ethylene glycol fluid became yellow-ish; (b) de-icer fluid turned a deep wine red colour; (c) and (d) anti-icer fluid appeared to separate into two layers.

Other observations were noted regarding fluid appearance throughout the test period. After only one week, fluid consistencies and colours changed, as can be seen in Figure 4.12.

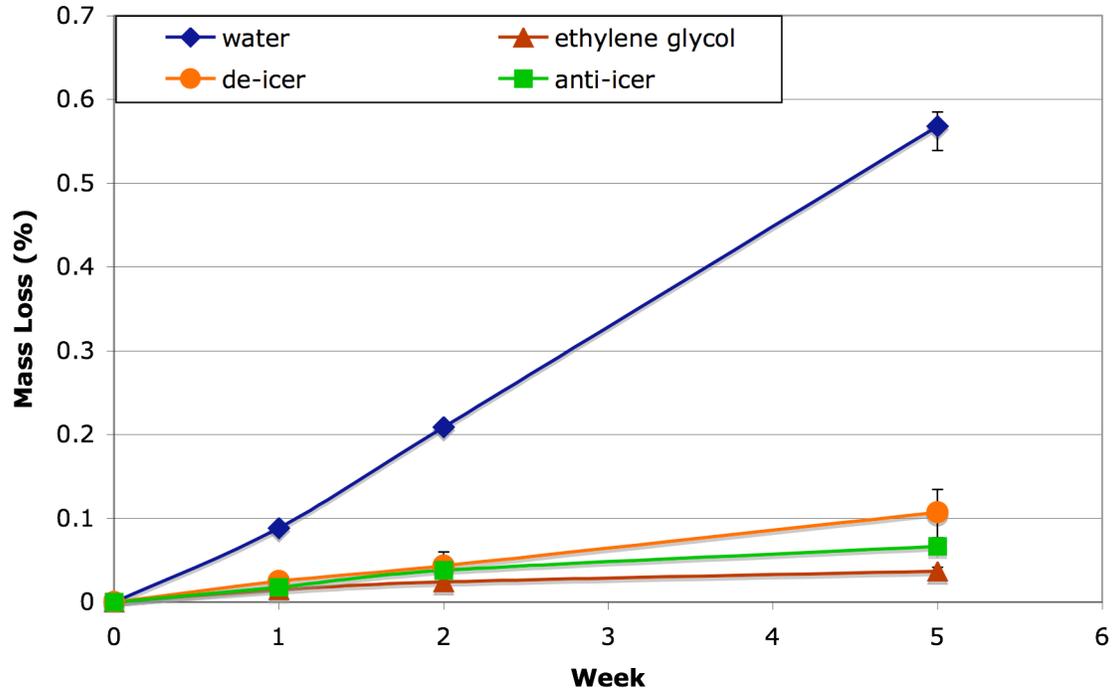
Figure 4.15 Accumulative mass loss of steel in test fluids.

Corrosion was negligible for steel in ethylene glycol, de-icer, and anti-icer, but was significant for steel in water. The average corrosion rate of the steel specimens in water

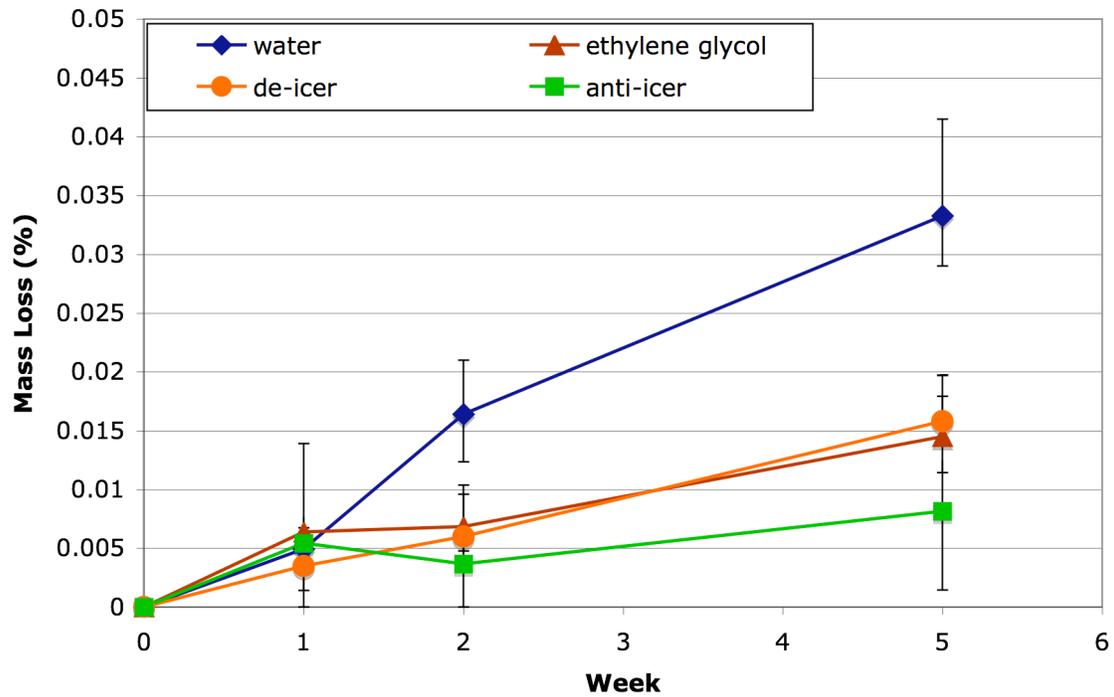
Figure 4.16 Accumulative mass loss of copper in test fluids.

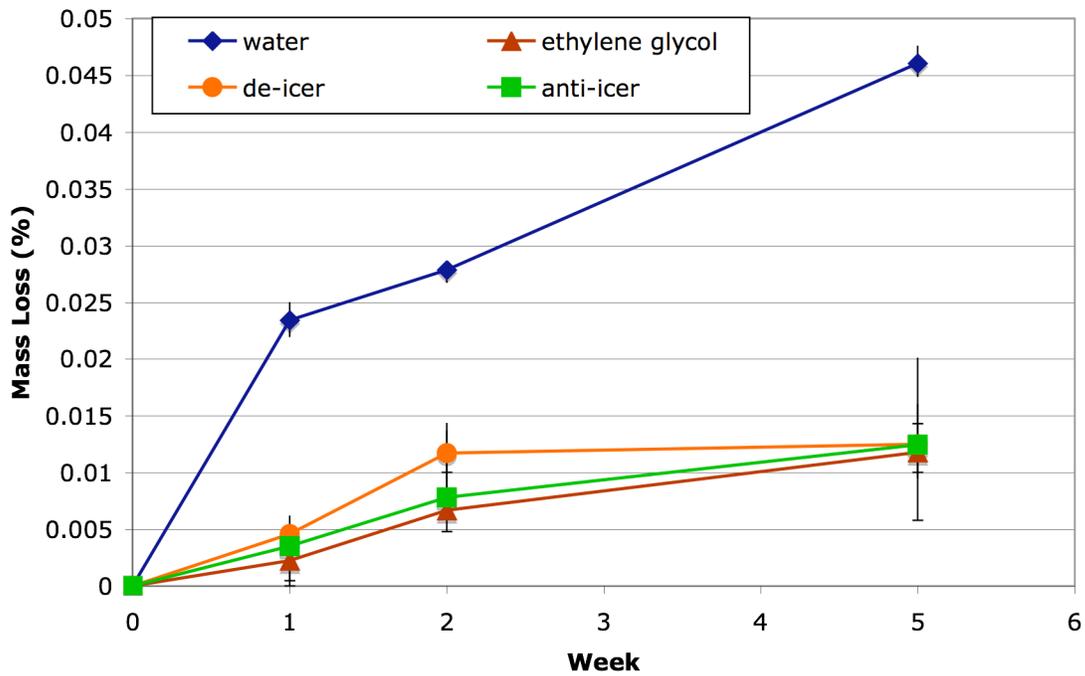
Figure 4.18 Accumulative mass loss of copper in fluids with cement paste.

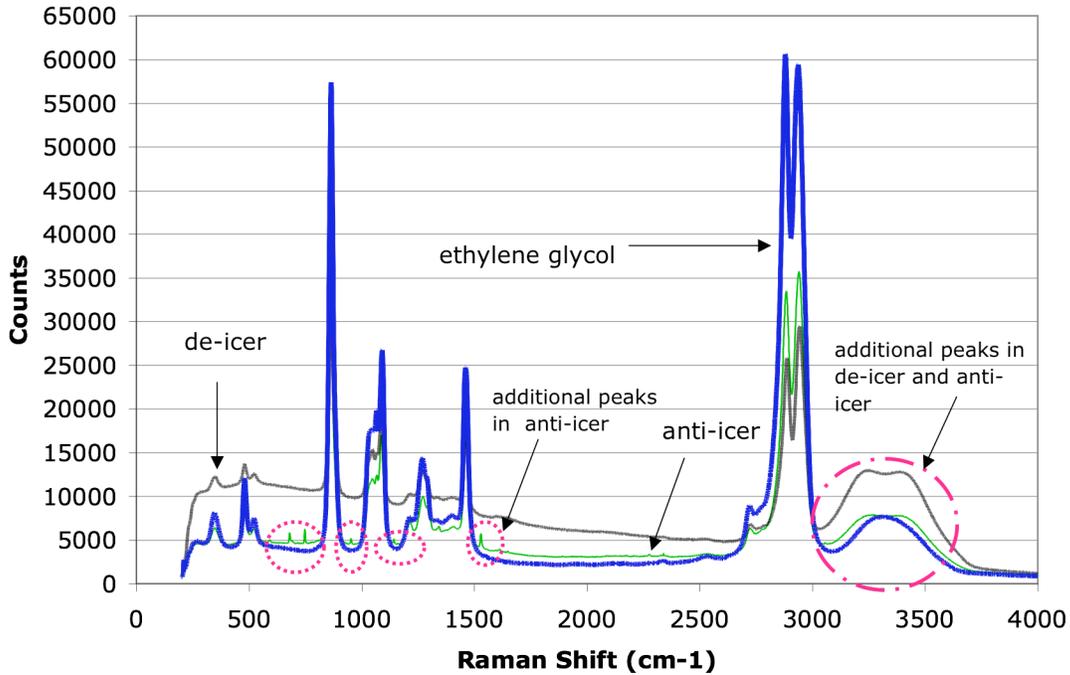
Figure 4.19 Raman spectra for ethylene glycol, de-icer, and anti-icer.

Raman spectroscopy was used to analyse de-icer and anti-icer fluid to obtain spectra that would be useful in comparing or identifying contrasting components between the two. Ethylene glycol was also analysed, in order to provide a baseline spectrum for the two fluids since it is the primary constituent in both fluids. The results for all three fluids are shown in Figure 4.19 below.

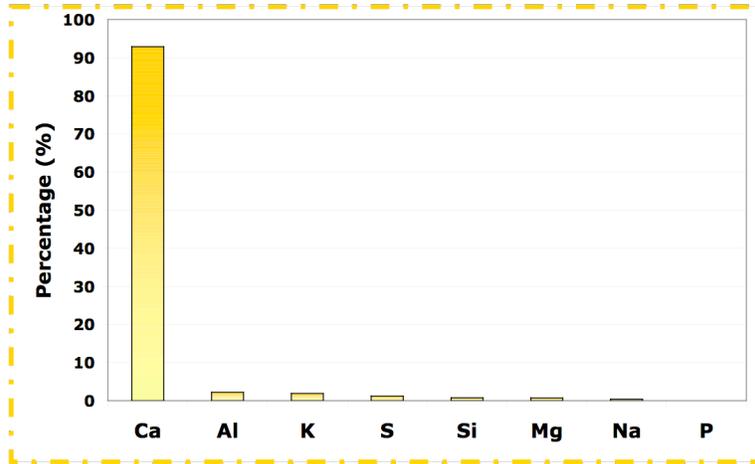
Figure 4.20 EDS analysis of precipitates formed from cement paste submerged in ethylene glycol.

A fine white precipitate was observed inside the container housing cement paste submerged in ethylene glycol. EDS analysis was performed on the dried precipitate, shown in Figure 4.20.

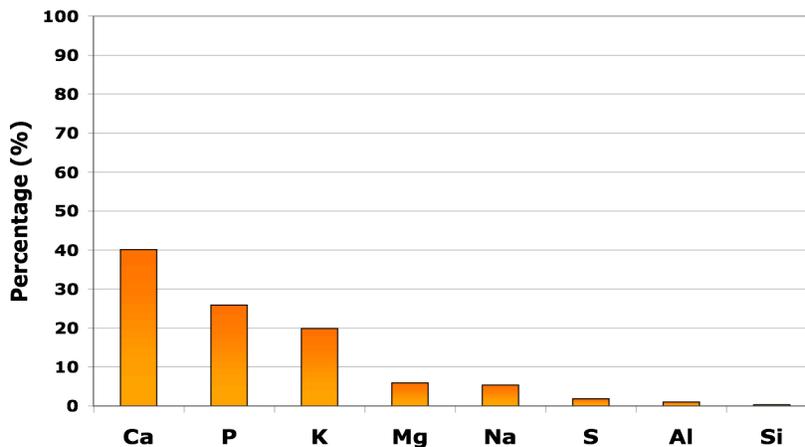
Figure 4.21 Micrograph and EDS analysis of exposed surface of cement paste in de-icer.

Because of the formation of adhered precipitate, the exposed surface of the cement paste was analyzed, as shown in Figure 4.21.

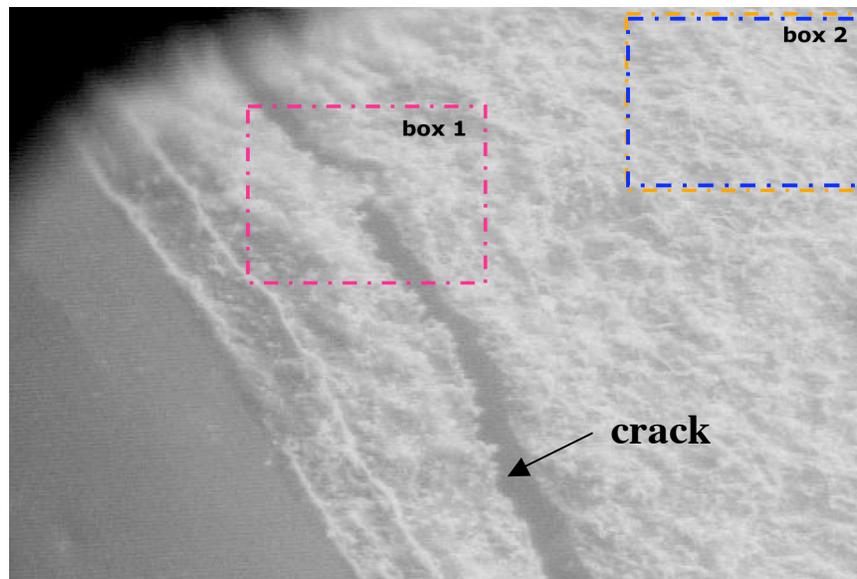
Figure 4.22 Micrograph of interior paste away from exposed surface of cement paste submerged in de-icer.

The cement paste disk was removed from the de-icer and fractured in order to examine the interior paste, shown in Figure 4.22, away from the exposed surface. This was done to observe how the elemental analysis changed at a distance away from the exposed surface.

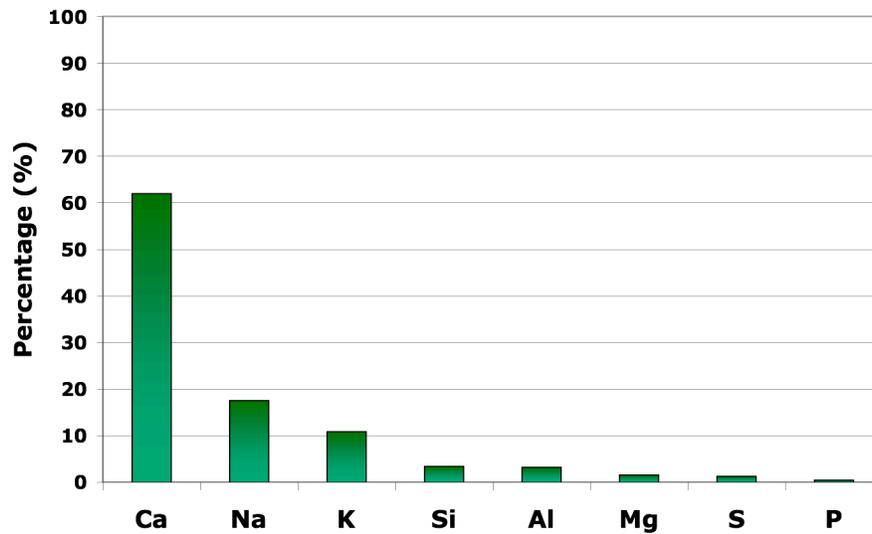
Figure 4.24 EDS analysis of precipitate from cement paste in anti-icer.
