# **THE DURABILITY OF AIRFIELD CONCRETE EXPOSED TO AIRCRAFT DE-ICERS**

A thesis

presented to the University of Waterloo

Master of Applied Science

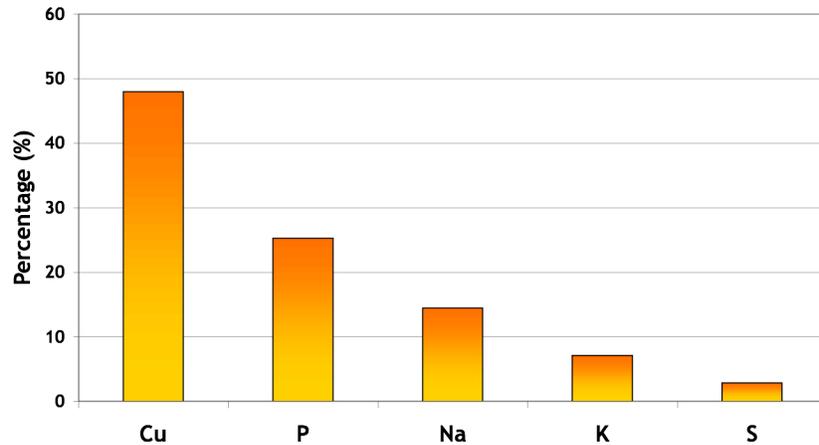
Figure 4.25 EDS analysis of precipitates collected from accelerated expansion test for concrete prisms in de-icer.

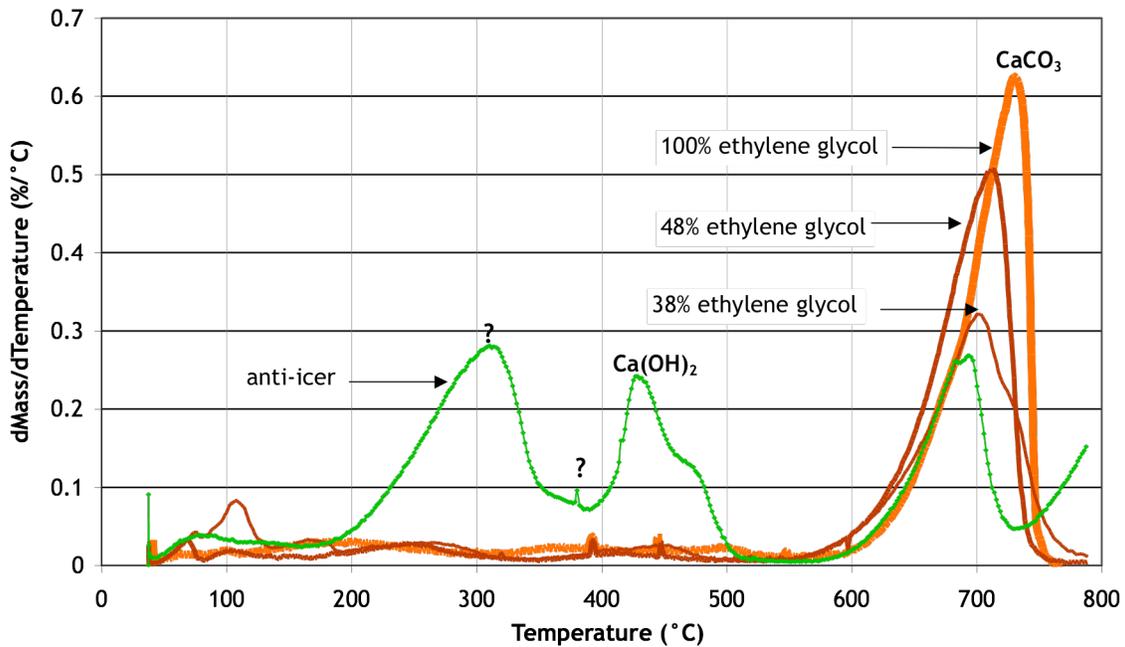
Figure 4.26 Thermogravimetric plots for four types of precipitates.

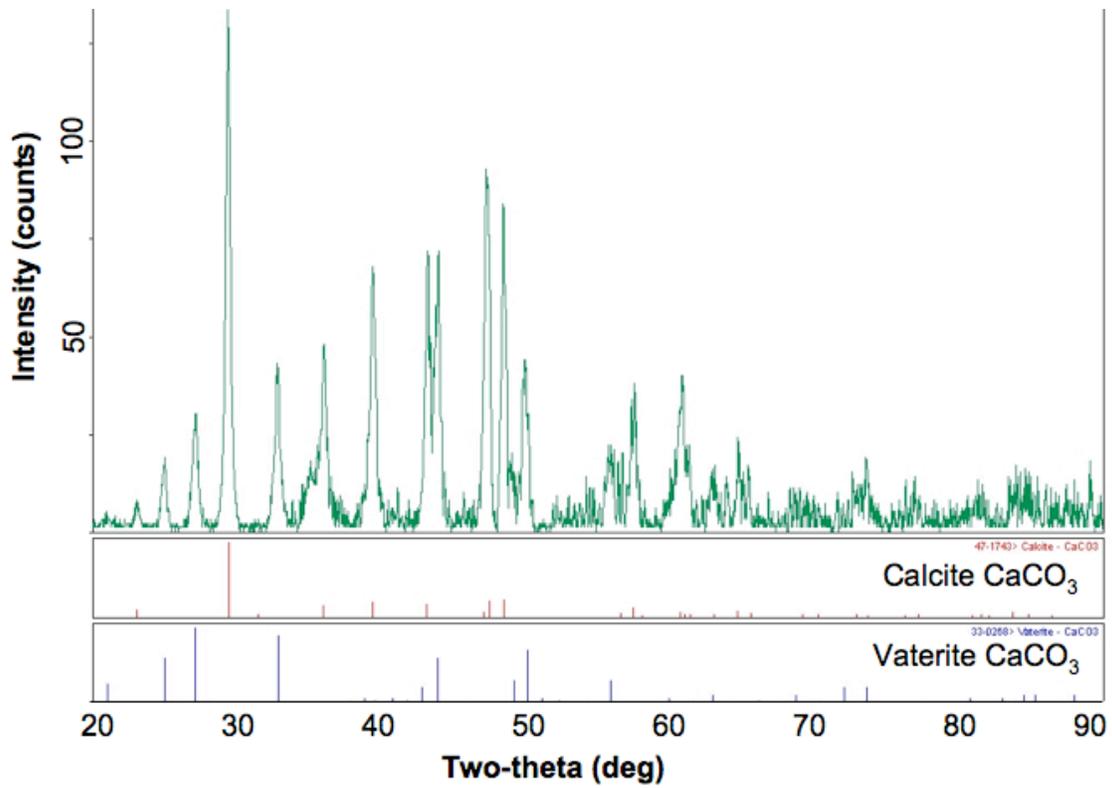
Figure 4.27 XRD analysis of precipitates from cement paste in ethylene glycol.

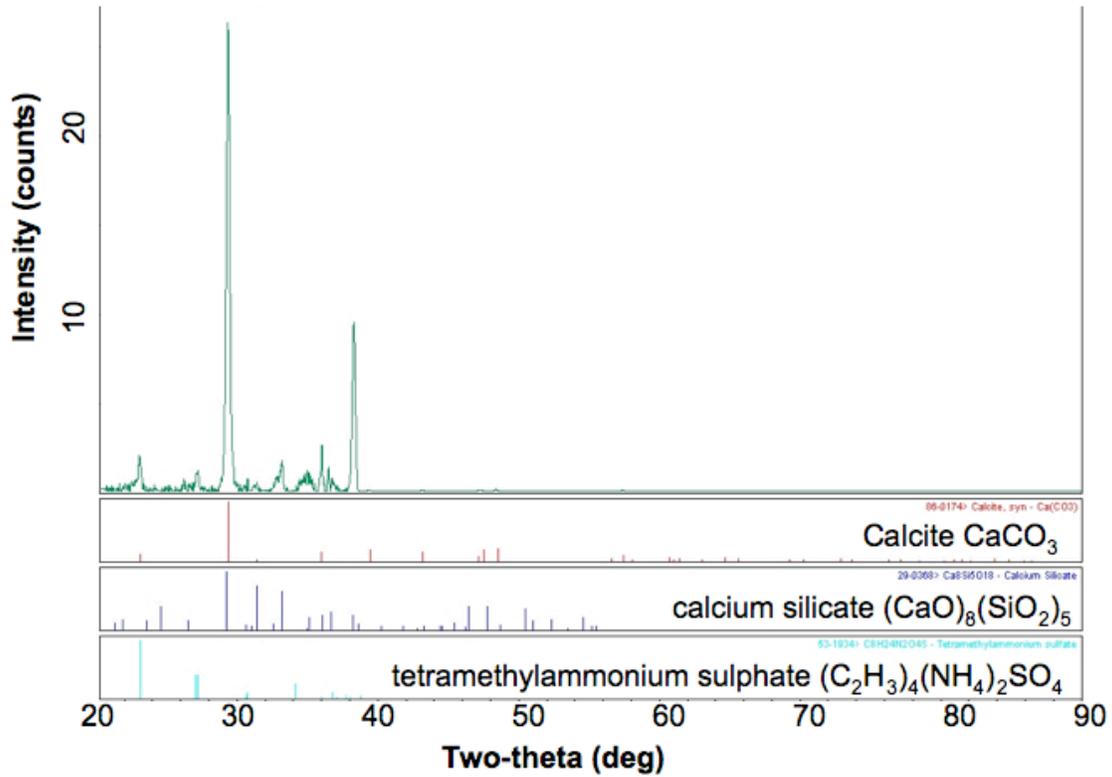
Figure 4.28 XRD analysis of precipitates from cement paste in anti-icer.

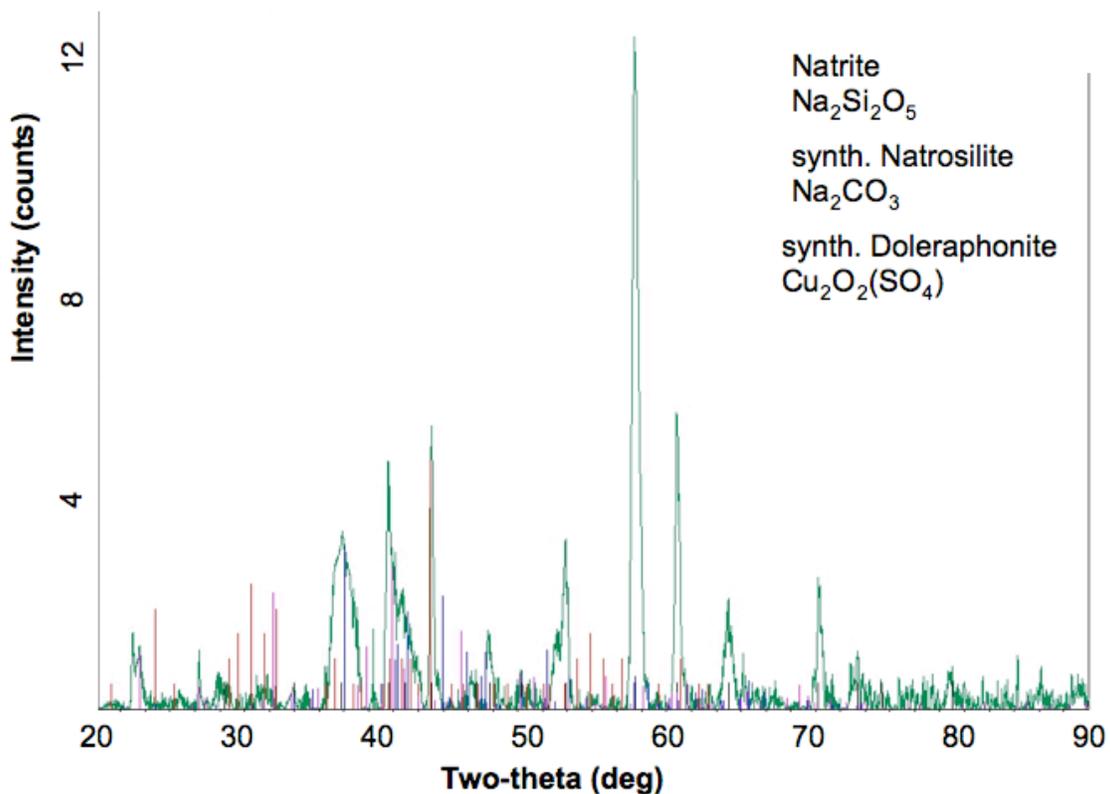
Figure 4.29 XRD analysis of precipitates from expansion test concrete in de-icer.
