# Punching Shear Retrofit of Concrete Slab-Column Connections with GFRP Shear Bolts

A thesis

presented to the University of Waterloo

Civil Engineering

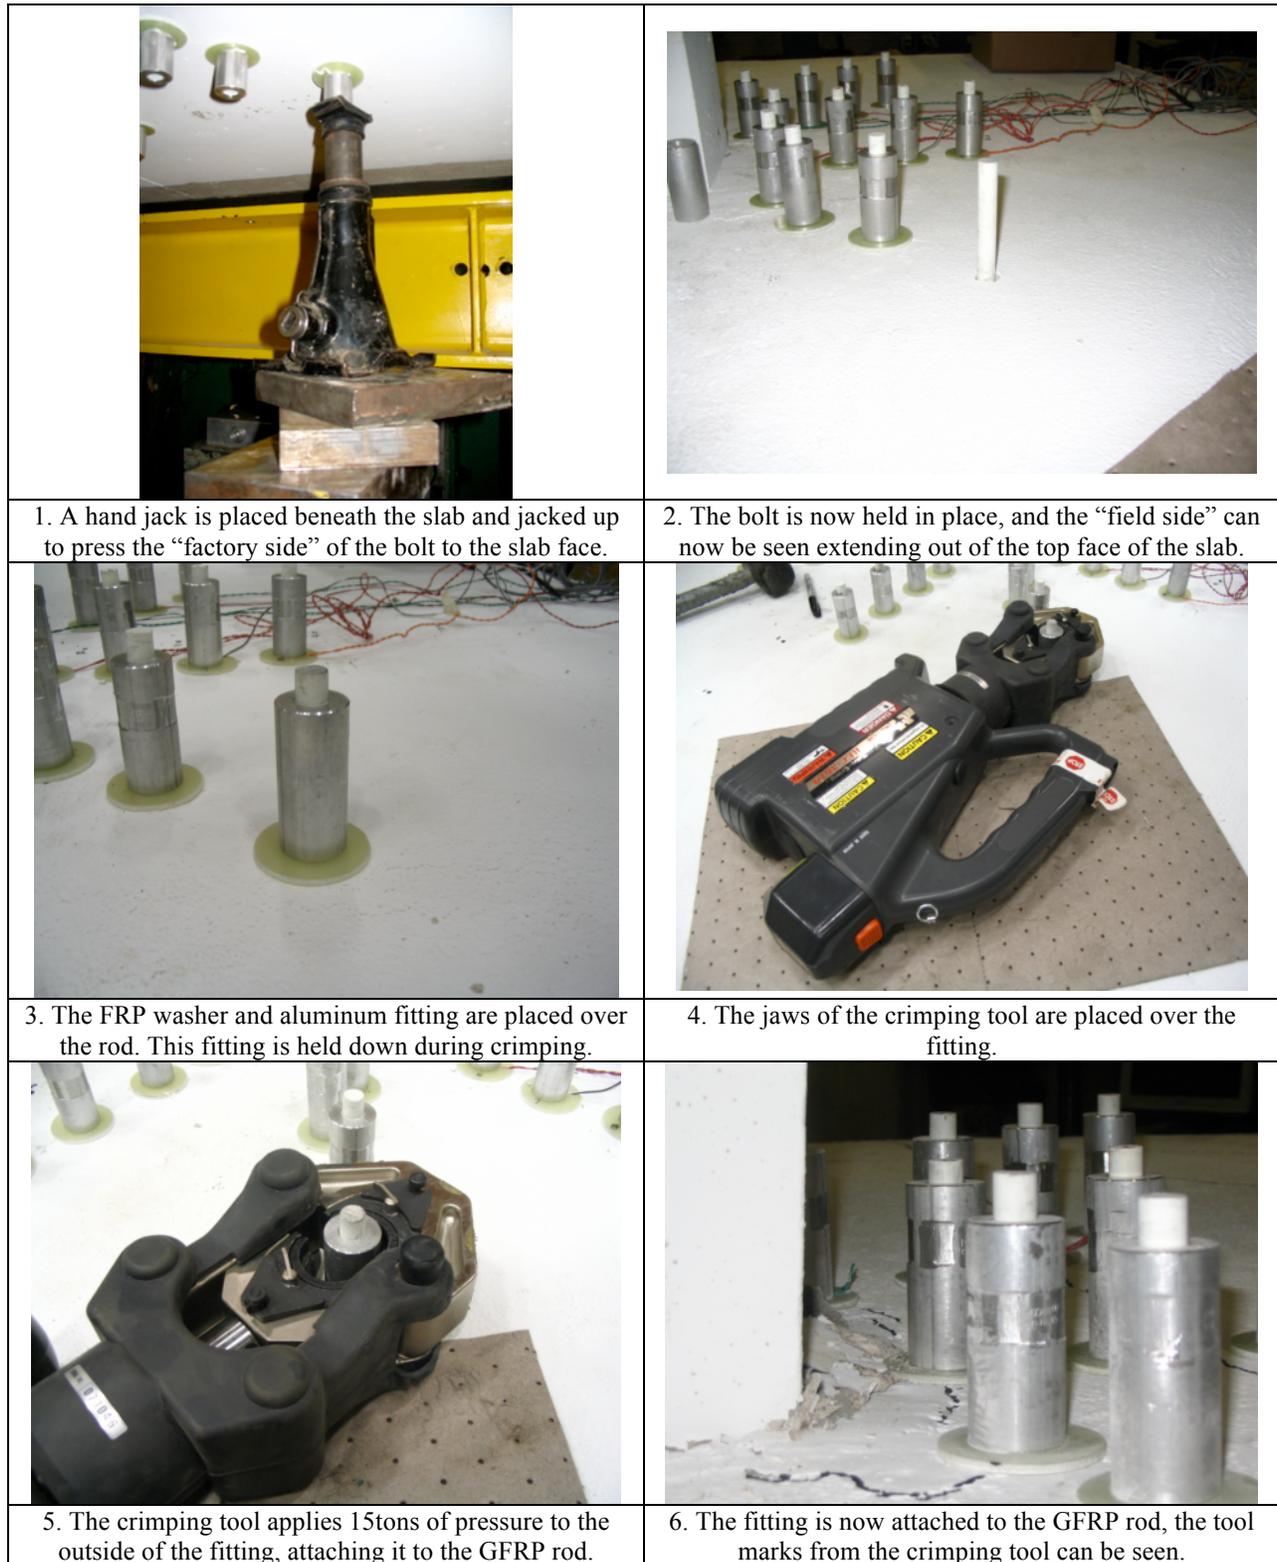
Figure 4.3 - Installation Process for Crimping Aluminum Fitting to GFRP rod.

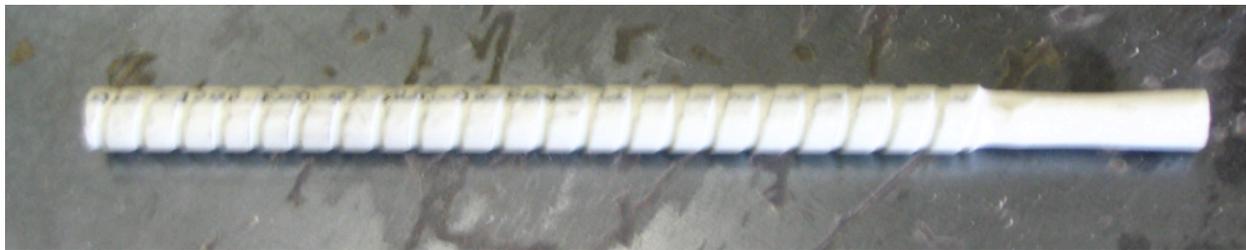
Figure 4.5 - ComBAR GFRP rod prior to fittings being attached

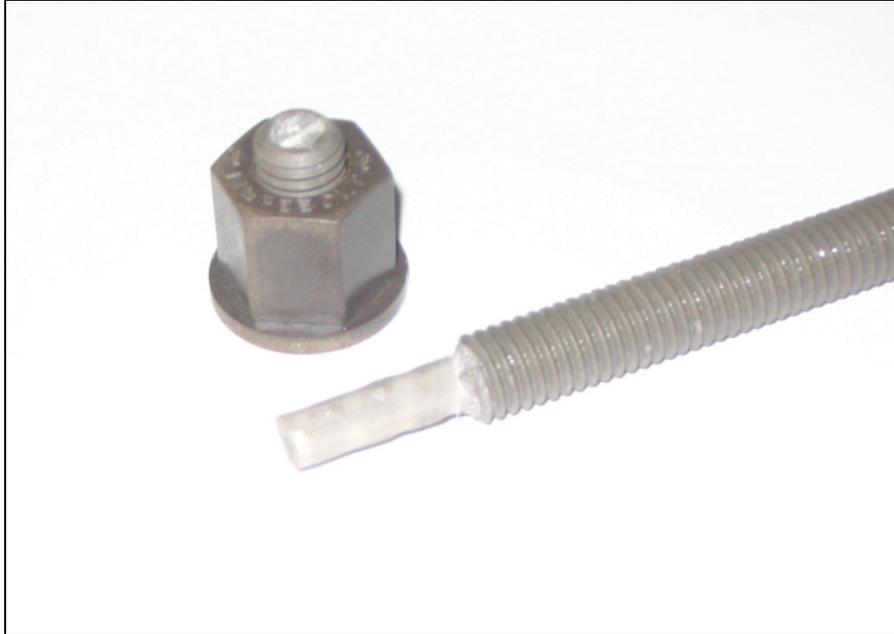
In all cases the failure mode was the same. In all of the bolts tested the threaded part failed, first in tension at the point where the nut was attached to the rod, and then by slipping off the FRP core. The best visible example was during the test of only one nut, where the threading completely slipped off the end of the FRP core, a picture taken at the time of the test is shown in Figure 4.9.

Figure 4.9 - Slip Failure of the Fiberbolt Under Direct Tension

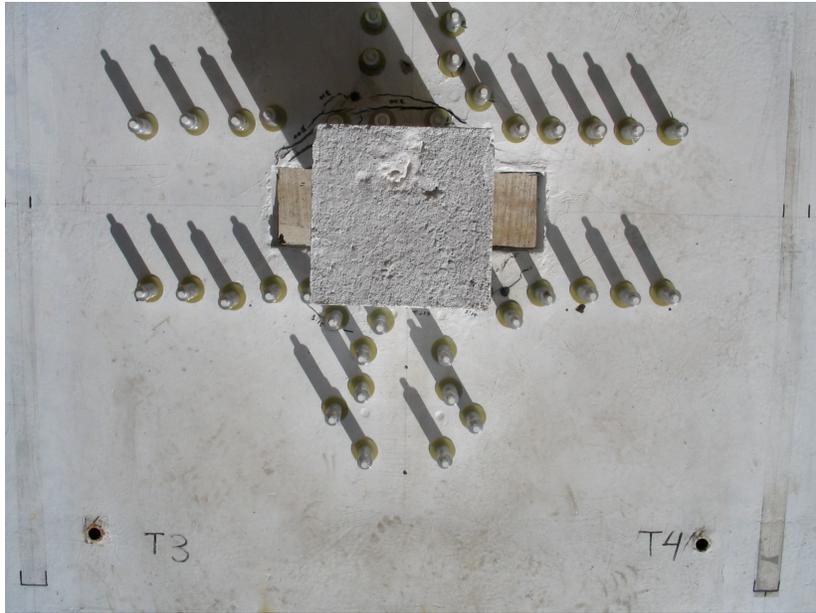
Figure 5.13 - Crack Pattern, Compression Side of Slab, SN6

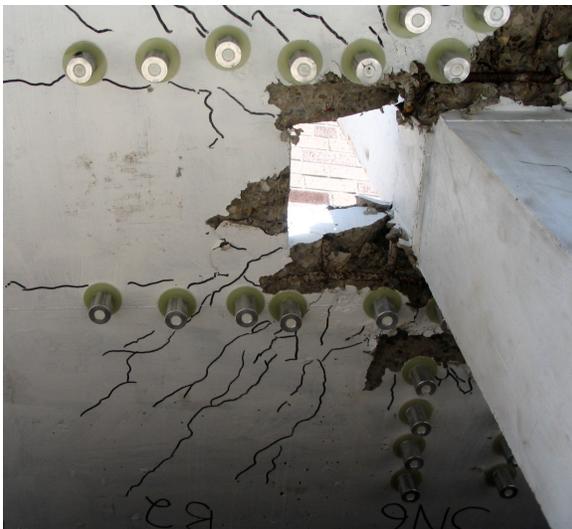
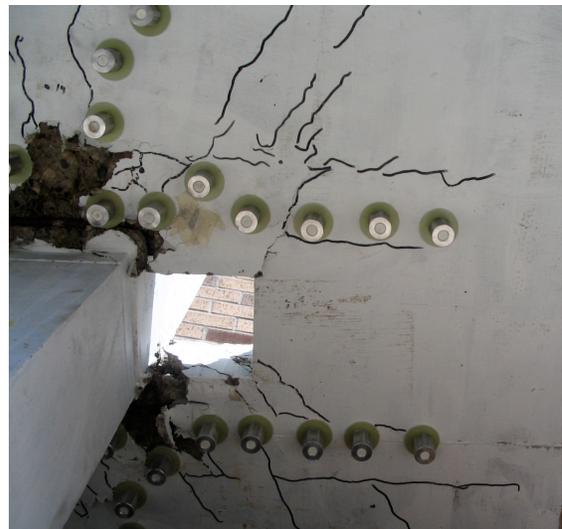
Figure 5.14 - Crack Pattern, Tension Side of Slab, SN6

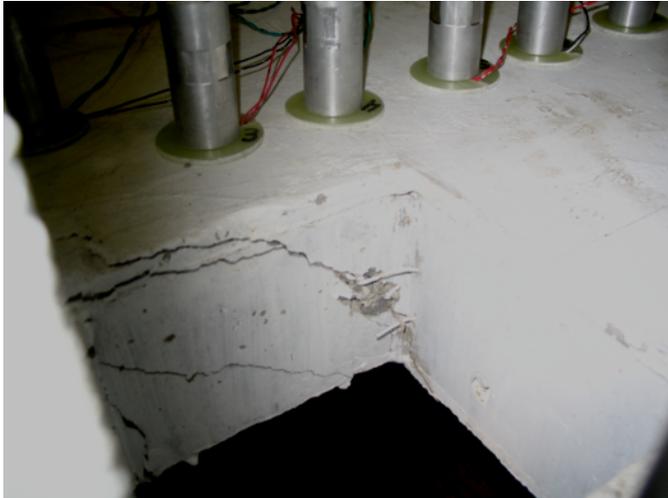
start of the formation of the punching cone. Bolt #1 in SN6 was placed near the opening and at the end of the test a shear crack could be seen in the opening near the location of Bolt #1, this follows as Figure 6.20.

Figure 6.20 - Shear Crack Through Opening, SN6

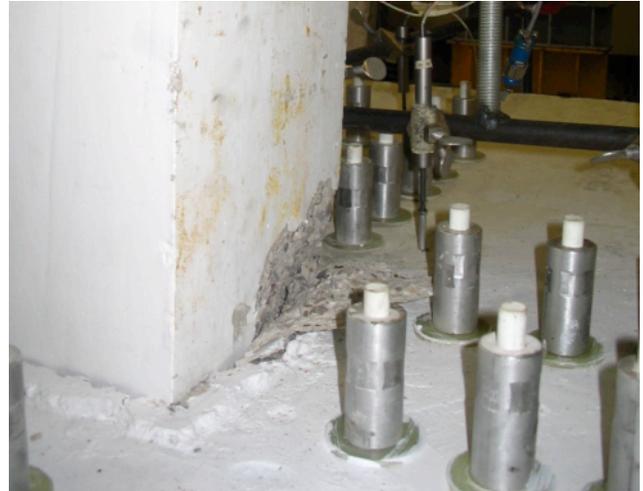
Figure 6.21 – Column Failure, SN5
