A Framework for Efficient Condition Assessment of the Building Infrastructure

A thesis
presented to the University of Waterloo
in fulfillment of the
thesis requirement for the degree of
Doctor of Philosophy
in
Civil Engineering

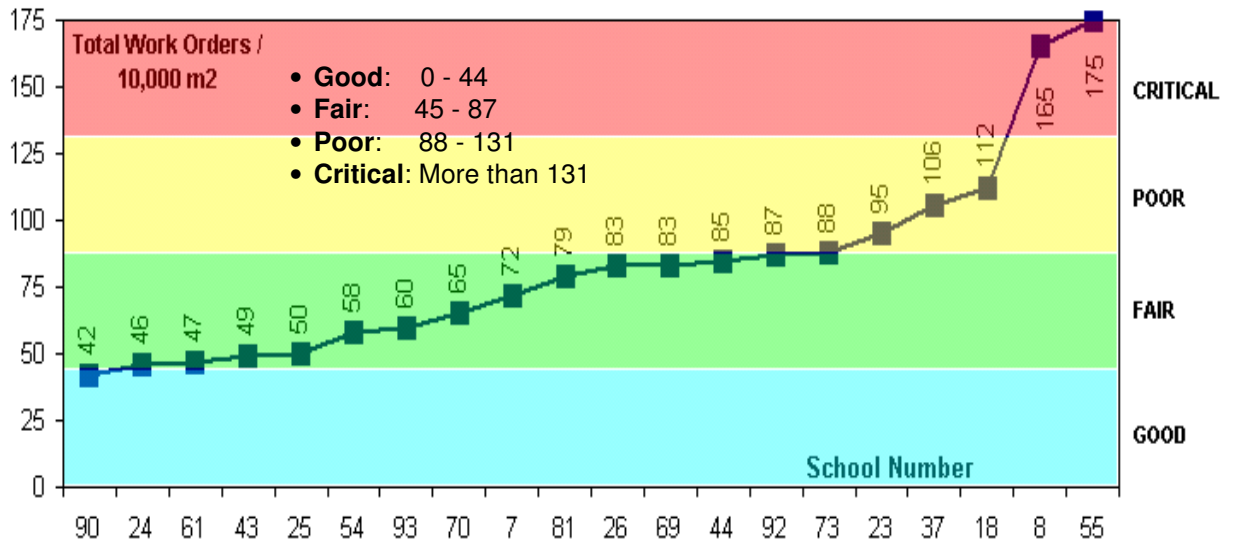
(a) Estimating HVAC condition as a function of reactive-maintenance costs

(b) Estimating HVAC condition as a function of the number of maintenance work orders

Figure 4.8: Two Condition Indicators Based on Maintenance Data for 20 Elementary Schools of NE1 family

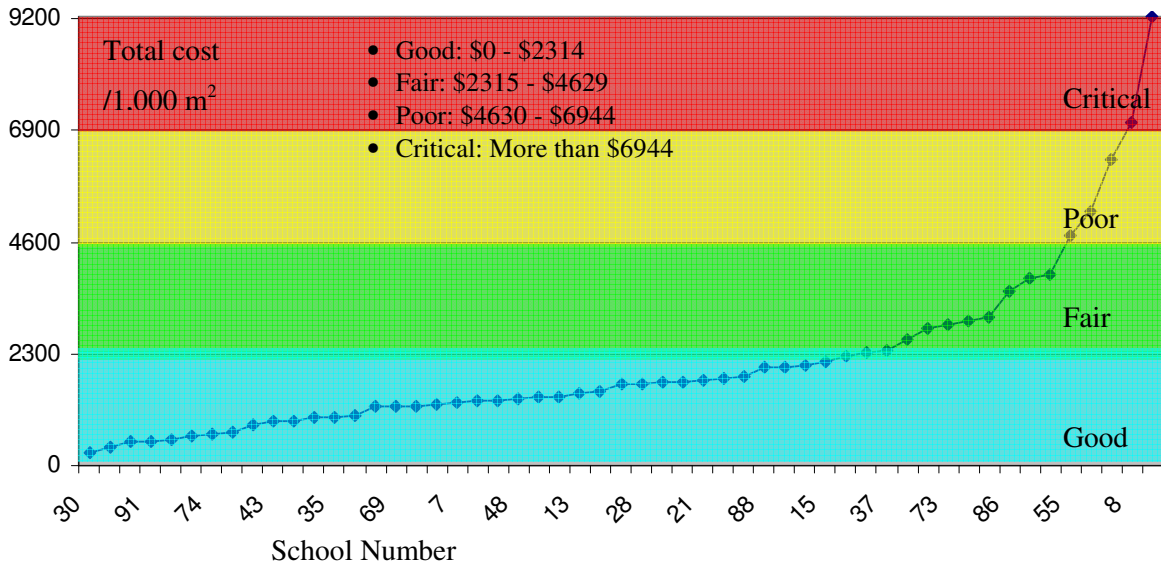
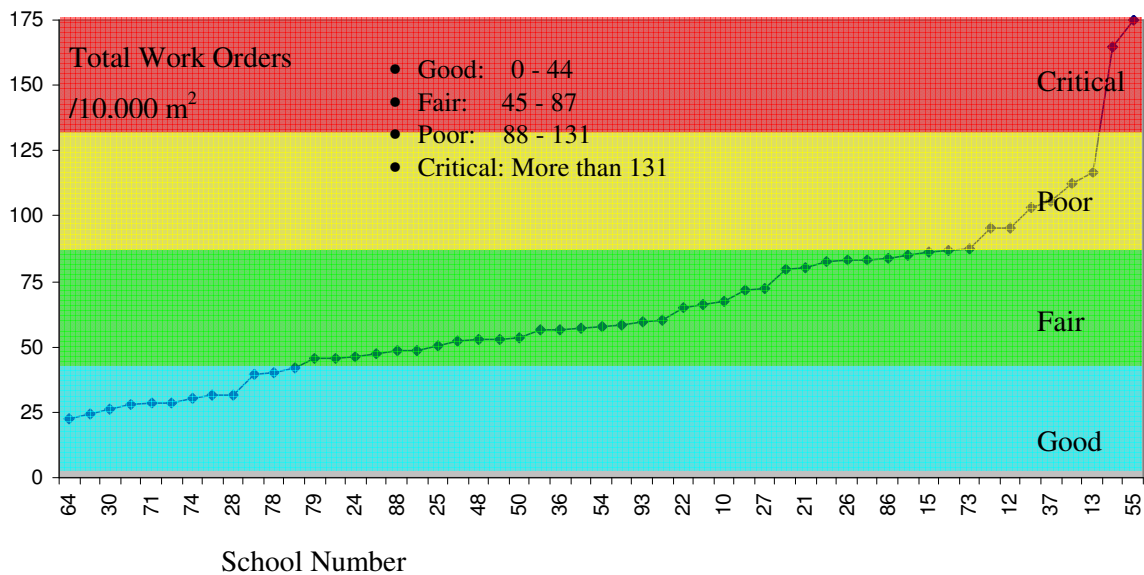
(a) Estimating HVAC condition as a function of reactive-maintenance costs (2006) for 52 schools of NE1 and NE2 families

(b) Estimating HVAC condition as a function of the number of maintenance work orders (2006) for 52 schools of NE1 and NE2 families

Figure 4.9: Two Condition Indicators Based on Maintenance Data for 52 Schools of NE1 and NE2 families

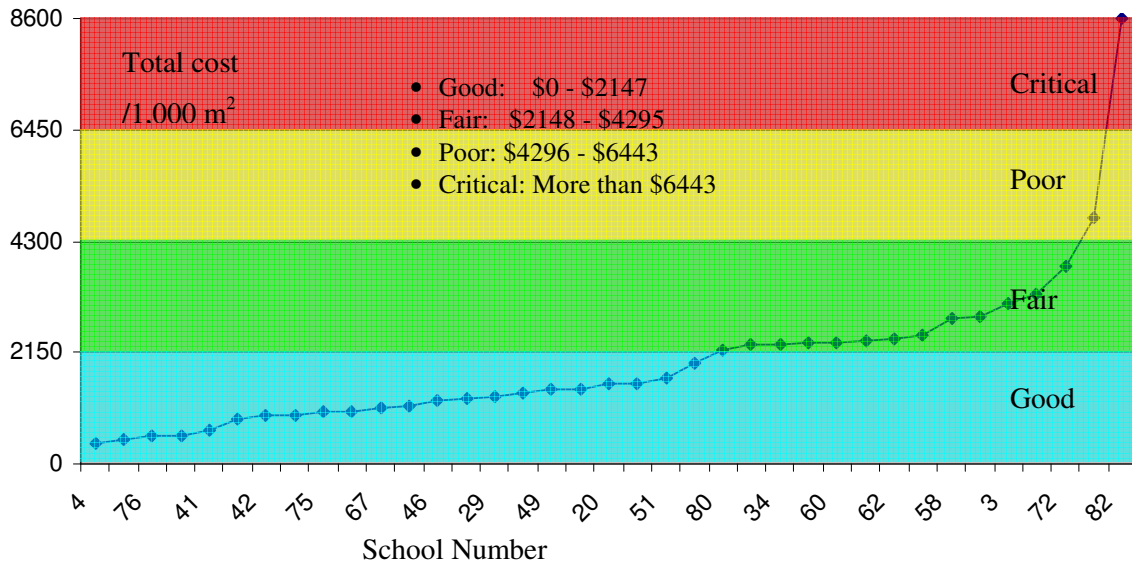
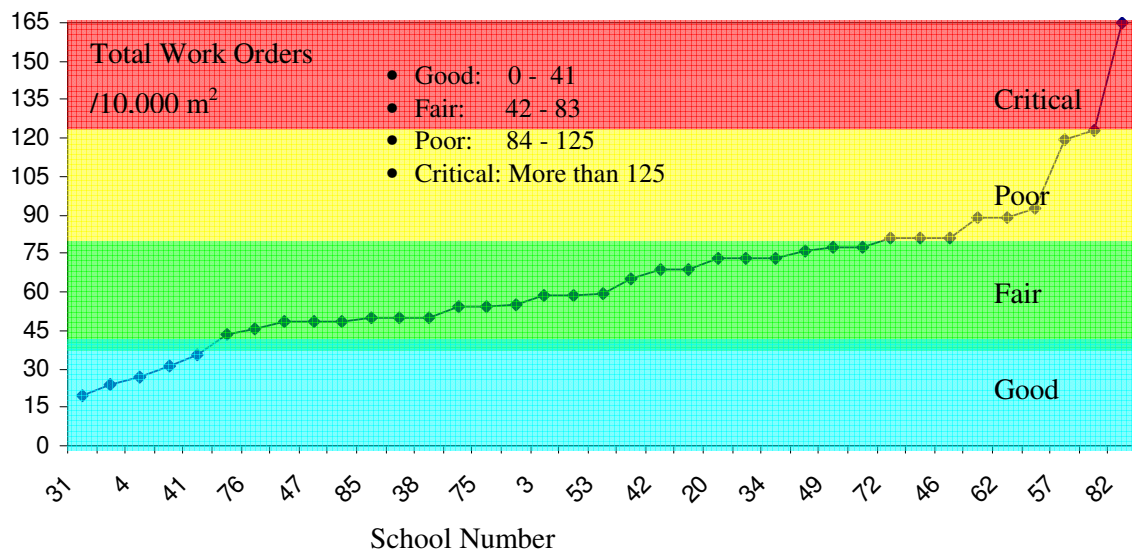
(a) Estimating HVAC condition as a function of reactive-maintenance costs (2006) for 36 schools of NE3 and NE4 families

(b) Estimating HVAC condition as a function of the number of maintenance work orders (2006) for 36 schools of NE3 and NE4 families

Figure 4.10: Two Condition Indicators Based on Maintenance Data for 36 Schools of NE3 and NE4 Families

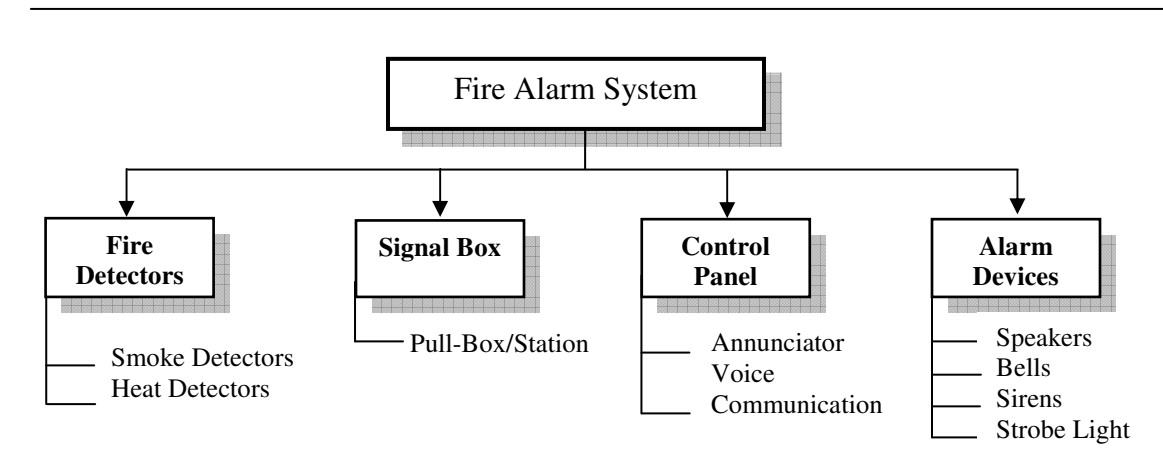
Figure 5.5: A Basic Fire Alarm System

Two types of fire alarm systems are used in buildings: single-stage systems and two-stage systems. In a single-stage system, an alarm signal is immediately transmitted throughout the building to warn the occupants about the fire. In a two-stage alarm system, a distinct, generally coded, alert signal first advises the staff of the fire emergency. The staff immediately investigates the source of the alarm and, if a fire exists, activates the alarm signal. If the alert is a false alarm, staff can stop the coded alert signal and reset the system. The alarm signal is automatically set off after a predetermined period (usually five minutes) if the staff have not already activated or reset the alarm.

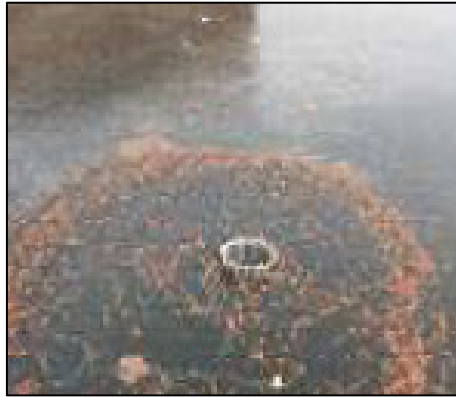
Reason: Blocked roof drain resulting in water ponding on the roof.

Re-Ranked Condition: Fair

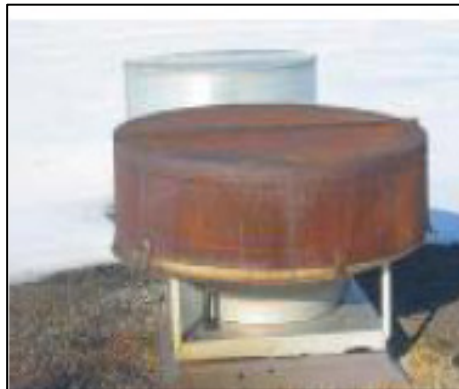
Reason: Extensive corrosion and damaged rooftop fans

Re-Ranked Condition: Poor

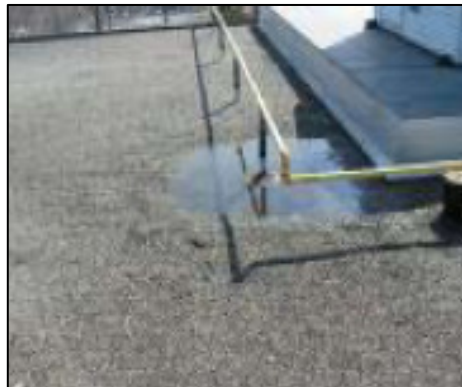
Reason: A depression from added packaged boiler room and gas lines.

Re-Ranked Condition: Critical

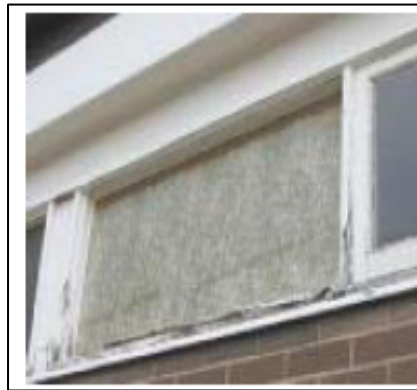
Reason: Laminated glass fibre on broken panel

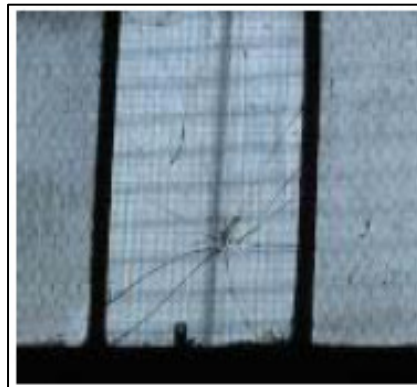
Reason: Cracked glass

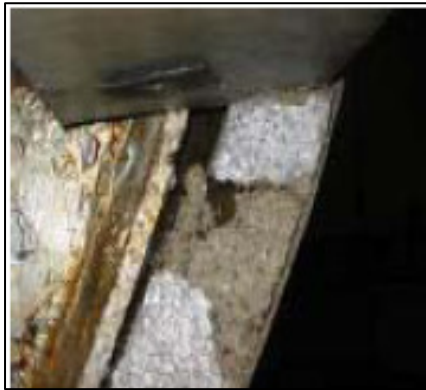
Reason: Damaged insulation of the boiler housing.

Re-Ranked Condition: Fair

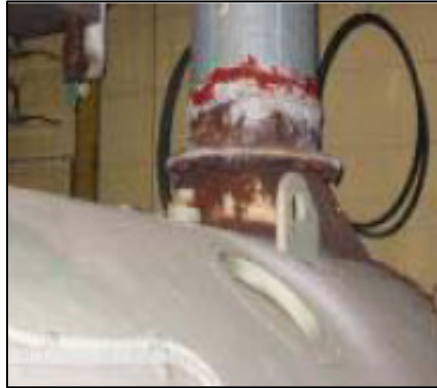
Reason: Rusted boiler stack.

Re-Ranked Condition: Critical

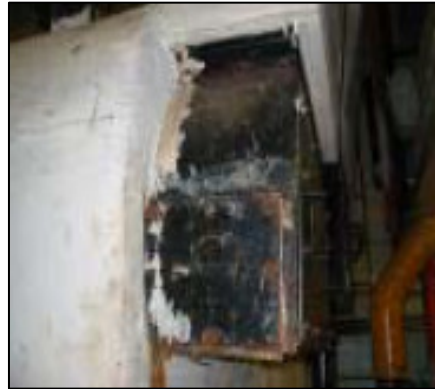
Reason: Severely deteriorated stack/breaching.

Re-Ranked Condition: Poor

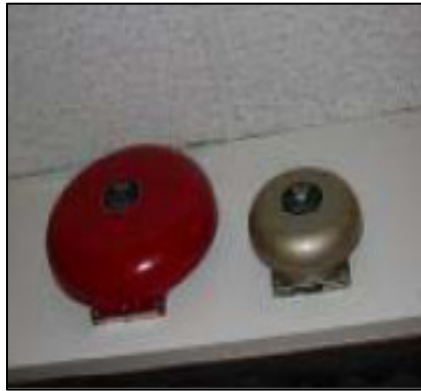
Reason: Horn low audibility levels.

Re-Ranked Condition: Critical

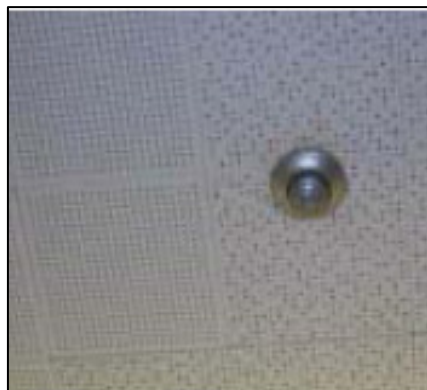
Reason: Functional but obsolete heat/smoke detector.

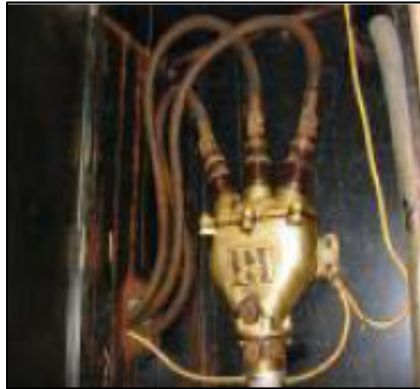
Reason: Loose connections due to vibrations.

Re-Ranked Condition: Critical
