Prediction and Prolongation of the Service Life of Weathering Steel Highway Structures

Neal R. Damgaard

A thesis

Civil Engineering

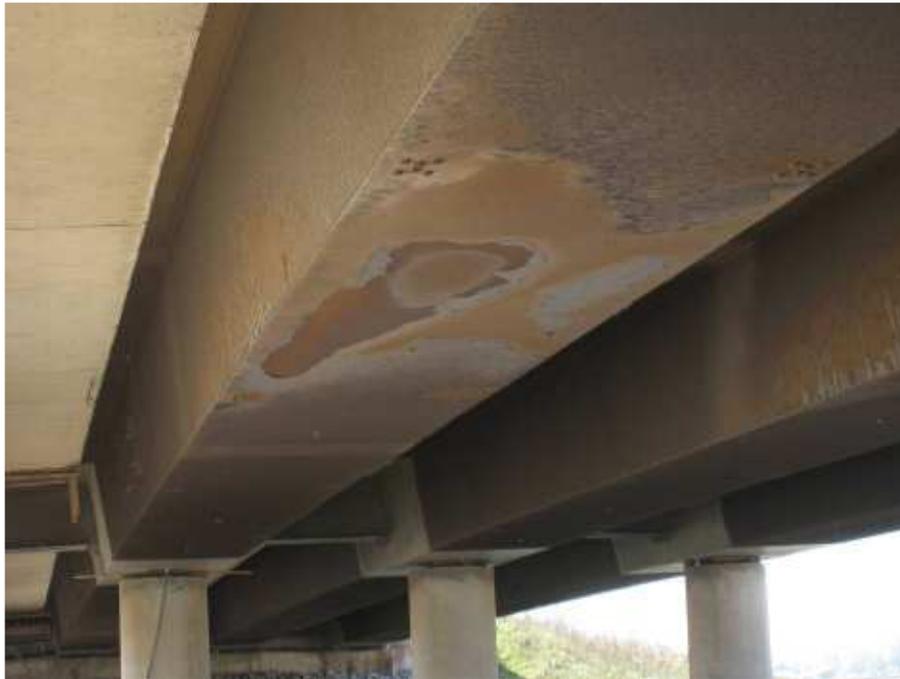
Figure 1.1: Underside of highway structure

- In many of the “problem structures”, the regions of poor corrosion performance can be related to the “splash zones” caused by trucks passing underneath the weathering steel structures. Figure 1.1 shows an example of this. In this figure, the region where the corrosion is most severe is the underside of the box girder bottom flange, on the side of the girder that faces the oncoming traffic.

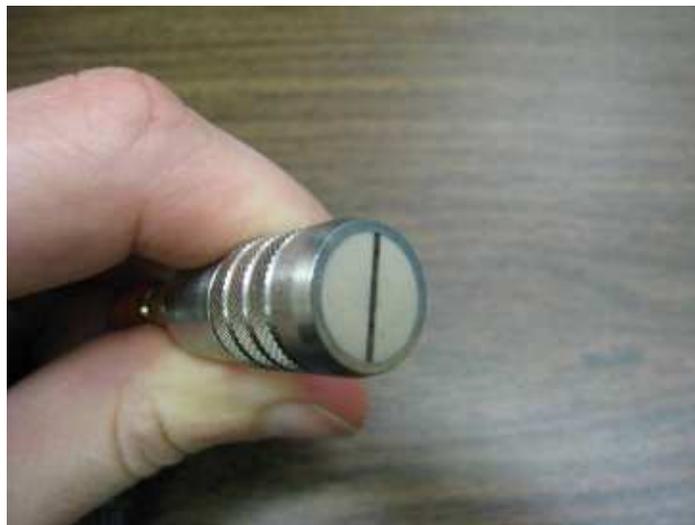
Figure 3.3: UTG probe head

The Nova Eclipse TG110DL was the UTG used for this study; Figure 3.4 is a photograph of this instrument. The TG110DL has a built-in microprocessor for calculating the thickness of the material and a liquid crystal display for the visual interface. It is a handheld unit with the transmitter and receiver contained together in the probe that is applied to the material being tested (Figure 3.3).

A variety of probes are available for use with this gauge, but for this project the Standard Probe (TG506) was the only one used. The gauge functions by sending a short ultrasonic pulse into the material and measuring the amount of time it takes for the signal to return after echoing off the back surface of the material. In calculating the material thickness, the gauge takes into account the characteristic ultrasonic velocity of the material. The gauge user's manual recommends a longitudinal ultrasonic velocity of 5.9 mm/ μ s for mild steel, and this is the value that is used for all measurements. The UTG results compared well with those provided by digital callipers and the Coordinate Measuring Machine described below. The couplant used was Sonotech Ultragel II, an ultrasonic couplant with a temperature range of -20° to 150° C.

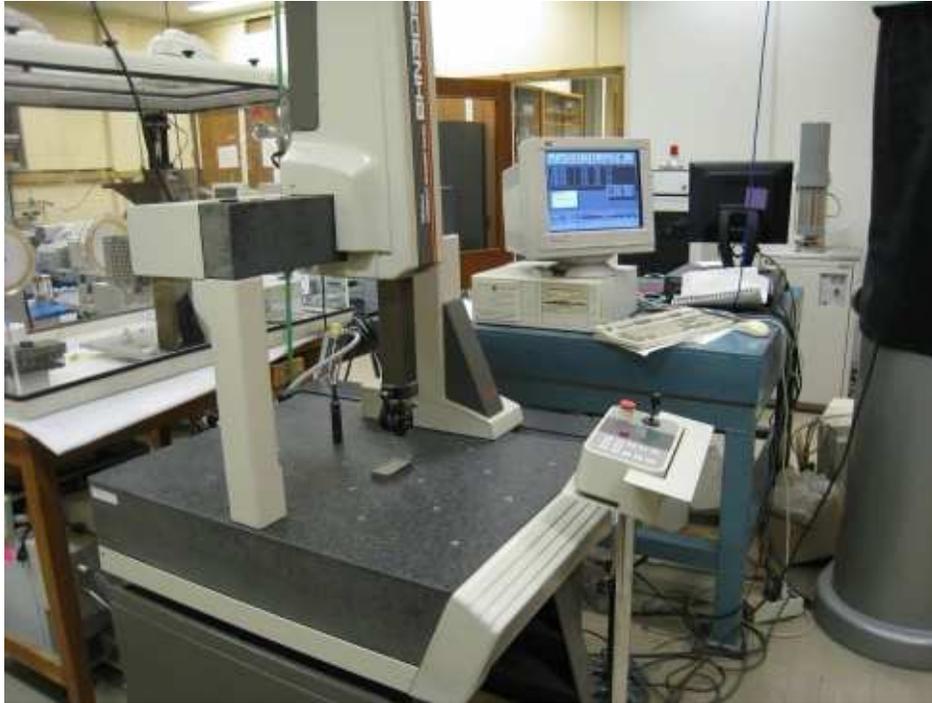
Figure 3.5: Coordinate Measuring Machine

A Mitutoyo BHN305 Coordinate Measuring Machine (CMM) was used to obtain measurements of the plate thickness with which the ultrasonic thickness measurements could be compared. The CMM (Figure 3.5) is a computer controlled measurement device used to measure the dimensions of three dimensional objects.

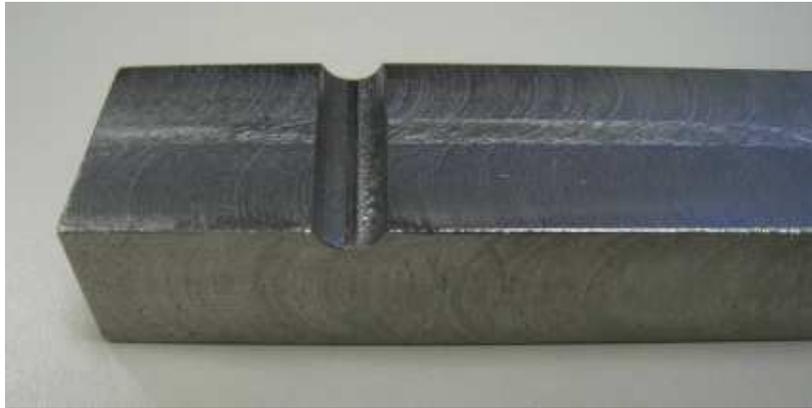
Figure 3.6: Steel specimen with groove

Prior to measuring the thicknesses of corroded plate specimens, it was decided to test the ultrasonic gauge on a machined groove of known geometry. The steel used in this test was taken from the “new weathering steel” sample provided by Algoma, as discussed in Section 3.3, with the corrosion product removed and all of the surfaces of the specimen machined smooth. For this test, the weathering steel specimen was first machined to a constant thickness. A groove (depth = 1.854 mm, radius = 3.175 mm) was then cut across the specimen to simulate a deep pit in the steel (Figure 3.6).

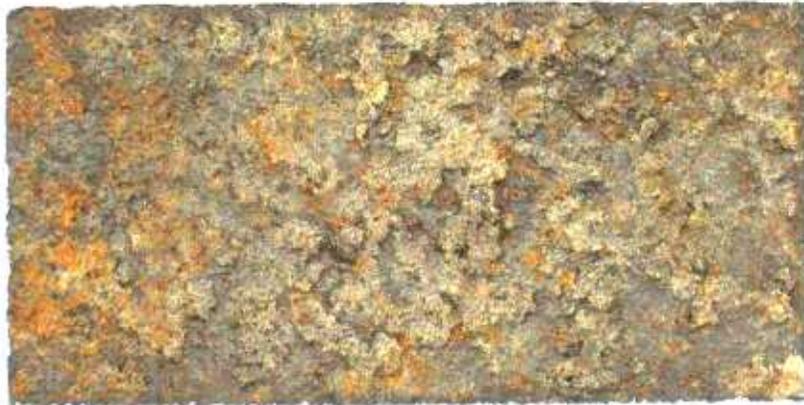
Figure 3.9: “Old steel” specimen with heavy corrosion (old steel)

For these tests, two types of specimens were considered, those with heavy corrosion and those with light corrosion. Figure 3.9 and Figure 3.10 are photos of typical specimens. Note that the heavily corroded specimens were “old steel” coupons cut from a larger sample taken from the Big Otter Creek Bridge; the lightly corroded specimens were “new steel” coupons cut from a sample provided by Algoma. The specimens were machined to a length of 90 mm and a width of 45 mm. The top, more heavily corroded, surface was initially left untouched, while the bottom surface was milled smooth.

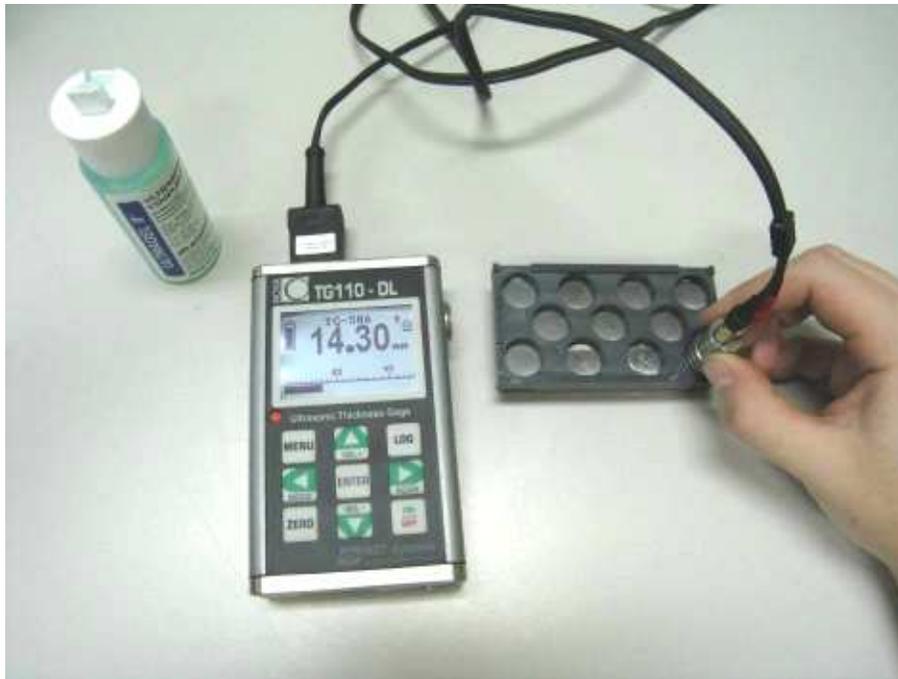
Figure 3.12: UT measurements with templates

The UTG was used to perform a 5 x 7 grid of thickness measurements from both sides of the specimen. Special templates, shown in Figure 3.11, were used to control the location of each of the measurements to ensure repeatability. These plastic templates contained holes slightly larger than the probe head and a lip so that they would fit snugly over the 90 x 45 mm specimens, as is shown in Figure 3.12.

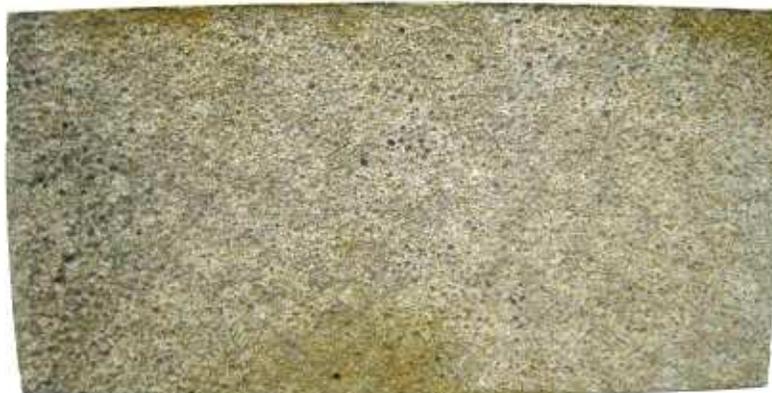
Figure 3.13: Pickled specimen with heavy corrosion (old steel)

Once the UT measurements were complete, the CMM was used to collect a 5 x 7 grid of thickness measurements at the center of each UTG measurement point. After these measurements were taken, the corrosion product was removed from each specimen by “pickling” as per [ASTM G1-03]. The clean specimens (Figure 3.13 and Figure 3.14) were examined under a microscope to ensure that the corrosion product was fully removed. Once cleaned, the UTG and CMM measurements were repeated.

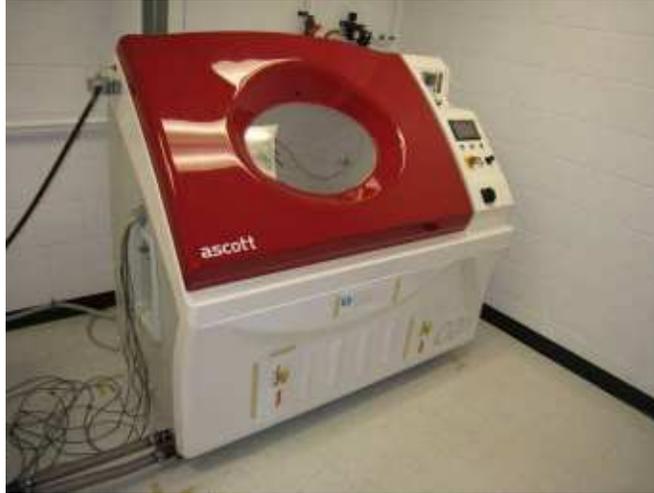
Figure 3.16: Corrosion chamber

The test regimen was imposed by placing the specimens in an Ascott Cyclic Corrosion Test Chamber (model CC450). The system, which has a 450 L capacity, has two components: a corrosion chamber and a solution reservoir (Figure 3.16 and Figure 3.17).

The Ascott system is programmable through a touch screen, and automatically adjusts the temperature, humidity, and immersion of the specimens. Its capacity for automatic operation means that it could operate continuously.

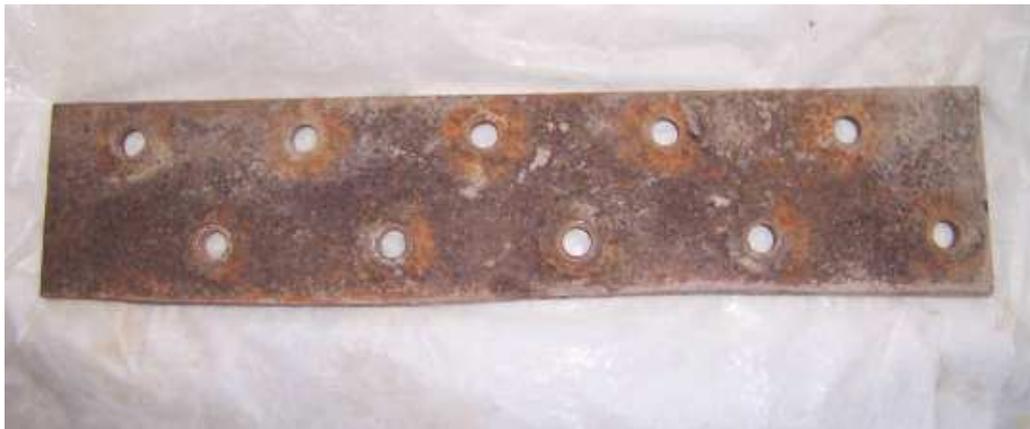
Figure 3.19: Old steel sample provided by MTO

Steel for the corrosion specimens came from two sources. The “old steel”, provided by the MTO, came from a splice plate from the Big Otter Creek Bridge on King’s Highway No. 3 near Tillsonburg, Ontario. Figure 3.19 shows a photo of the old steel in its “as received” state.

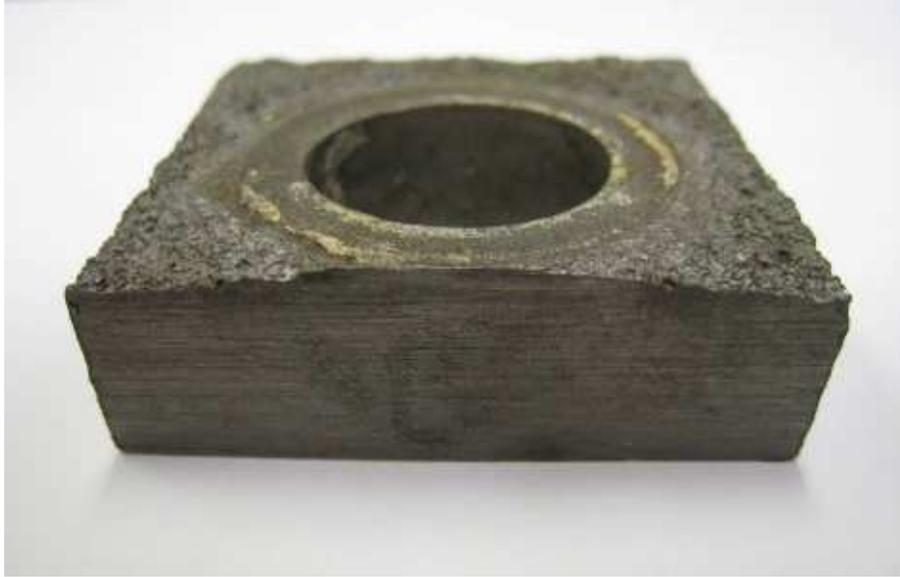
Figure 3.20: Bolt hole specimen (old steel)

The bridge drawings specify CSA G40.11 Grade 50A (yield strength, $F_y = 345$ MPa) atmospheric corrosion resisting steel. Inspections indicated this I-girder bridge, which is near Tillsonburg, Ontario, was experiencing very high corrosion rates and, as part of the repair procedure, some of the splice plates, as well as parts of the I-girder, were removed and replaced. This steel was observed to be heavily pitted and had lost some of its section. The section loss could be deduced because the steel under the bolt holes was not corroded, and the steel around them was much less thick. Figure 3.20 shows a photo of the profile of a pickled specimen cut from the old steel splice plate.

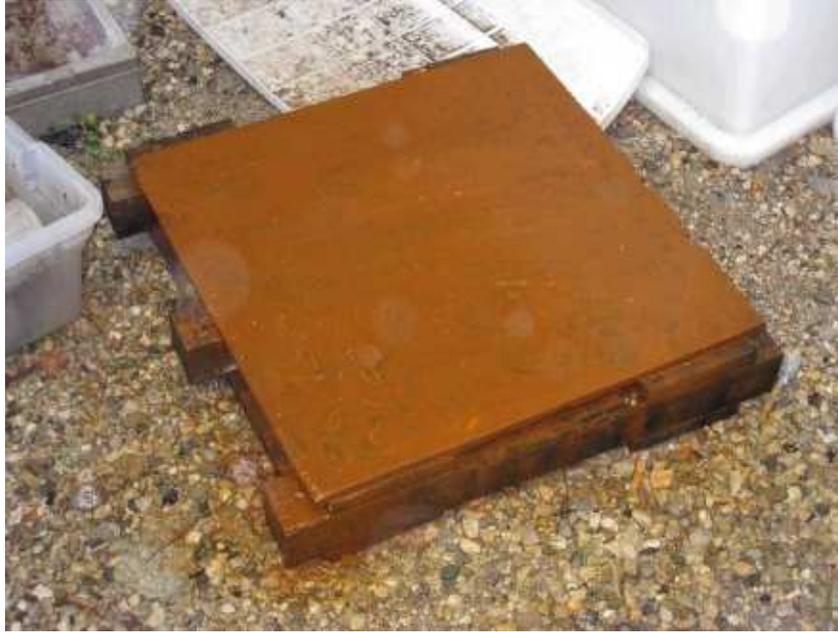
Figure 3.22: New steel sample provided by Algoma

a photograph of the steel sample. The new steel was exposed outdoors to approximately six months of cold and wet environment with road salt and snow prior to testing. The effect of this exposure was a small amount of corrosion of the steel surface.

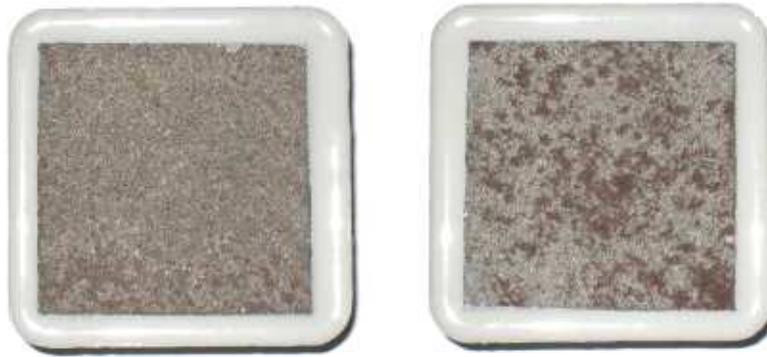
Figure 4.13: Specimens N0W3 (left) and O0W1 (right), prior to test start

Figure 4.13 shows two examples of the uncoated specimens prior to the start of the test.

As can be seen from these figures, already at the start of the test (after blast cleaning) a small amount of atmospheric corrosion had occurred.

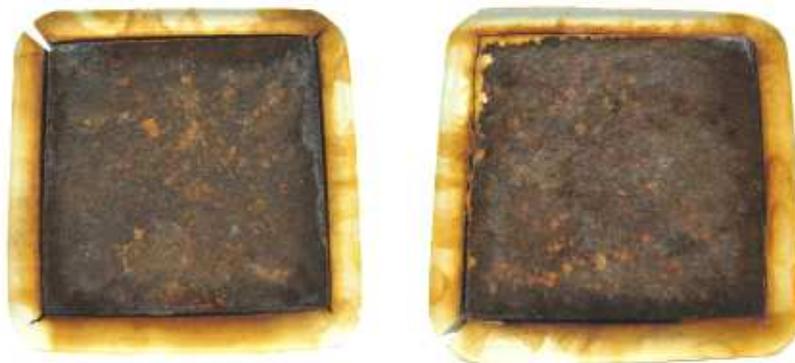
Figure 4.14: Specimens N0W3 (left) and O0W1 (right), after test conclusion

Figure 4.14 is a photo of the specimens after their removal from the corrosion chamber.

In Figure 4.14, the surfaces of the specimens are heavily corroded. The epoxy casings were removed from four of the uncoated specimens, which were then pickled in order to remove the corrosion products. However, it was discovered that once an uncoated specimen had been removed from the tester and left aside for a few days, the corrosion layer would come off as a single piece. Interestingly, this corrosion piece was very similar in appearance to the large flakes of corrosion product that can be found on and under a heavily corroded weathering steel structure. Figure 4.15 shows a specimen with a detached corrosion layer.

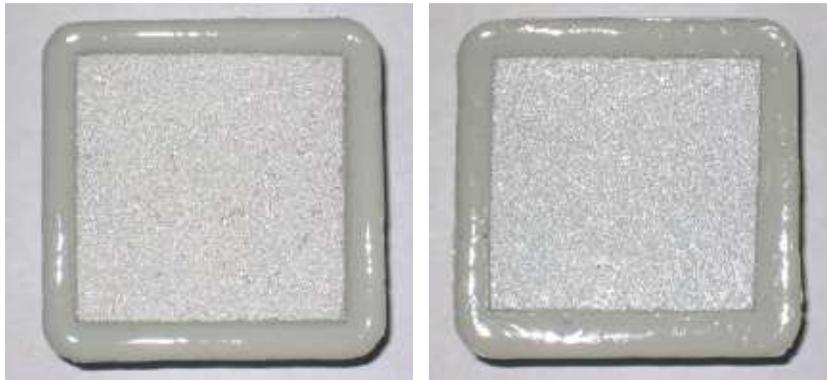
Figure 4.20: NIW3 (left) & NZR4 (right), prior to test start

Figure 4.20 shows two of the metallized specimens prior to the start of the corrosion test. Both specimens began the test with a coating of shiny metallizing product.

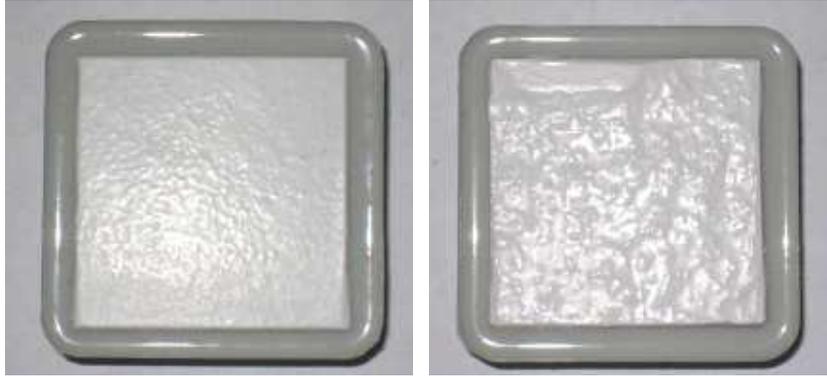
Figure 4.27: NTR1 (left) and OTR1 (right), prior to start of test

Figure 4.27 shows two examples of taped specimens prior to the start of the test.

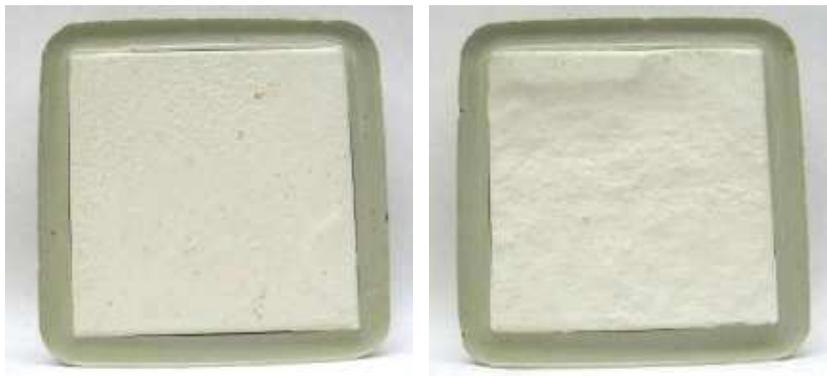
Figure 4.28: NTR1 (left) and OTR1 (right), after end of test

Figure 4.28 shows the same specimens after they had been removed from the corrosion chamber after 212 cycles.

As can be seen from Figure 4.28, little appears to have happened to most of the taped specimens during the corrosion test. There are some exceptions: on specimen NTR1, a blister had formed in the right-hand side of the tape. Figure 4.29 was taken after the specimen had been sectioned and the PVC layer had been cut and removed from the zinc tape with a scalpel.

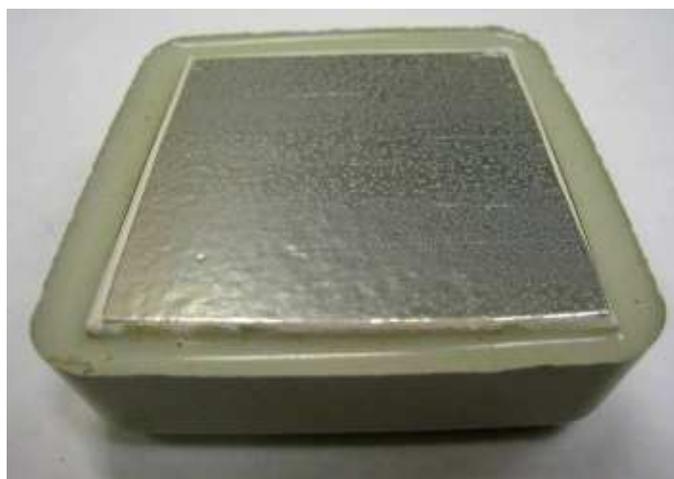
Figure 4.30: Specimen NTR4 with PVC cover removed

The source of the mass loss is difficult to determine. As mentioned in Section 3, the tape is a layer of pure zinc covered with a layer of PVC. For an oxidation reaction to occur, the salt solution has to penetrate the layer; for mass loss to occur, the reaction products have to escape the PVC layer again. However, most of the tape specimens do not appear to have experience significant amounts of corrosion. Figure 4.30 shows another taped new steel specimen with its PVC layer removed; very little corrosion product is visible.

The zinc layer in the specimen in Figure 4.30 is still shiny; when the zinc layer corrodes, it becomes darker and duller. It is possible that some part of the mass loss is due to the degradation of the PVC topcoat of the tape.
