Pavement Performance Modeling of Unique Crosswalk Designs

A thesis
presented to the University of Waterloo
in fulfilment of the
thesis requirement for the degree of
Master of Applied Science
in
Civil Engineering

This thesis presents a research project involving the design, construction, instrumentation, performance modeling and other field tests of eight ICP crosswalks with four different design assemblies. The research projects were constructed at the Centre for Pavement and Transportation Technology (CPATT) Test Track and at the University of Waterloo Ring Road. Each of the test sections is instrumented with structural and environmental sensors of sensors to monitor the pavement performance under heavy truck traffic, typical municipal loadings and to quantify environmental effects. A database is generated and the measured stress, strain, temperature and moisture measurements are analysed to evaluate the expected long-term performance of the structural components of ICP crosswalk designs.

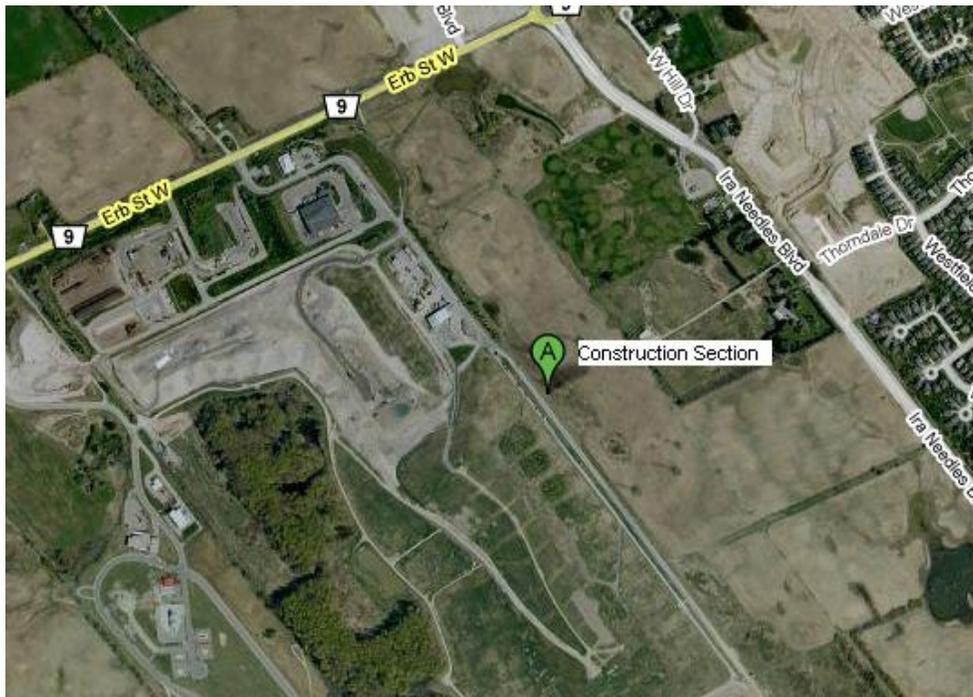
Figure 1 CPATT Test Track Satellite View

There are four crosswalks with different bases and bedding materials located at the first section of the Test Track. The centreline of the first crosswalk is located at 0+060, the second is at 0+070, the third is at 0+080 and the fourth is at 0+090 of the Test Track as shown in Figure 1.

The first series of crosswalks is situated at the Centre for Pavement and Transportation Technology (CPATT) Test Track in the south east corner of the Regional Municipalities of Waterloo Waste Management Facility, located at 925 Erb Street West in the City of Waterloo. The University of Waterloo, CPATT Test Track is as shown in Figure 1.

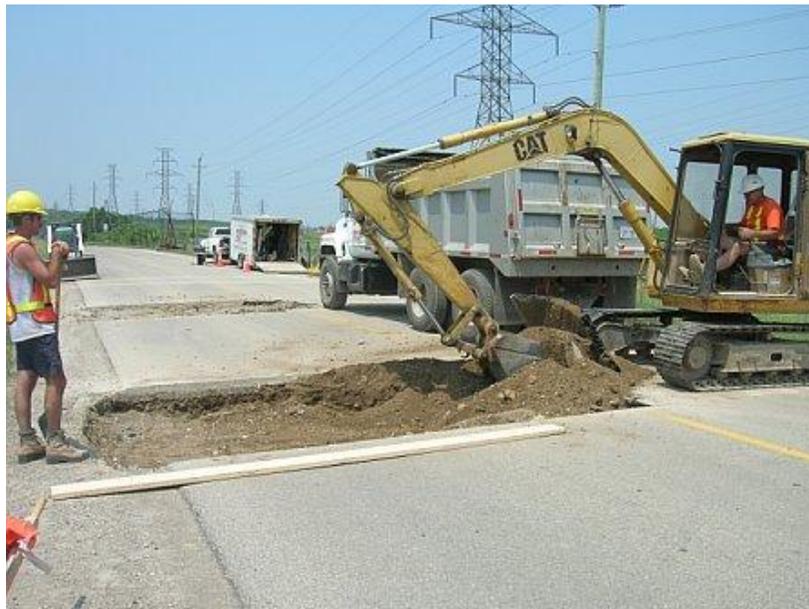
Figure 9 Excavation of Asphalt Pavement

The CPATT crosswalk construction involved the excavation of the existing asphalt section. The carpenter square was used to mark the section to be cut. The cutting of the sections started approximately at 8:30 a.m. on June 18, 2007 and the 100mm thick asphalt layer for all three sections was cut in approximately four hours as shown in Figure 9. Immediately following the cutting, the excavator removed the asphalt pavement and granular A materials to create a trench for each section with an approximate depth of 300mm for placing the crosswalk base. The entire excavation process took approximately five hours and was completed at 2 p.m. on June 18, 2007.

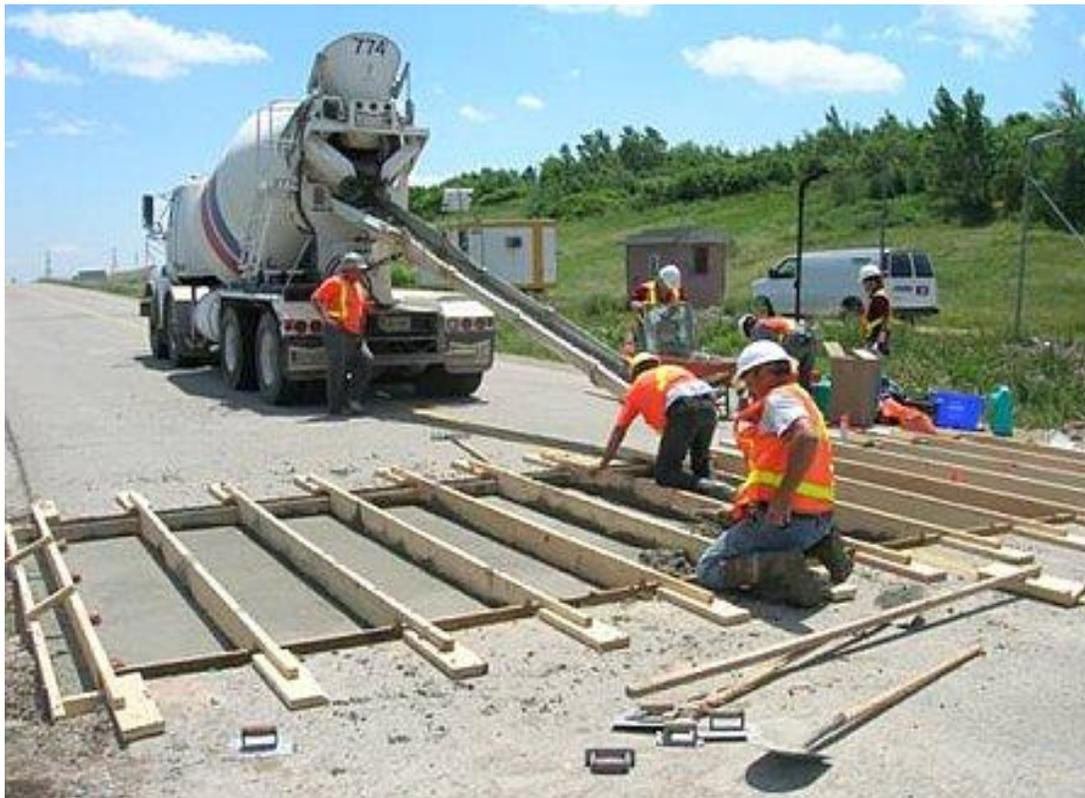
Figure 10 Concrete Base Construction

Within the three crosswalk test sections, SSCBCH and BSCBCH have a concrete base underneath the ICP while SSABSH has an asphalt base underneath the ICP. The southernmost crosswalk BSCBCH base was constructed first. After excavating the trench, the sensors designed to be placed in the subbase were installed. The subbase course then was levelled and compacted with a 20 KN/ 4500 lbs vibrating plate compactor. Wooden forms were installed around the perimeter of the crosswalk for curbs and headers. Reinforcement rebars having mesh size of 150mm /150mm were placed on the top of the subbase course before the concrete pouring as shown in Figure 10. High Early concrete from Dufferin Concrete's Forwell Plant in Kitchener was brought to the construction site at 1:20 PM on June 20, 2007 and poured into the forms from 1:30 PM to 3:35 pm. A total of 6.5m³ of concrete poured in place over a two hour period. The first concrete base crosswalk was constructed on June 21, 2007 using concrete as the third crosswalk's base. The concrete pouring started at 1:10 PM and lasted one and half hours as shown in Figure 10.

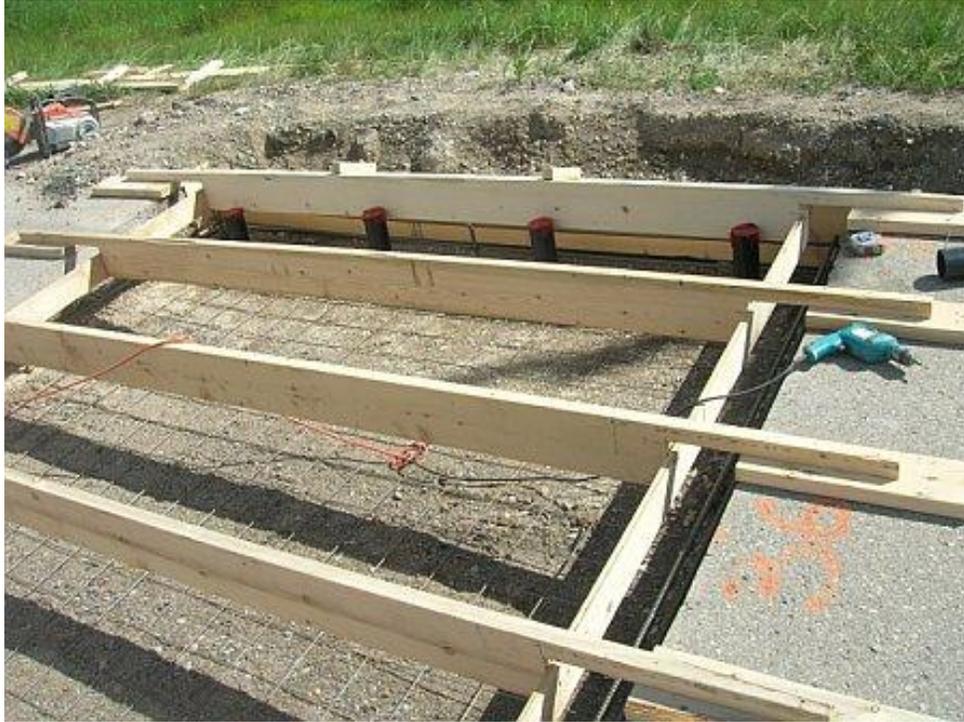
Figure 11 Formworks, Drain Pipes and Reinforcement Bars for Concrete Base Section

Prior to the concrete pouring of the base, eight ABS pipes with diameter of 75mm and length of 300 mm were installed perpendicular to the road surface at the lowest level of the base course. The pipes were filled with pea gravel and covered with geotextile to prevent the loss of bedding materials. Their purpose is to remove excess water from the bedding sand. Since the road base is constructed with two percent slope towards the edge, four pipes were installed along the two outer edges of the bases. One set of four drainage pipes are located in the northbound lane and another set are located in the southbound lane. The distance between adjacent drainage pipes (centre to centre) is approximately 80cm and the first drainage pipe of each set is 20cm offset from the edge of the base.

radius to reduce the likelihood of chipping. Three control joints for shrinkage were provided at three locations throughout the base. The procedure is shown in Figure 11, 12 and 13.

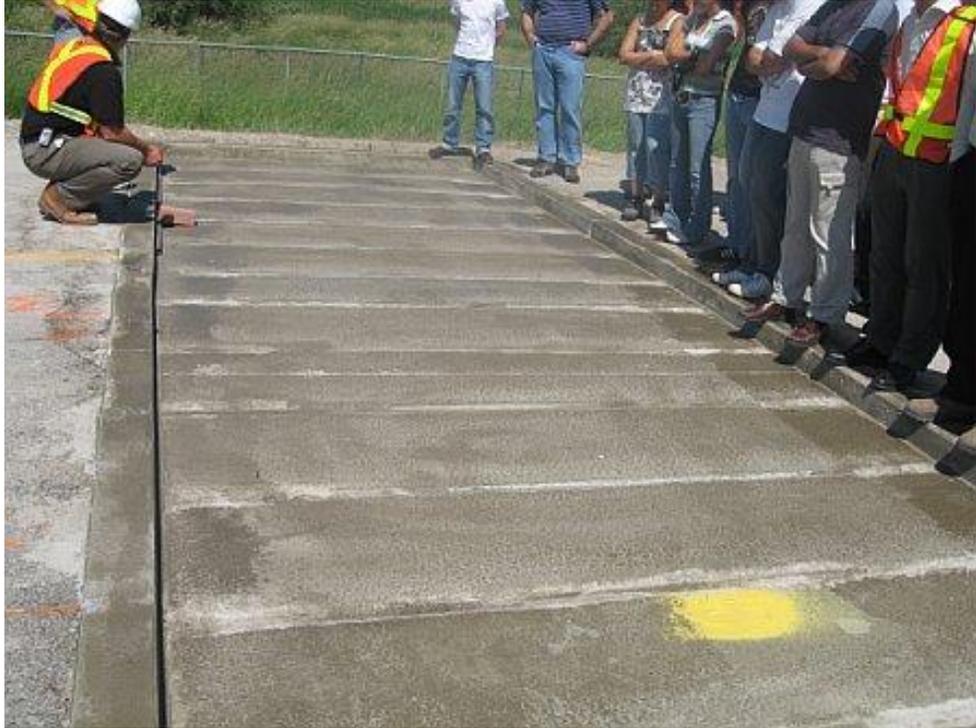
Figure 13 Concrete Base Section

The length of the concrete base is 8.3m including curbs and the width is 3m including the headers on both sides. The thickness of the concrete bases is 200mm. Each base has curb and headers around the perimeter; the width of the curb/header is 150mm. Exposed concrete headers edges are trimmed to 3mm

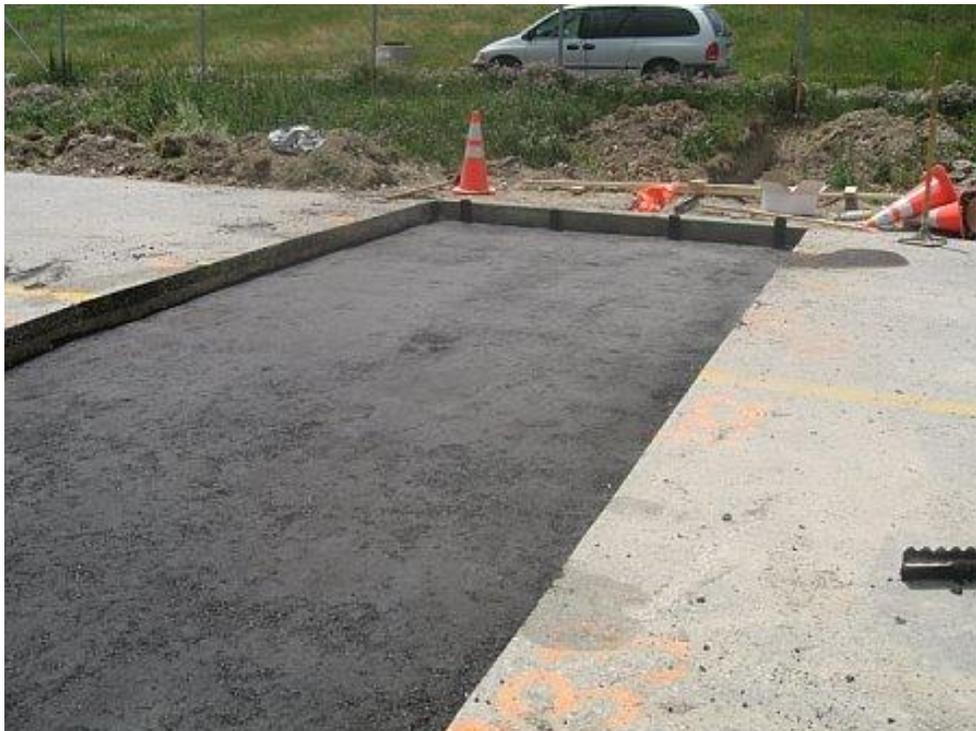
Figure 14 Asphalt Base Section

The construction of the asphalt base crosswalk was started on June 22 at 9.30 am and took approximately two hours to complete the first 50mm lift. Within the two hours of paving, 3.6 tonnes of HL3 was spread, screeded, and compacted with a 20 kN plate compactor as shown in Figure 13. The paving of the second/final 50mm lift of asphalt was started on the same day at 2.00 pm and completed at 4.00 pm. The air temperature during this operation ranged from 27 to 34 degree Celsius. The mix temperature on arrival to the site was 114°C and 106°C before compaction of the first lift. Similarly, the mix temperature of the second lift before the compaction was 72°C. The mix was prepared at Kitchener Asphalt Plant of Steed and Evans Limited.

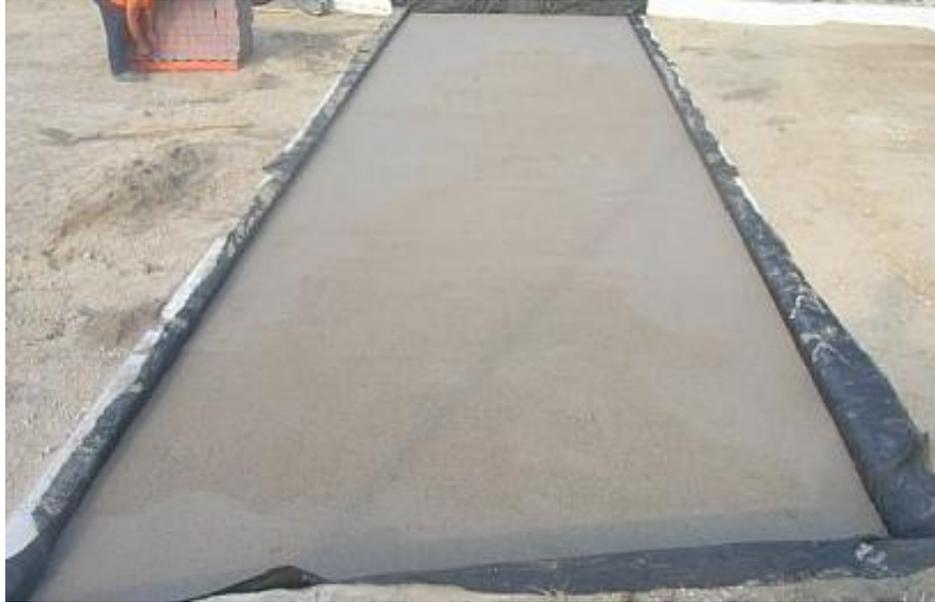
Figure 15 Bedding Sand and Non-woven Geotextile

For SSCBCH, a layer of non-woven geotextile was placed in the constructed base and a layer of bedding sand with approximate thickness of 25mm was spread and screeded on top of the non-woven geotextile as shown in Figure 15.

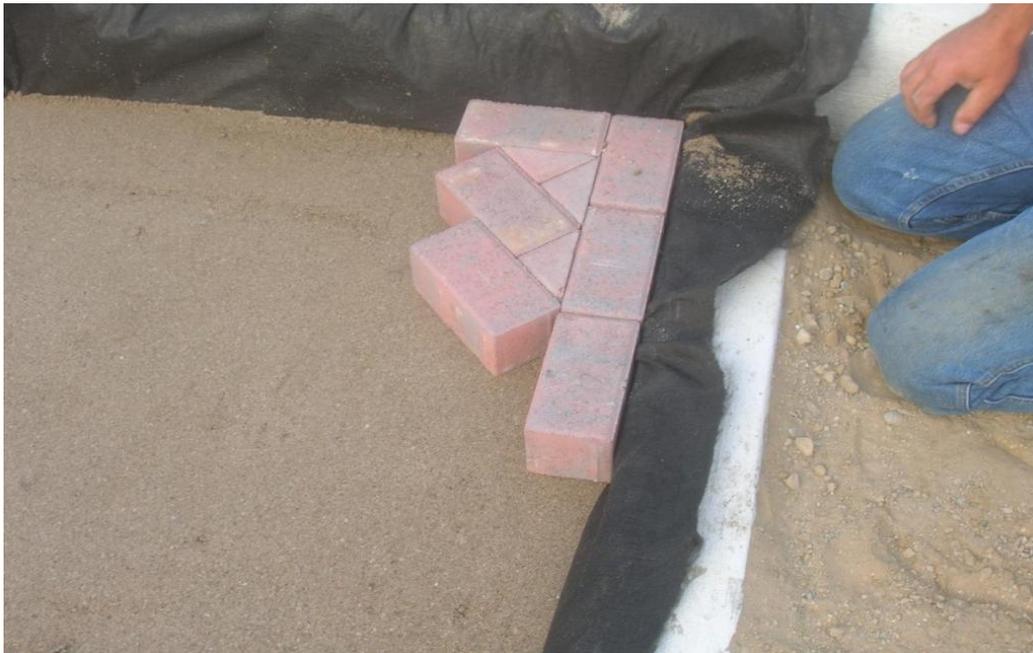
Figure 17 Laying Interlocking Concrete Pavers

The interlocking concrete pavers were placed into the concrete/asphalt base at SSCBCH, SSABSH and BSCBCH on June 22, 26 and 25, respectively. Approximately 1070 pieces of interlocking concrete pavers with approximate dimension of 200mm × 100mm × 80mm were placed in each section. The pavers were laid in 45° herringbone pattern. Installation was started from the corner with securing 45° string lines on the bedding course. Edge pavers are saw cut to fit against the sailor and soldier courses. The sailor and soldier are interlocking concrete pavers which were placed in such a way that SSABSH and BSCBCH have three sides (one long side and two short sides) with sailor course and one long side with soldier course. In contrast, SSCBCH has sailor courses on both sides. After the installation, the surface was compacted with a vibratory plate to compact the bedding sand, seat the pavers in it and force the bedding sand into the joints at the bottom of the pavers. Figure 16 provides details of the paver while Figure 17 and 18 presents the layout. The final elevation of the surface course was kept 6mm above the adjacent asphalt pavement to accommodate any future settlement.

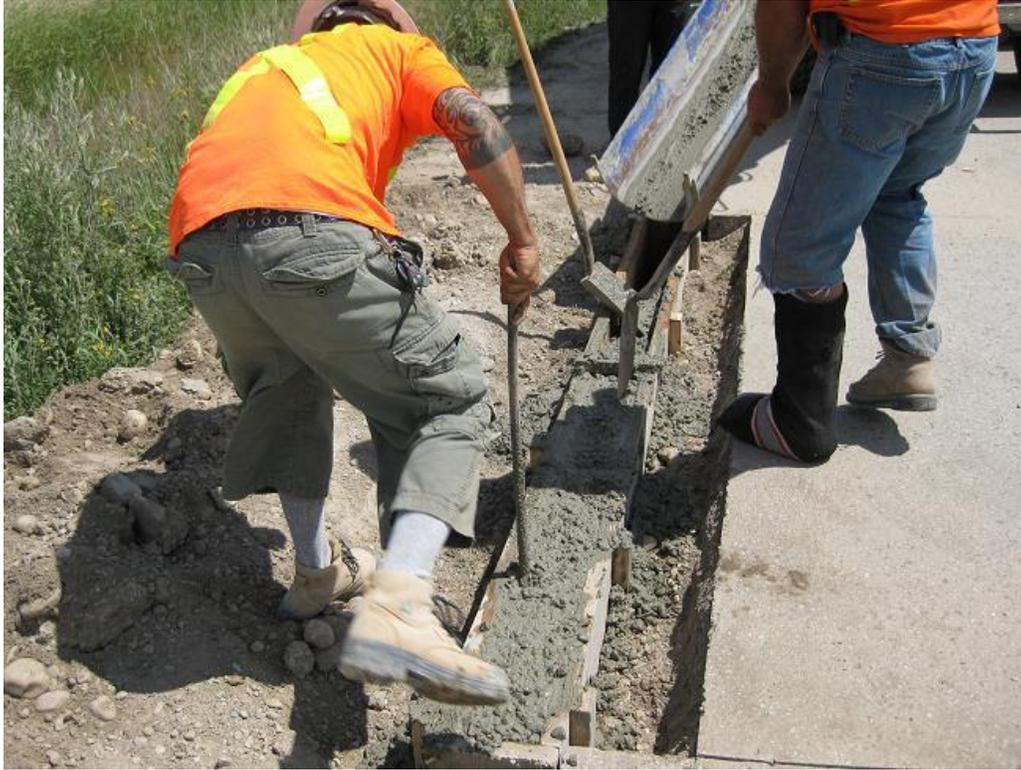
Figure 19 Construction of Curb

Figure 19 shows the construction of the curb on the southbound lane. The construction of the curb occurred one week in advance of the construction to allow for proper curing. The curb area was protected by pylons and reopened to traffic. The saw cut of asphalt for the whole crosswalk section was completed the same day to decrease the work load on July 22. The work was completed around 3:30 pm.

On July 16, 2009, the concrete curb was constructed for the new crosswalk along the edges. The work started at 8 am with saw cut of asphalt for the curb construction followed by excavation of asphalt, construction of form work and concrete placement on both sides.

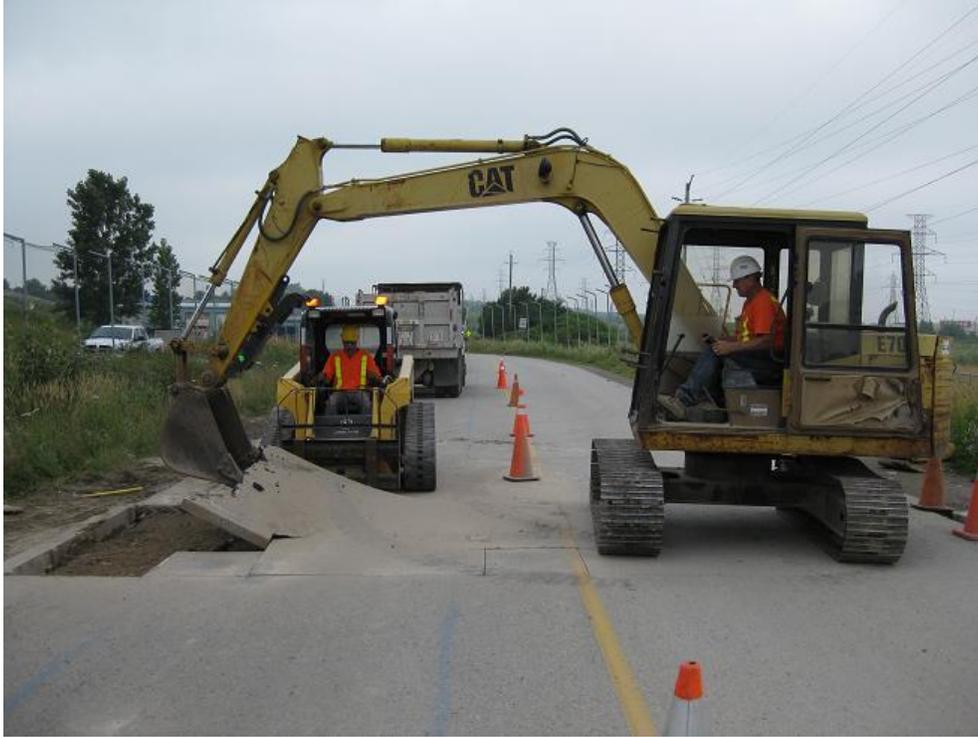
Figure 20 Excavation of Asphalt Pavement

Since the saw cut of asphalt section was already completed, the work started at 8:15 am on July 22nd by excavating the asphalt layer in the southbound lane. Following the cutting of the asphalt sections, the excavator removed existing road base material (Granular 'A'). The leveling was completed during this process with the assistance of the laser level to ensure an accurate depth to be excavated. Approximately 300mm of depth was maintained. The process was completed in two hours. Figure 20 shows the excavation of existing asphalt pavement in the southbound lane. And Figure 21 shows the excavation of Granular A with the laser level on site.

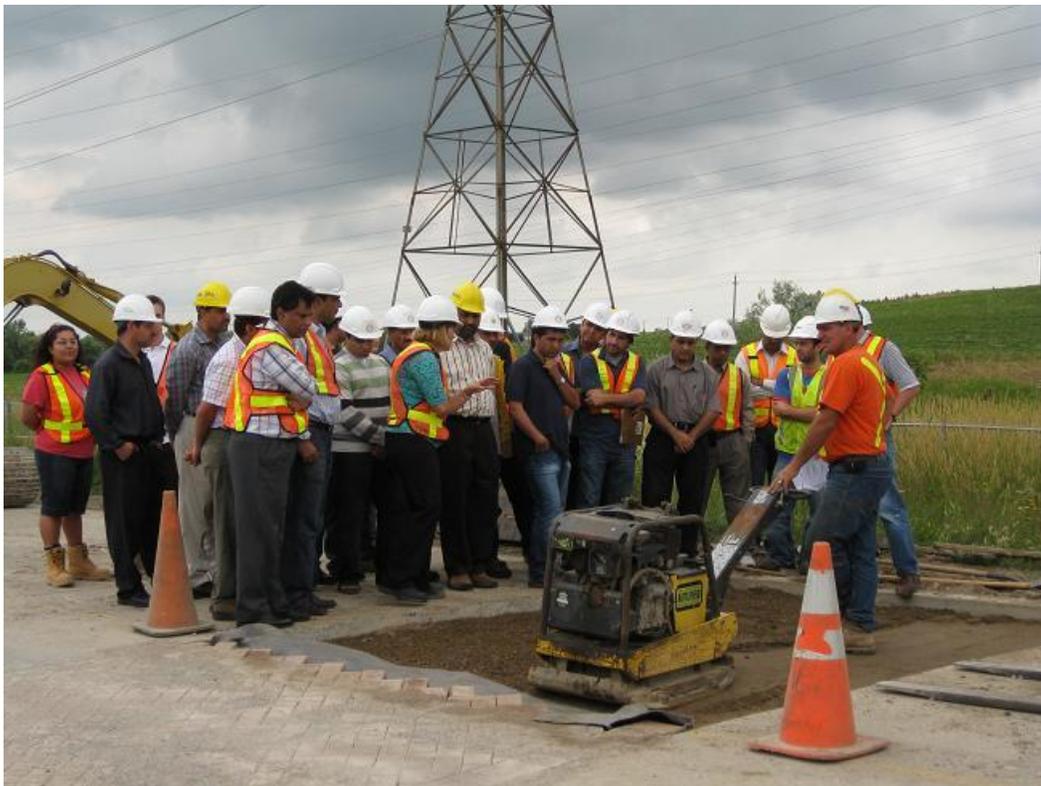
Figure 22 Vibratory Plate Compactor in Crosswalk Base

The base material was then compacted with 1000 lbs vibrating plate compactor. The vibratory plate compactor repeated six times to achieve 98% of compaction. The corners and the sides of the base were compacted with a Jumping Jack compactor with 254mm plate on the bottom. Figure 22 shows the vibratory plate compactor in operation in the northbound lane. The photo shows a group of students who also came to visit the site to see the construction work.

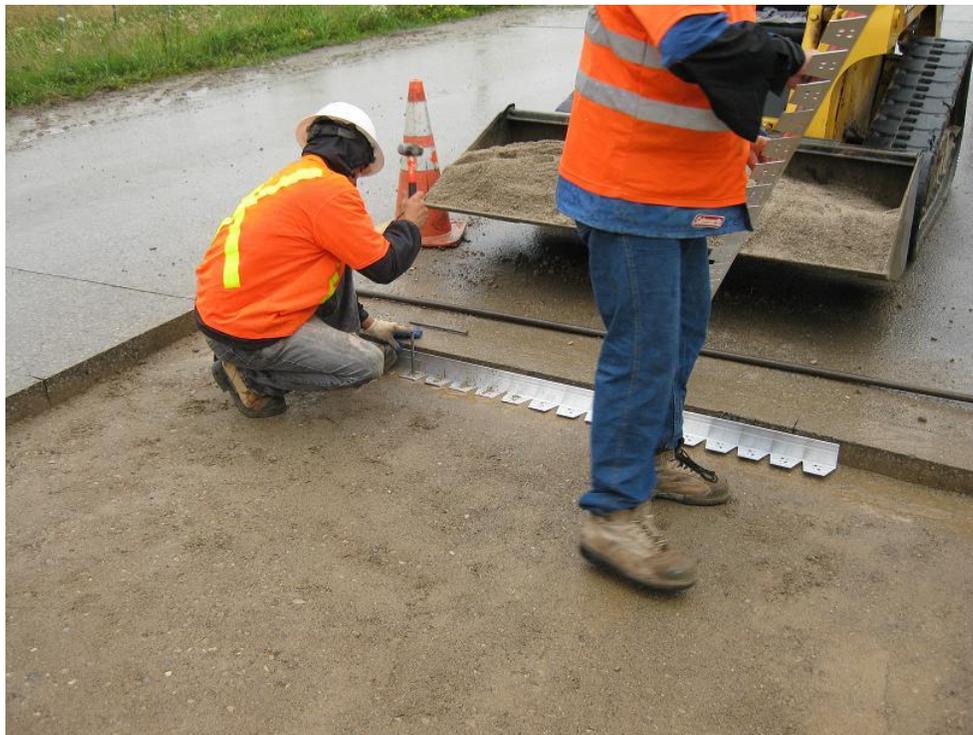
Figure 23 Installation of Aluminum Header

On Day 2 of construction, July 23, 2009 the work started around 9:15 am but, was delayed for an hour because of rain. Granular 'A' was again compacted in the morning to confirm compaction with a small compactor and levelling was done for the base material. Aluminum header was brought from Permaloc Corp. The header was fastened in the granular base with 254mm long steel spikes as shown in Figure 23. The nails were spaced approximately 200 mm which were from Tree Island Industries. After the successful installation of Header, non-woven geotextile was spreaded over the crosswalk base.

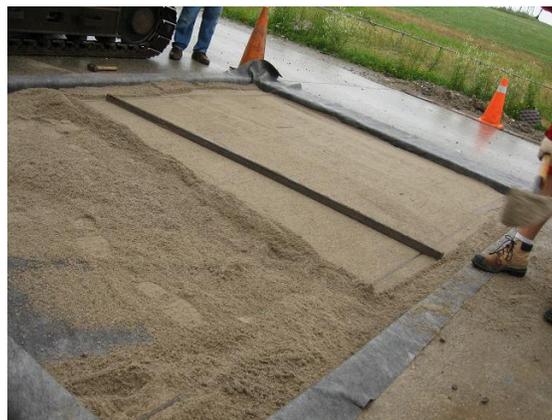
The 25mm of bedding sand was spread above the non-woven geotextile by placing screed rails on it. The bedding sand was screeded across the rails with a straight strike board as shown in Figure 24. Screed rails were removed after that, filling the void with the bedding sand.

Figure 24 Spreading and Screeding of Bedding Sand

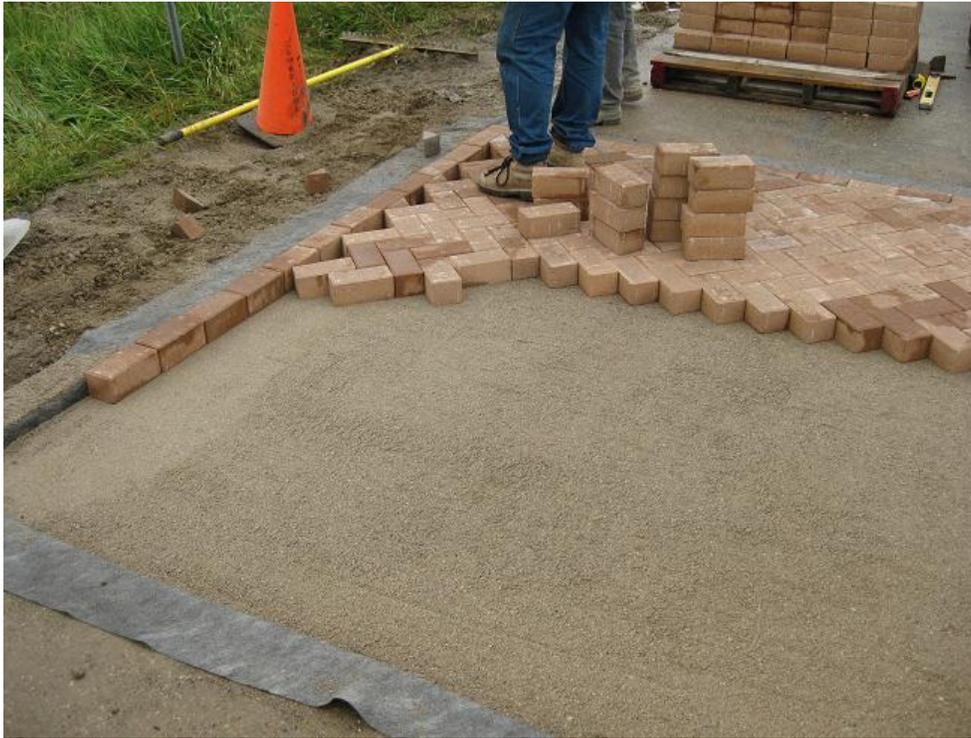
On Day 2 of construction, July 23, 2009 the Interlocking Concrete Pavers were placed on the crosswalk. Concrete pavers were placed in 45 degree herringbone patterns as shown in Figure 25. The interlocking concrete pavers used in the new crosswalk were from Permacon with a dimension of 200mm X 100 mm X 80 mm. The Herringbone pattern is recommended in ICPI Tech Spec 2 as these interlocking patterns

provide the maximum load bearing support (3). Construction was started from the corner with utmost care in the joint width, which should be between 2 mm to 5 mm according to Tech Spec 2. The pavers on the edges were saw-cut to maintain the pattern and cut pavers were used to fill gaps along the edges of the pavement.

Figure 25 Interlocking Concrete Pavers

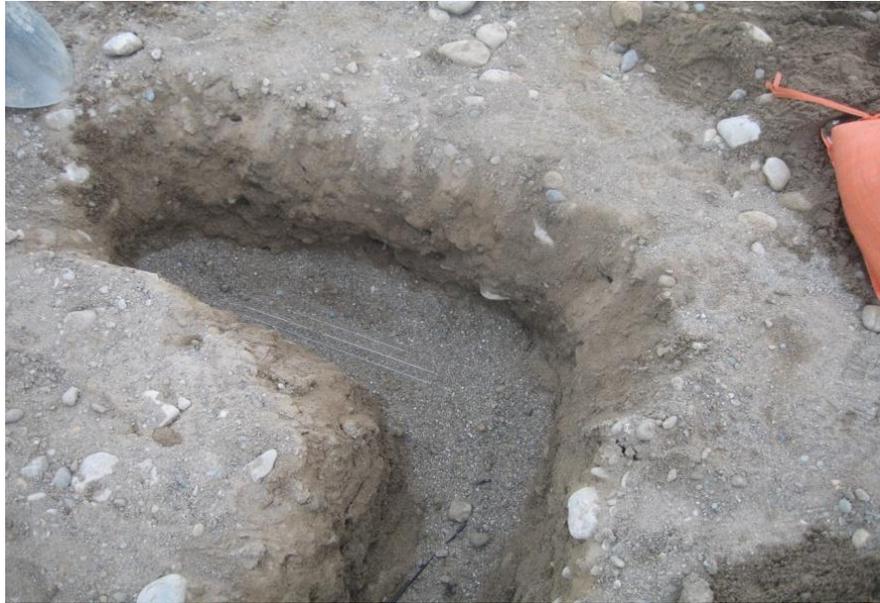
After placing the sensors and cables the trench was filled with sand and subbase materials and compacted with a Marshall hammer to ensure the density. Similarly, the second probe was installed at 150mm above the first probe and filled with sand and compacted with a Marshall hammer.

Figure 29 Installation of Moisture Probes in First Phase

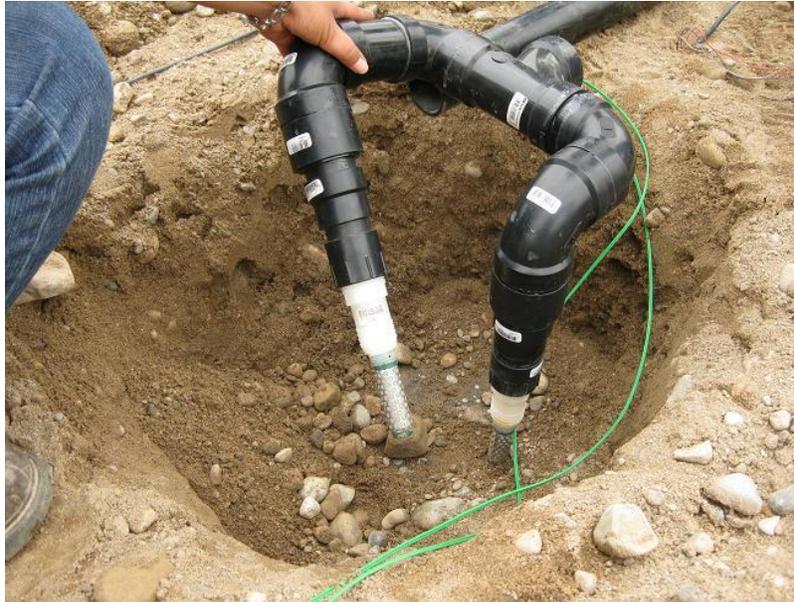
In the second phase, to install the moisture sensor, a pit of 400mm depth is excavated. The sensors fitted in the sensor tree at the depths 375mm and 200mm from the top of the subbase were installed. Sensor tree was constructed on site to hold two sensors at various depths in same area. Figure 30 shows the sensor tree ready to be placed on site.

Figure 30 Moisture Sensors in Sensor Tree in Second Phase

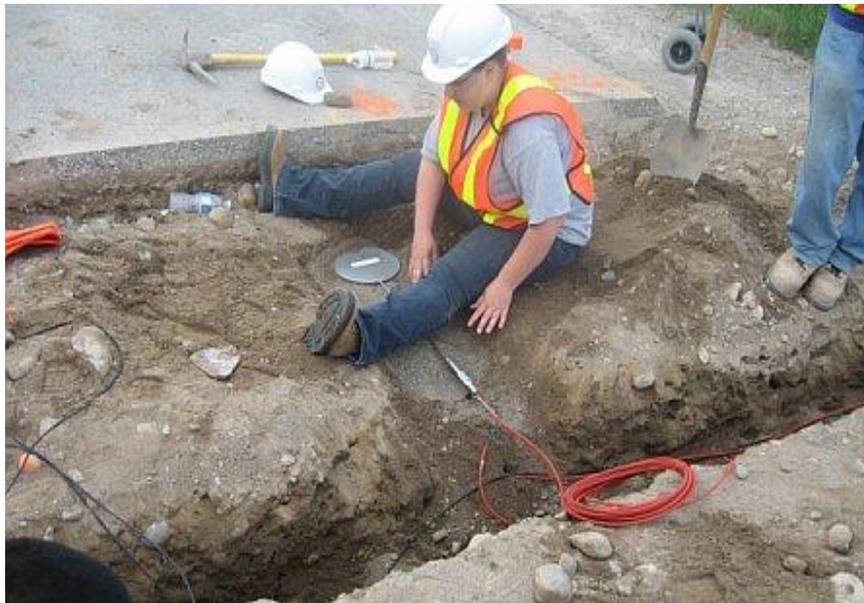
Figure 31 Earth Pressure Cells Installation

To install pressure cells, a cavity of 700mm x 300mm x 300mm is excavated into the subbase to accommodate the pressure cells. Cable trench excavated for moisture probes cables is used to run the pressure cells cables as well. All sharp stone fragments were removed from the cavity and the trench. The cavity and the trench were filled with 5mm sand layer and the probes and cables were placed. After placing the pressure cells and cables, the trench was filled with sand and subbase materials and compacted with a Marshall hammer to ensure the density. Similarly, the second cell is installed at 250mm above the first cell and filled with sand and compacted with a Marshall hammer.

Earth Pressure Cells, a device to measure the vertical stress are constructed from two circular stainless steel plates and welded together around their periphery. An annulus exists between the plates, which is filled with de-aired glycol. The cell is connected via a stainless tube to a transducer forming a closed hydraulic system. As stress is exerted on the surface of the cell, it pressurizes the fluid within the cell, which in turn is measured by the pressure transducer.

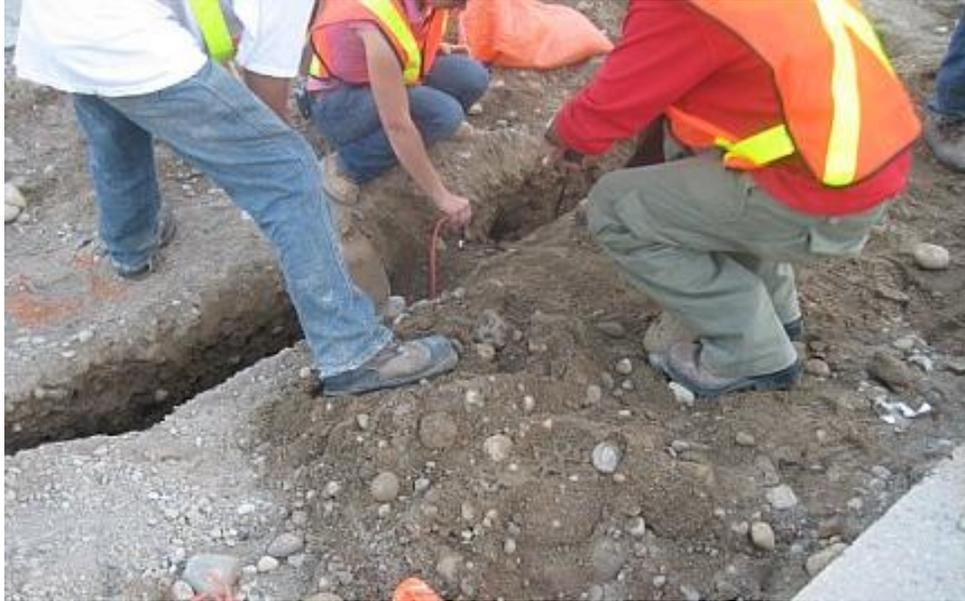
Figure 32 Temperature Probe Installation in First Phase

To install the temperature probes, a cavity of 300mm x 300mm x 600mm is excavated into the subbase as shown in Figure 32. All sharp stones fragments were removed from the cavity and the trench. The cavity

and the trench were filled with 5mm sand layer and the probes and cables were placed. After placing the temperature probe and the cables, the trench was filled with sand and subbase materials and compacted with a marshal hammer to ensure the density.

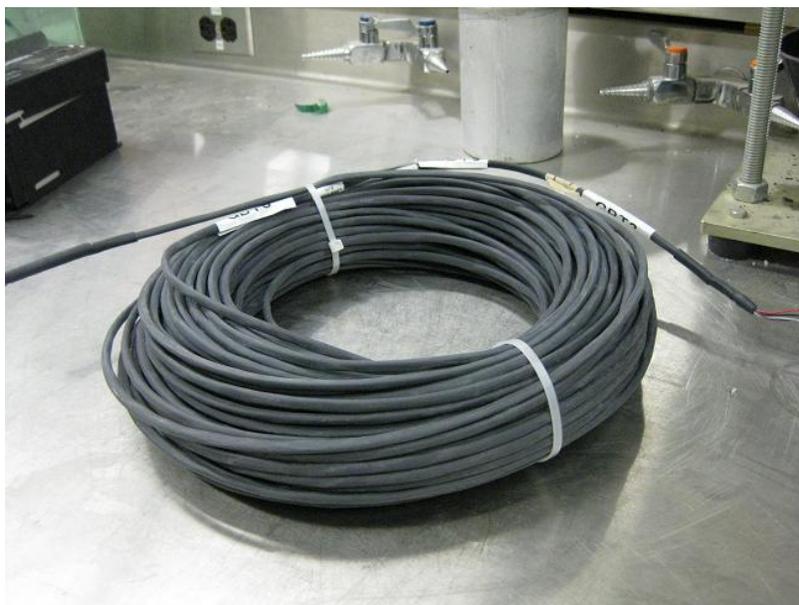
Figure 33 Temperature Probes

The temperature probes used in the second phase of the project is shown in Figure 33 and the Sensor tree which was constructed for installation is shown in Figure 34.

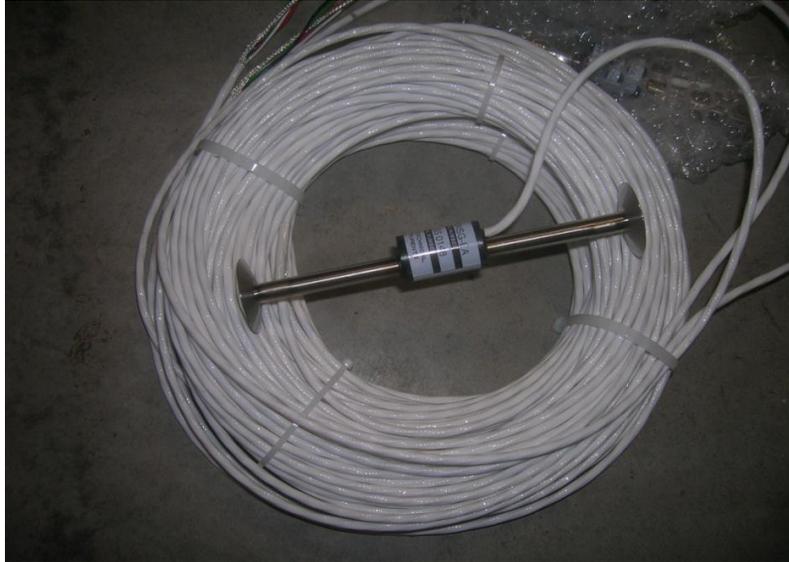
Figure 35 Vibrating Wire Asphalt Strain Gauge

The strain gauges are designed to measure the change of strain and the change of temperature in the concrete. Concrete strain gauges (Model-VWSGE) are installed at 50mm and 150mm below from the top of the concrete base at the right wheel pathway at Test Track site. Two types of strain gauges are installed to measure a strain in asphalt and concrete bases as shown in Figure 35 and 36 respectively. Three asphalt strain gauges are placed at the bottom of the asphalt base at 1.1m, 2.2m and 3.3m offsets from the road edge. Alternatively, concrete strain gauges are installed at the depth of 50mm and 150mm below from the top of the concrete base at 1.15m offset from the road edge.

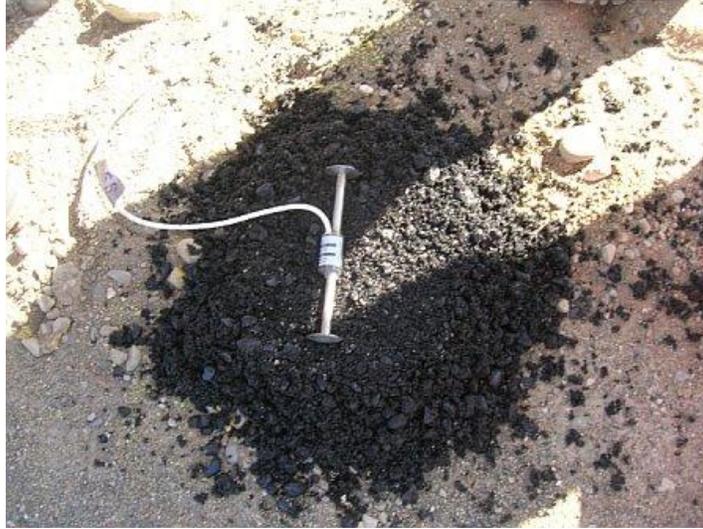
Figure 37 Asphalt Strain Gauge Installation

A HMA pad was placed at the asphalt strain gauges locations. After the asphalt is cooled, the strain gauges are hand placed and gently pressed into the mix as shown in Figure 37. A shallow cable trench was excavated and routed the cables to the edge. The backfill then was filled with sand and compacted with the Marshall hammer.

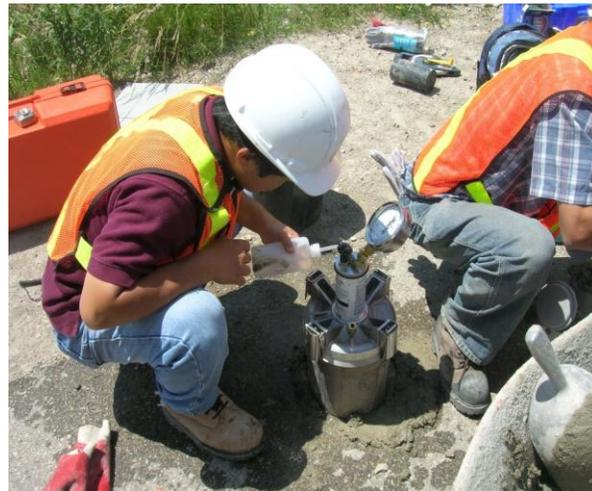
Figure 43 On-site Concrete Air-Void Testing

In addition to extracting samples, mix temperature of the HL3 and sand asphalt were also measured during the placement and before compaction. Slump and air-void testing were carried out for every batch of the concrete as shown in Figure 43.

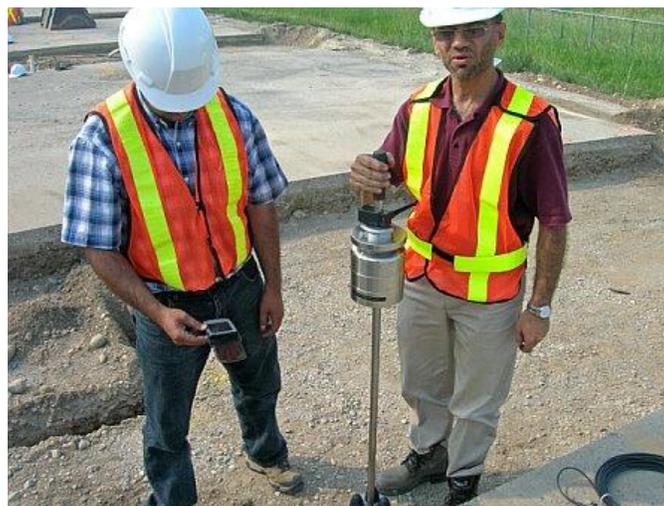
Figure 44 PFWD Testing on Crosswalk Subbase

Figure 44 shows the performance testing using the Portable Falling Weight Deflectometer (PFWD) that was undertaken on subbase, base and surface course layers on the project.

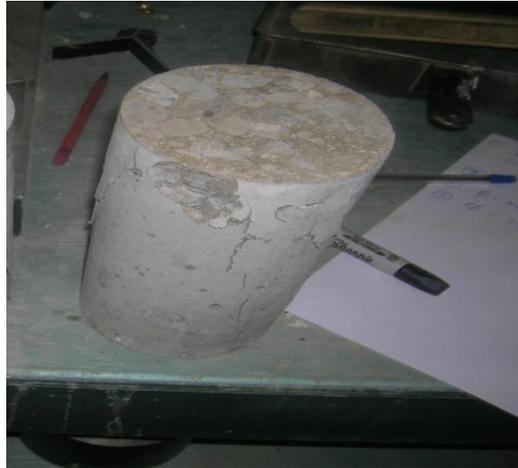
Figure 45 A Cylinder after Compressive Strength Testing

Laboratory compressive strength testing, laying conduits and feeding cables into conduits, connecting sensors with data logger are carried out in this phase.

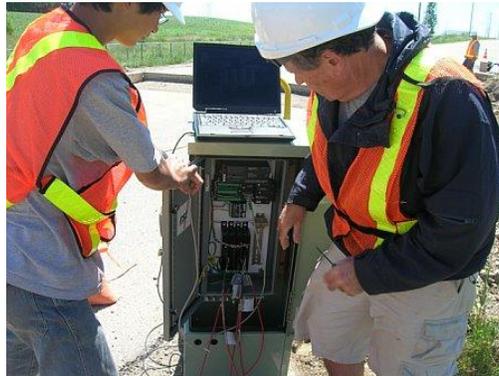
Figure 47 A Preliminary Check of the Sensors after Installation

After installation, all sensors were tested for functionality by connecting to the data logger. All of them were working normally during the testing. The data logger was installed on August 14, 2007 and all sensors have been connected to the data logger were working properly as shown in Figure 47.

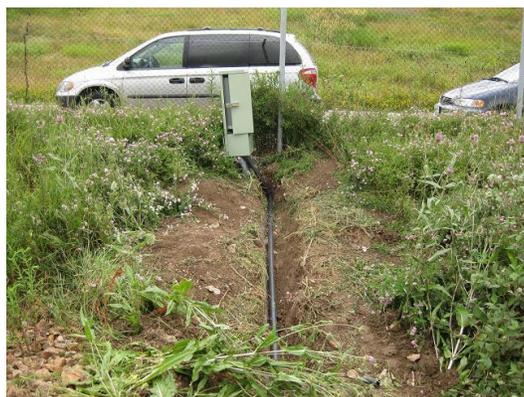
Figure 48 Conduit with Cables Running to Data Logger

A 100mm diameter ABS conduit was used to route the cables to the data logger. A 50cm wide trench was excavated along the road embankment and the conduits were laid and buried with the excavated materials. The data logger is installed at 8.5m west of middle crosswalk section near the fence.

As for phase two, a separate conduit was run parallel to the phase one conduit and the sensors are connected to the same data logger as shown in Figure 48.

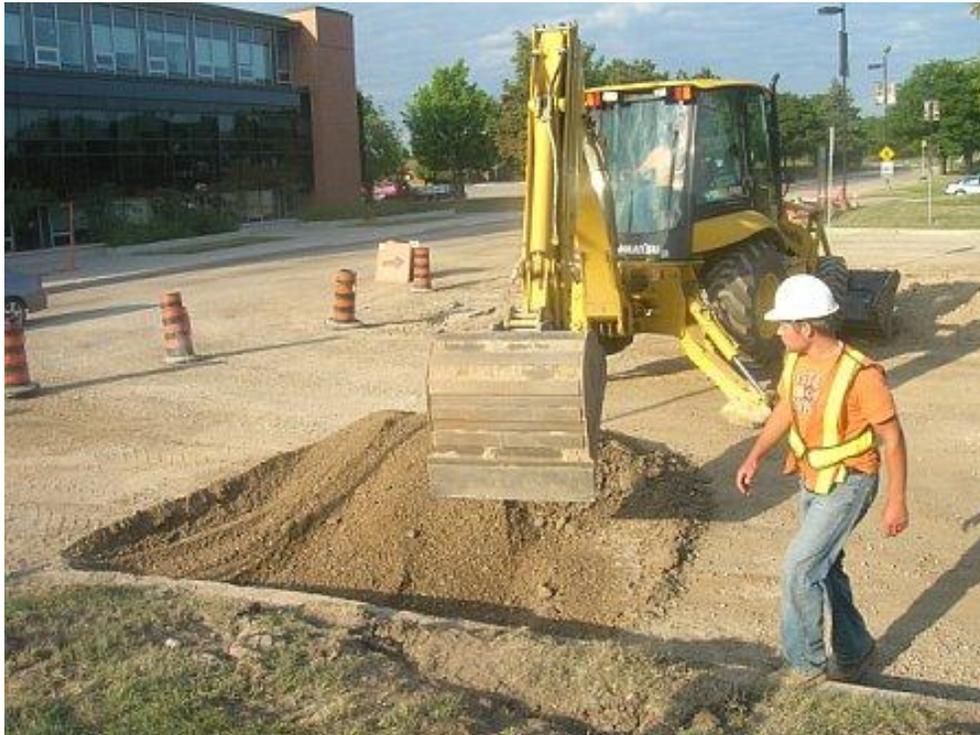
Figure 56 Excavation of Subbase

The first phase in the Ring Road crosswalk construction involved excavating the subbase layer for the resurfacing of the road as shown in Figure 56. After this was completed, the first crosswalk section used a backhoe excavator to excavate the newly built Granular B subbase layer. The cutting of the section started at approximately 8:00 am on July 23, 2007 and lasted for two hours. Immediately following the cutting, the moisture and temperature probes were installed in the designed locations in the subbase and backfilled and compacted with a small plate compactor.

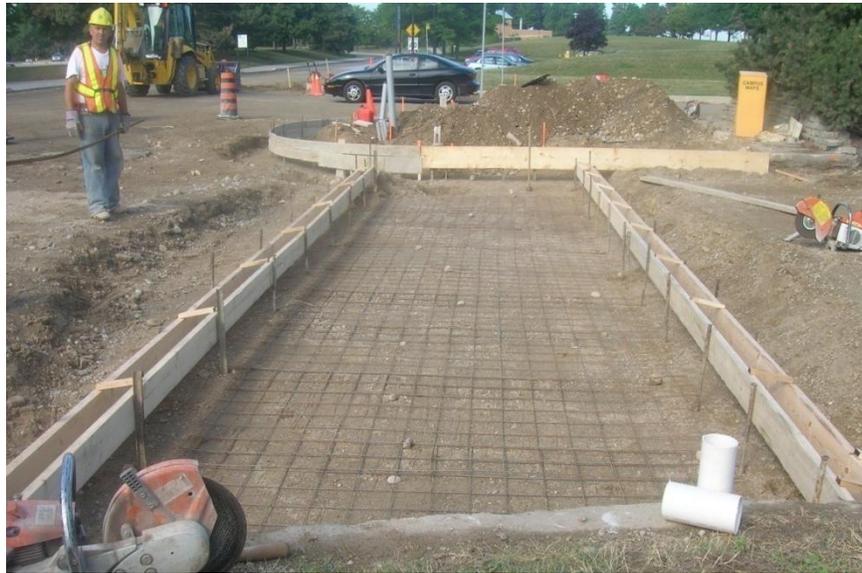
Figure 57 Formworks, Drain Pipes and Reinforcement Bars for Concrete Base Section

crosswalk (SSCBCH) was constructed first. After the final compaction of the subbase with a 20 kN/ 4500 lbs vibrating plate compactor, wooden forms were installed around the perimeter of the crosswalk for curbs and headers. Reinforcement rebars having mesh of 150mm /150mm were placed on the top of the subbase course before the concrete placement as shown in Figure 57. High Early Concrete from Cross Country Concrete Ontario Limited, Heidelberg was brought to the construction site at 10:10 AM on July 24, 2007 and placed into the forms from 10:16 am to 10:50 am. A total of 7.0m³ of concrete poured in place over half an hour period.

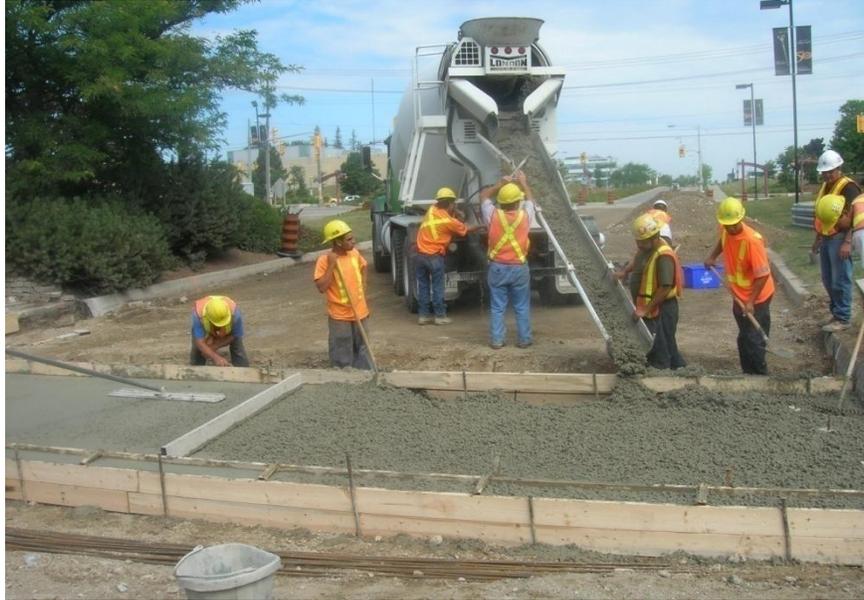
Figure 58 Concrete Placement

The concrete base of BSCBCH was constructed on July 26, 2007. High Early Concrete from Cross Country Concrete Ontario Limited, Heidelberg was brought to the construction site at 7:15 AM and poured into the forms from 7:20 AM to 7:55 AM. A total of 7.0m³ of concrete poured in place over thirty five minutes period as shown in Figure 58.

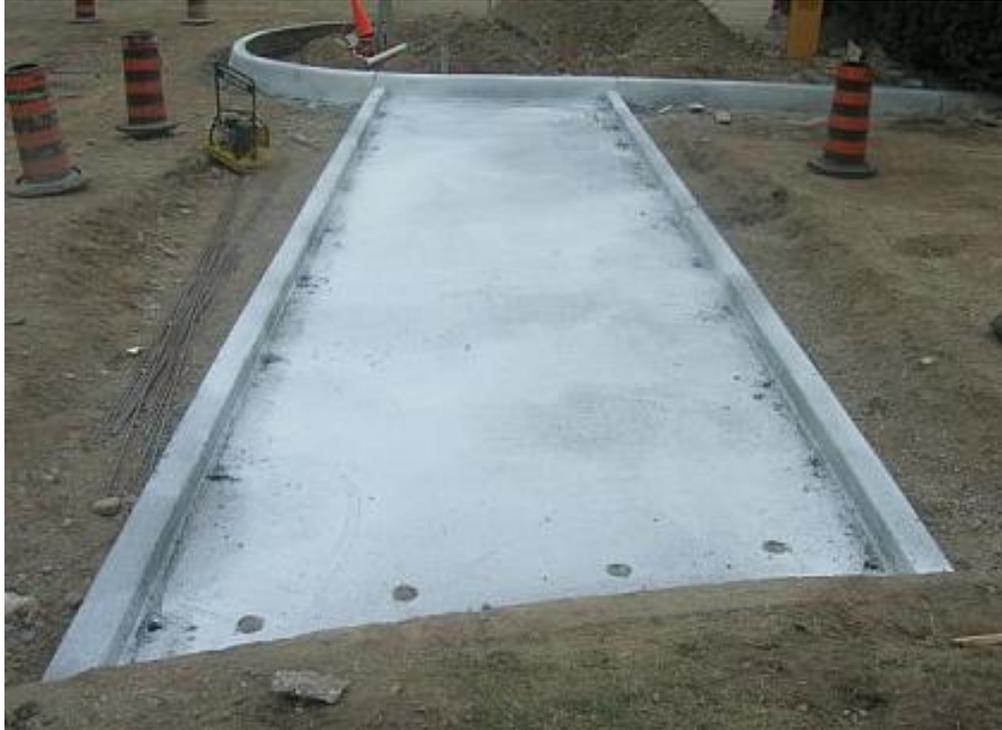
Figure 59 Concrete Base Section

The length of the concrete base sections is 11.25m and the width is 2.635m including the headers on both sides is shown in Figure 59. The thickness of the concrete bases is 200mm. Each base has curb and headers around the perimeter, the width of the curb/header is 150mm. Exposed concrete header edges are trimmed to 3mm radius to reduce the likelihood of chipping. The curing agent was applied after the initial setting of the concrete.

Prior to the concrete placement, twenty four ABS pipes with diameter of 75mm and length of 300mm were installed perpendiculars to the road surface at the lowest level of the base course. Since the road base is constructed with a two percent slope towards the edge, four pipes were installed along the two outer edges of the bases and sixteen pipes were placed longitudinally along the inner side of the crosswalk. The pipes were filled with pea gravel and covered with non-woven geotextile to prevent the loss of bedding materials. Their purpose is to remove excess water from the bedding course. The distance between adjacent drainage pipes (centre to centre) is approximately 60cm and the first drainage pipe of each set is 20cm offset from the edge of the base.

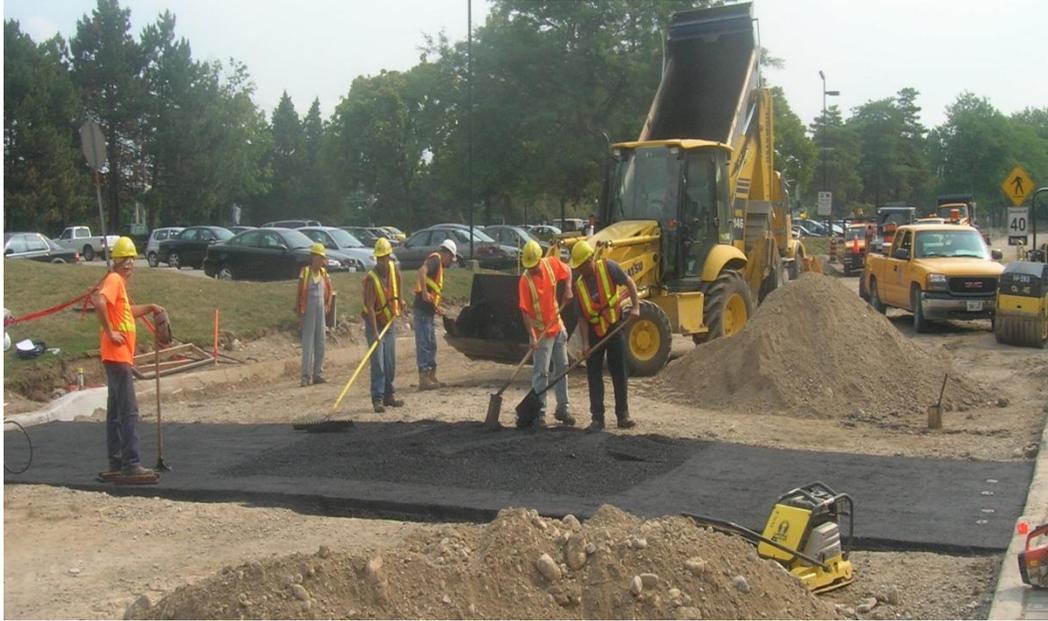
The asphalt base also has two concrete curbs similar to the concrete bases along the two edges that are parallel to the Ring Road. Two sets of four ABS pipes were placed along the outer edges of the base and filled with pea gravel and covered with geotextile. The distance between adjacent drainage pipes (centre to centre) is approximately 60cm and the first drainage pipe of each set is 20cm offset from the edge of the base.

Figure 60 Asphalt Base Construction
