Pavement Performance Modeling of Unique Crosswalk Designs

A thesis
presented to the University of Waterloo
in fulfilment of the
thesis requirement for the degree of
Master of Applied Science
in
Civil Engineering

This thesis presents a research project involving the design, construction, instrumentation, performance modeling and other field tests of eight ICP crosswalks with four different design assemblies. The research projects were constructed at the Centre for Pavement and Transportation Technology (CPATT) Test Track and at the University of Waterloo Ring Road. Each of the test sections is instrumented with structural and environmental sensors of sensors to monitor the pavement performance under heavy truck traffic, typical municipal loadings and to quantify environmental effects. A database is generated and the measured stress, strain, temperature and moisture measurements are analysed to evaluate the expected long-term performance of the structural components of ICP crosswalk designs.

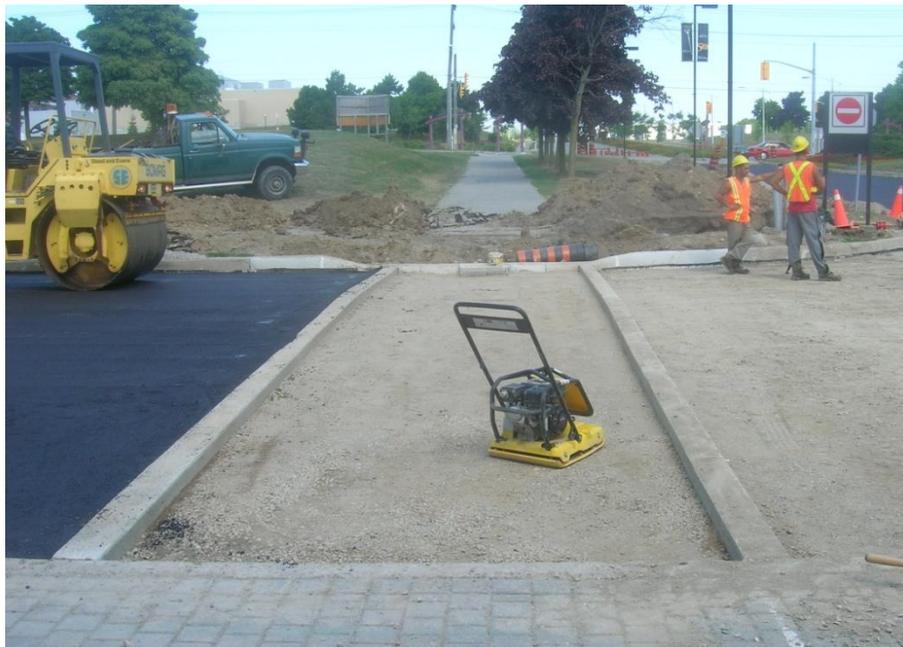
The construction of the aggregate base SSGBCH was started on July 26 2007, and the installation of moisture and temperature probes in subbase, 150mm thick Granular A base course was placed and compacted with a 20 kN plate compactor. The concrete curbs and headers were built on July 27, 2007 as shown in Figure 61.

Figure 61 Aggregate Base Construction

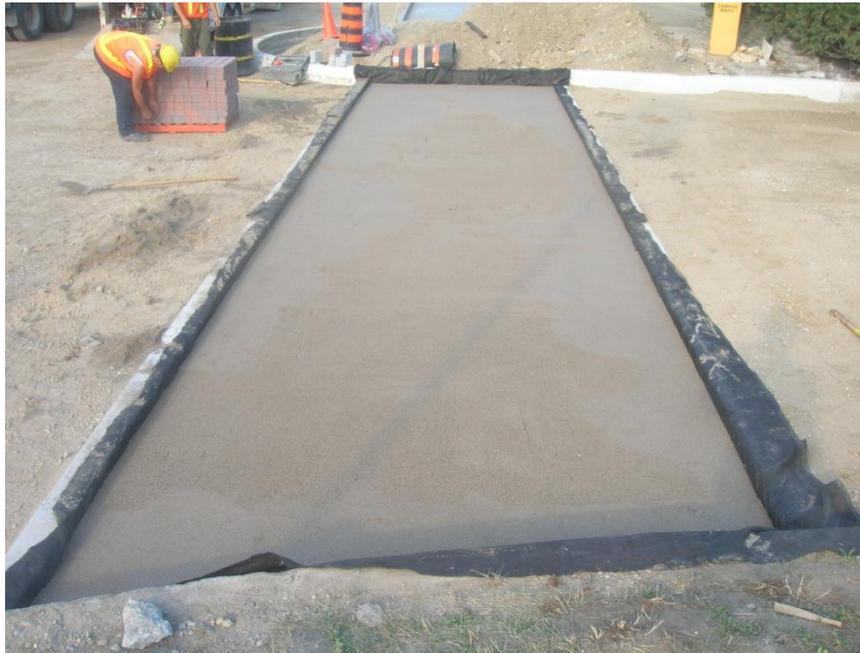
Figure 62 Bedding Sand and Non-woven Geotextile

For asphalt base crosswalk (SSABAH), L-shaped aluminum angles were installed on top of the asphalt base and along the cut pavement edge. The aluminum angle is 9.5cm wide and 9.5cm high and 6 mm thick. Nails and screws were drilled alternatively through the aluminum angle and into the asphalt base 60cm apart to fasten the edge restraint onto the base. On top of the angle plate and the asphalt base, a similar layer of non-woven geotextile and bedding sand were placed.

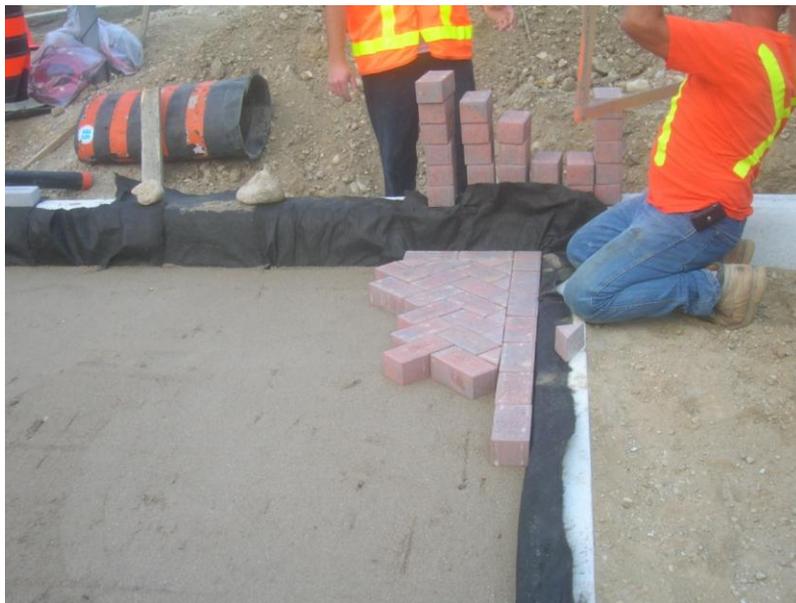
Figure 63 Laying Interlocking Concrete Pavers

The interlocking concrete pavers were placed into the SSCBCH, two, three and four on July 27, 2007, August 1, 2007, August 24, 2007 and July 31, 2007 respectively. Interlocking concrete pavers from NAVA STONE in Cambridge, Ontario with approximate dimension of 200mm × 100mm × 80mm were

placed in 45° herringbone pattern. Installation was carried out in an identical manner to the test sections at the CPATT Test Track started from the corner with securing 45° string lines on the bedding course. Edge pavers are saw cut to fit against the sailor and soldier courses. The sailor and soldier are interlocking concrete pavers which were placed in such a way that each section has three sides (one long side and two short sides) with sailor course and one long side with soldier course. After the installation, the surface was compacted with a vibratory plate roller to compact the bedding sand, seat the pavers in it and force the bedding sand into the joints at the bottom of the pavers. The procedure is presented in Figure 63. The final elevation of the surface course was kept 6mm above the adjacent asphalt pavement to accommodate any future settlement.

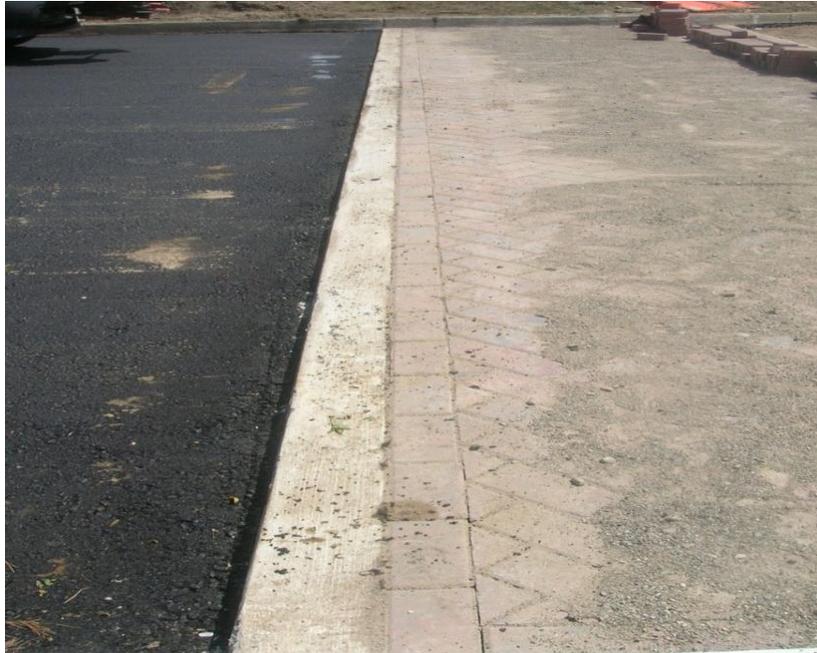
Figure 64 Concrete Header and Joint Sand

After the initial compaction of the pavers was completed, dry joint sand was spread on the surface and compacted with a vibratory compactor to ensure that the spaces between pavers are filled. Excess joint sand was later removed.

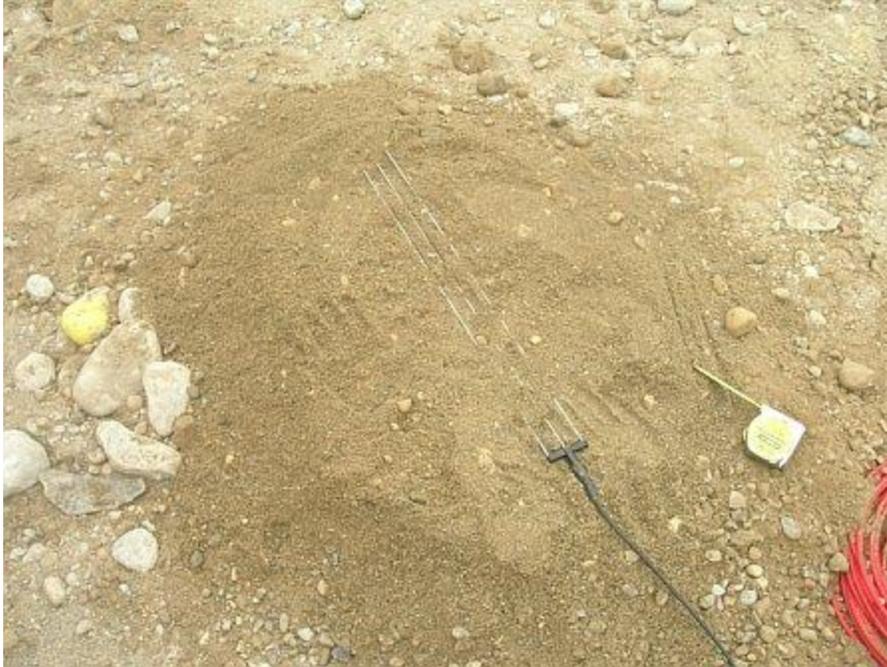
To install a moisture probe, a cavity of 700mm x 200mm x 300mm is excavated into the subbase to accommodate the moisture probe. A cable trench of 200mm wide x 250mm deep running from the cavity to the edge of pavement was also excavated as shown previously. This trench is used to run the cables of pressure cells and temperature probes as well. All sharp stone fragments were removed from the cavity and the trench. The cavity and the trench were filled with 5mm sand layer and the probes and cables were placed. After placing the sensors and cables the trench was filled with sand and subbase materials and compacted with a Marshall hammer to ensure the density. Similarly, the second probe is installed at 150mm above the first probe and filled with sand and compacted with a Marshall hammer. The cables were run along the trench together and then fed into conduit.

Figure 65: Installation of Moisture Probes

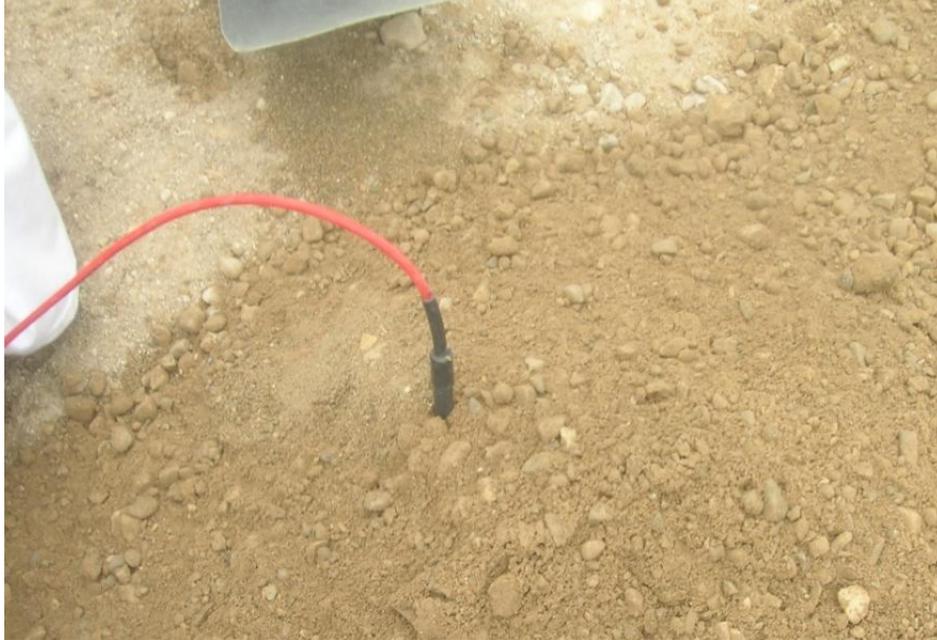
Figure 66 Temperature Probe Installation

Temperature probes are installed to measure temperature variation at different elevations within the pavement structure. The temperature probe consists of two thermistors which are 200mm long and are installed vertically in the subbase in each section. The thermistors are located at 50mm and 250mm from the top of the subbase at 1.4m offset from the road edge. Figure 66 shows the top of the probe after installation.

To install the temperature probes, a cavity of 300mm x 300mm x 600mm is excavated into the subbase. All sharp stone fragments were removed from the cavity and the trench. The cavity and the trench were filled with 5mm sand layer and the probes and cables were placed. After placing the temperature probe and the cables, the trench was filled with sand and subbase materials and compacted with a Marshall hammer to ensure the density. The cable was routed along the trench and then fed into conduit.

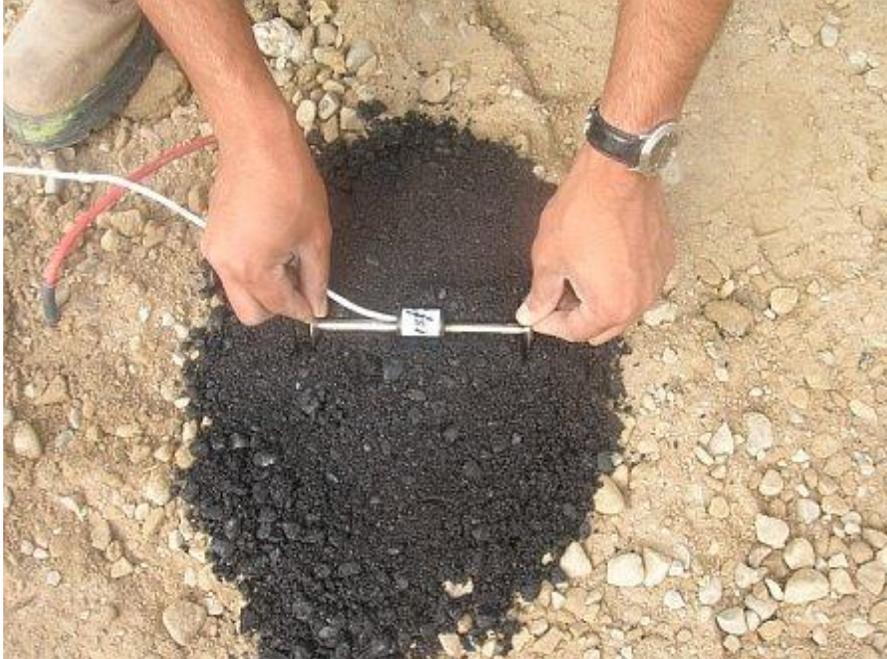
Figure 67 Asphalt Strain Gauge Installation

Two types of strain gauges were installed to measure a strain in asphalt and concrete bases as shown in Figures 67 and 68 respectively. Three asphalt strain gauges were placed at the bottom of the asphalt base at 1.1m, 2.2m and 3.3m offsets from the road edge. Alternatively, concrete strain gauges were installed at the depth of 50mm and 150mm from the top of the concrete base at 1.15m offset from the road edge.

A HMA pad was placed at the asphalt strain gauges locations. After the asphalt cooled, the strain gauges were hand placed and gently pressed into the mix as shown in Figure 67. A shallow cable trench was excavated and routed the cables along the trench and fed into conduit. The trench then was filled with sand and compacted with the Marshall hammer.

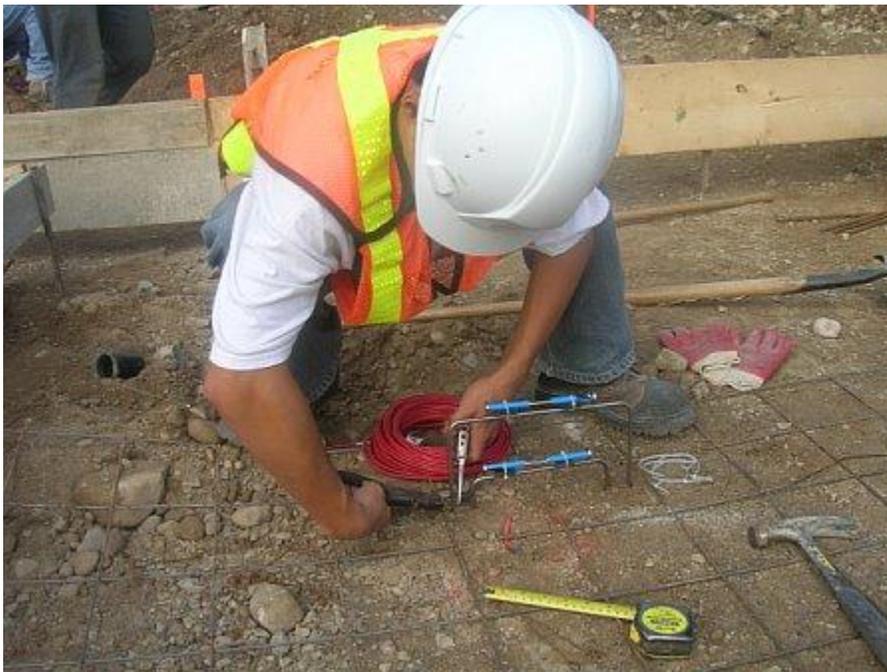
Figure 68 Vibrating Wire Concrete Strain Gauges Installation

Concrete strain gauges were attached with U-shaped chairs and the chairs were driven into the ground and tied together to prevent from movement as shown in Figure 68. A shallow cable trench was excavated to run the cable and finally fed into conduit. The trench was then filled with sand and compacted with the Marshall hammer.

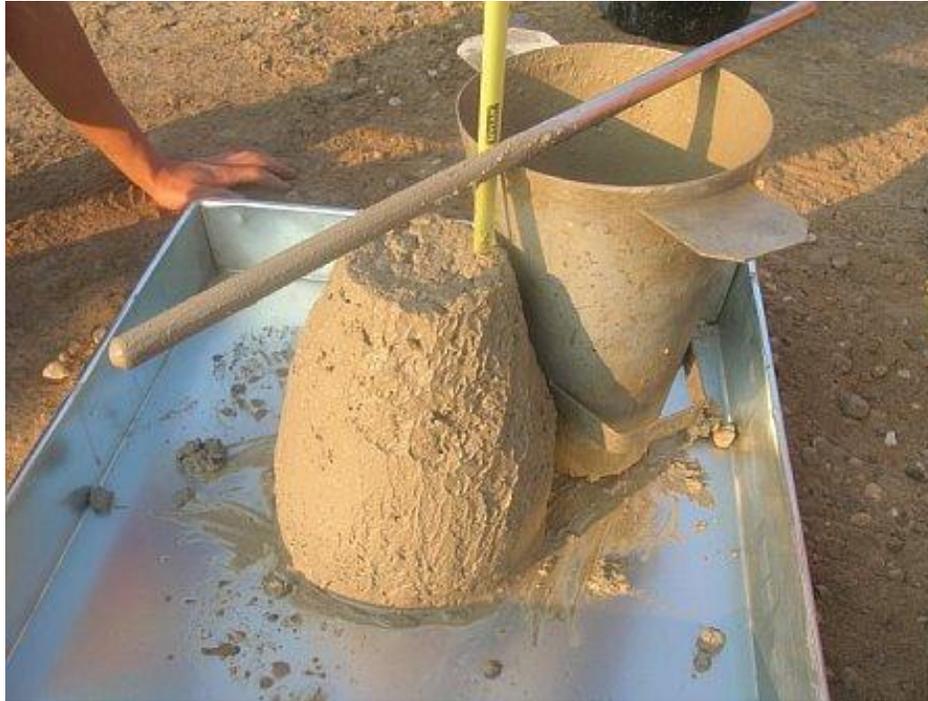
Figure 73 On-site Concrete Slump Testing

In addition to extracting samples, mix temperature of the HL4 and sand asphalt were also measured during the placement and before compaction. Slump (Figure 73) and air-void testing were carried out for every batch of the concrete.

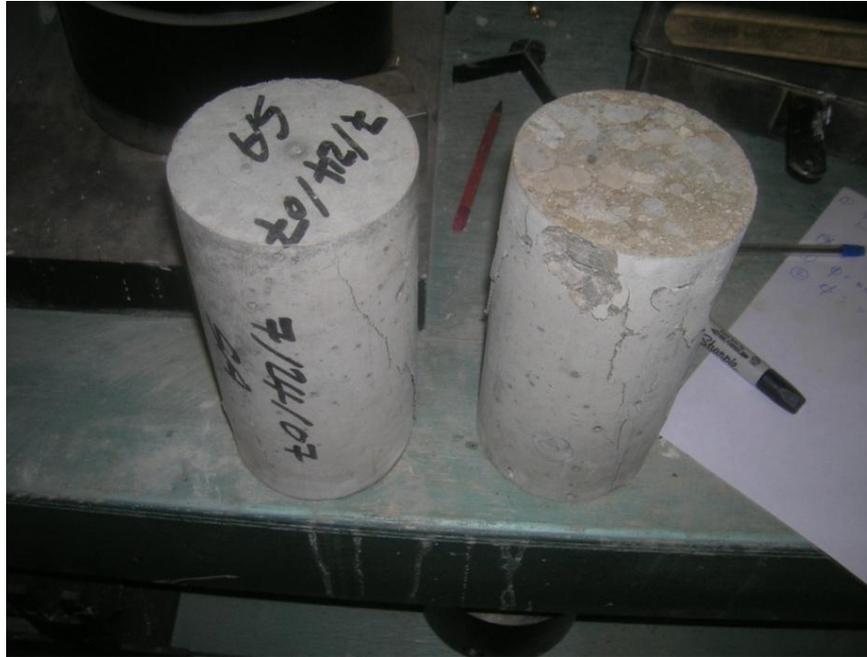
Figure 74 A Cylinder After Compressive Strength Testing

Laboratory compressive strength testing, Figure 74, laying conduits and feeding cables into conduits were carried out in this phase.

During the concrete placement at the Test Track, twelve 100mm x 200mm concrete cylinders from each concrete mix were made. Two cylinders from each section were crushed using compressive strength testing machine on 1 days, 2 days, 3 days, 7 days, 14 days, and 28 days after placement. As shown in Figure 75, the 28 day compressive strength for cylinders from both sections did meet the 28 days compressive strength requirement (32 MPa).

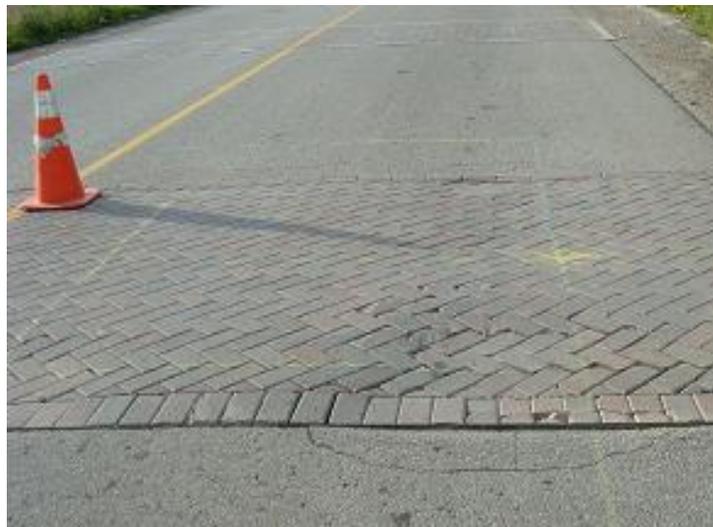
In a survey done in July, 2009 out of the three crosswalks at the Test Track the second one which is Sand Set Asphalt Base Steel Header failed under existing loading conditions and repair was necessary. This crosswalk was constructed on July 2007. A conference call was held on July 5, 2009 between the CPATT research team, Ross Yantzi the contractor and the ICPI technical committee to discuss about the condition and possible repair method. After the discussion, it was decided to remove the pavers and examine possible failure causes. As per discussion, Susan Tighe, Ross Yantzi and other CPATT members the visited Test Track to investigate the cause of failure. Figure 78 shows the crosswalk's picture before pavers were lifted.

Figure 78 Crosswalk Before Lifting the Pavers

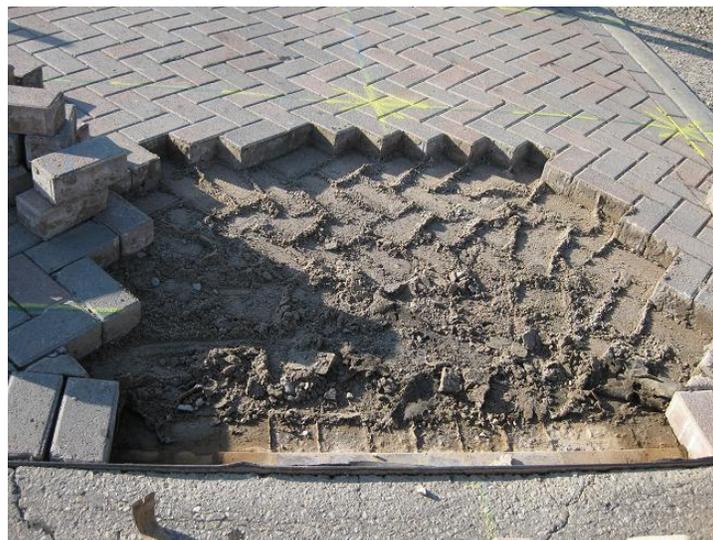
Figure 79 Crosswalk After Lifting the Pavers

The pavers with the soldier course which were against the steel edge were lifted and it was found that no bedding sand was remaining under the pavers. The geotextile in that area had also failed. Figure 79 shows the section right after the paver was lifted. However, the area under the paver, bedding sand and geotextile were intact and were performing well. It can be seen clearly in Figure 79, the sand is in good condition. It had shoved, but the gradation was very good. After a discussion, the team concluded that the reason for failure of this crosswalk at the edges is due separation of the steel edges from the asphalt edge which would vibrate when vehicles went over. As a result of the vibration, the steel edges moved and eventually resulted in the movement of pavers.

Consequently, the joint sand also was lost allowing for the infiltration of water into the pavers, which resulted in bedding sand being pumped out. The sample of bedding sand from the failing section and the good section were collected and gradation test was performed. The summaries of test results are provided in Table 8. All except three of the sieves are within the percent passing. The slightly higher percentage passing of the failed sample on the No. 100 sieve is most probably due to contamination.

As described in the earlier paragraph, the header was changed from steel to aluminum. The maintenance work was done along with the construction of the new crosswalk. The same methods and materials were used as for the SSGBAH. Following the repair this test section was renamed to reflect the change in the header. Please refer to section Construction of SSGBAH for the detail description of each work. However there are a few variations which are summarized in Table 9.

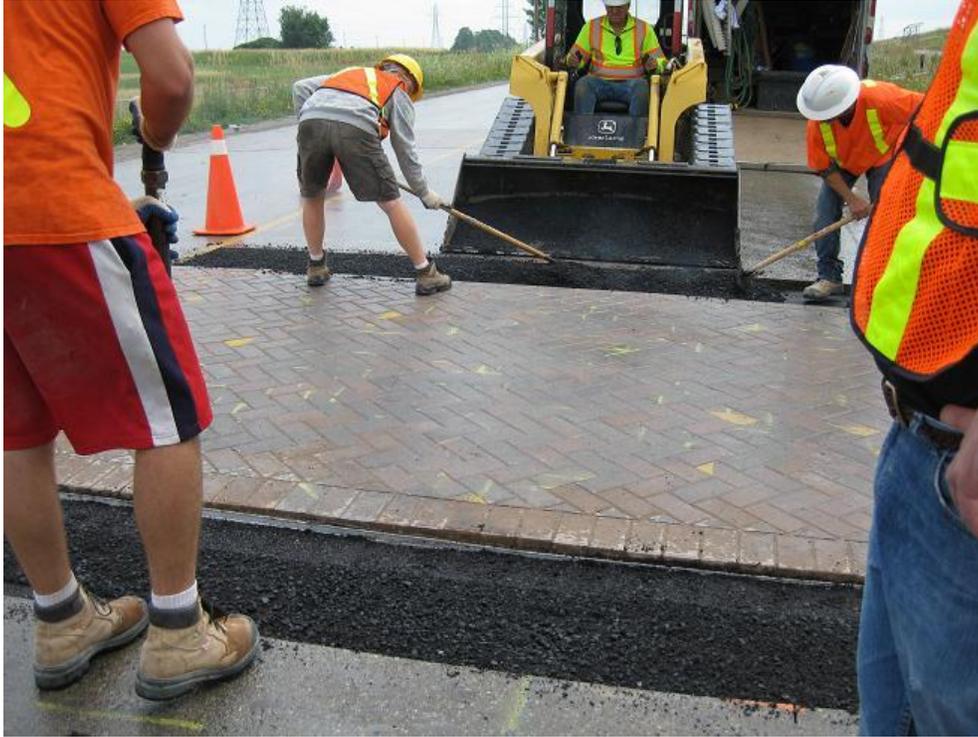
Figure 80 Replacement of Hot Mix Asphalt

In the southbound lane during maintenance, the good pavers were cleaned and reused while any bad or failed pavers were replaced with new pavers. The joint sand stabilizer was used instead of joint sand. The asphalt was cracked on the edges of the crosswalk. In order to ensure a better load transfer, the existing asphalt was replaced with new hot mix asphalt. It is 610mm wide and 102mm thick. Replacement of asphalt was done only in the southbound lane which is shown in Figure 80. This asphalt was placed to prevent any future settlement.

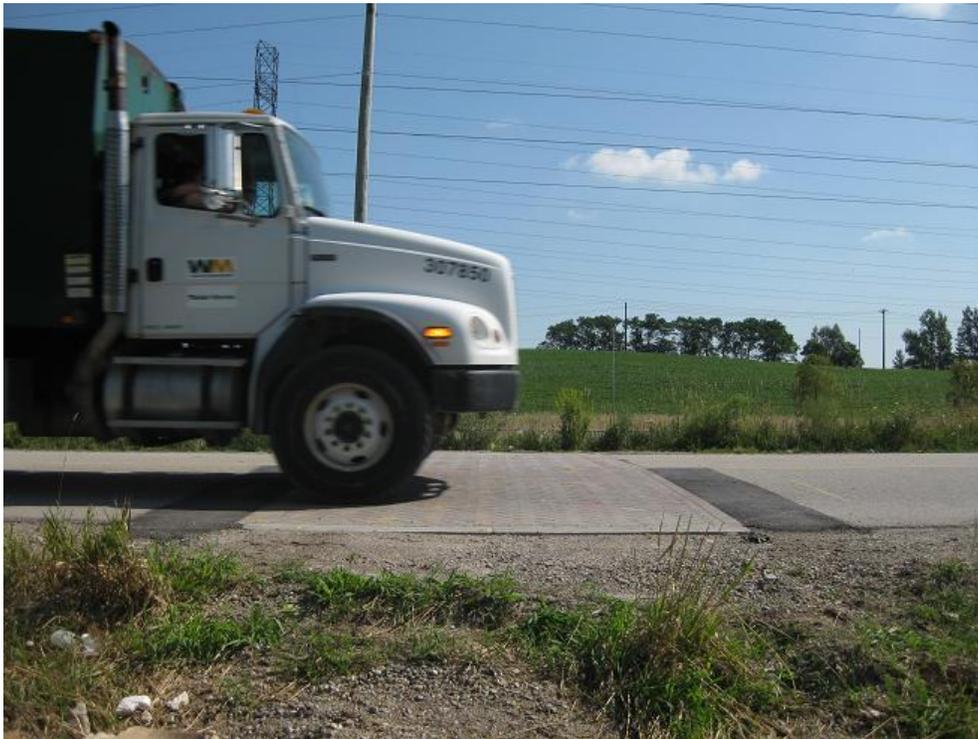
Figure 81 Vehicle in Operation After Final Completion

Figure 81 shows the vehicle in operation. This picture was taken on July 30, 2009 which is a week after construction.

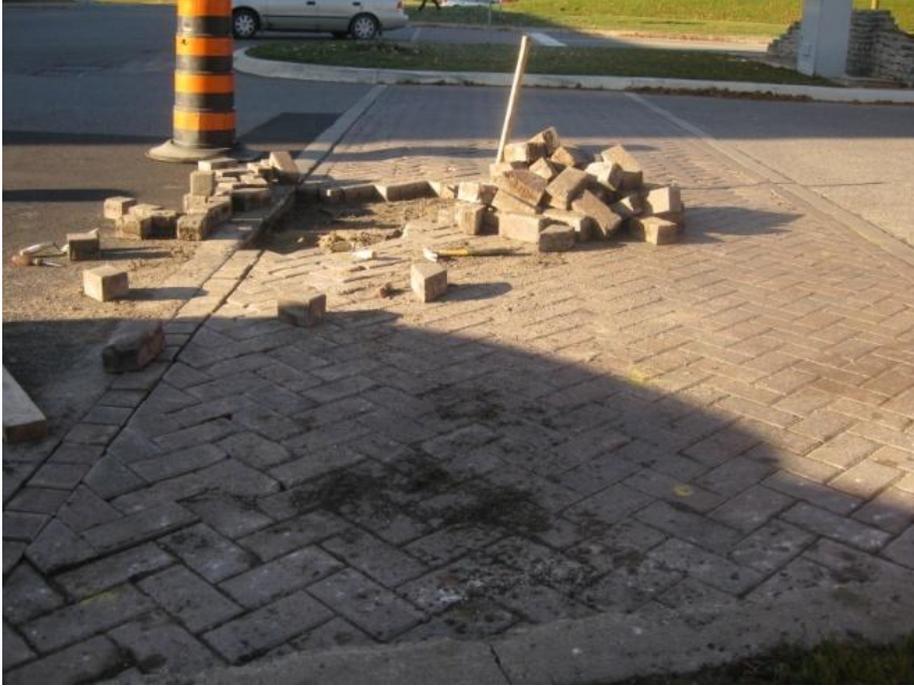
The failure of the crosswalk was primarily due to the drainage in the crosswalk. More specifically, water remained on this crosswalk as it was the low point of the intersection. Thus, despite having two catch basins located in the intersection, due to the elevation the water remained on the SSCBCH crosswalk. Thus, over time the crosswalk began to fail due to its continuously saturated state. A new asphalt batch was placed adjacent to the crosswalk which would result in water being drained to the catch basin areas. The drainage problem has also been fixed before the repair of the crosswalk by regarding the asphalt section in the intersection. The following Figure 82 shows work in progress. Figure 83 shows the re-graded intersection.

Figure 82 Repair work in Progress SSCBCH

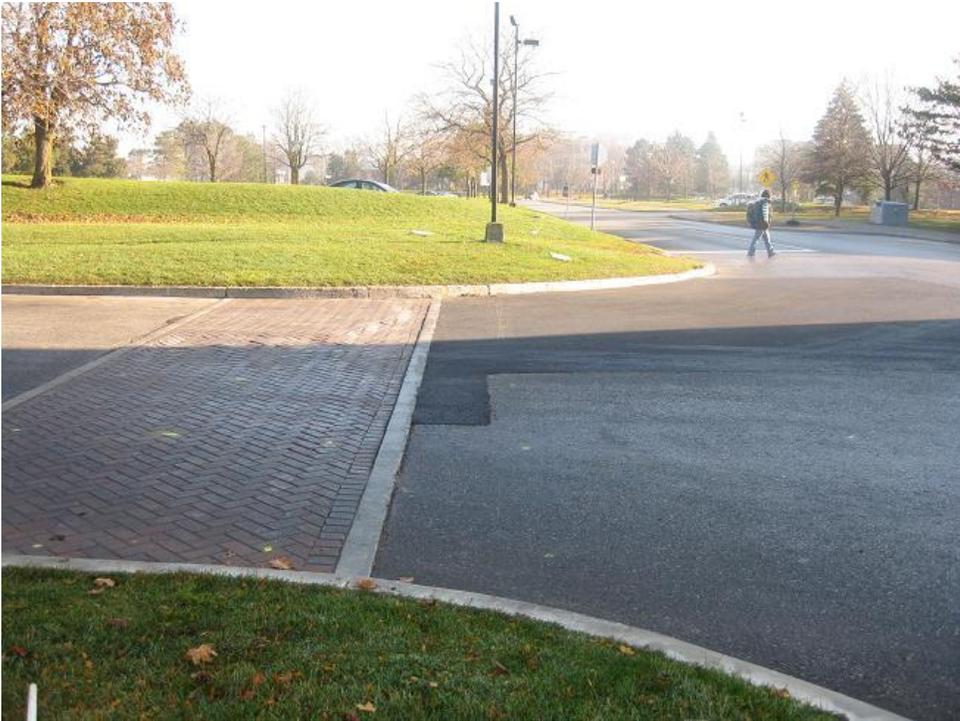
Figure 83 Re-graded with Asphalt SSCBCH

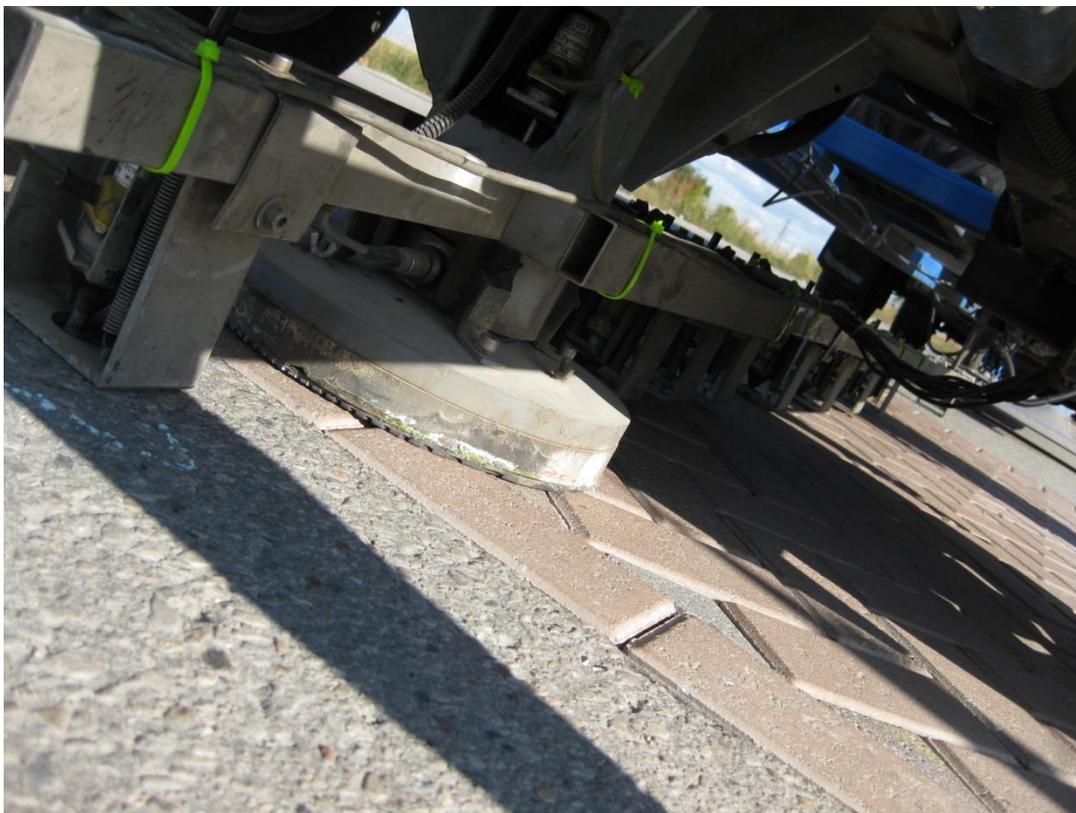
Figure 112 FWD Testing on SSGBAH

measures the pavement response (i.e., deflection) to a load that simulates the in-service truck loads applied to the pavement. The FWD applies a dynamic load through a circular plate that is lowered to the pavement surface. Sensors in contact with the surface measure the downward deflection of the pavement surface. The use of a FWD enables the engineer to determine a deflection basin caused by a controlled load.

FWD testing was carried out in the CPATT Test Track-Crosswalks on September 16, 2009 with the help of Stantec Consulting Limited. Six drops were carried out at the edge of the crosswalk with three different loadings. Figure 112 shows the test being done in Sand Set Granular Base (SSGBAH) crosswalk design.

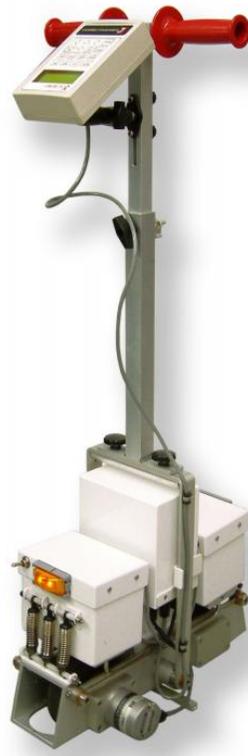
Figure 116 SurPro 2000

The CPATT SurPRO 2000 is a Class 1 multipurpose walking profiler manufactured by ICC as shown in Figure 116. The unit operates on a battery, two inertial inclinometers and an optical encoder. Data is collected by rolling the profiler at a constant speed along a line of interest. Inclinometers operate under the same principles as accelerometers; however, they are more sensitive to vibrations and are able to compute the angle of the profiler's inclination. Using the angle of inclination and distance travelled, the SurPRO 2000 calculates elevation changes with respect to the starting elevation.

The CPATT SurPRO was calibrated prior to starting the surveys. Longitudinal roughness profiles were taken in the left and right wheel paths and transverse profile were taken of each crosswalk as shown in the figure below. Prior to testing each crosswalk was inspected to ensure that they were free of any loose debris and profiling lines were marked with spray paint to help in reducing the meandering by operators. The test area is shown in the Figure 117.
