The effect of in-stream wood on channel
morphology and sediment deposition in
headwater streams of the Oldman River
Basin, Alberta

A thesis
presented to the University of Waterloo
in fulfillment of the
thesis requirement for the degree of
Master of Environmental Studies
in
Planning

Waterloo, Ontario, Canada, 2012

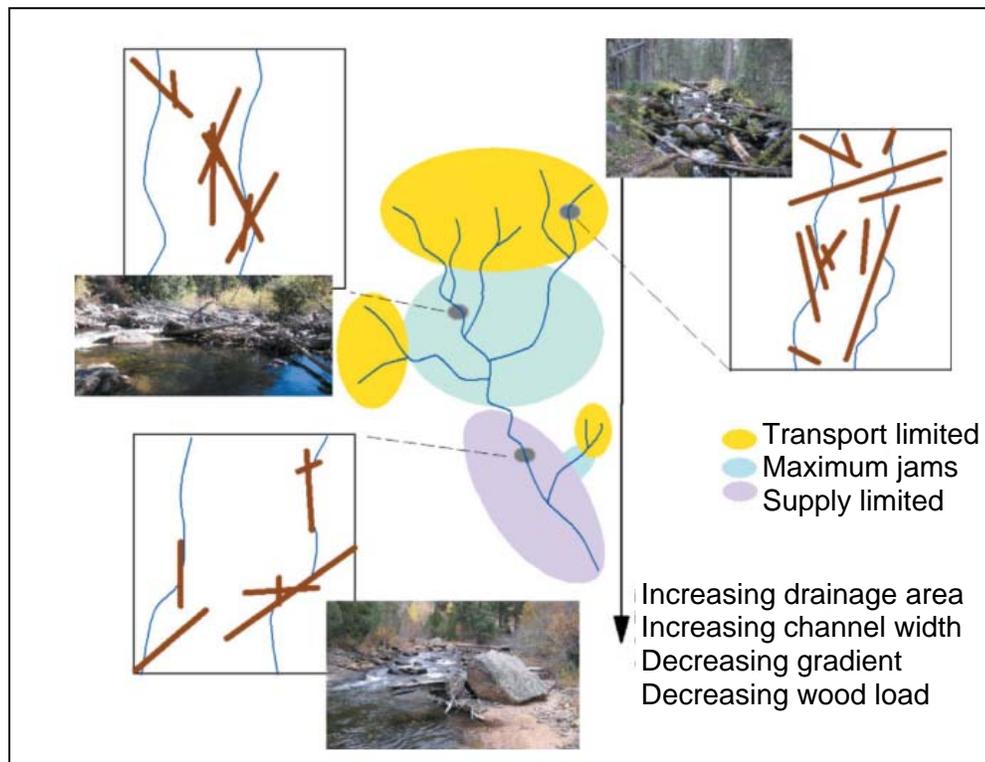
Figure 1-1: The downstream changes in distribution and abundance of in-stream wood and movement of organic matter (Fetherston et al., 1995; Gurnell et al., 1995)

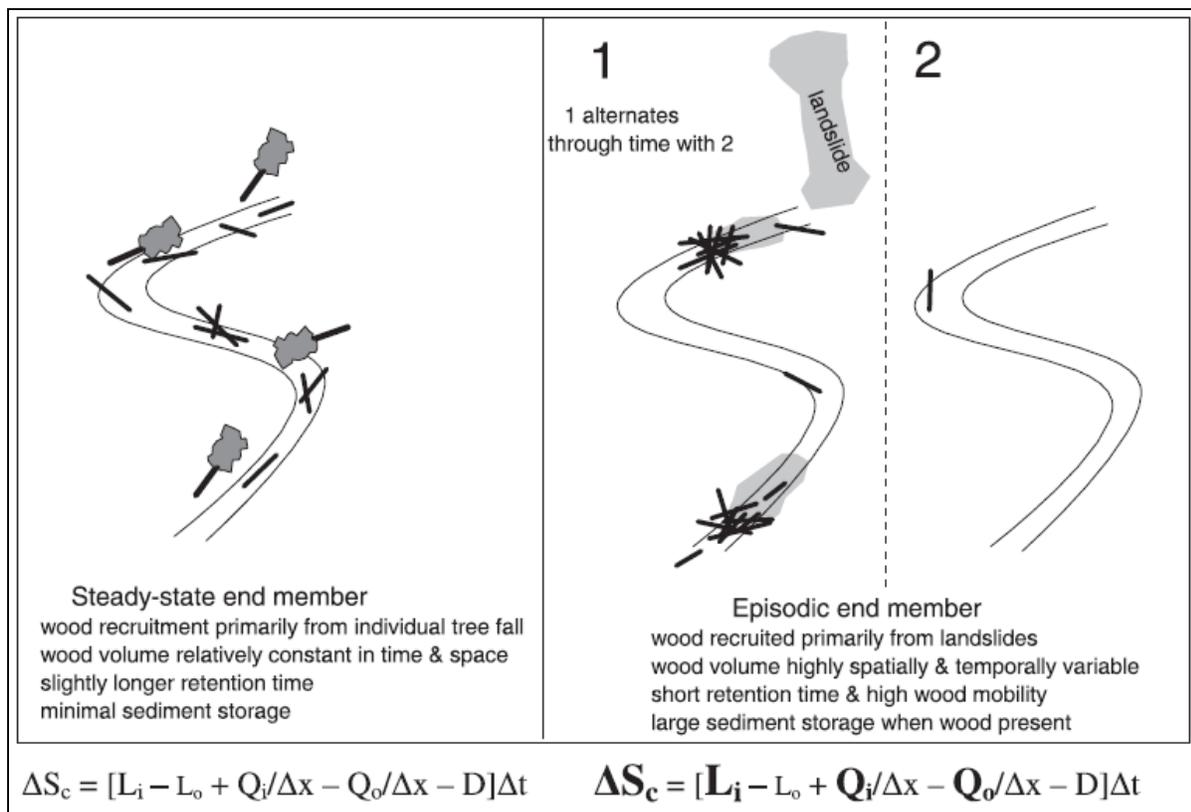
Figure 1-3: Schematic illustration of the two end-member model of wood dynamics. The size of symbols for variables from equation 1 represents their relative importance in the respective end-members. The grey shaded area represents sediment storage (Wohl et al., In Press)

The stability of in-stream wood is influenced by a balance between the physical characteristics of the valley, channel and wood. Valley form has been found to explain more variability of wood loading than channel characteristics, as the availability and stability of wood is determined by hillslope processes (Comiti et al., 2008; Nowakowski & Wohl, 2008). Wohl et al. (In Press) used the wood budget concept to explain the significance of variables and their influence on the distribution of in-stream wood (Figure 1-3). The steady-state end-member has a gradual but steady recruitment of

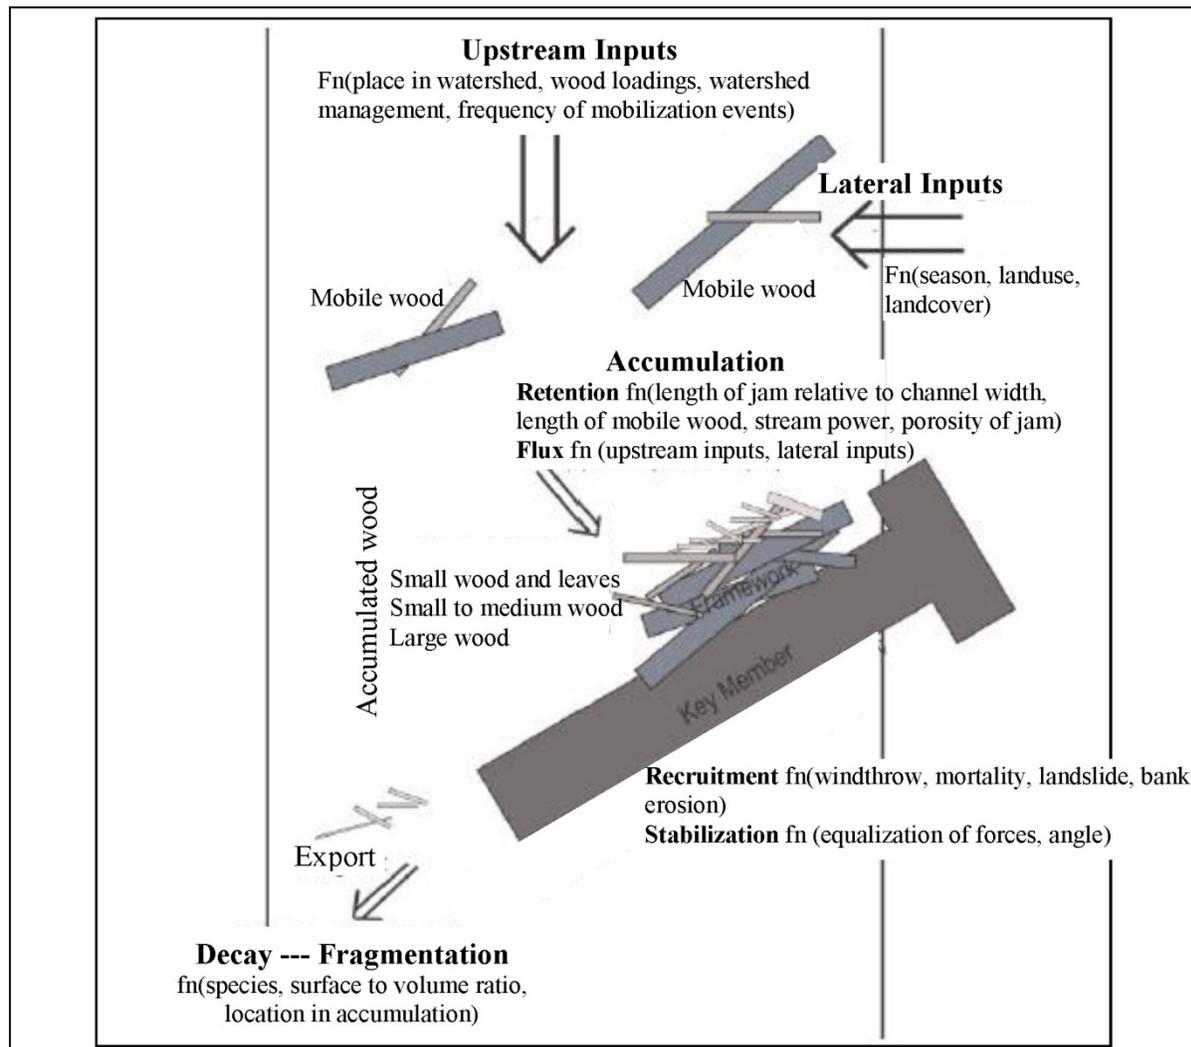
Figure 1-4: Schematic model of the evolution of a jam modified from Manners & Doyle (2008)

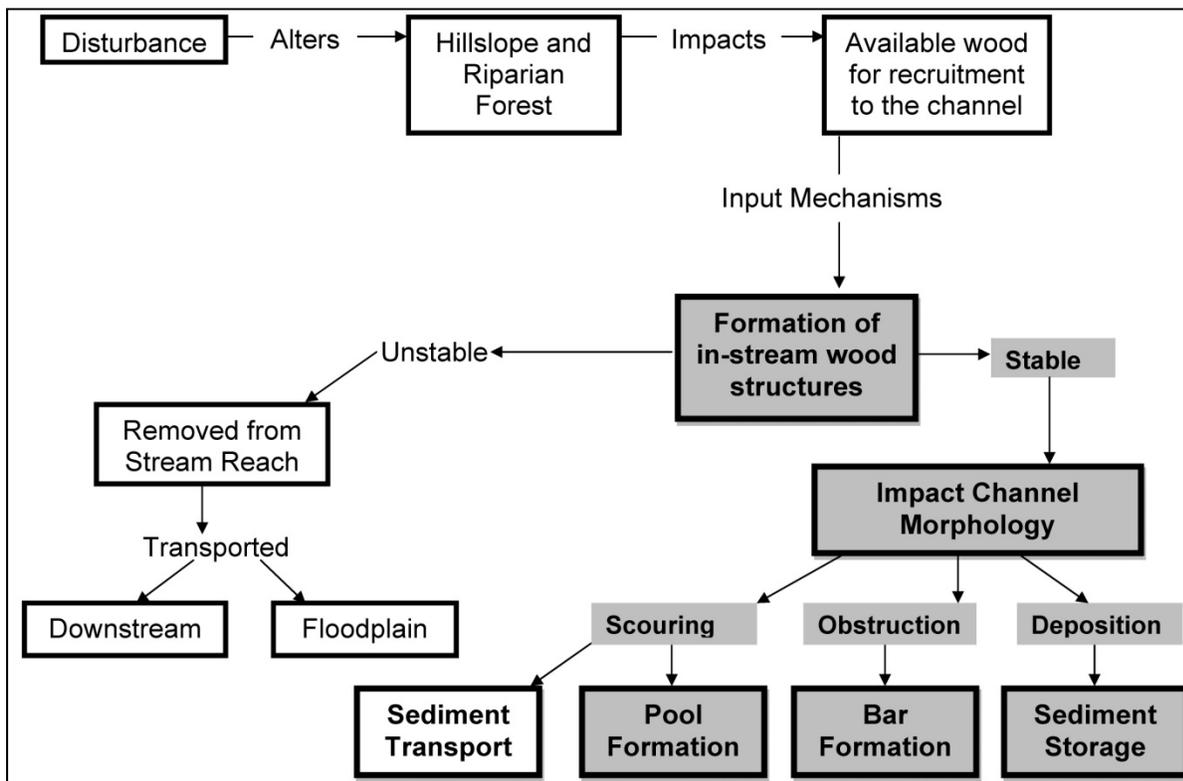
Figure 2-1: Conceptual diagram illustrating the formation and impact of in-stream wood structures on channel morphology. This thesis will explore the concepts contained within the bold and shaded boxes.

Based on the literature review, a conceptual diagram (Figure 2-1) of the current research is presented to illustrate key processes that influence in-stream wood structures and their impacts on channel morphology. Within this conceptual diagram specific aspects which form the basis of this thesis are shaded and bolded. The thesis was conducted to examine the spatial distribution and type of in-stream wood located along the main stem of two headwater streams impacted by different land-use disturbances. The second goal of this project was to understand the reach scale impact of wood structures on depositional and scour features in the channel morphology. In particular the study focused on the formation of pools and associated cohesive sediment storage (Figure 2-1).

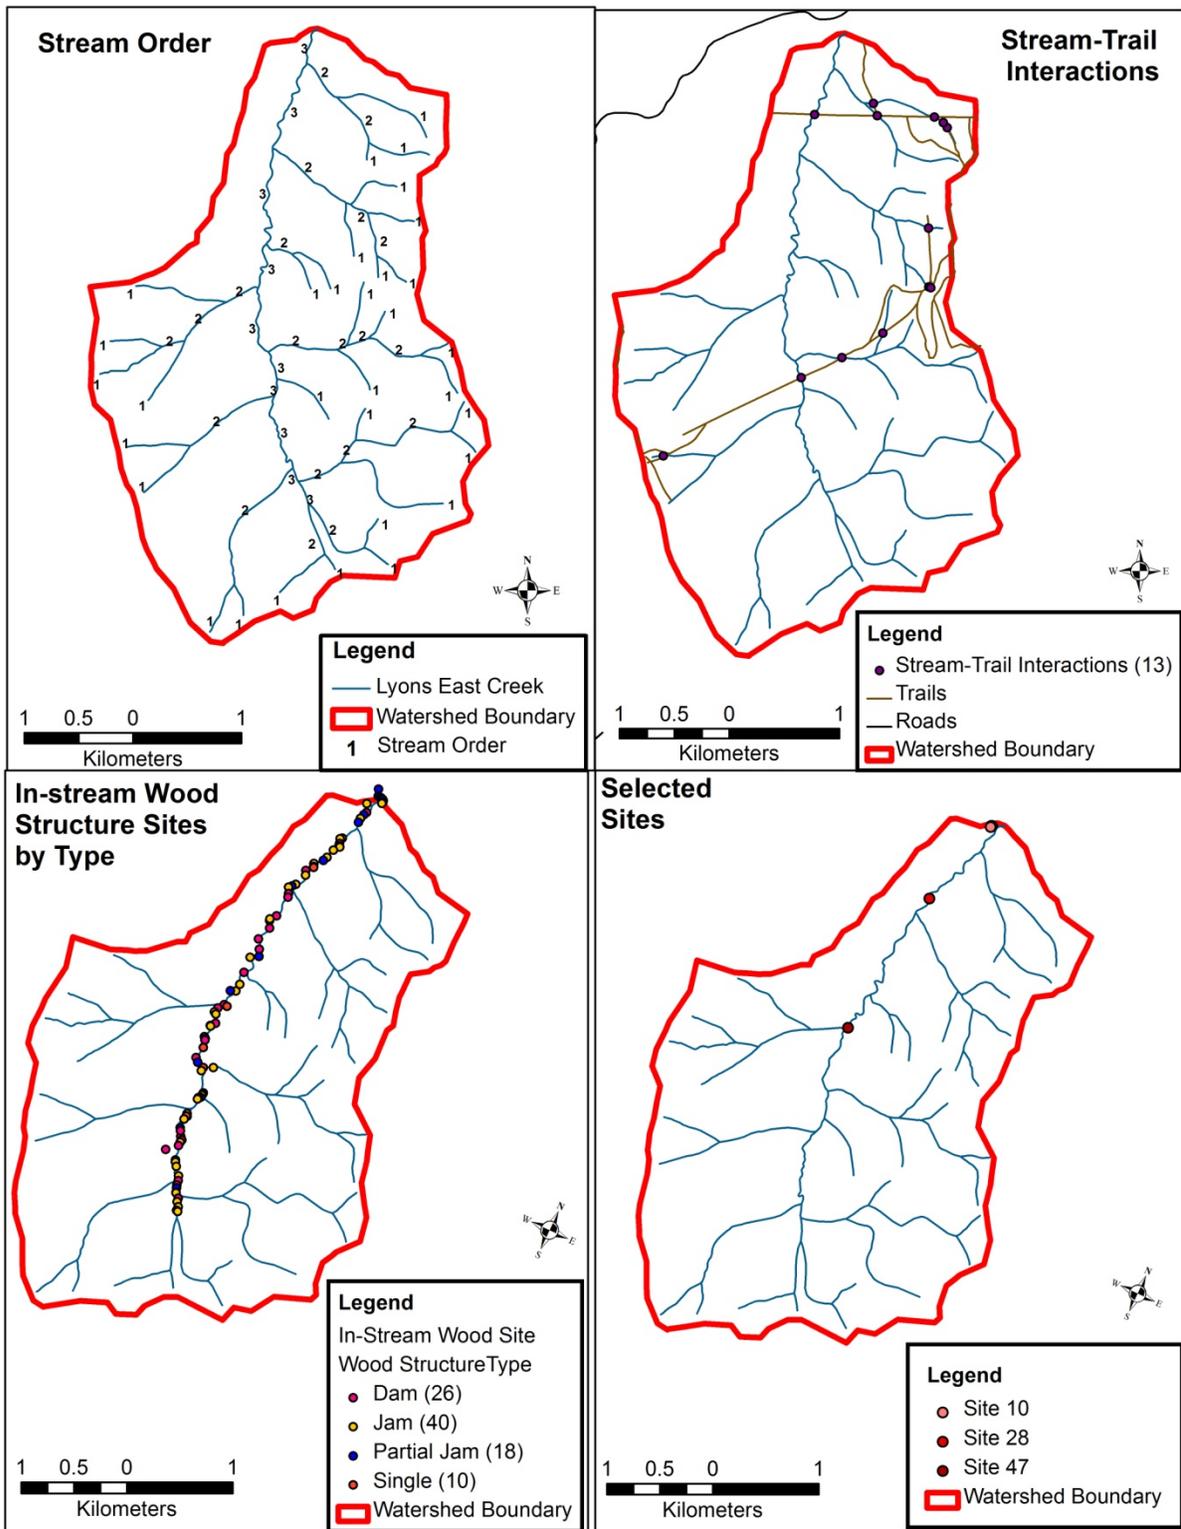
Figure 2-4: Four maps illustrating the watershed and wood characteristics for Lyons East. The stream order was completed based on Strahler (1952). The lower two maps illustrate the type of in-stream wood found and the location of the sites chosen for reach scale analysis

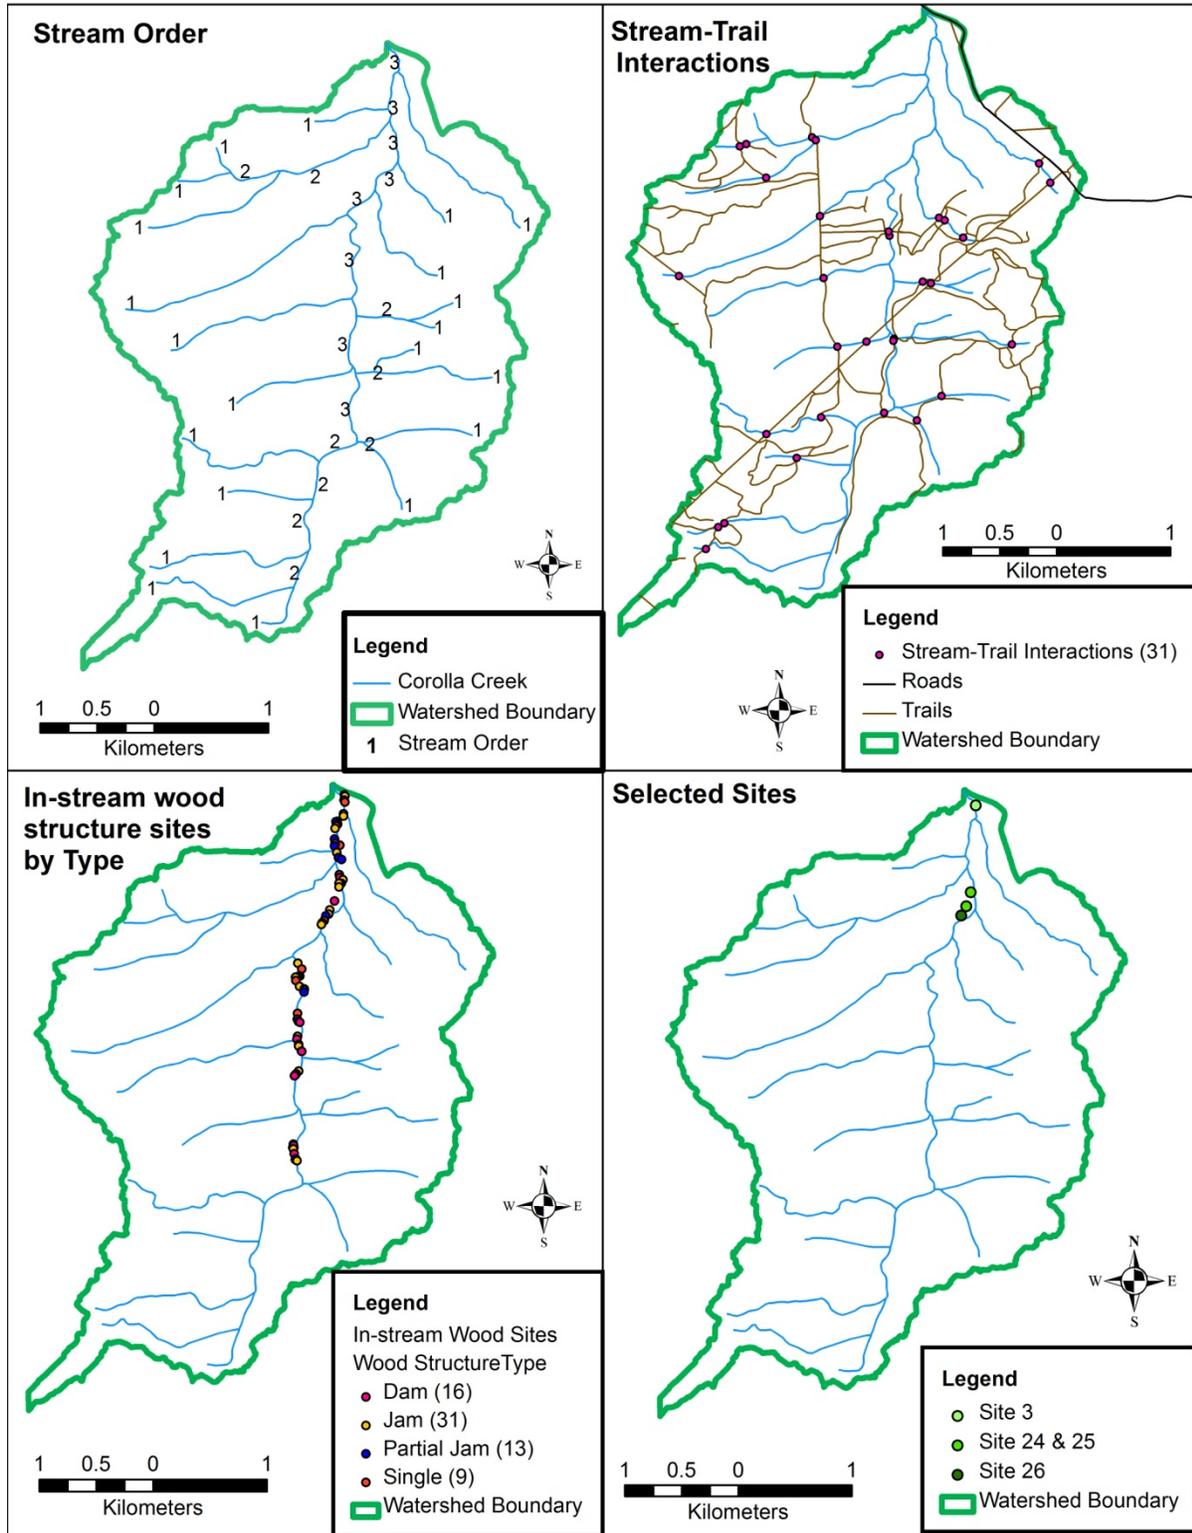
Figure 2-5: Four maps illustrating the watershed and wood characteristics for Corolla Creek. The stream order was completed based on Strahler (1952). The lower two maps illustrate the type of in-stream wood found and the location of the sites chosen for reach scale analysis.

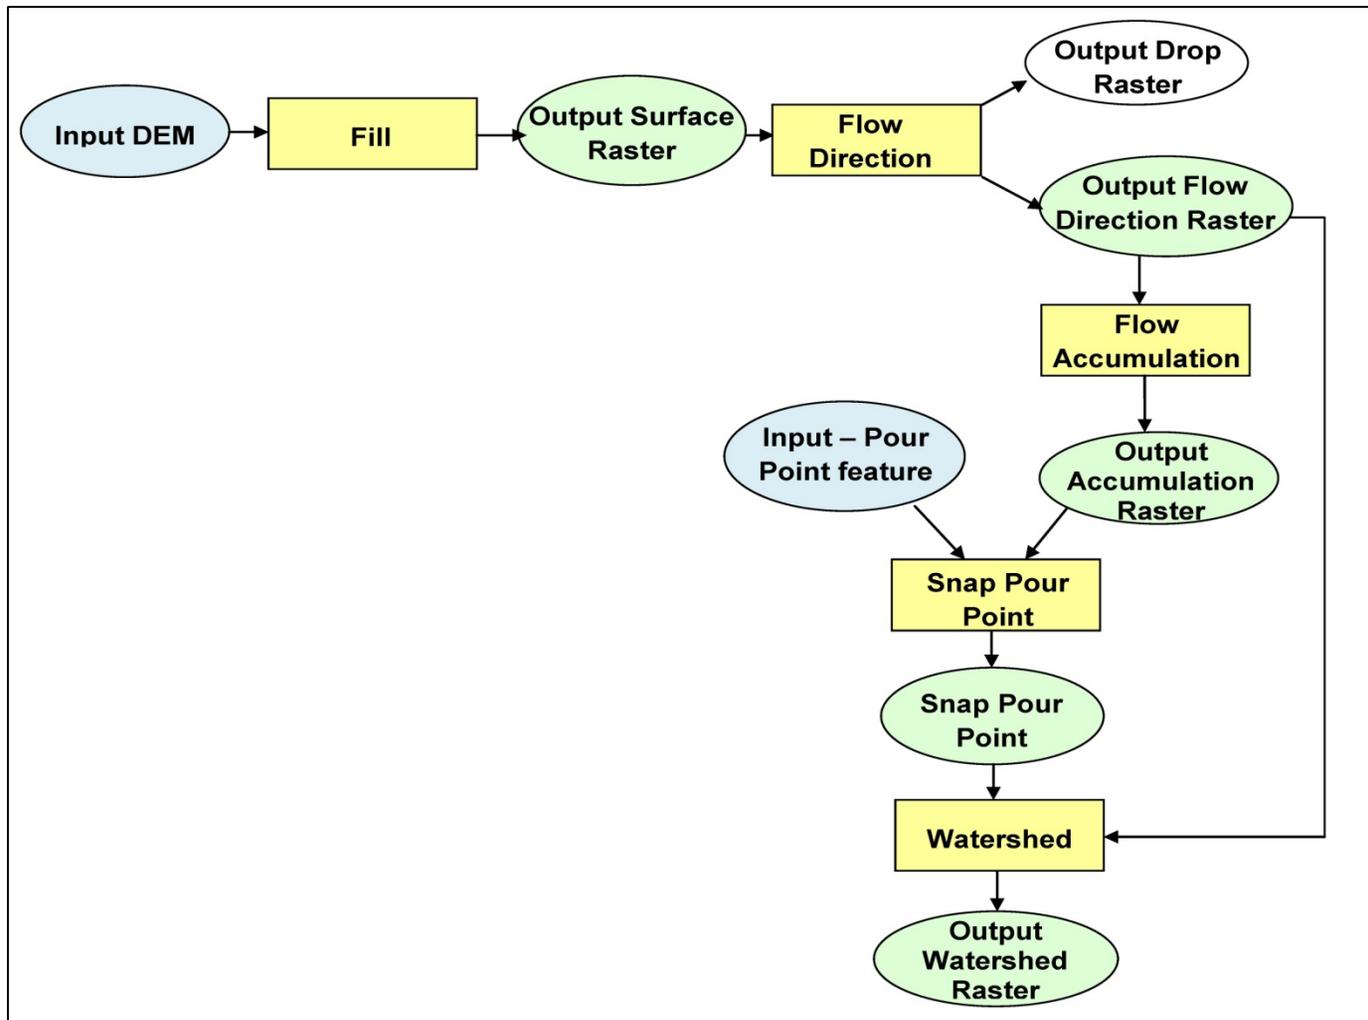
Figure 2-6: The ArcMap 9.3 ModelBuilder process used to create the watershed boundary raster for each watershed using the spatial analyst hydrology toolbox.

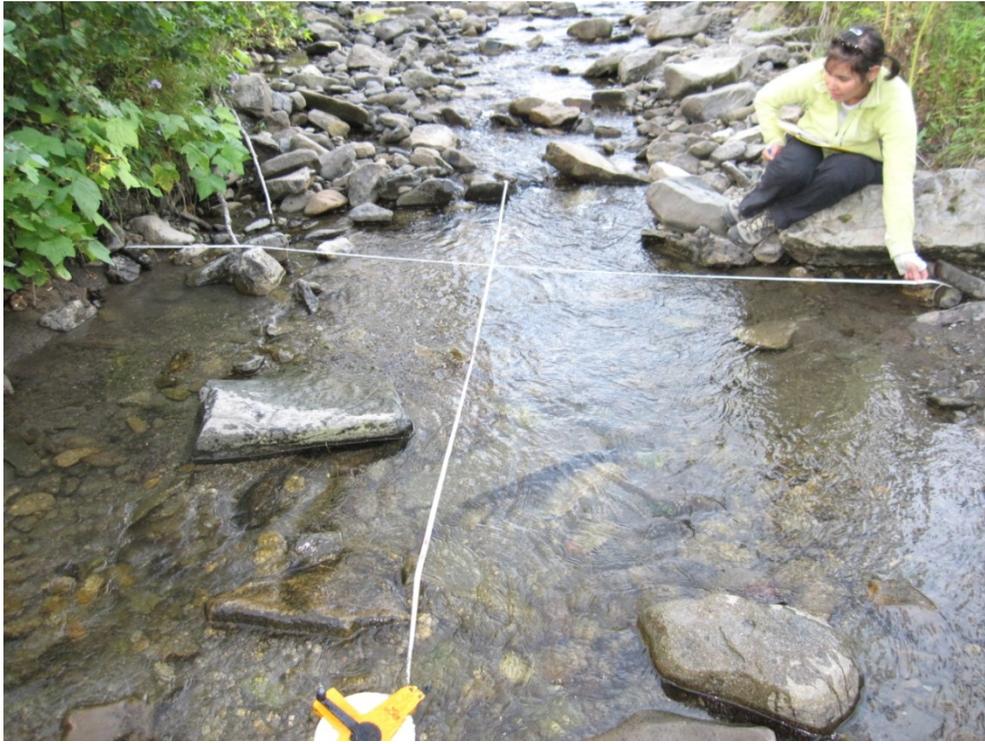
Figure 2-7: Pool analysis field set up according to the methods presented in Hilton and Lisle (1993)

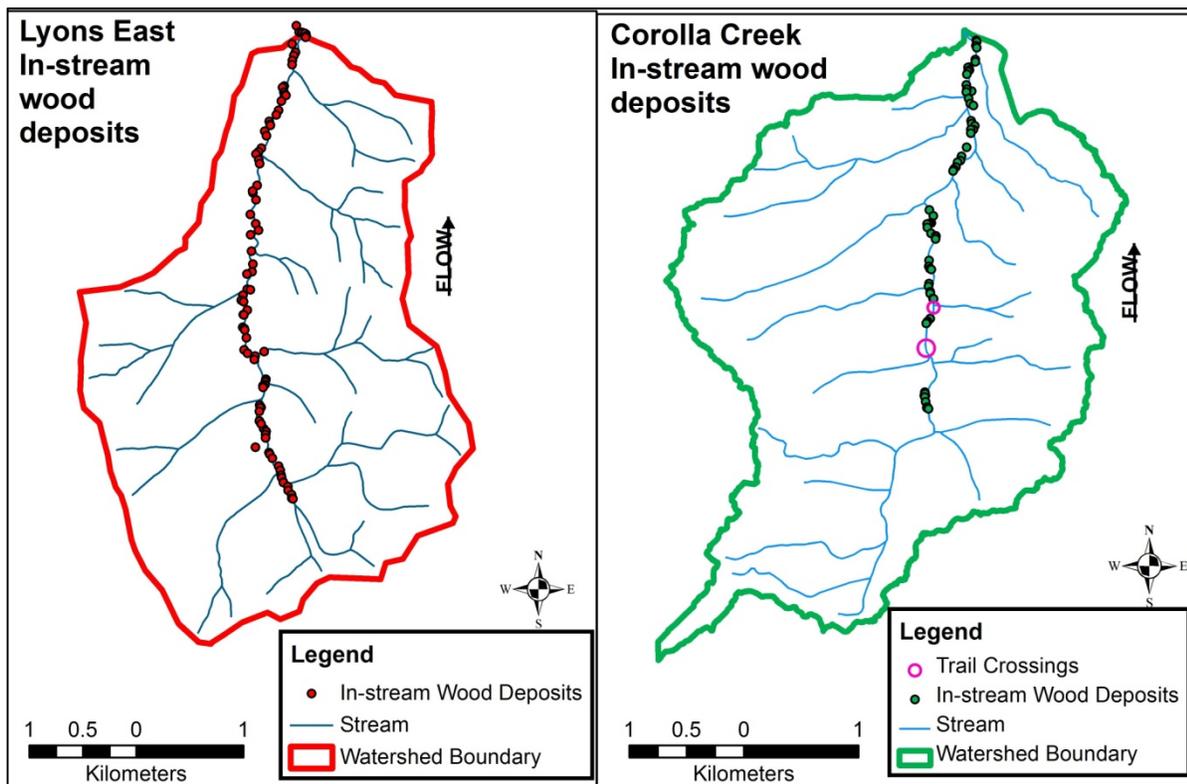
Figure 3-1: Distribution of in-stream wood deposits in Lyons East (left) and Corolla Creek (right). In Corolla Creek, trail crossing buffers are represented by pink circles.

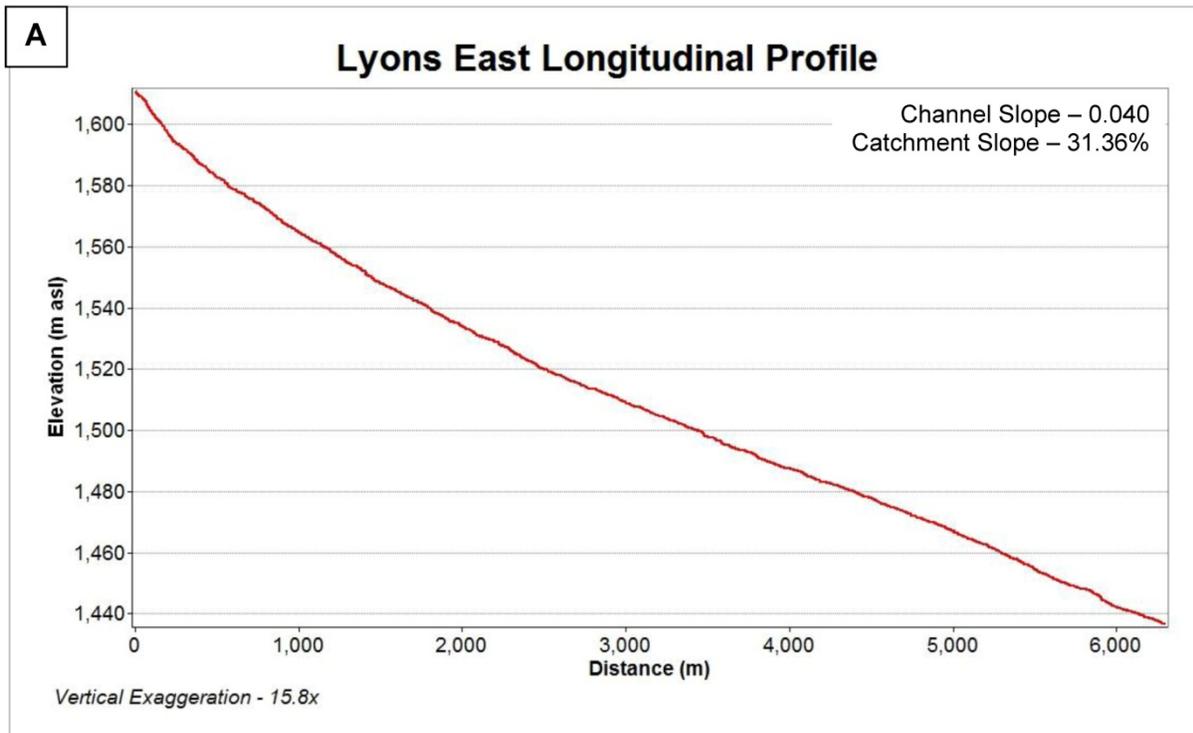
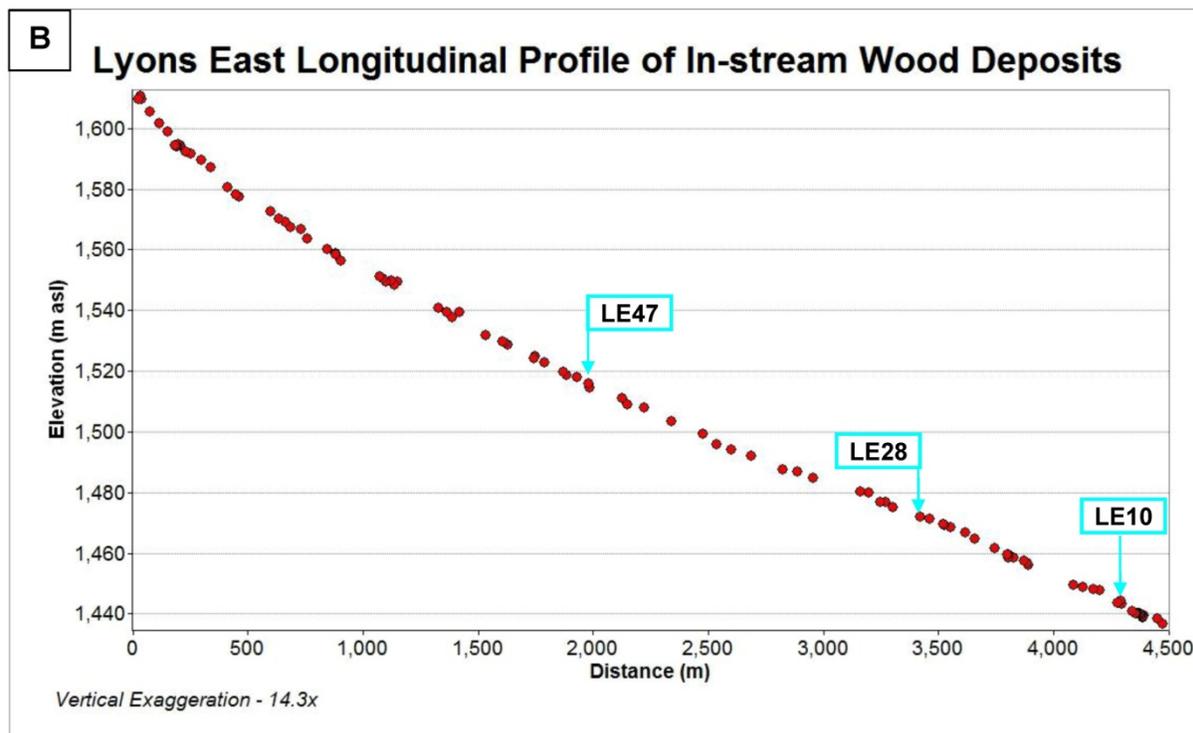
Figure 3-2: Longitudinal profile for Lyons East illustrating the channel main stem (2A) and location of in-stream wood deposits (2B). Note the different vertical exaggerations and x-axis scale.

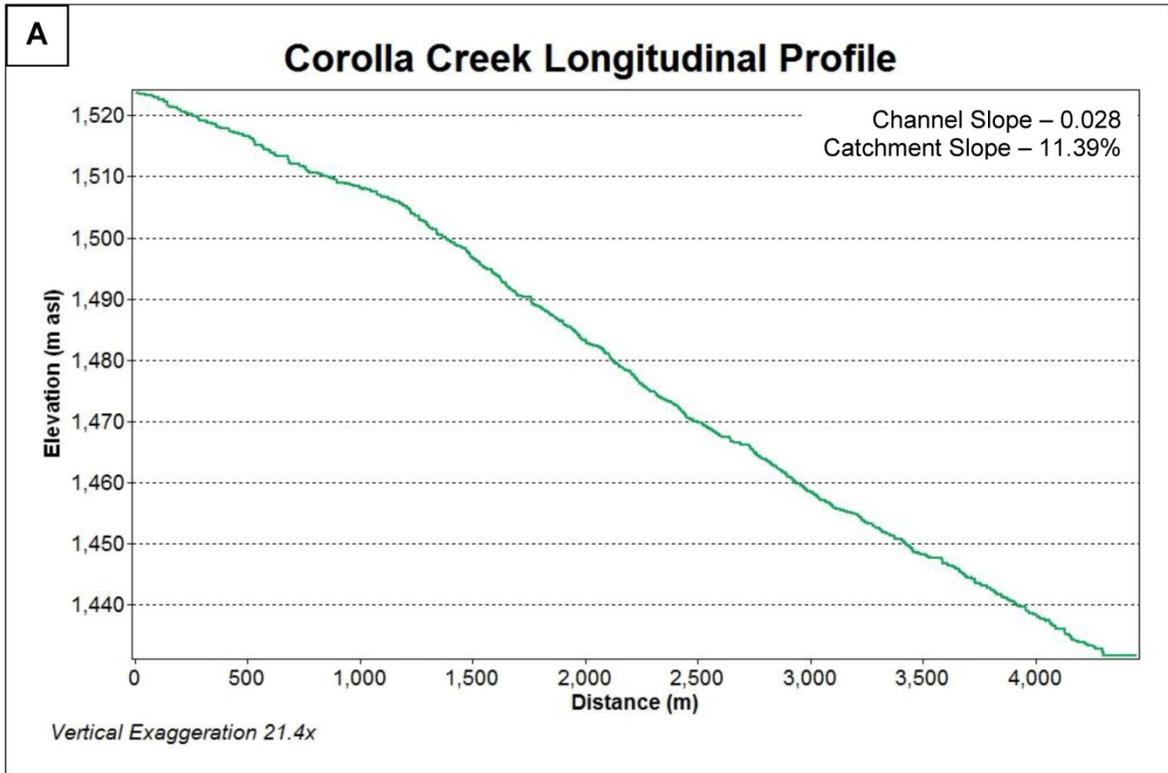
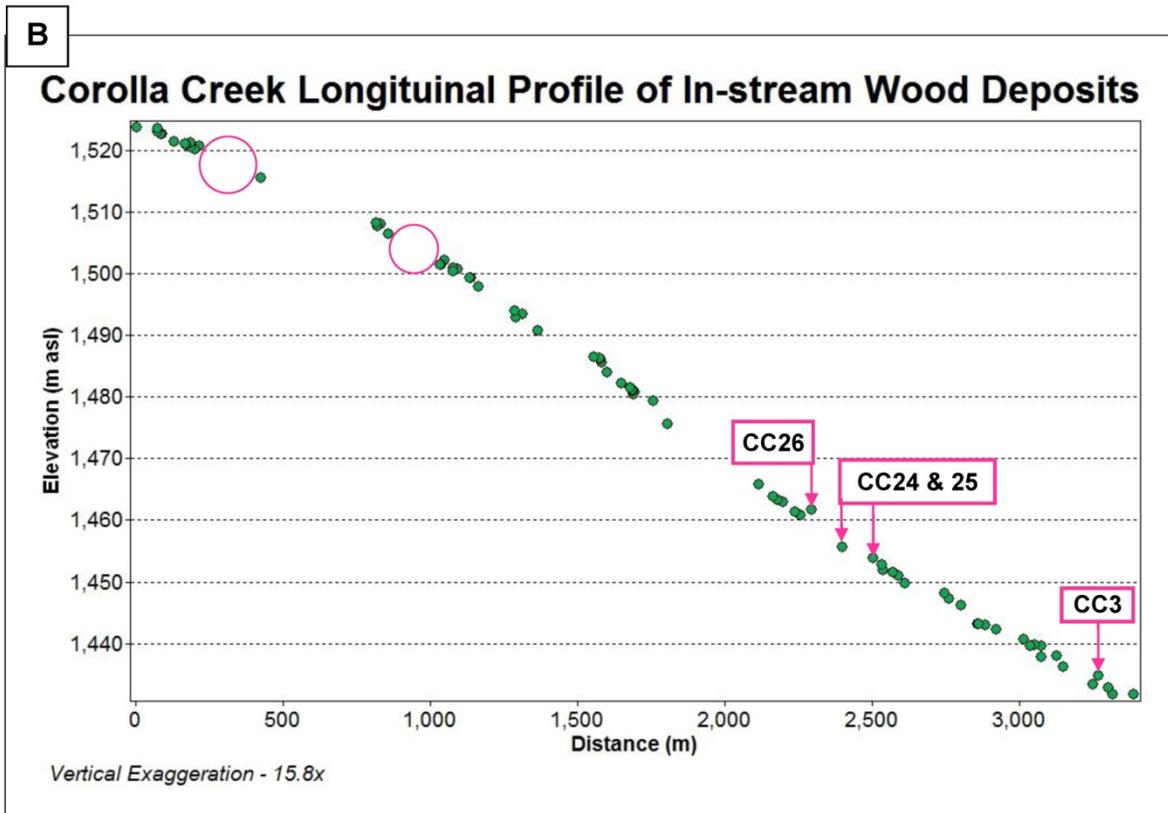
Figure 3-3: Longitudinal profile for Corolla Creek illustrating the channel main stem (3A) and location of in-stream wood deposits (3B). Note the different vertical exaggerations and x-axis scales.

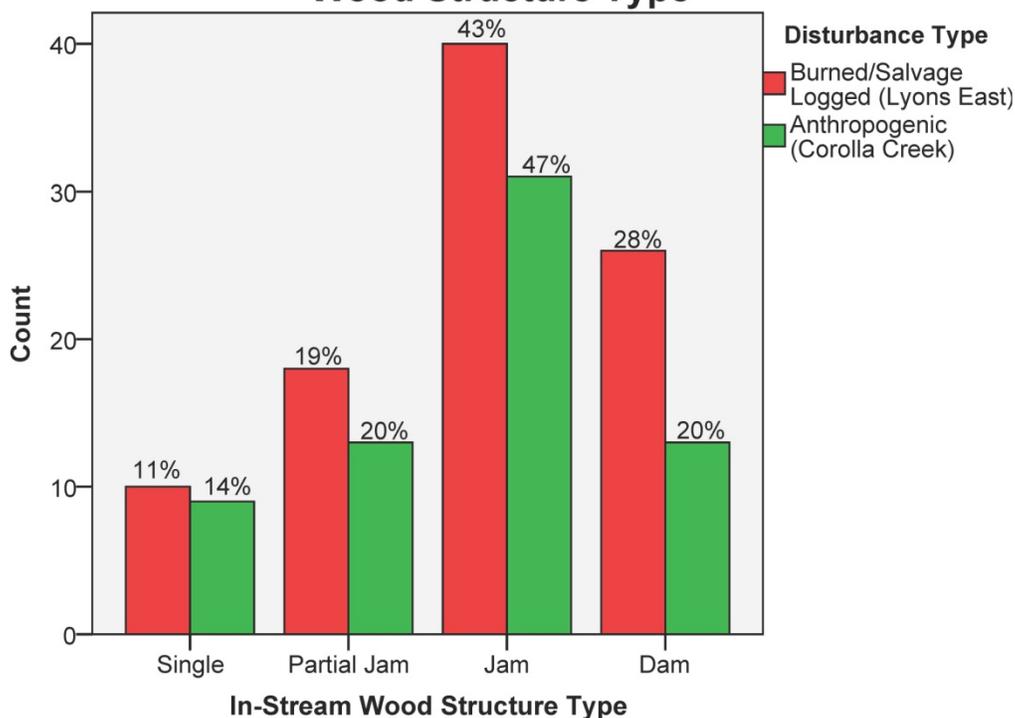
Figure 3-4: The number (and percentage) of in-stream wood structure types found in the two study watersheds.

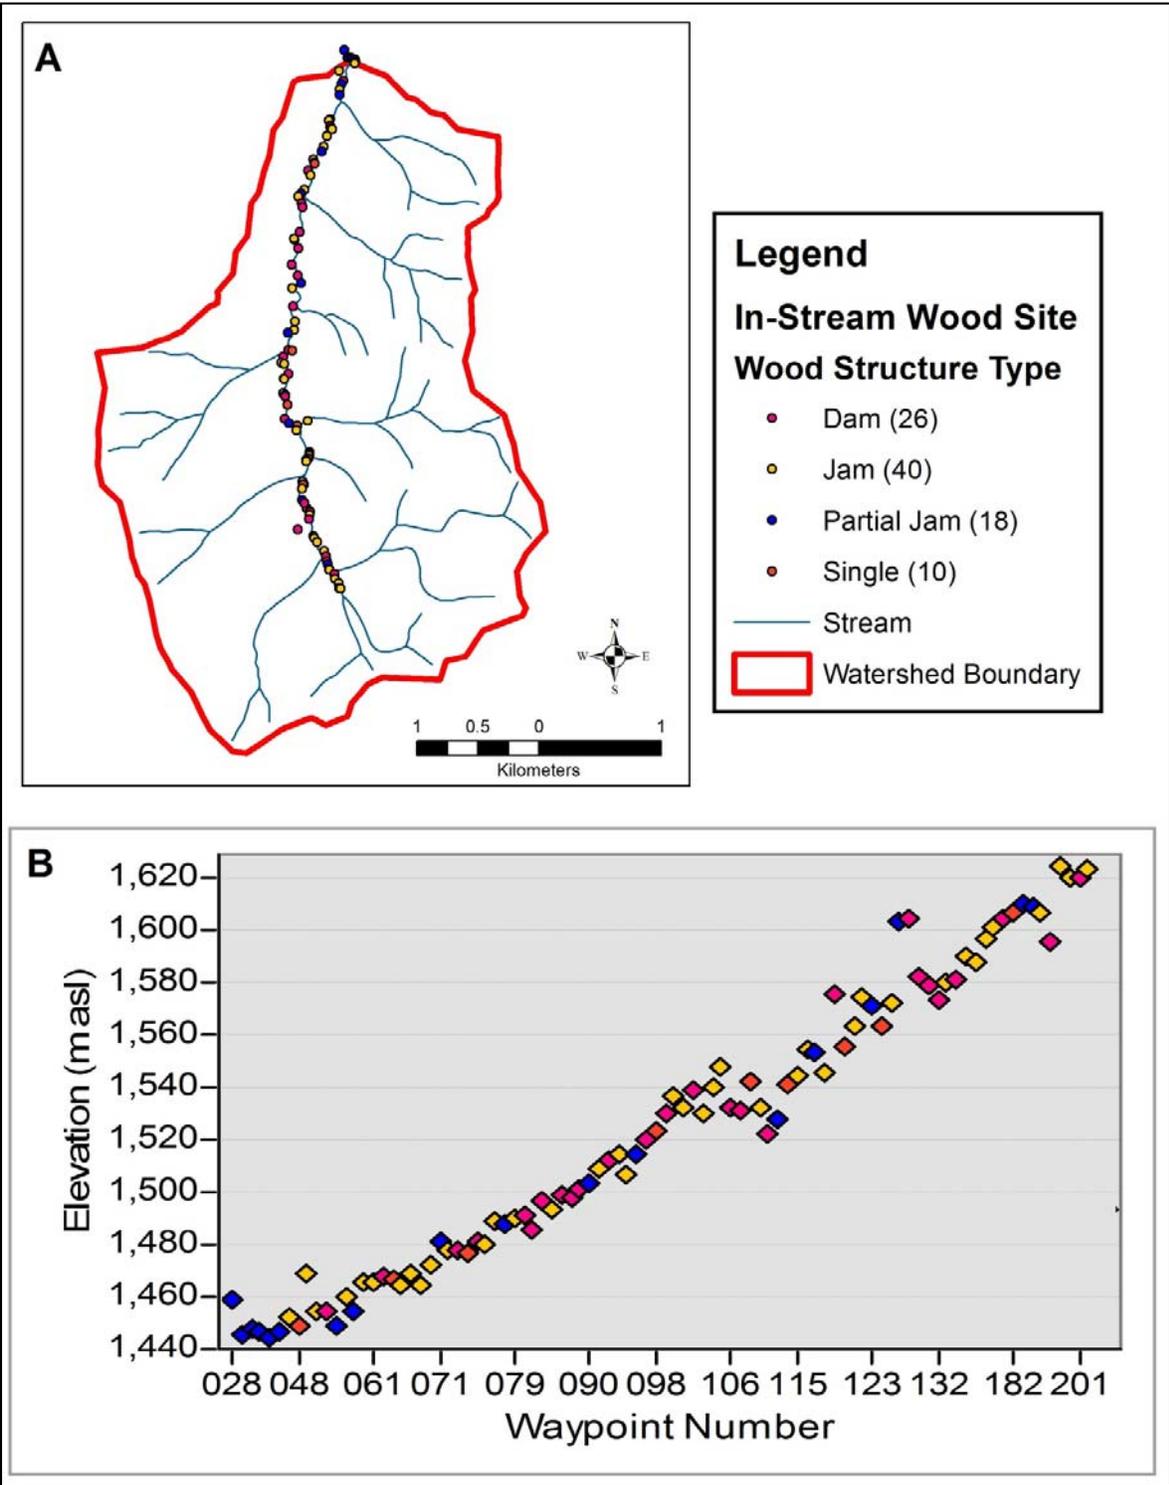
Figure 3-5: Spatial distribution of in-stream wood structure type along the planform (5A) and longitudinal profile (5B) for Lyons East

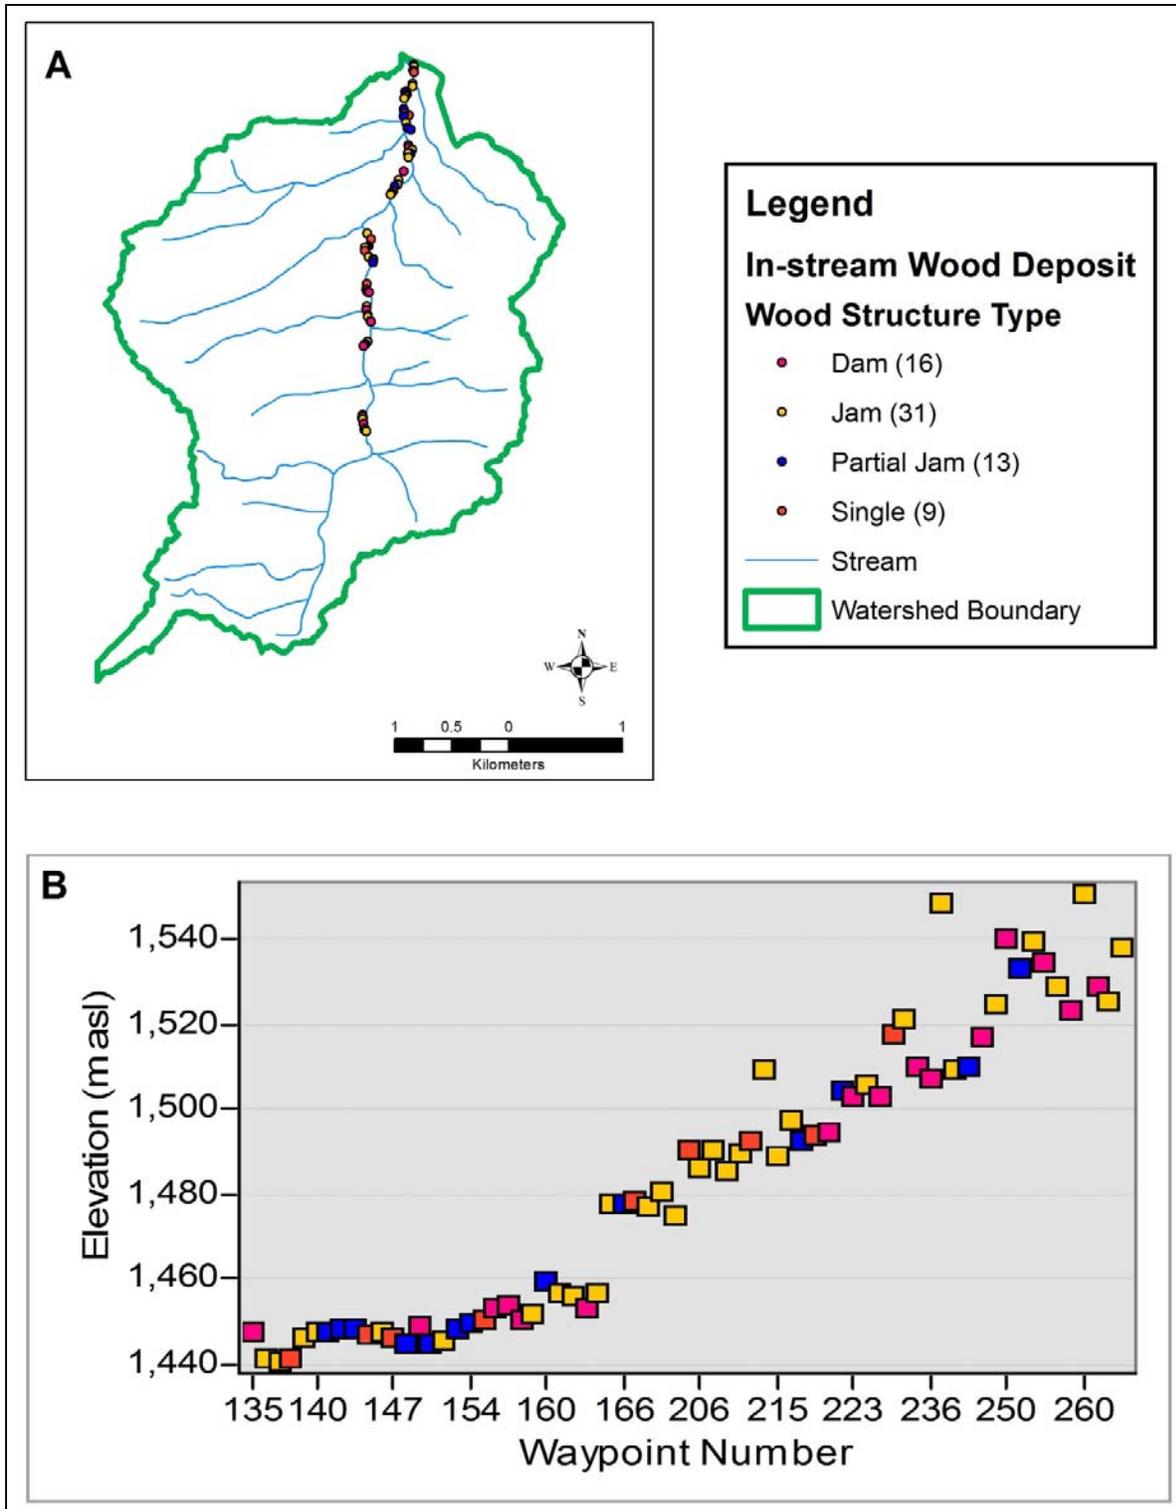
Figure 3-6: Spatial distribution of in-stream wood structure type along the planform (6A) and longitudinal profile (6B) for Corolla Creek

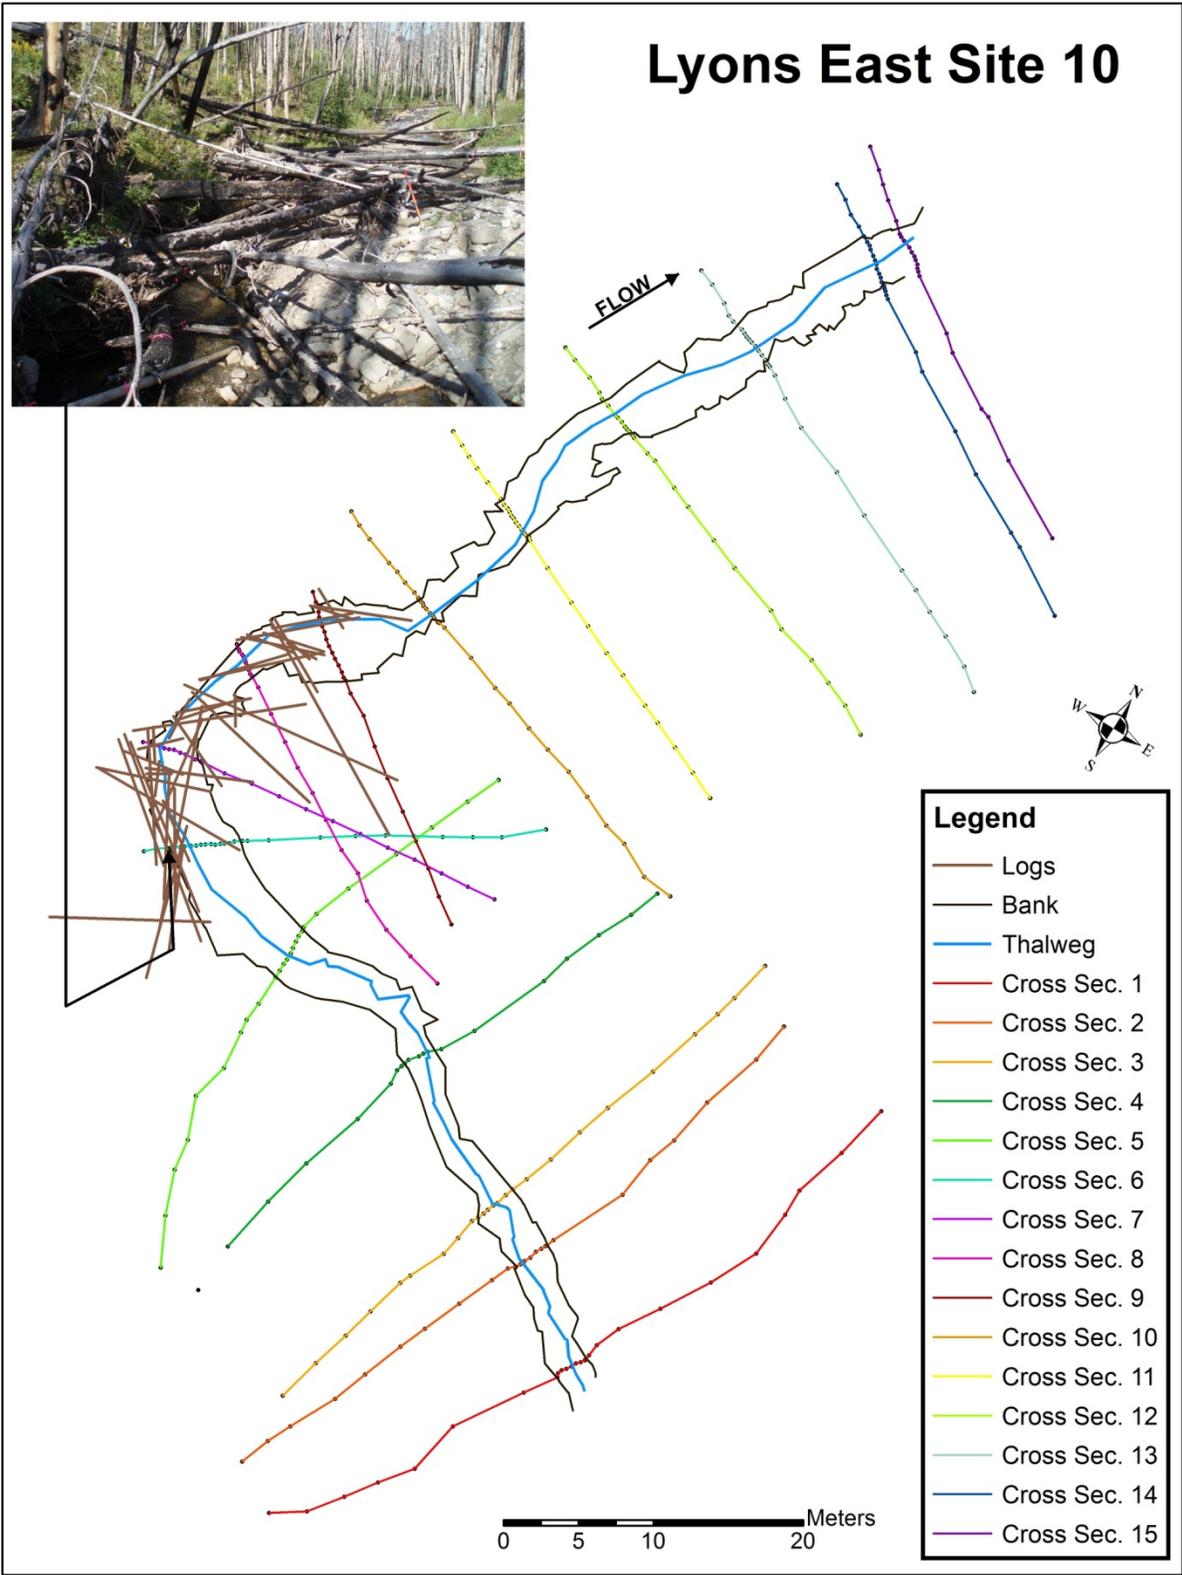
Figure 3-7: Cross sections and in-stream wood structure for site 10 in Lyons East

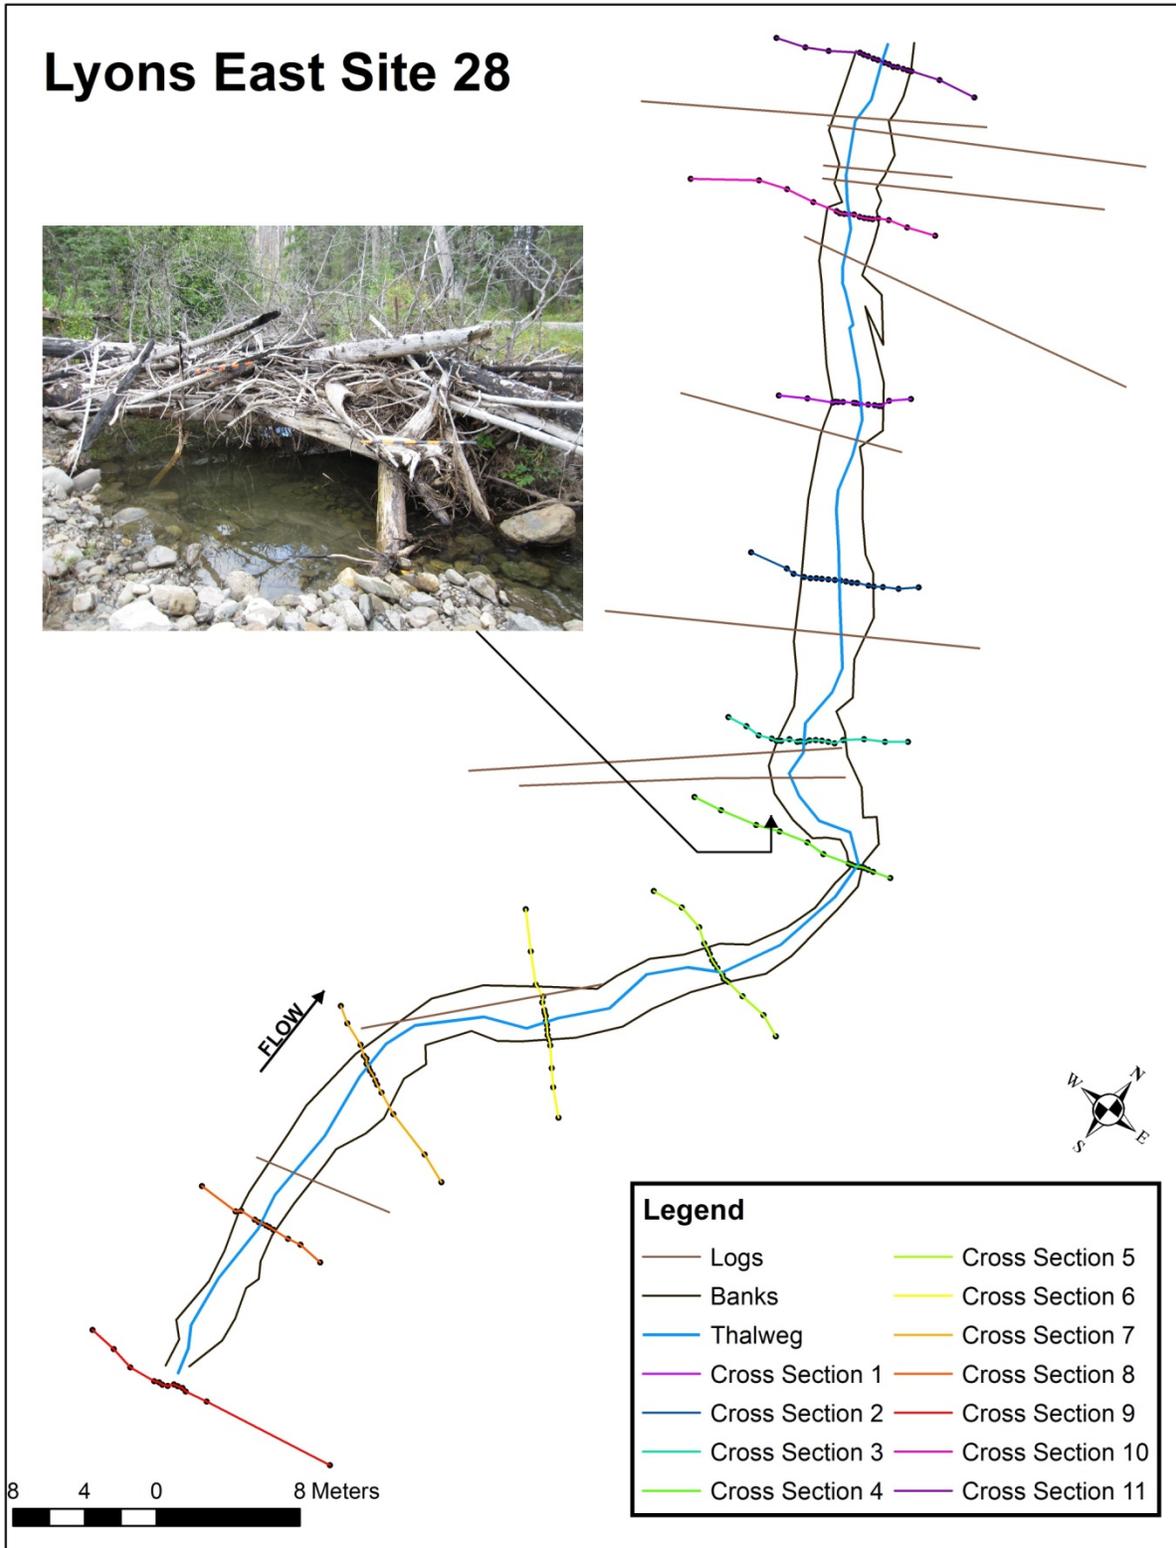
Figure 3-8: Cross sections and in-stream wood structure for site 28 in Lyons East
