The effect of in-stream wood on channel
morphology and sediment deposition in
headwater streams of the Oldman River
Basin, Alberta

A thesis
presented to the University of Waterloo
in fulfillment of the
thesis requirement for the degree of
Master of Environmental Studies
in
Planning

Waterloo, Ontario, Canada, 2012

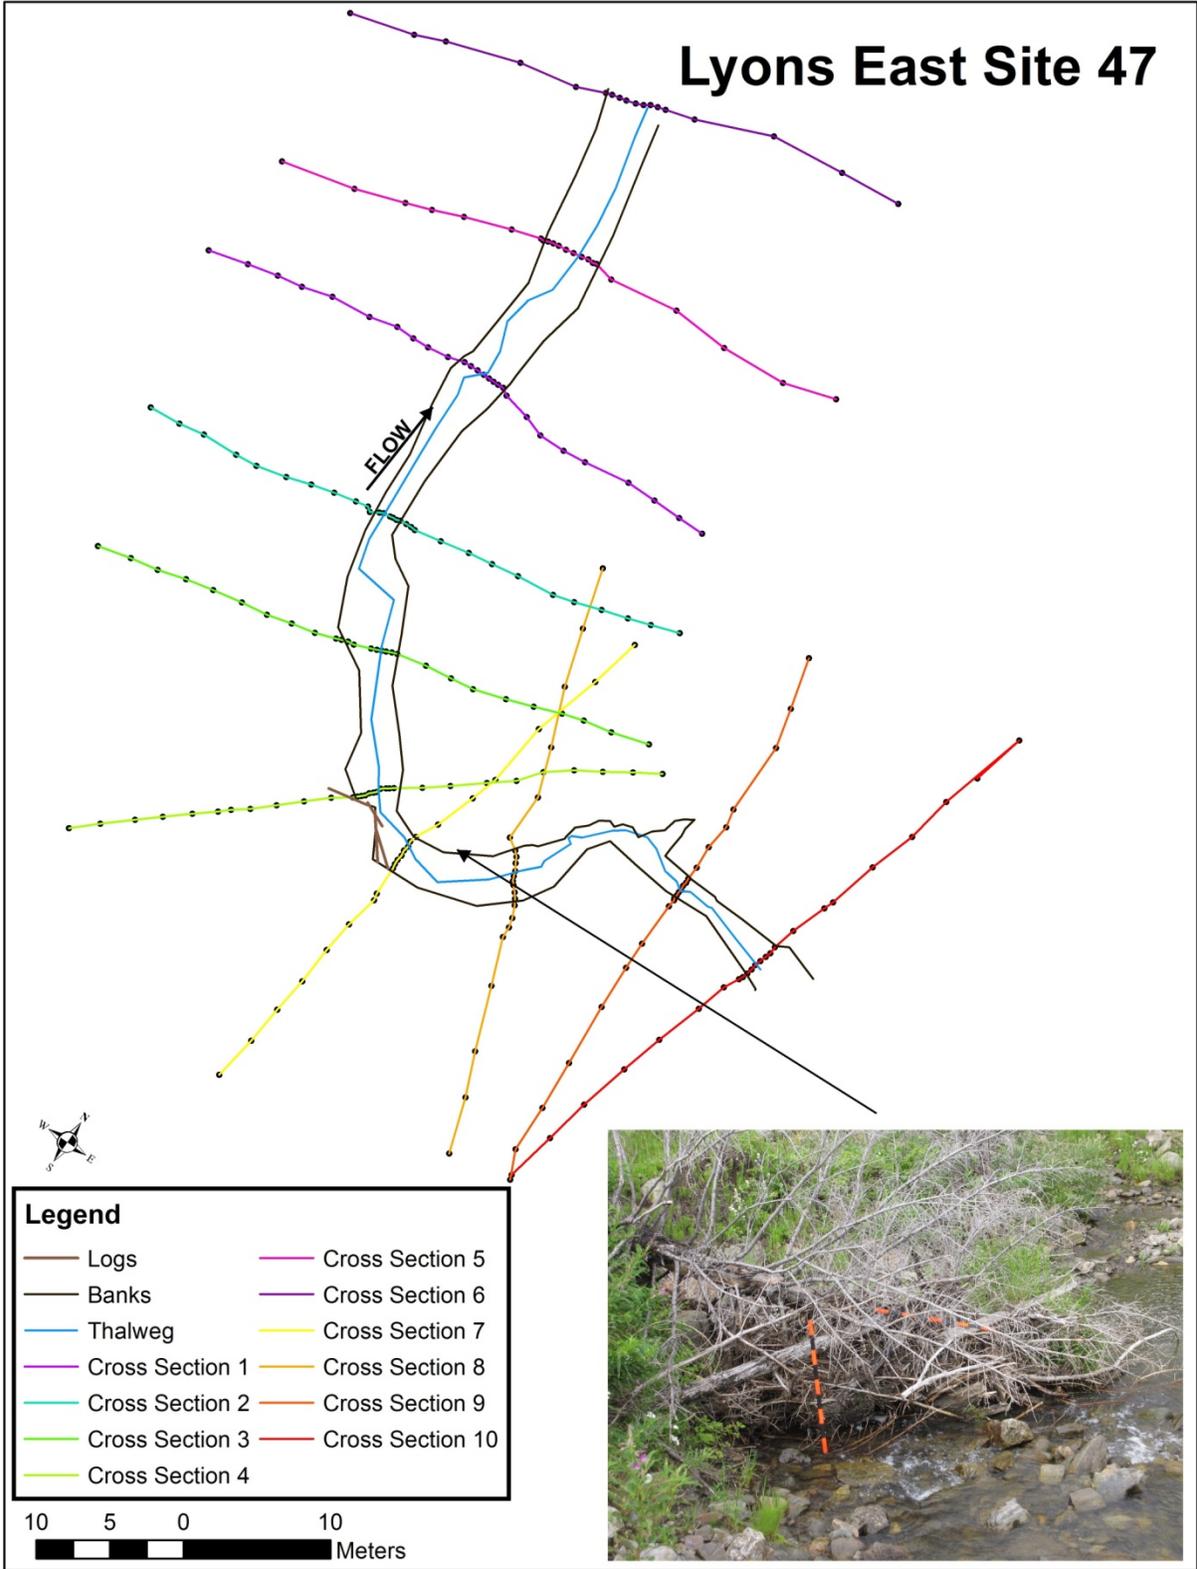
Figure 3-9: Cross sections and in-stream wood structure for site 47 in Lyons East

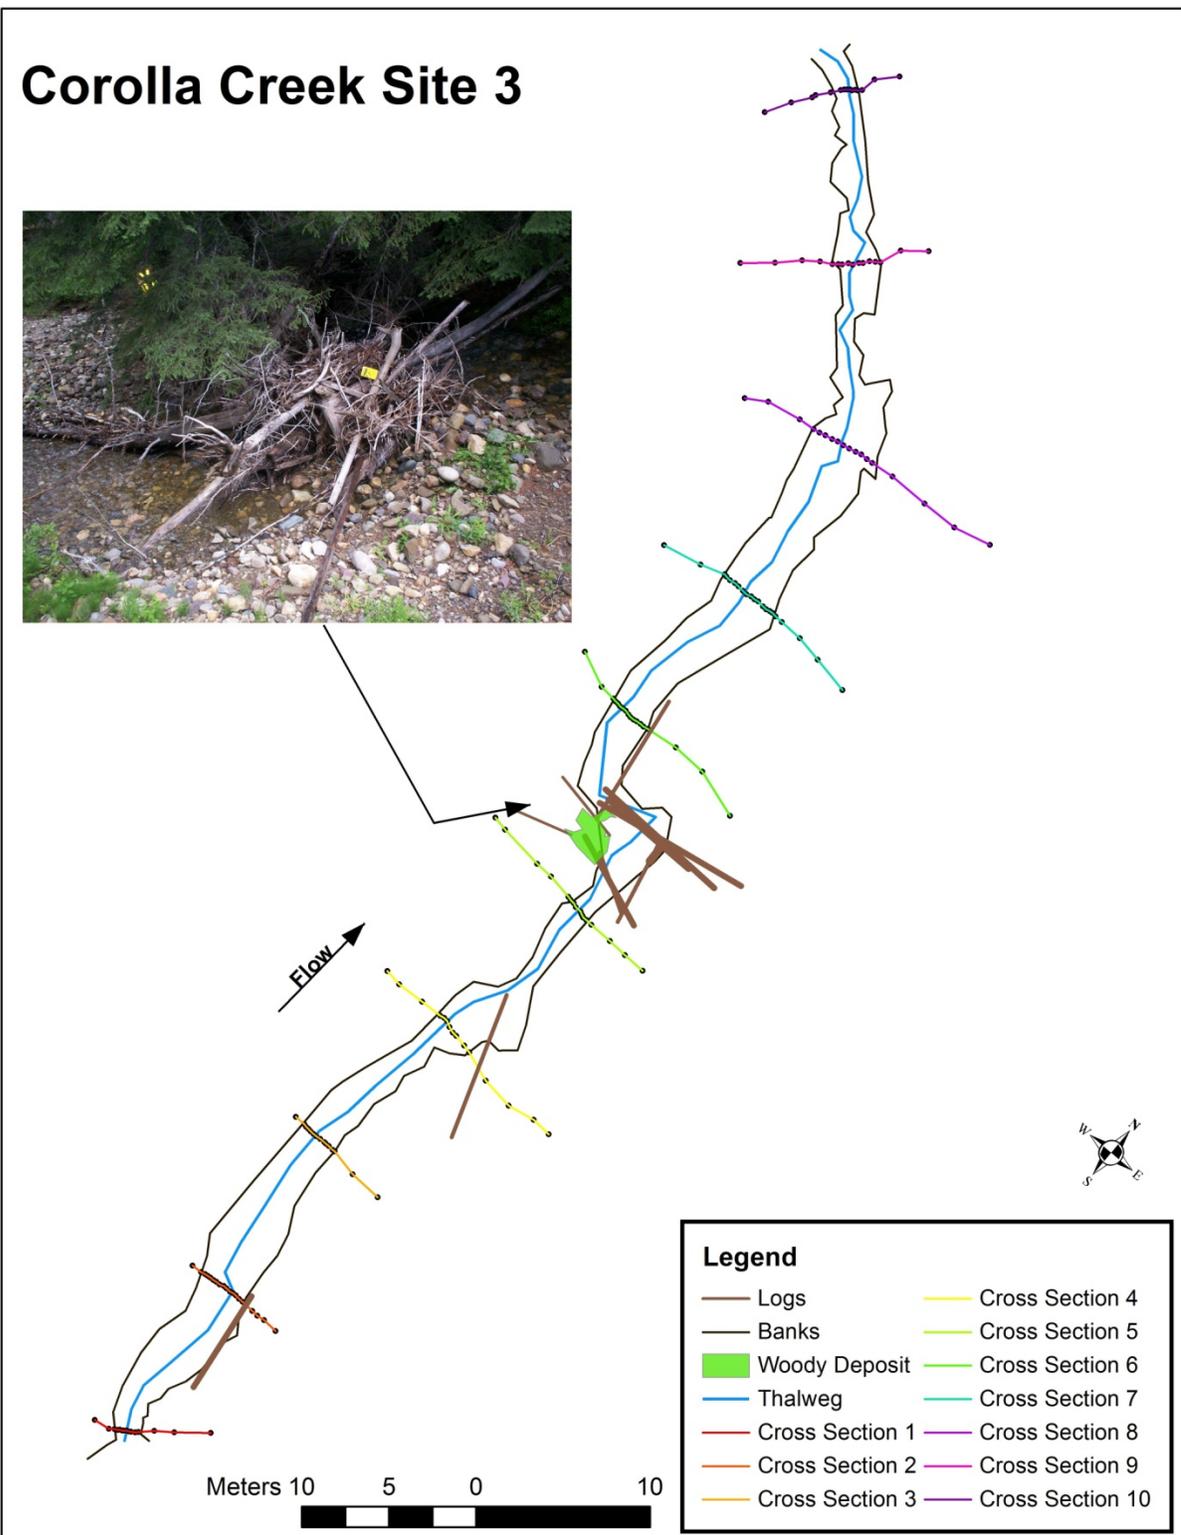
Figure 3-10: Cross Section and in-stream wood structure for site 3 in Corolla Creek

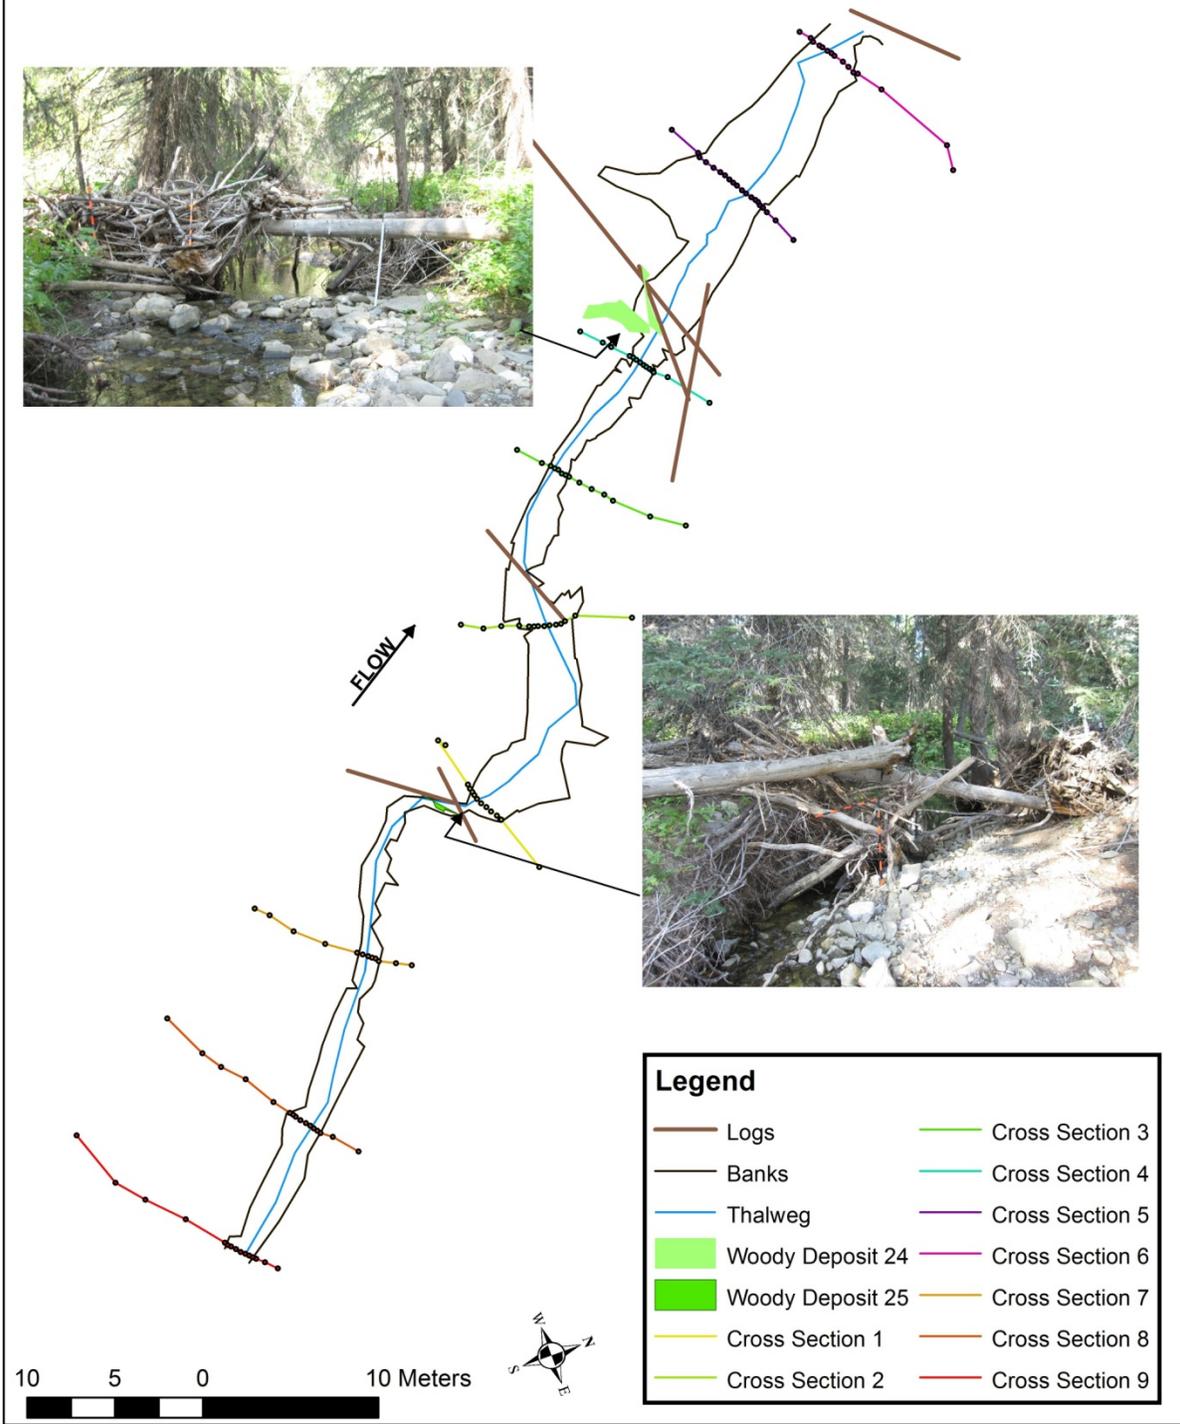
Figure 3-11: Cross sections and in-stream wood structure for sites 24 and 25 in Corolla Creek

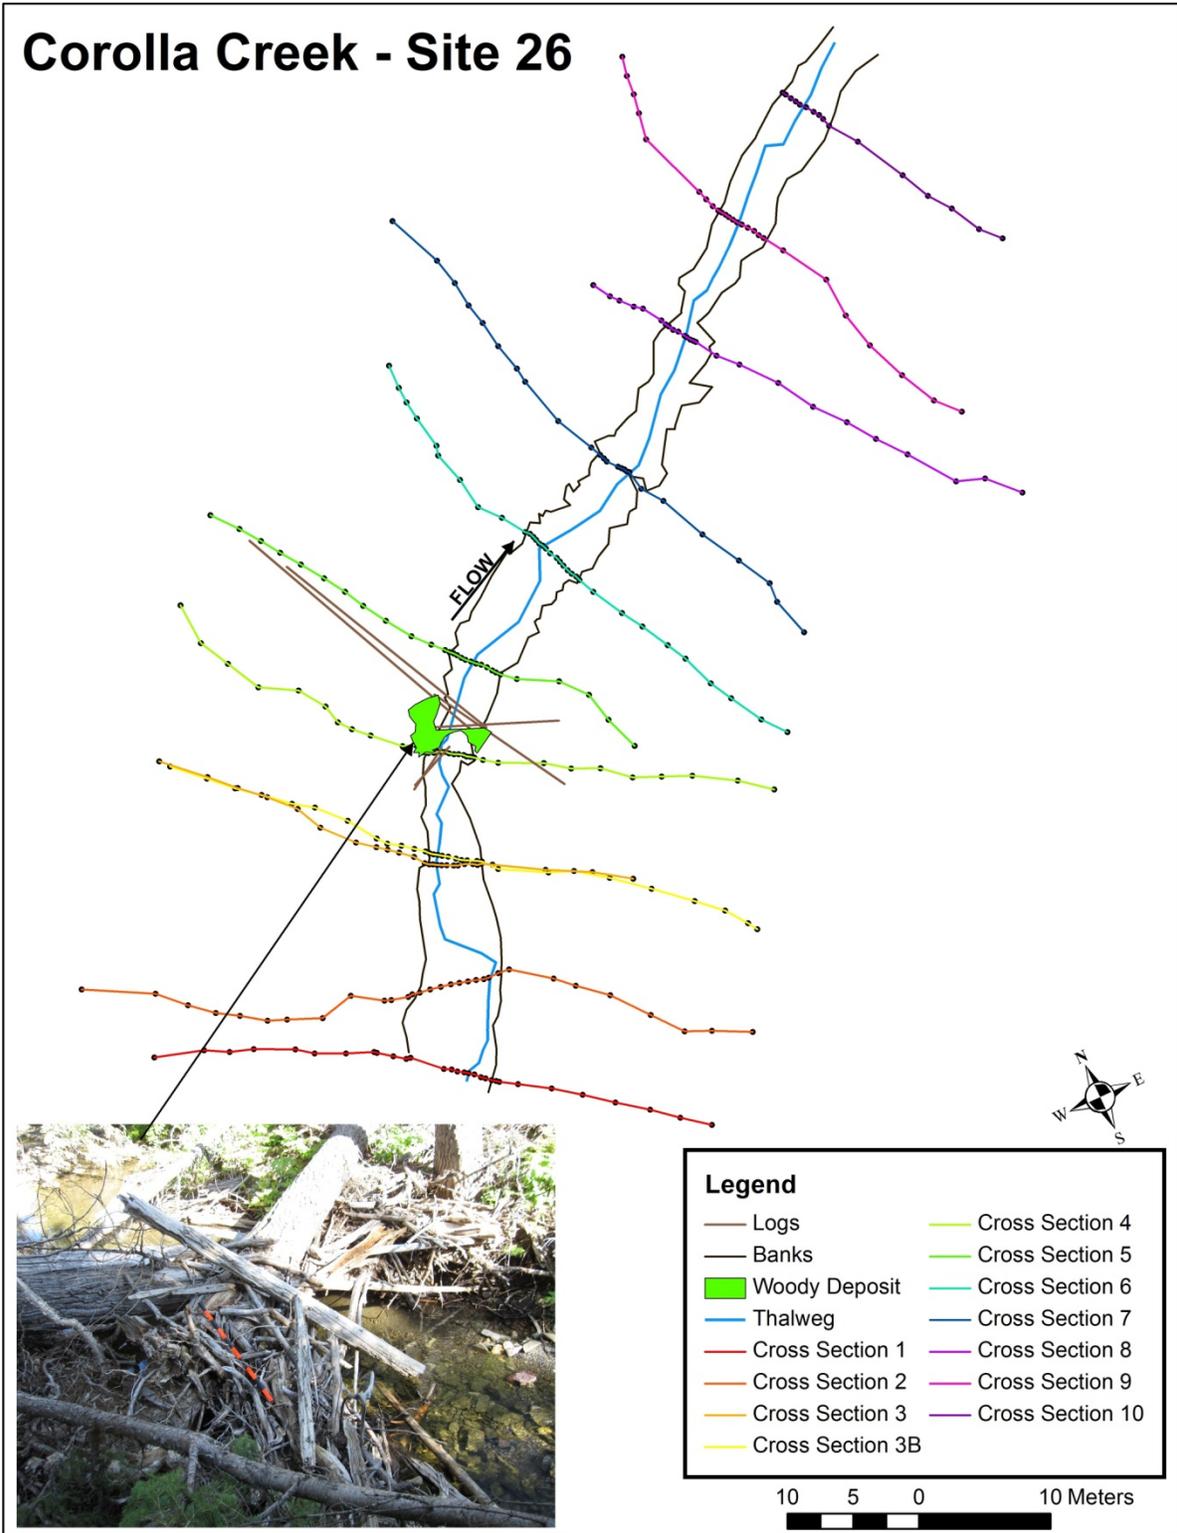
Figure 3-12: Cross sections and in-stream wood structure for site 26 in Corolla Creek

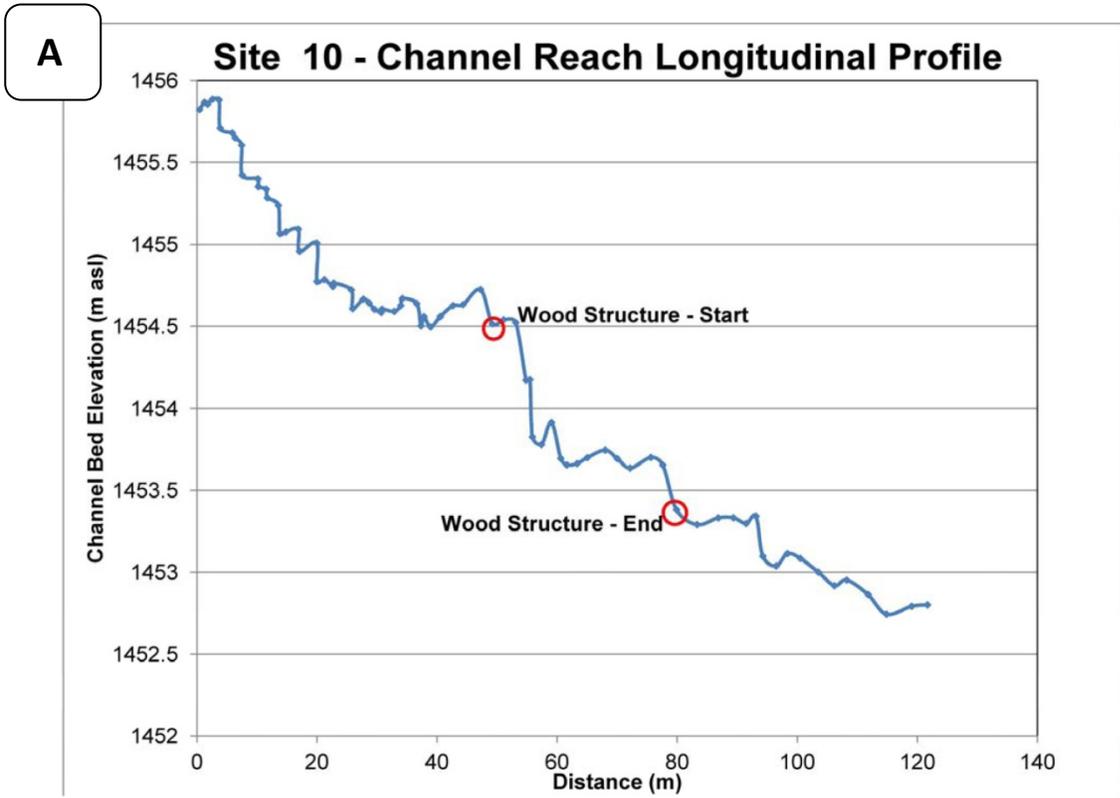
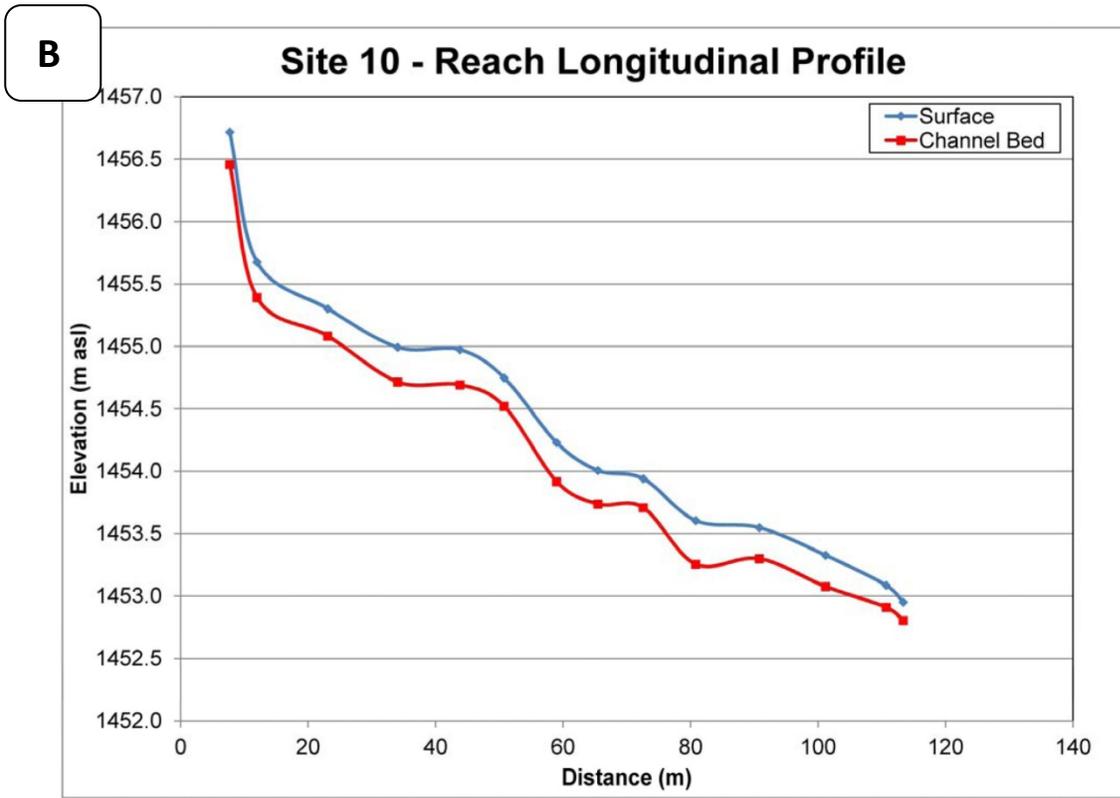
Figure 3-13: Longitudinal profile of channel bed for Lyons East site 10 with a vertical exaggeration of 26.7x (A). Water surface profile for Lyons East site 10 with a vertical exaggeration of 27.1x (B).

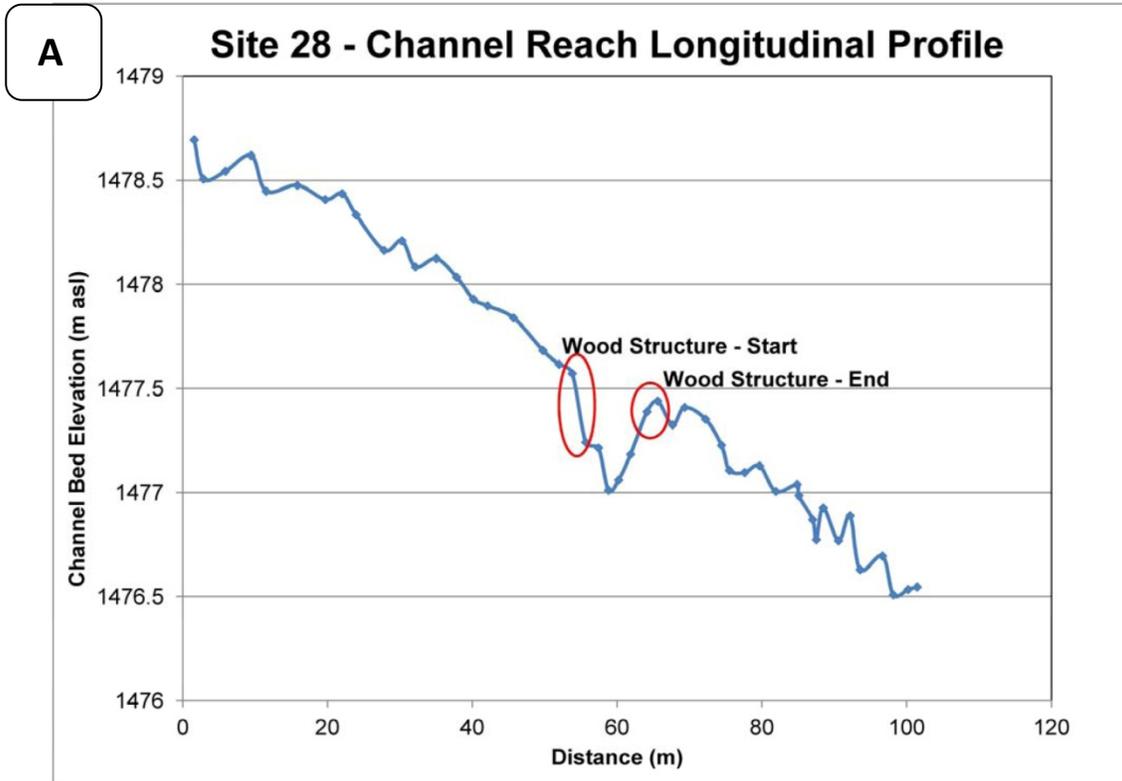
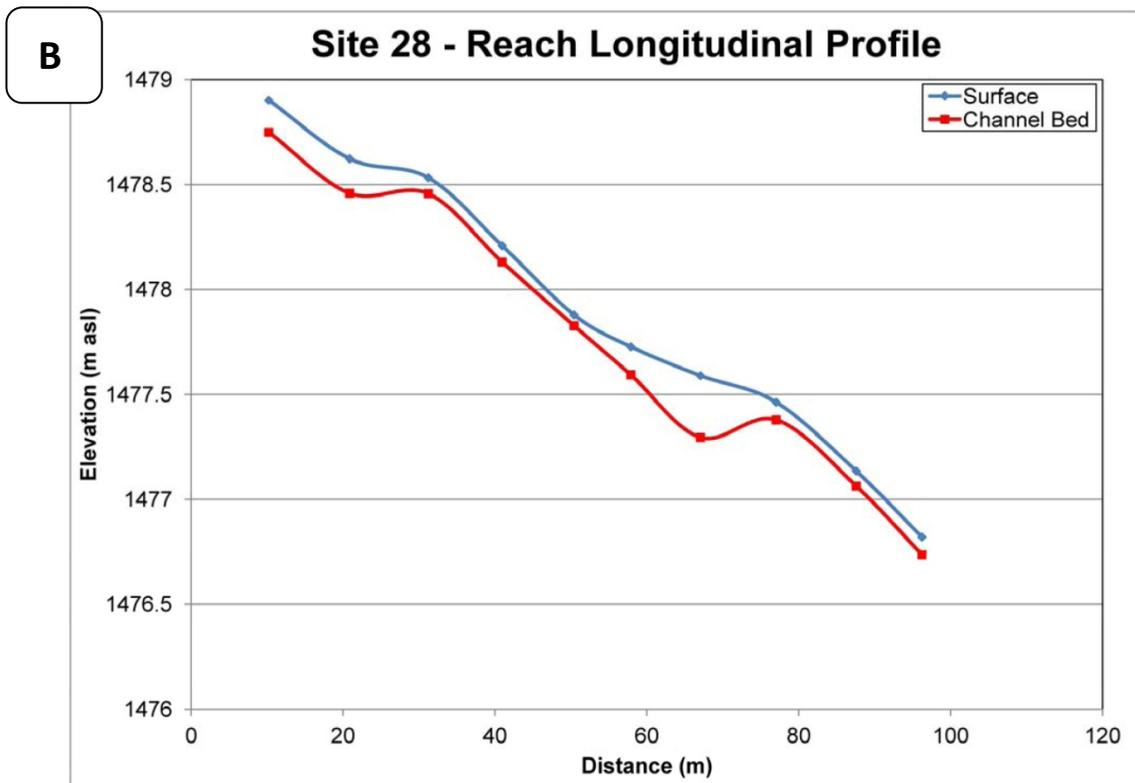
Figure 3-14: Longitudinal profile of channel bed for Lyons East site 28 with a vertical exaggeration of 29.2x (A). Water surface profile for Lyons East site 28 with a vertical exaggeration of 27.5x (B).

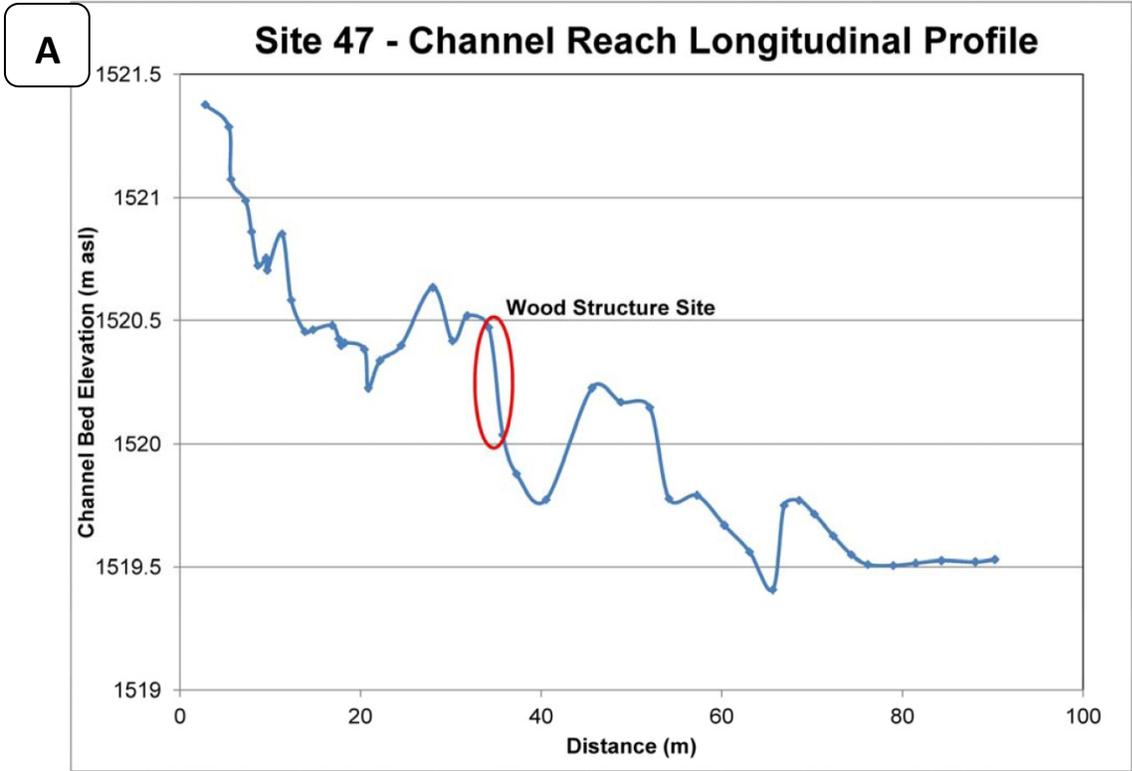
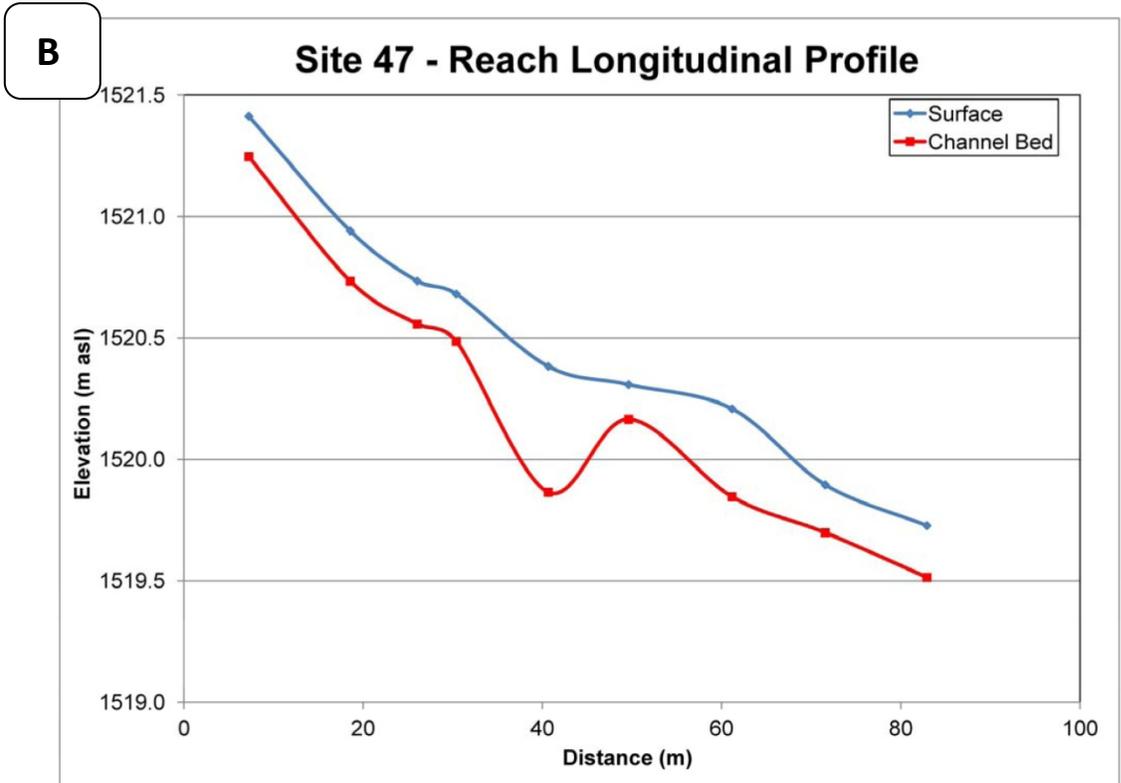
Figure 3-15: Longitudinal profile of channel bed for Lyons East site 47 with a vertical exaggeration of 27x (A). Water surface profile for Lyons East site 47 with a vertical exaggeration of 27x (B).

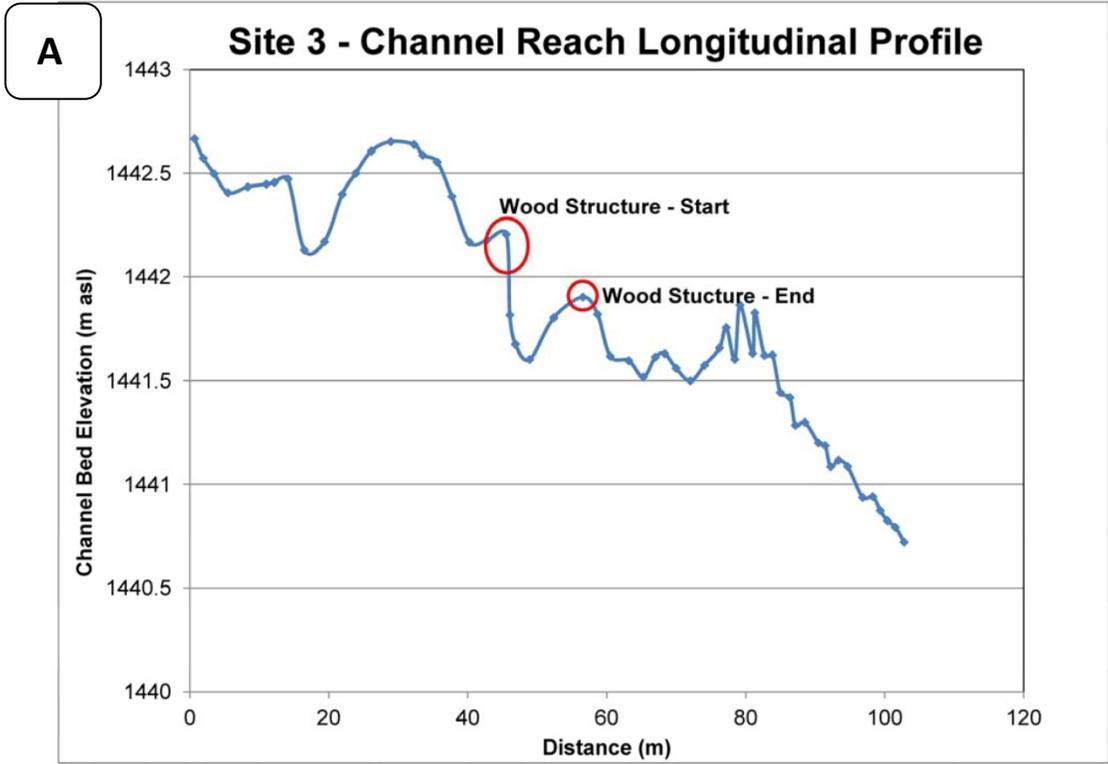
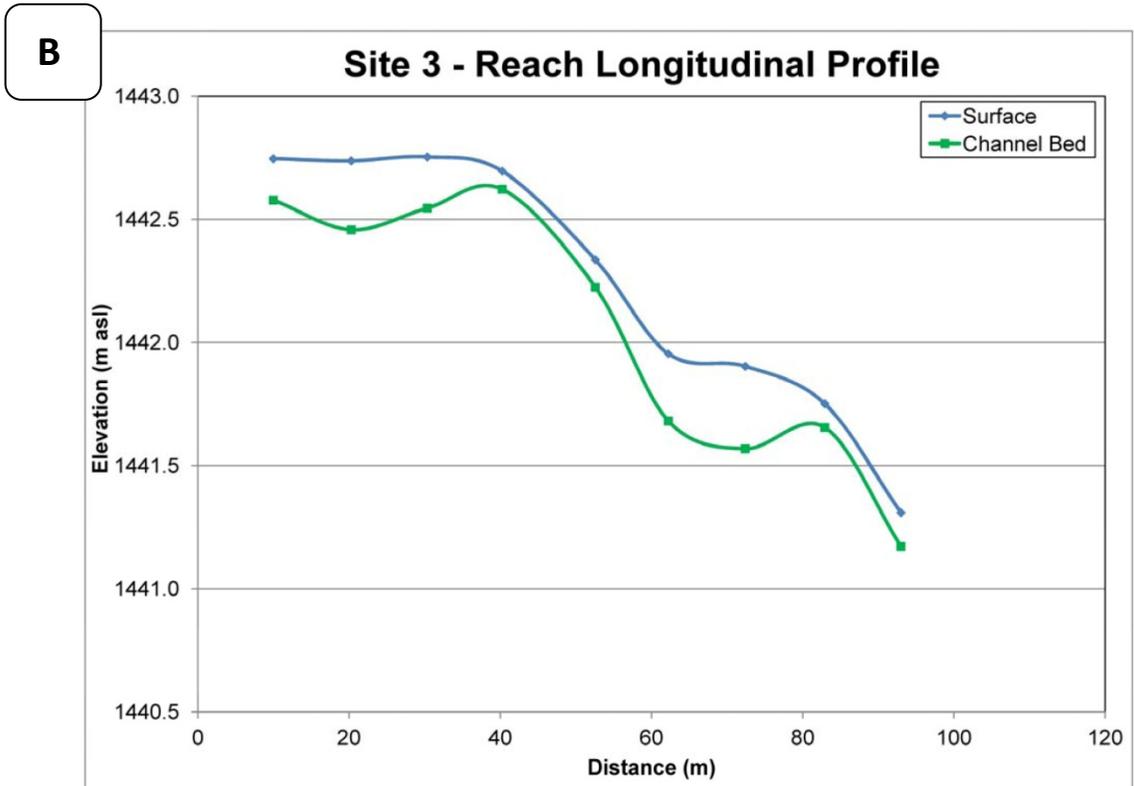
Figure 3-16: Longitudinal Profile of channel bed for Corolla Creek site 3 with a vertical exaggeration 29.7x (A). Water surface profile for Corolla Creek site 3 with a vertical exaggeration 30.1x (B).

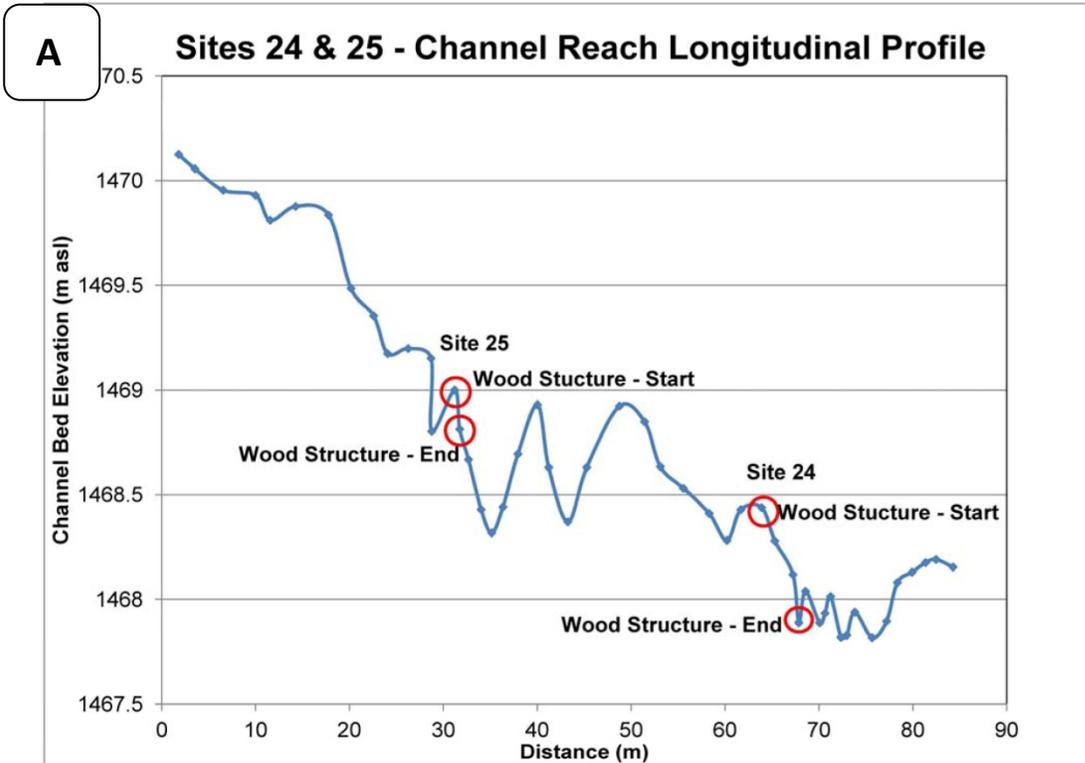
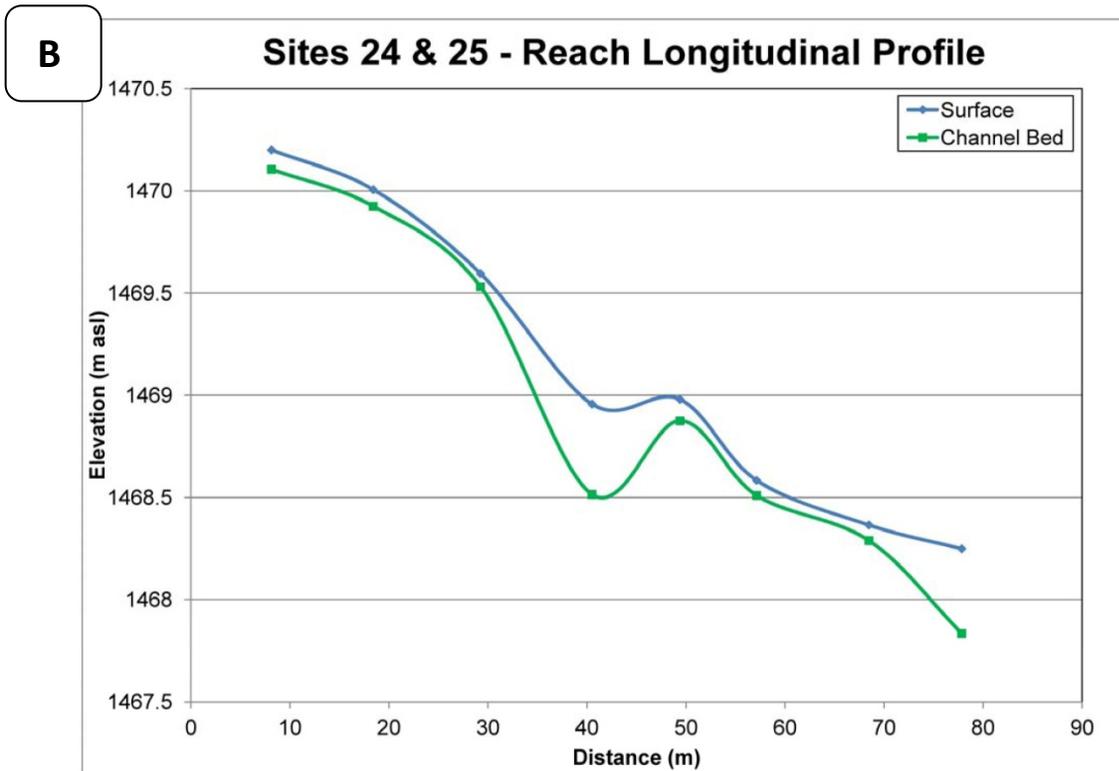
Figure 3-17: Longitudinal profile of channel bed for Corolla Creek sites 24 & 25 with a vertical exaggeration of 21.9x (A). Water surface profile for Corolla Creek sites 24 & 25 with a vertical exaggeration of 20.0x (B).

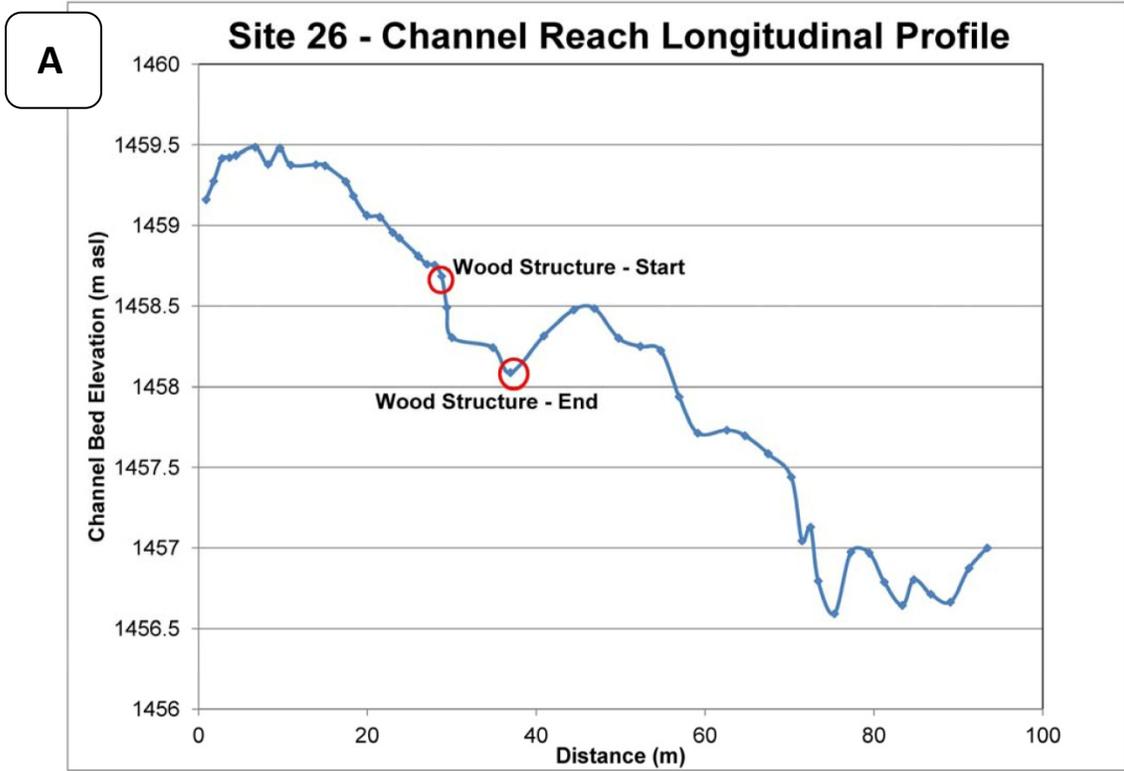
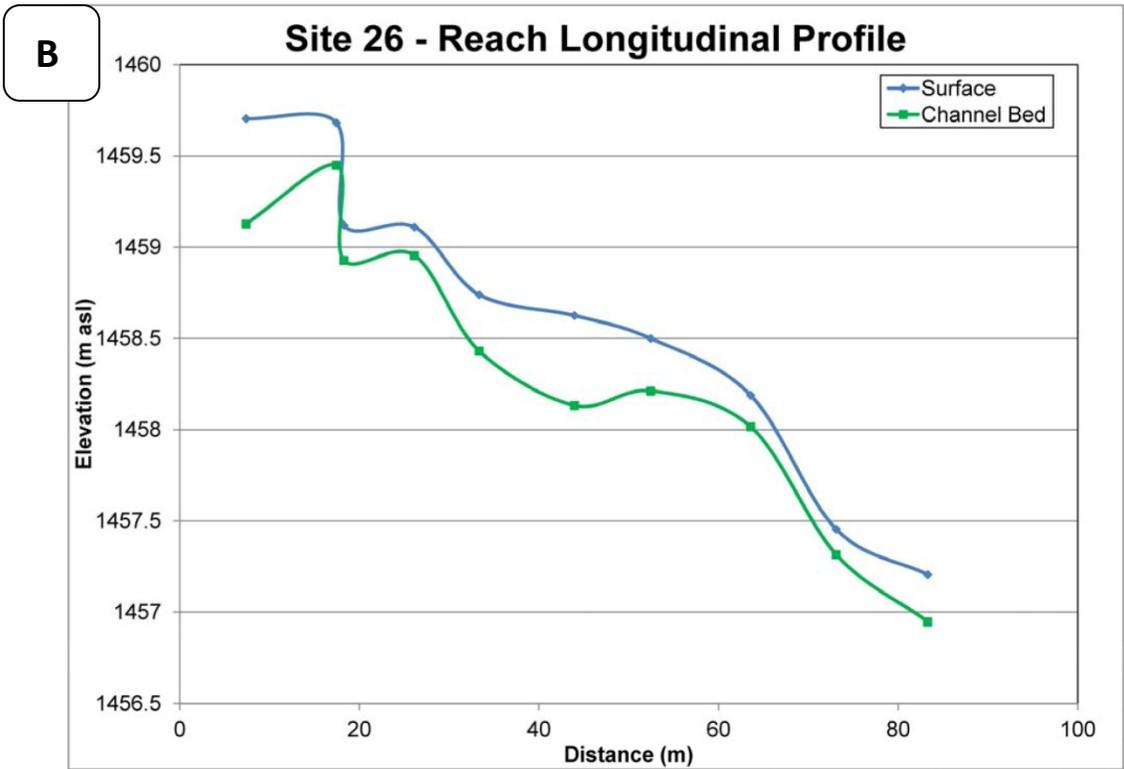
Figure 3-18: Longitudinal profile of channel bed for Corolla Creek site 26 with a vertical exaggeration of 18.9x (A). Water surface profile for Corolla Creek site 26 with a vertical exaggeration of 20.5x (B).

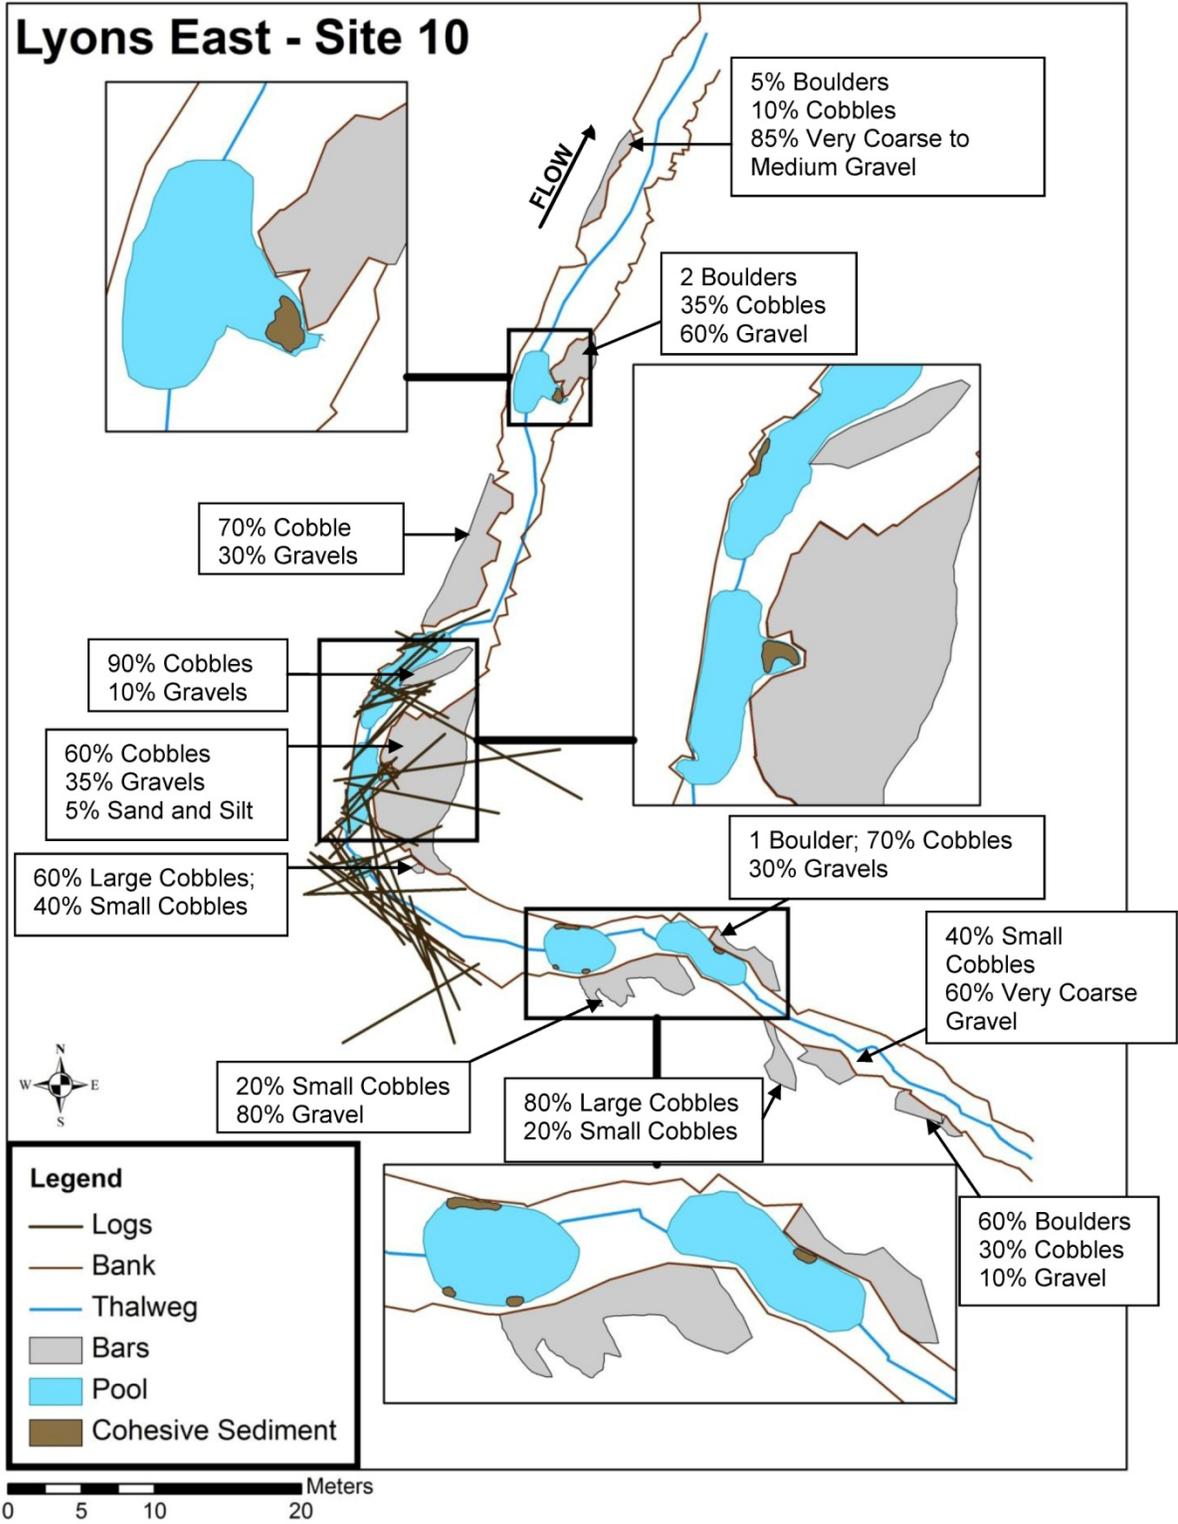
Figure 3-19: Stream reach morphology characteristics, in particular bar and pool formations in relation to in-stream wood deposit for Lyons East site 10

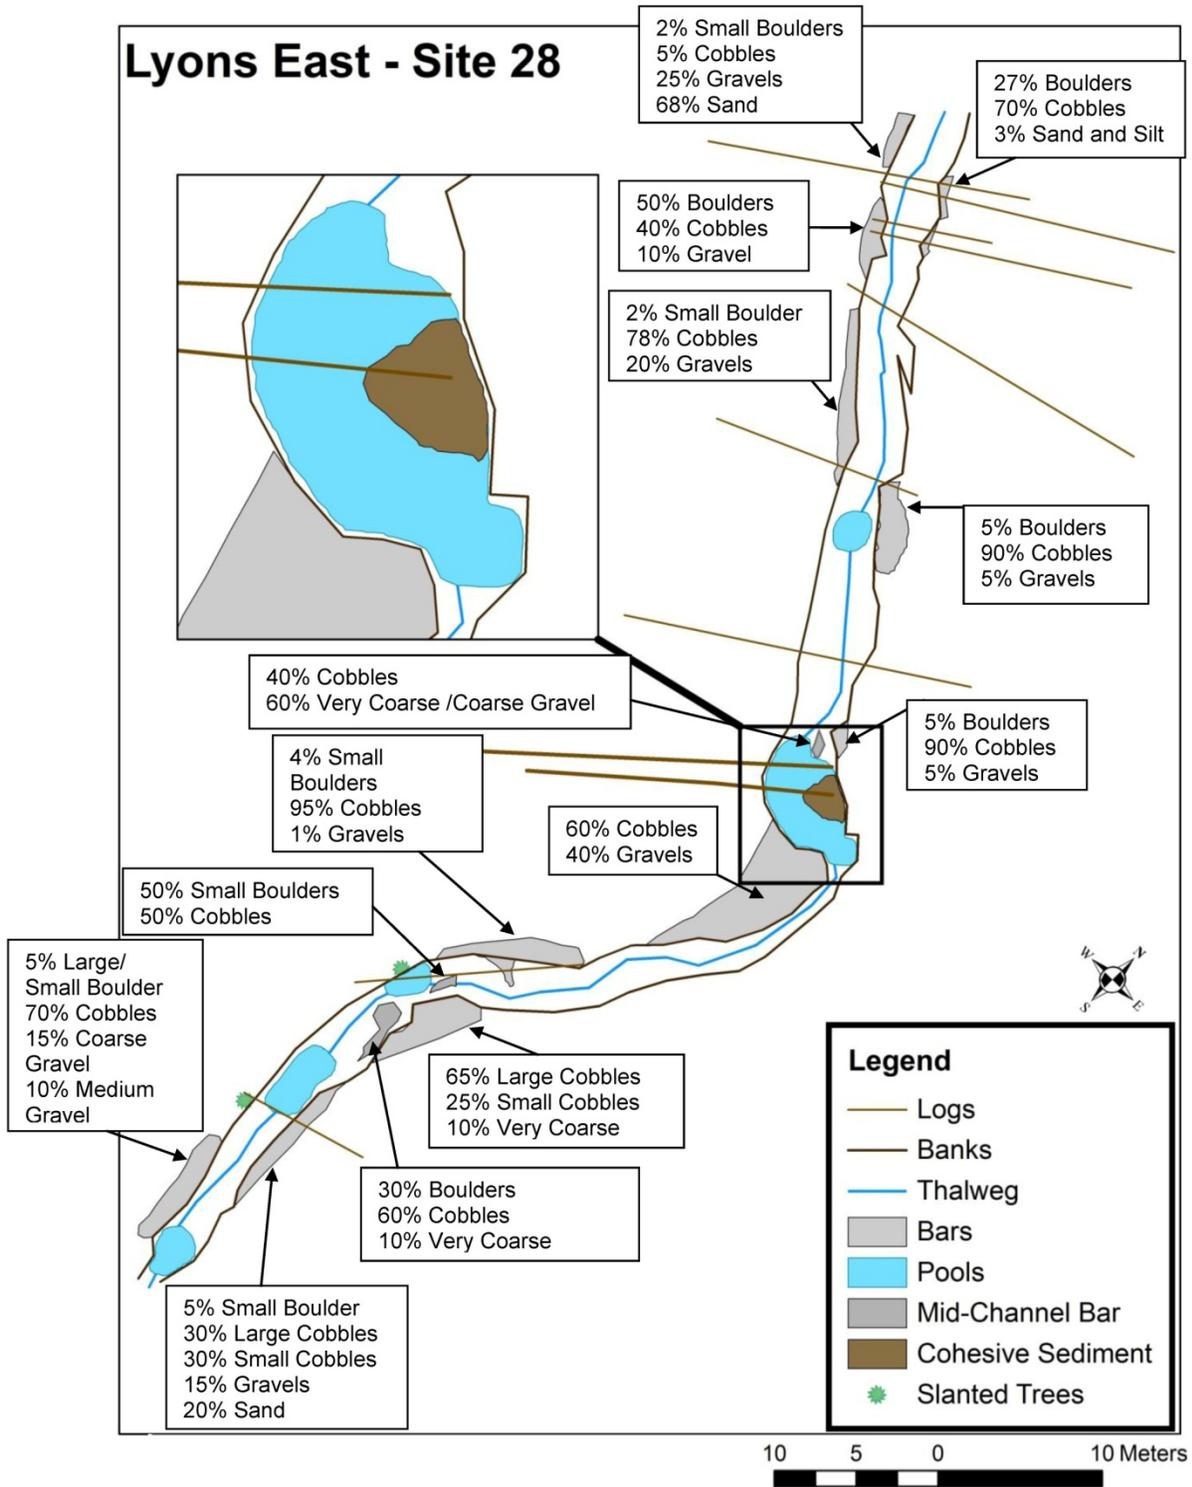
Figure 3-20: Stream reach morphology characteristics, in particular bar and pool formations in relation to in-stream wood deposit for Lyons East site 28
