The effect of in-stream wood on channel
morphology and sediment deposition in
headwater streams of the Oldman River
Basin, Alberta

A thesis
presented to the University of Waterloo
in fulfillment of the
thesis requirement for the degree of
Master of Environmental Studies
in
Planning

Waterloo, Ontario, Canada, 2012

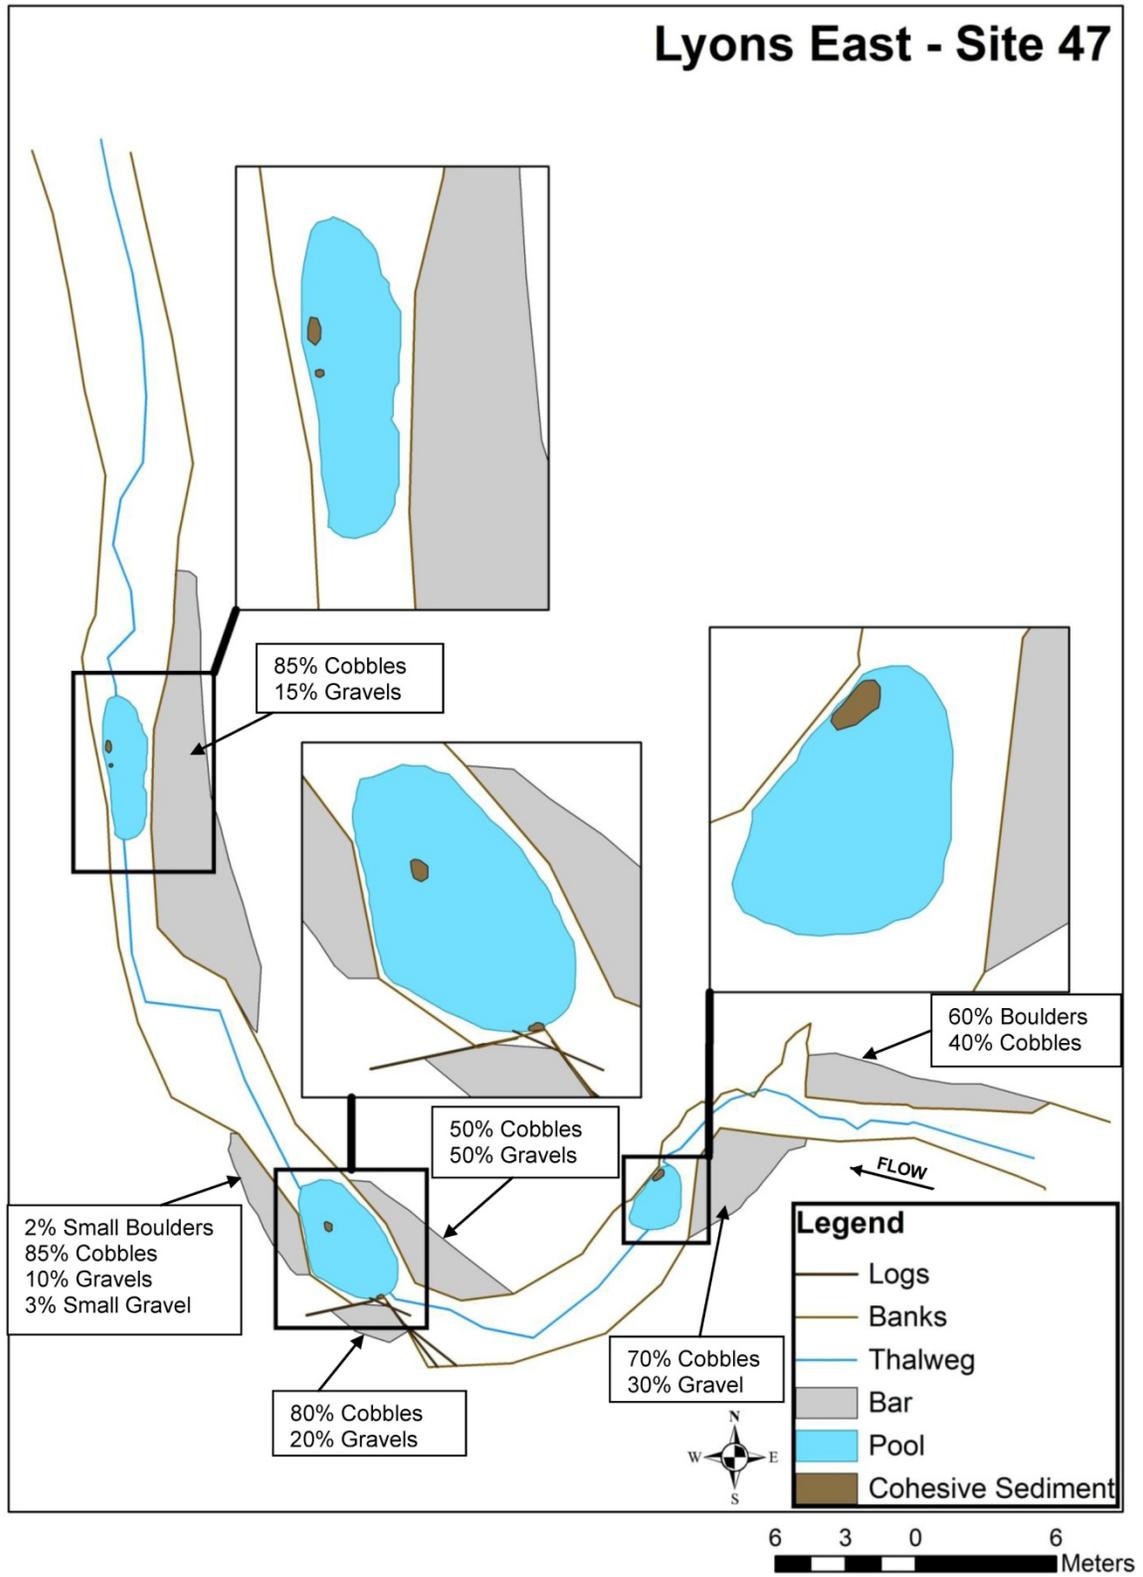
Figure 3-21: Stream reach morphology characteristics, in particular bar and pool formations in relation to in-stream wood deposit for Lyons East site 47

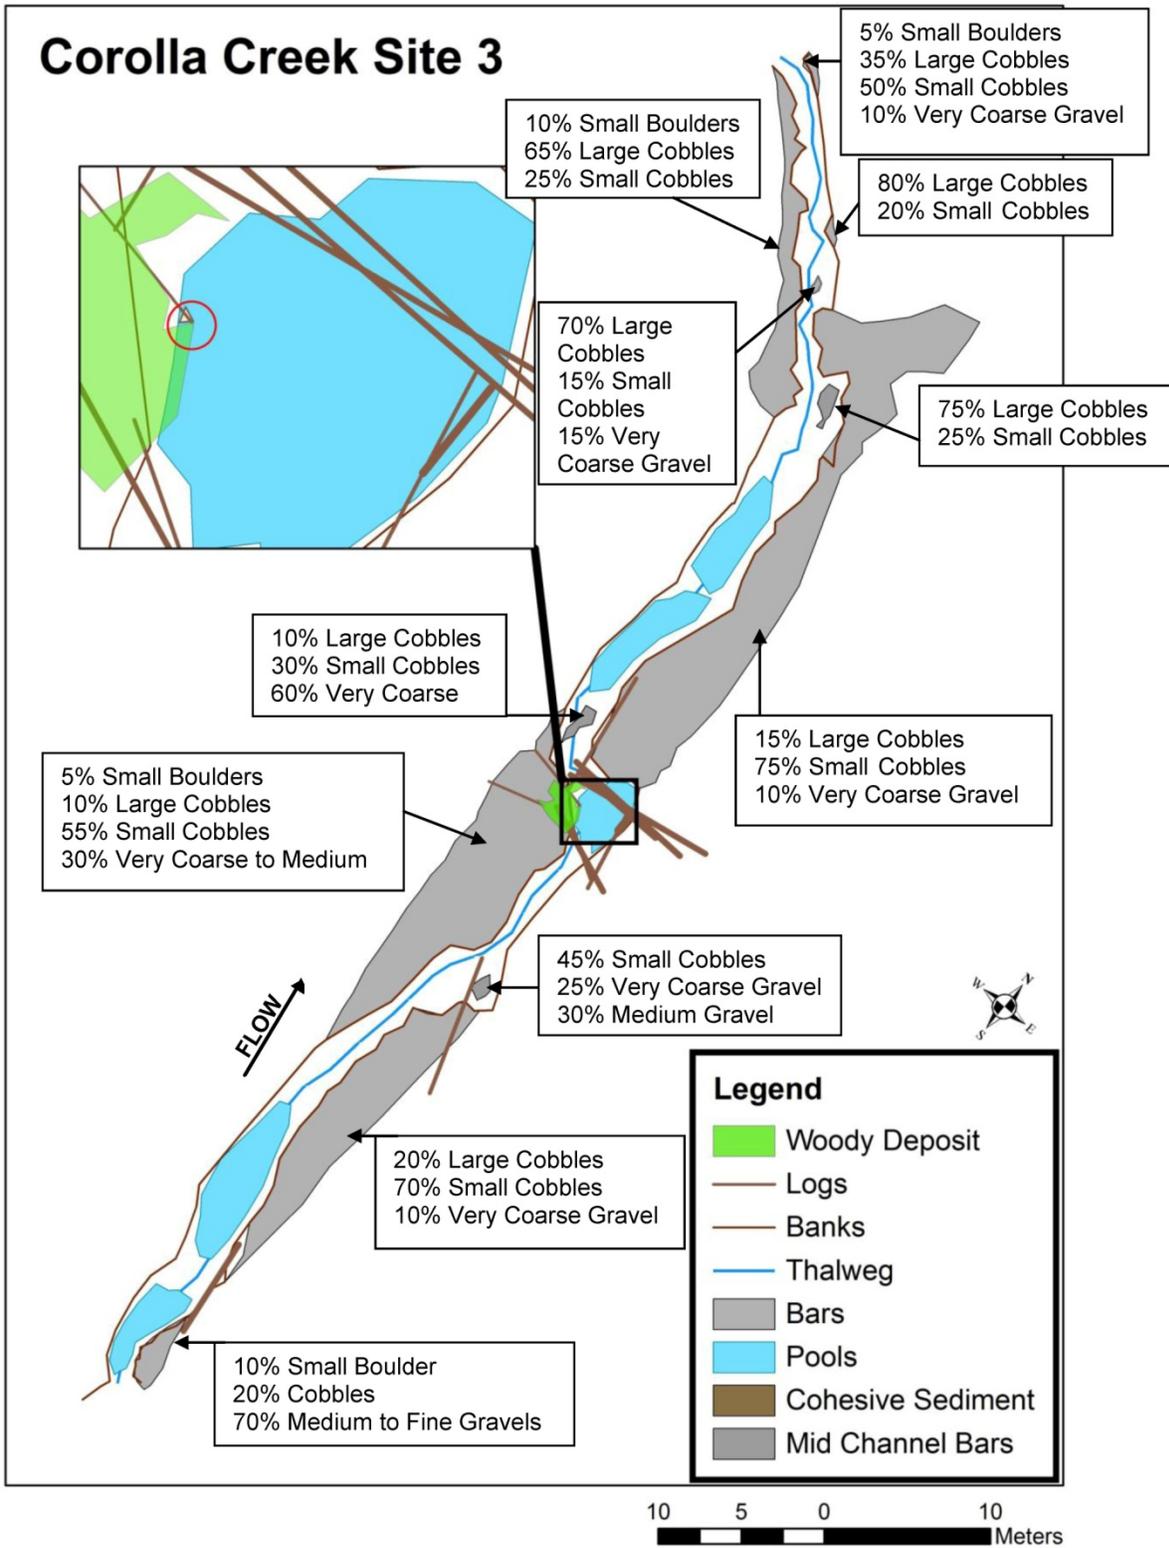
Figure 3-22: Stream reach morphology characteristics, in particular bar and pool formations in relation to in-stream wood deposit for Corolla Creek site 3

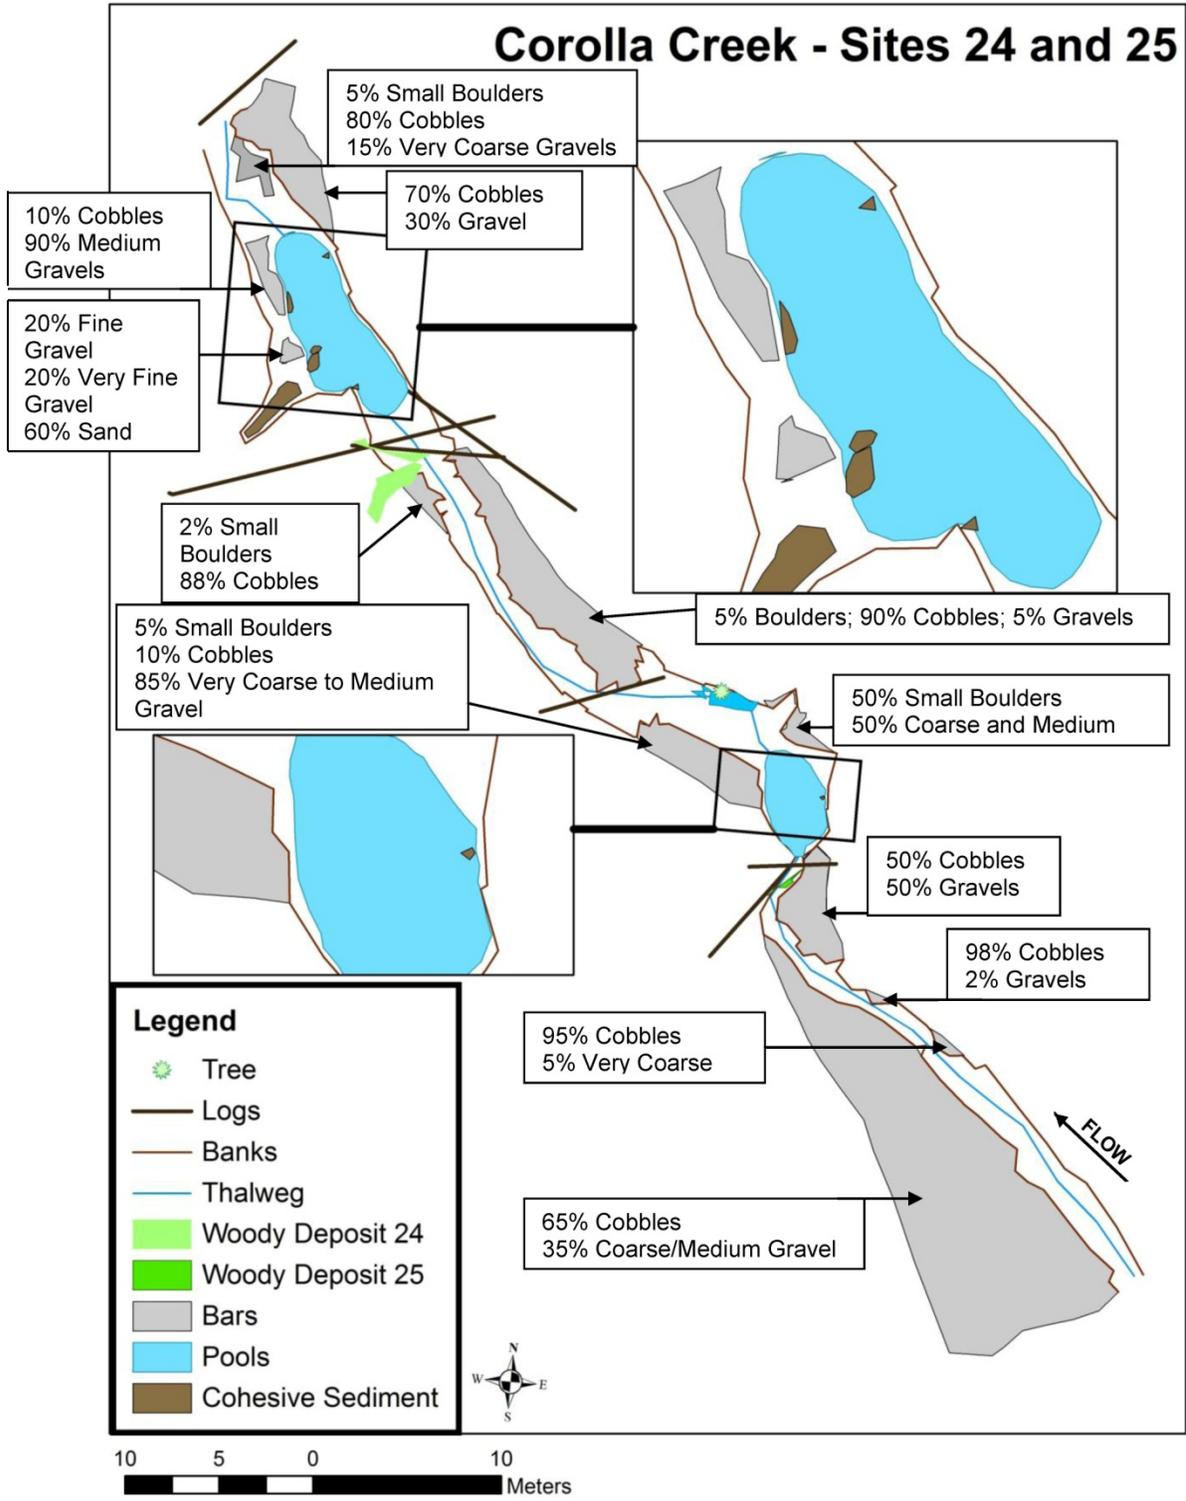
Figure 3-23: Stream reach morphology characteristics, in particular bar and pool formations in relation to in-stream wood deposit for Corolla Creek sites 24 & 25

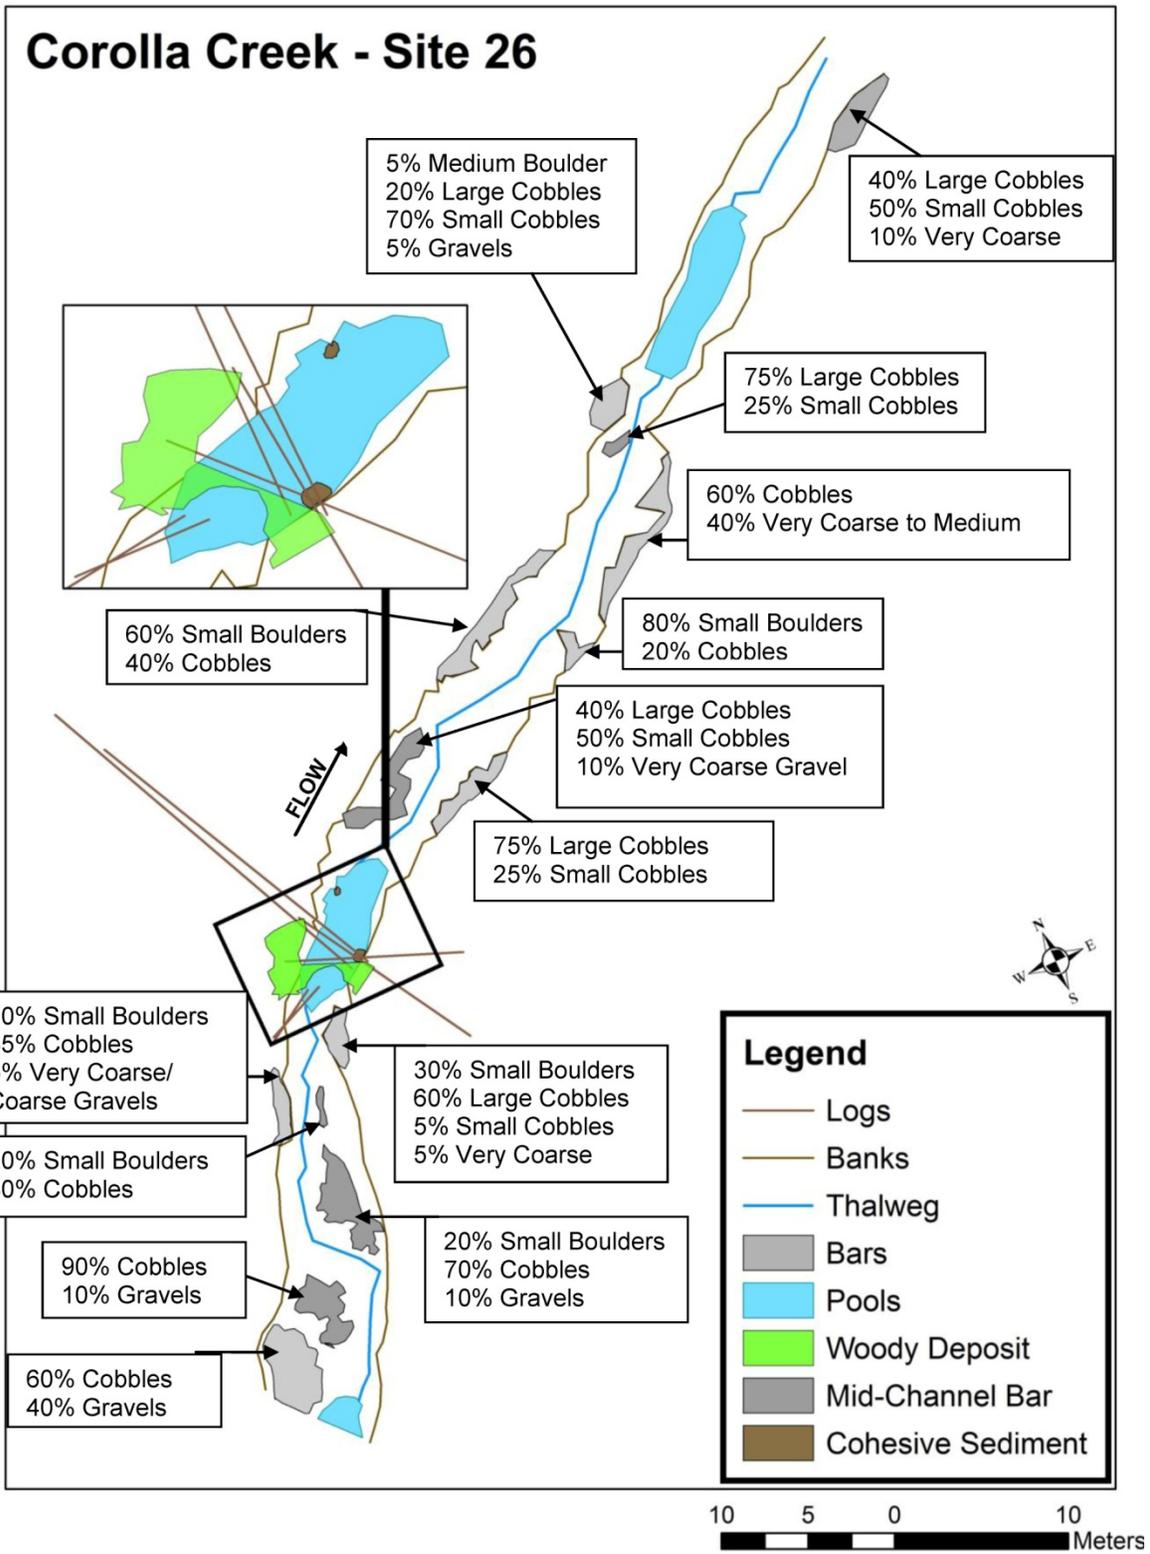
Figure 3-24: Stream reach morphology characteristics, in particular bar and pool formations in relation to in-stream wood deposit for Corolla Creek site 26

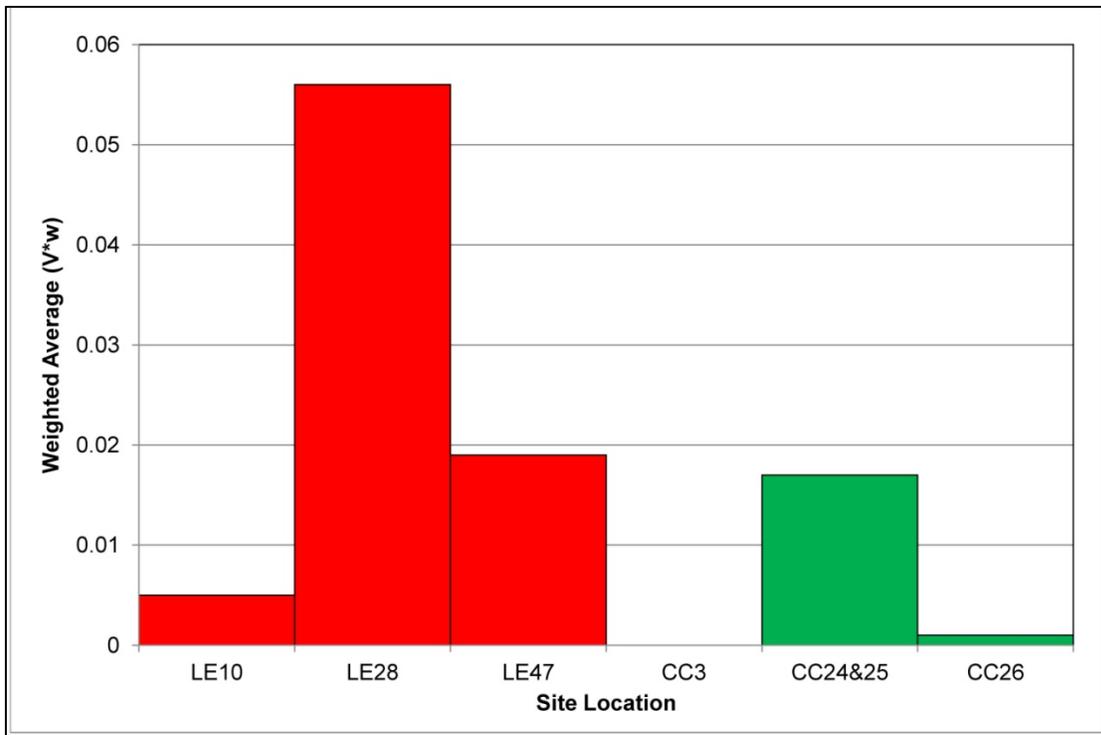
Figure 3-25: Weighted averages of V^* for the six selected study reaches

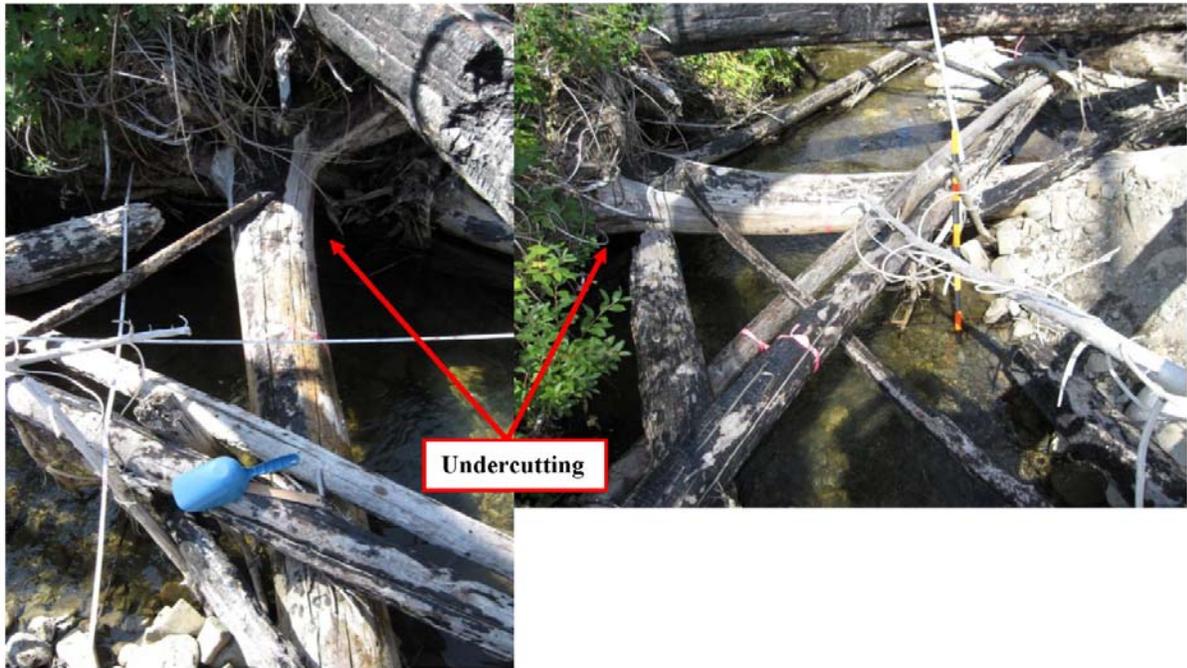
Figure 4-1: Undercutting at site LE10 in Lyons East. This particular location extended approximately 30cm to 40cm under the bank.

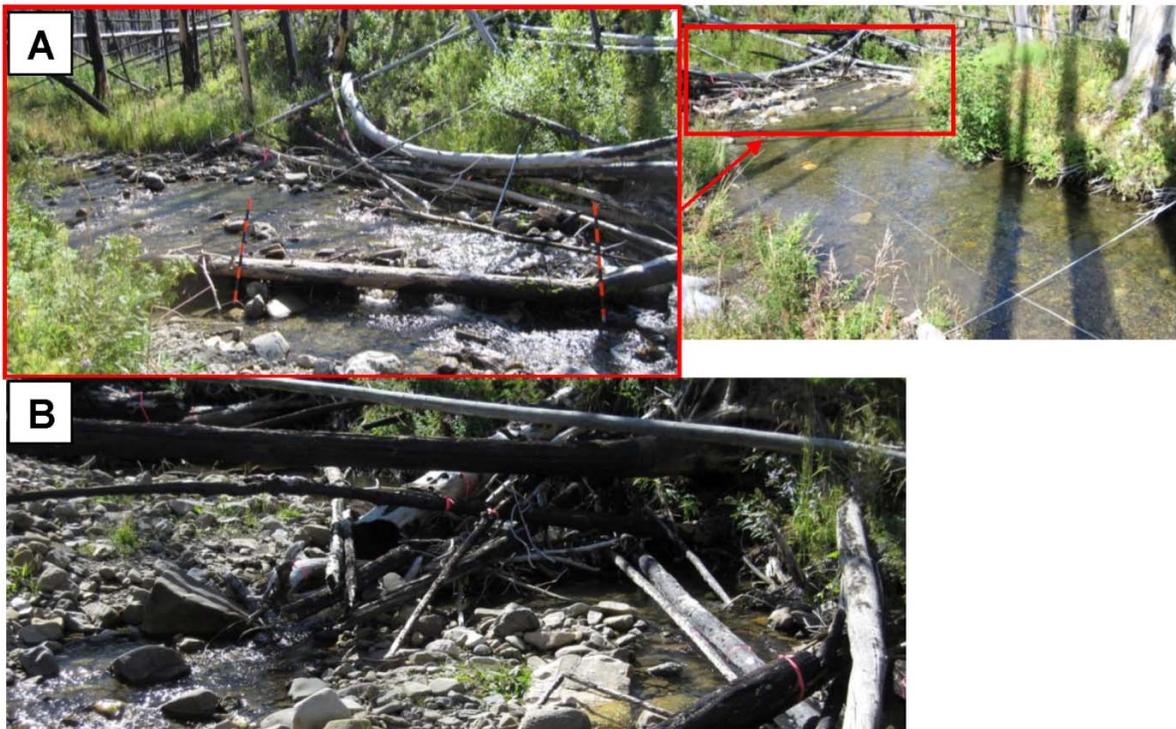
Figure 4-2: Channel width and in-stream wood clusters found at the upstream (A) and downstream (B) end of the jam structure at site LE10.

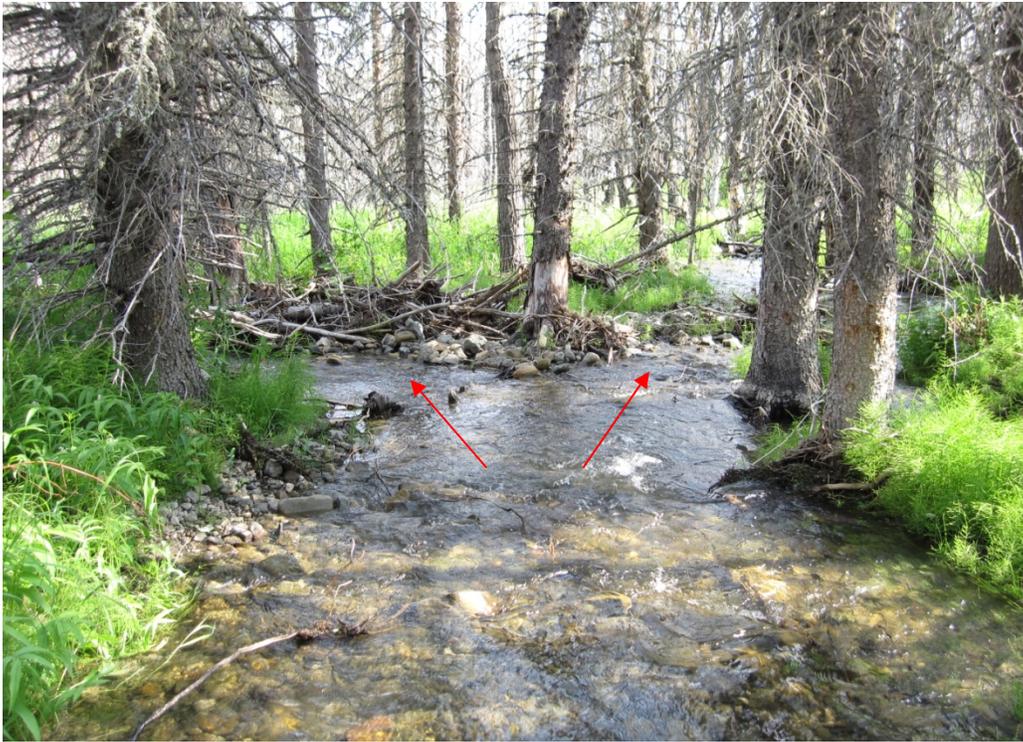
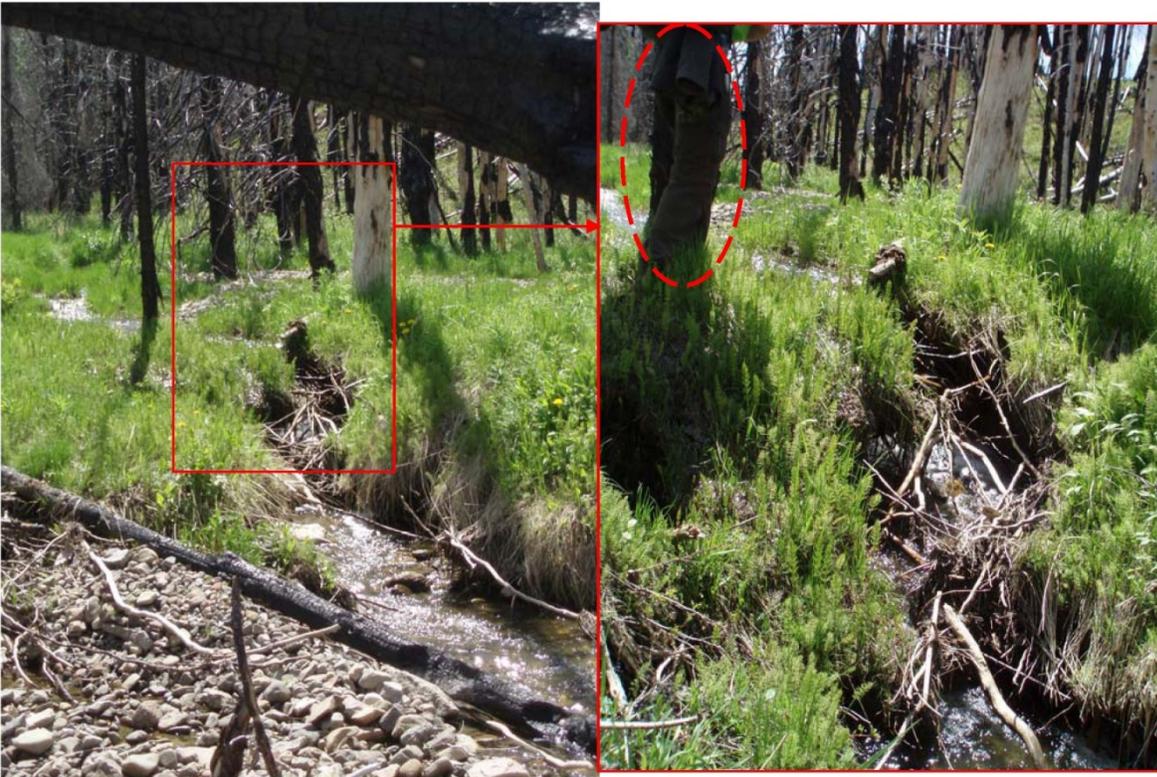
Figure 4-3: Branching of the channel just downstream of site LE11 in Lyons East (top). The floodplain channels further downstream from the first photograph, illustrating the erosion and creation of root steps as the water cuts a channel (bottom). The circle highlights the research assistant's legs for scale.

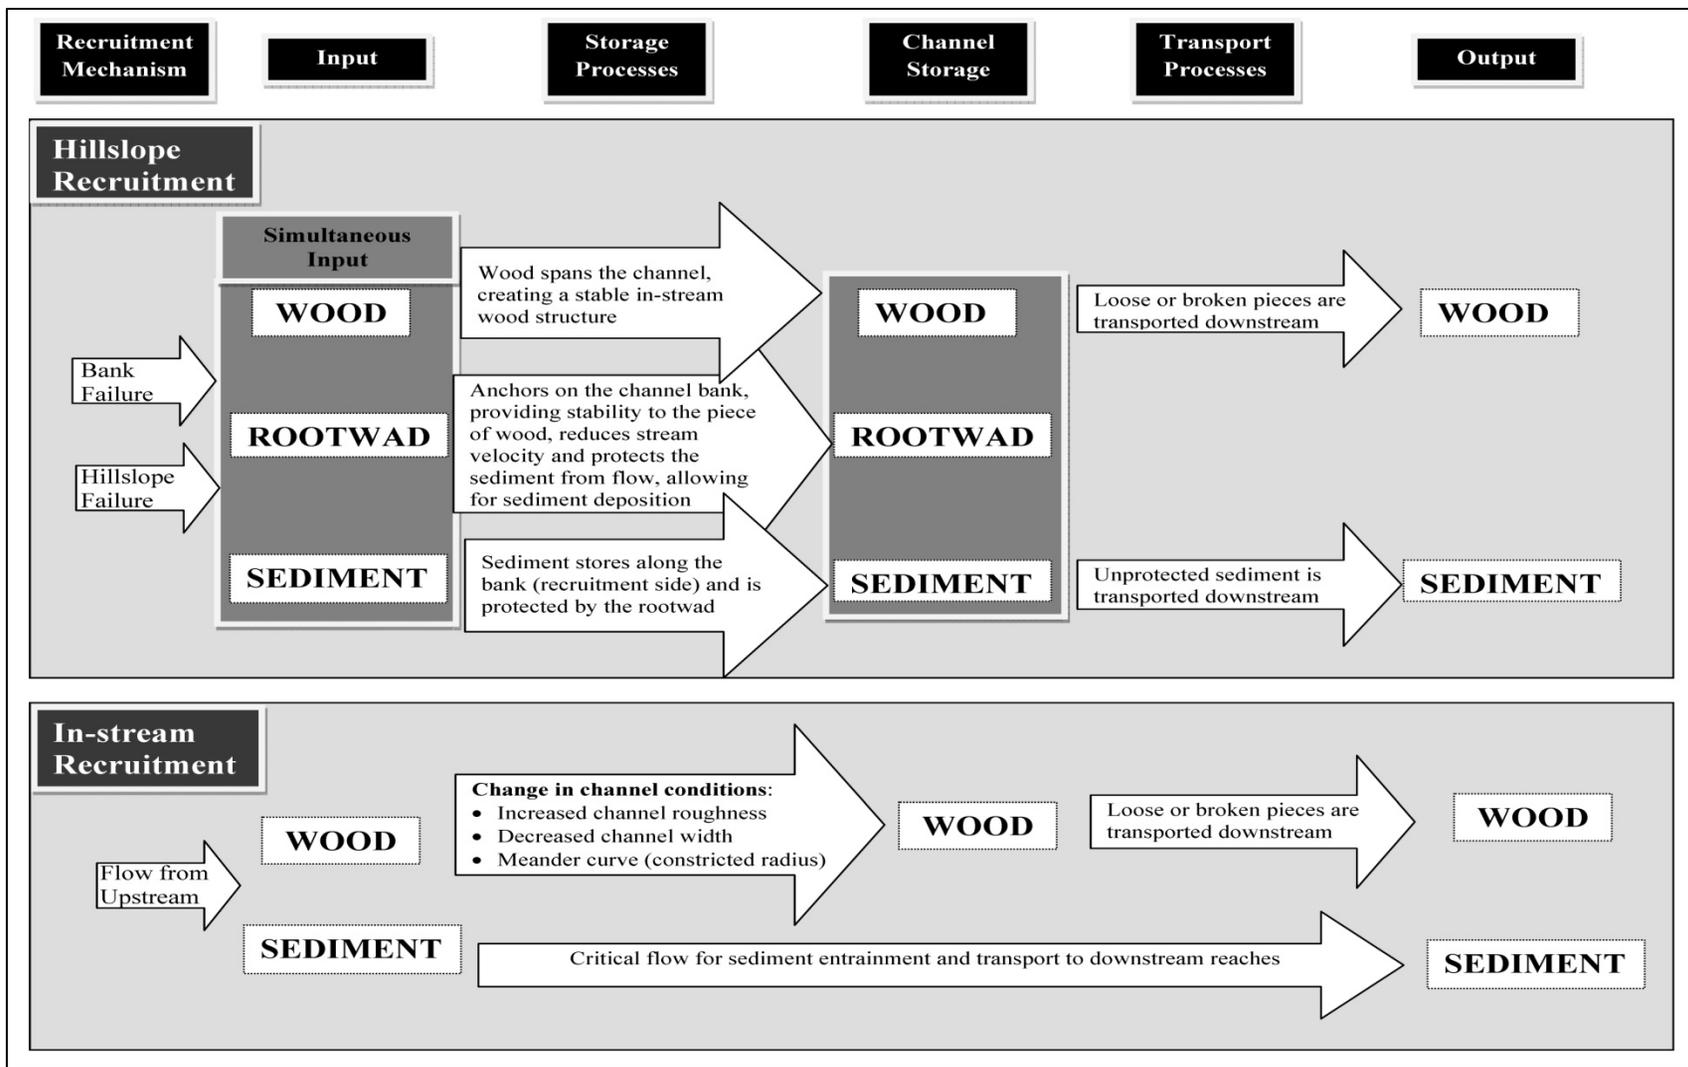
Figure 4-4: Conceptual model of in-stream wood as a mechanism for cohesive sediment storage based on recruitment mechanism of wood and sediment inputs. The size of the arrows represents the approximate proportion of input and output for each component.

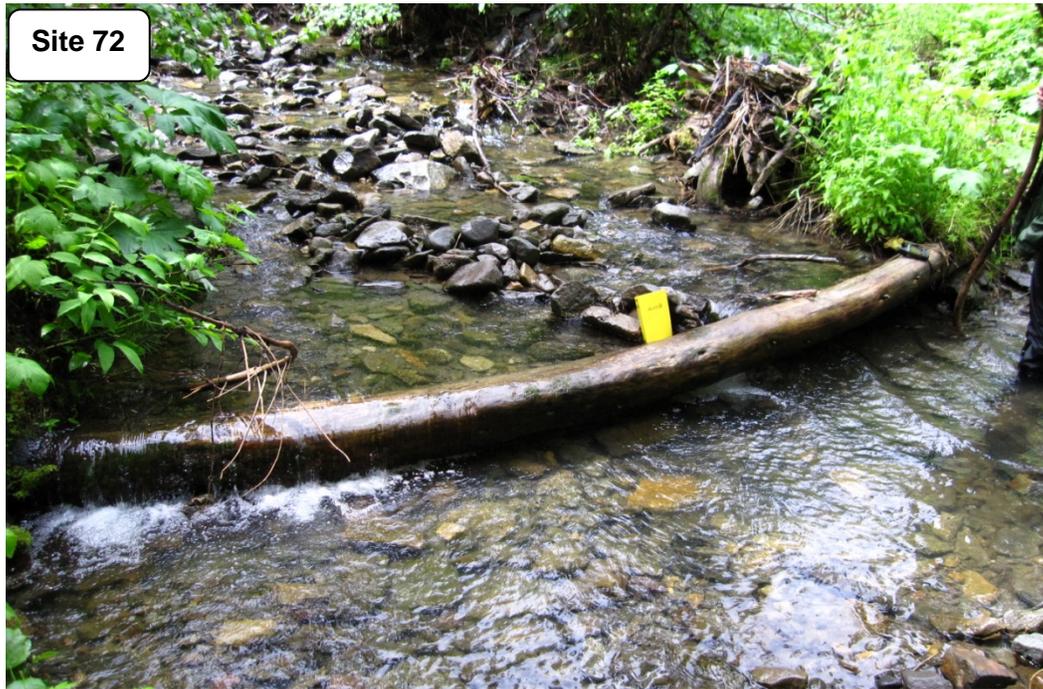
Figure D-1: A photo looking upstream towards an example of a single log structure in Lyons East.

The left side of the photo shows water flowing over the log, creating a plunge pool downstream. The middle of the photo shows an accumulation of cobbles that have been scoured out, allowing water to flow under the log. The yellow “Rite in the Rain” field book provides scale.

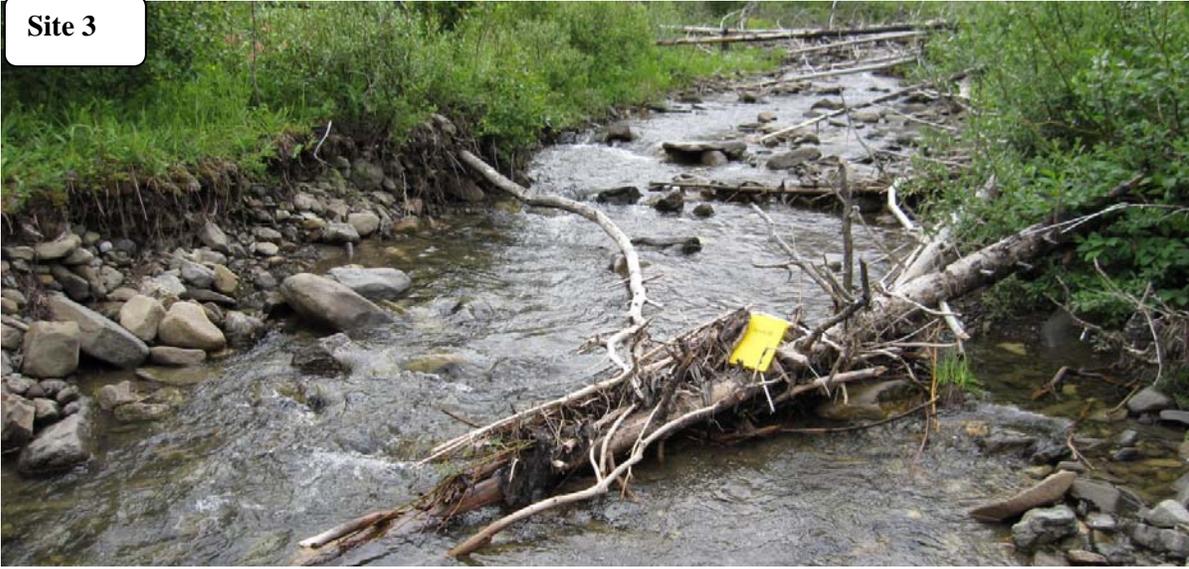
Figure D-2: A photo looking upstream towards an example of a simple partial jam in Lyons East This structure does not extend the width of the channel, but impacts the flow by diverting it along the log. The increased roughness and decreased velocity allows loose wood to accumulate along the key member. The yellow “Rite in the Rain” field book provides scale.

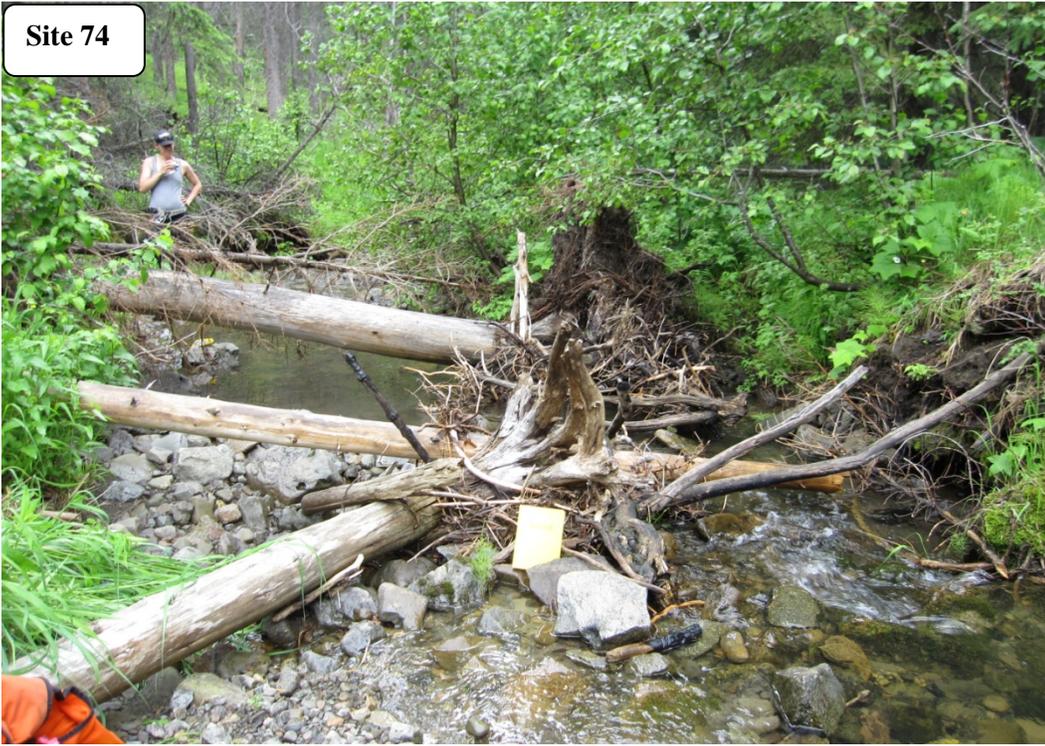
Figure D-3: A photo looking downstream towards a partial jam site in Lyons East. This structure does not extend the width of the channel, but impacts flow by diverting water towards the channel bank causing erosion. The yellow “Rite in the Rain” field book provides scale.

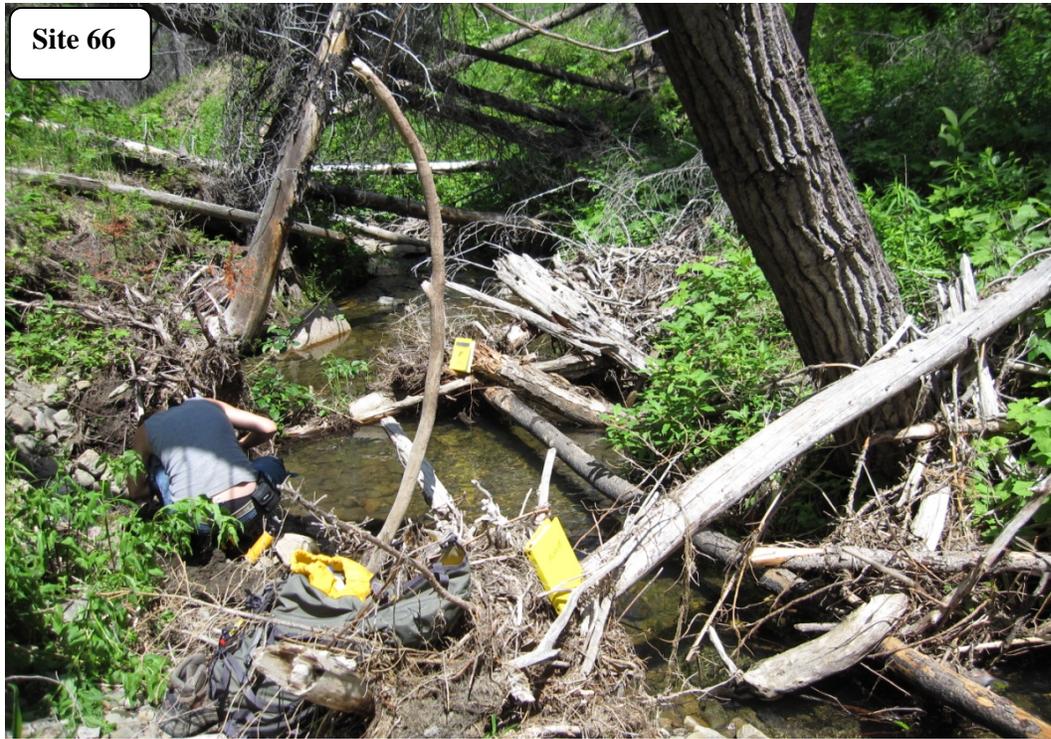
Figure D-5: A photo looking downstream towards a jam site in Lyons East.

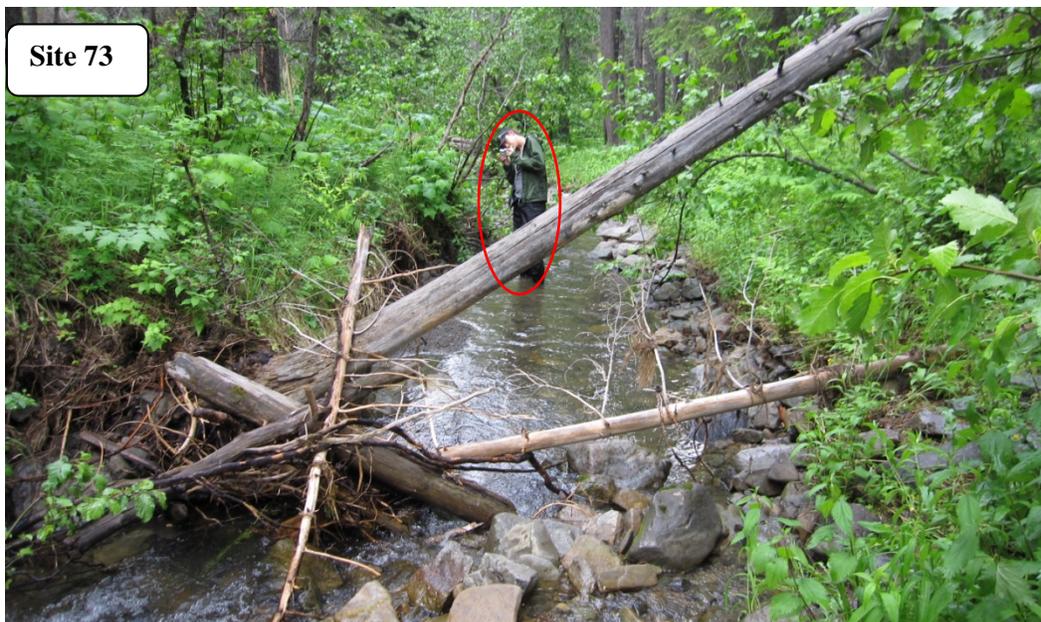
Figure D-4: A photo looking downstream towards a jam site in Lyons East.

The logs were transported through fluvial processes and are trapped on the bank recruited snags, creating an obstruction to flow. Scouring processes have created a pathway next to the boulder and formed a pool on the downstream side.

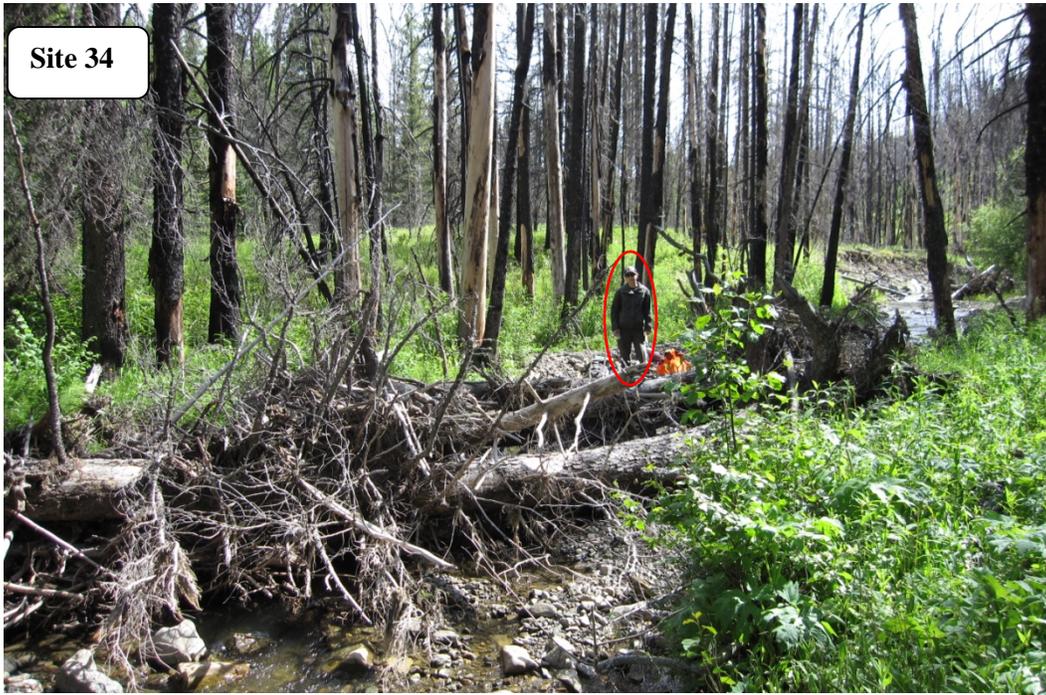
Figure D-6: A photo looking upstream towards a dam in Lyons East. The logs are oriented diagonally along the channel and have caused scouring of the channel bed, which provides flow pathways for water. A person standing (5’8”) provides scale in the photograph.

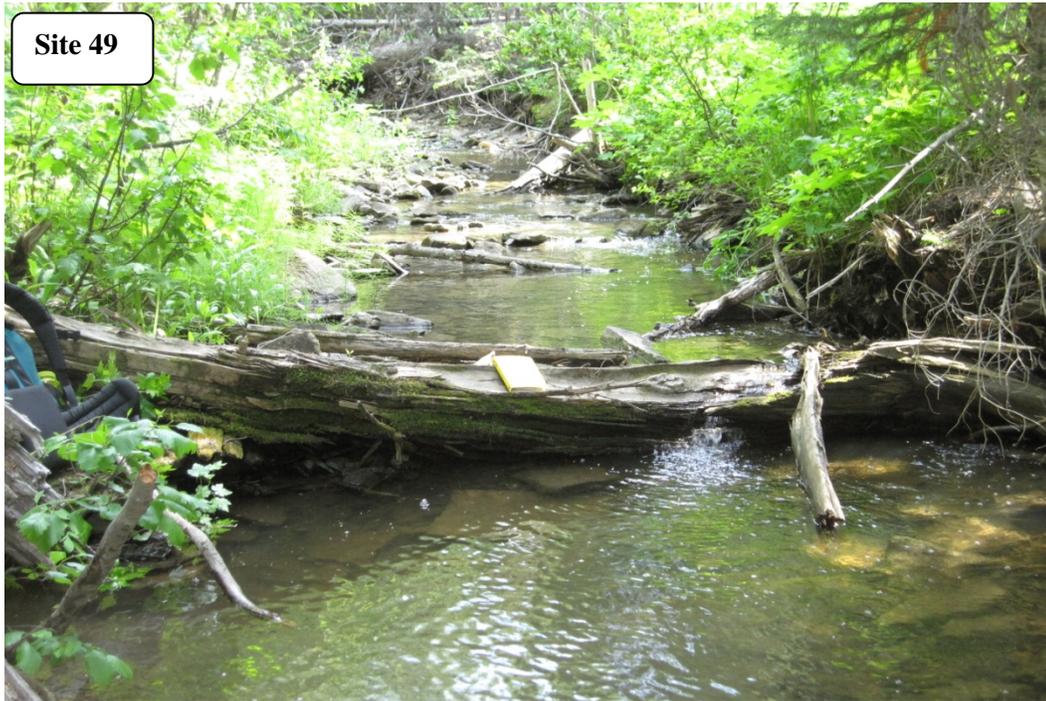
Figure E-1: A photo looking upstream towards an example of a single log site in Corolla Creek.

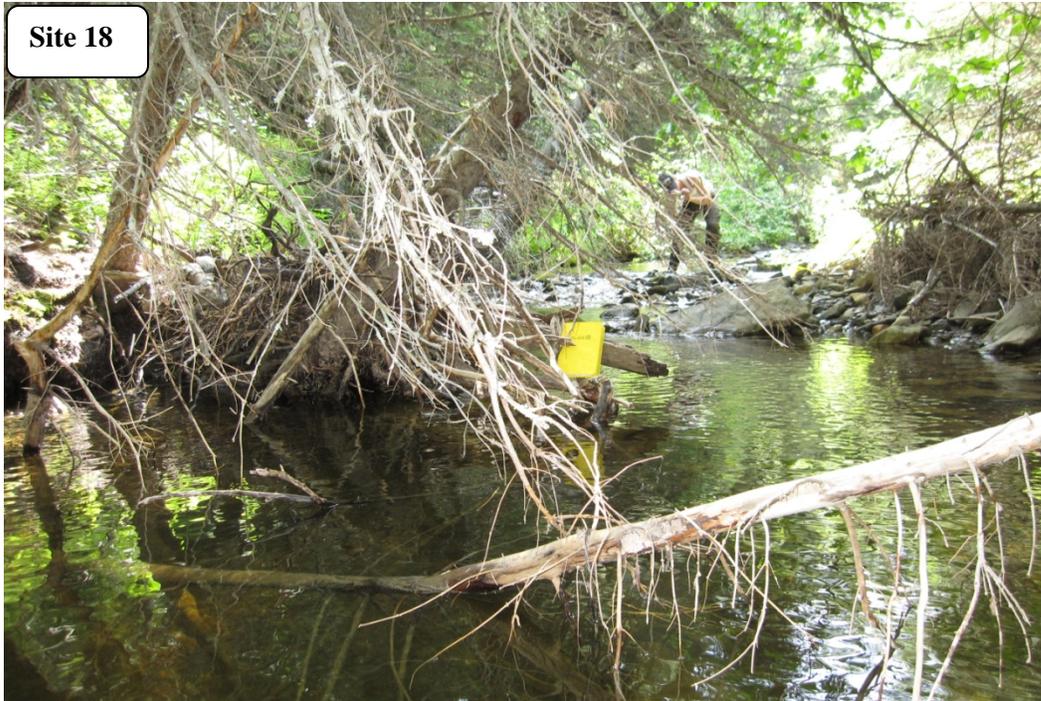
Figure E-2: A photo looking upstream towards an example of a partial jam site with leaning tree influence in Corolla Creek.

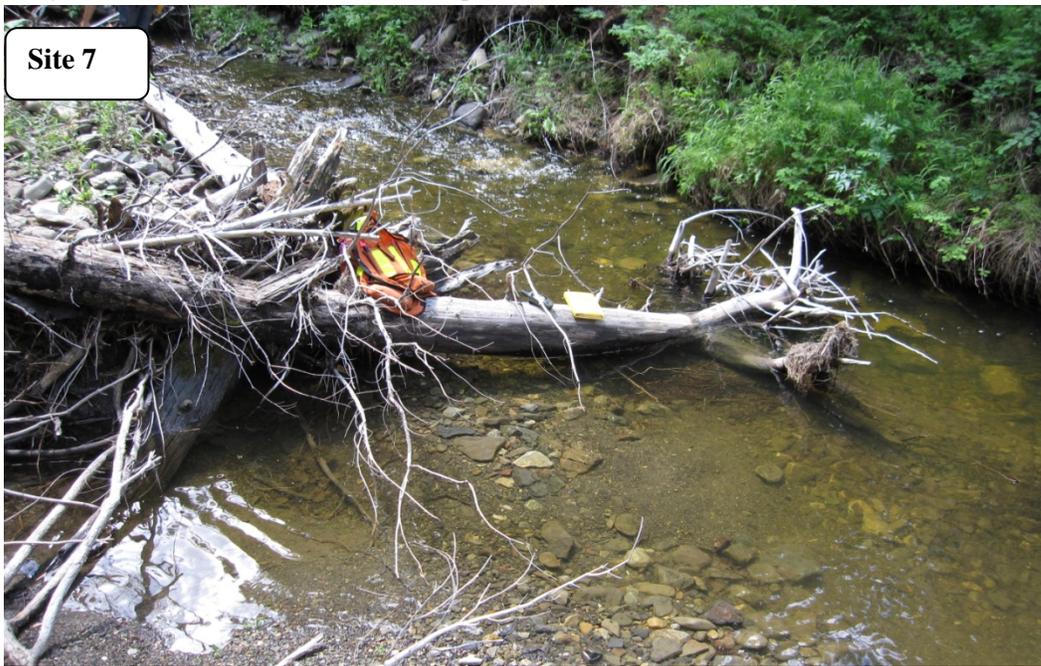
Figure E-3: A photo looking upstream towards an example of a partial jam formed through fluvial processes in Corolla Creek

The flow is diverted towards the left bank due to the obstruction, undercutting the bank and depositing finer sediment upstream. The yellow “Rite in the Rain” field book provides scale.

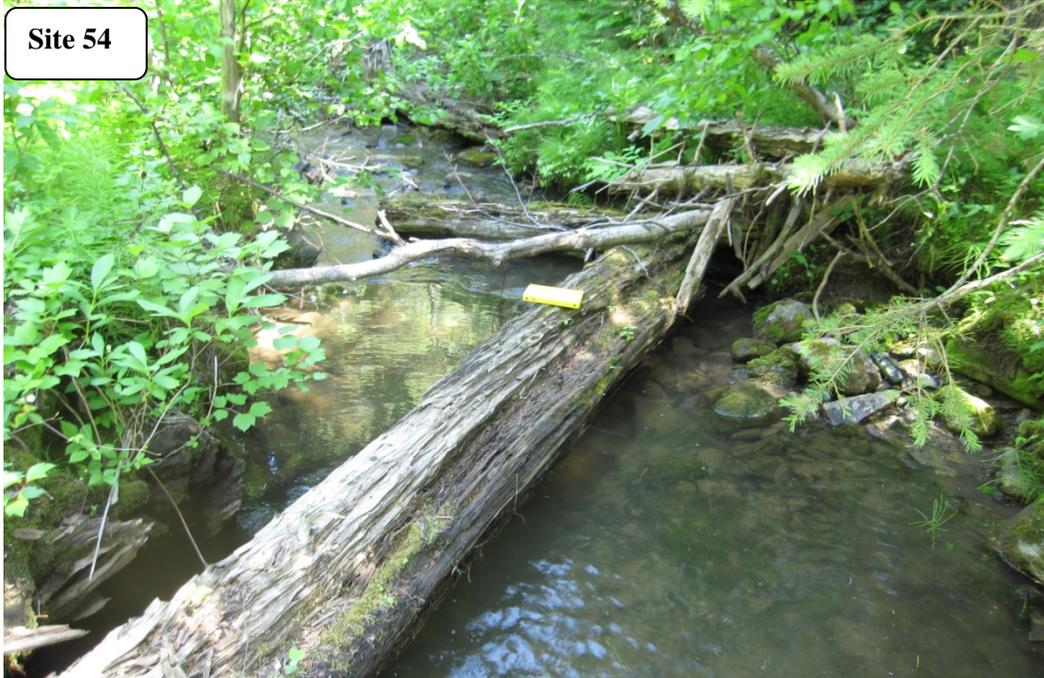
Figure E-4: A photo looking upstream towards an example of a simple jam in Corolla Creek.

The larger log spans the channel diagonally, trapping additional wood pieces upstream primarily recruited through fluvial processes. The water flows underneath the large log due to channel bed scouring. The yellow “Rite in the Rain” field book provides scale.

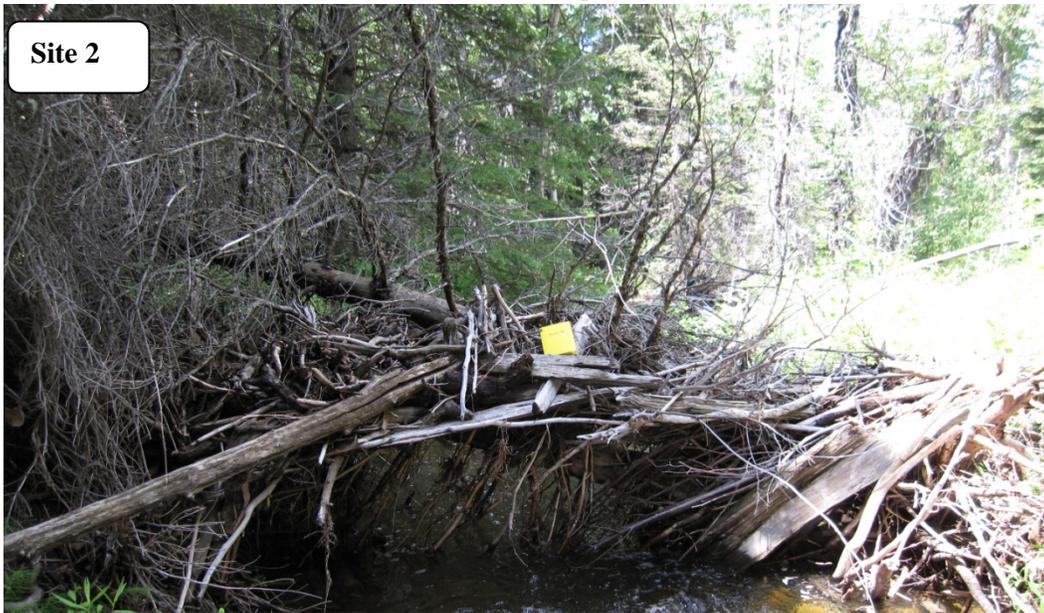
Figure E-5: A photo looking downstream towards an example of a jam in Corolla Creek.

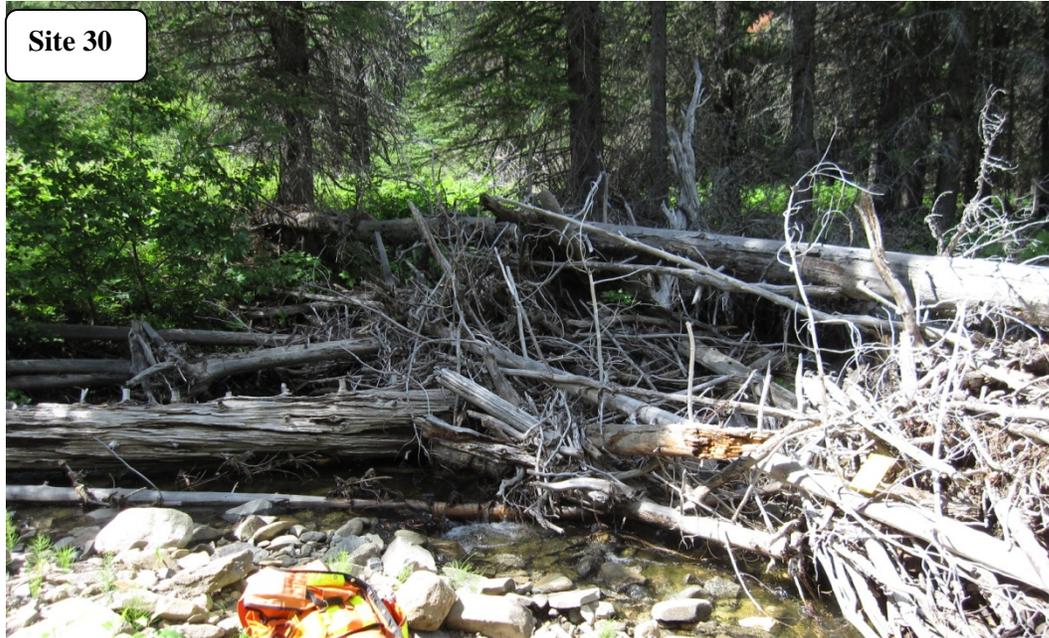
Figure E-6: A photo looking across the meander bend towards an example of a jam in Corolla Creek.
