The effect of in-stream wood on channel
morphology and sediment deposition in
headwater streams of the Oldman River
Basin, Alberta

A thesis
presented to the University of Waterloo
in fulfillment of the
thesis requirement for the degree of
Master of Environmental Studies
in
Planning

Waterloo, Ontario, Canada, 2012

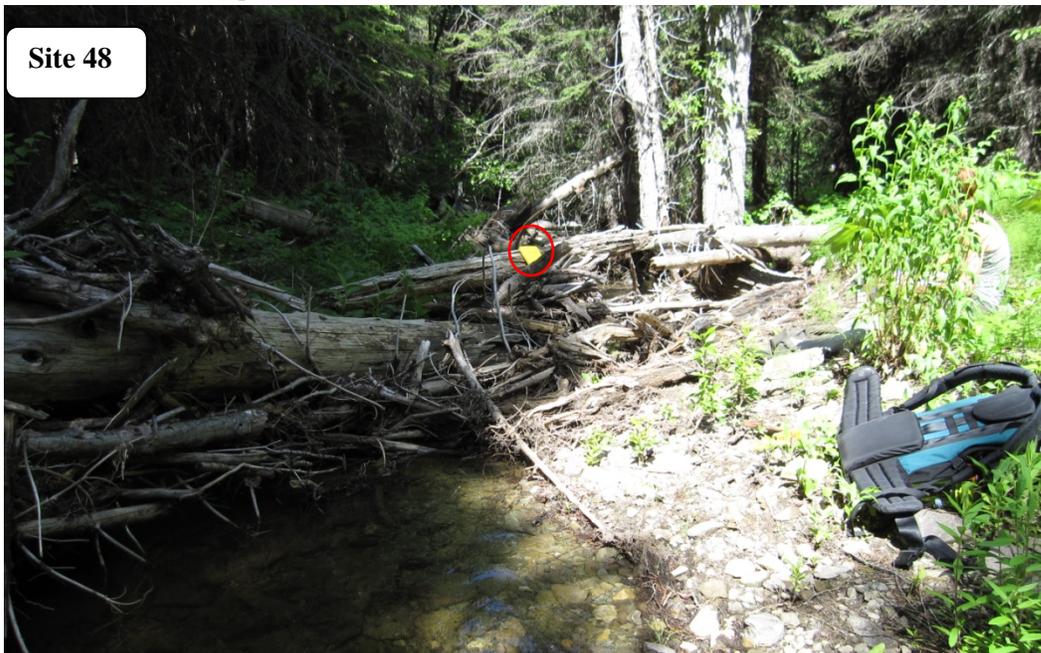
Figure E-7: A photo looking downstream towards an example of a dam in Corolla Creek.

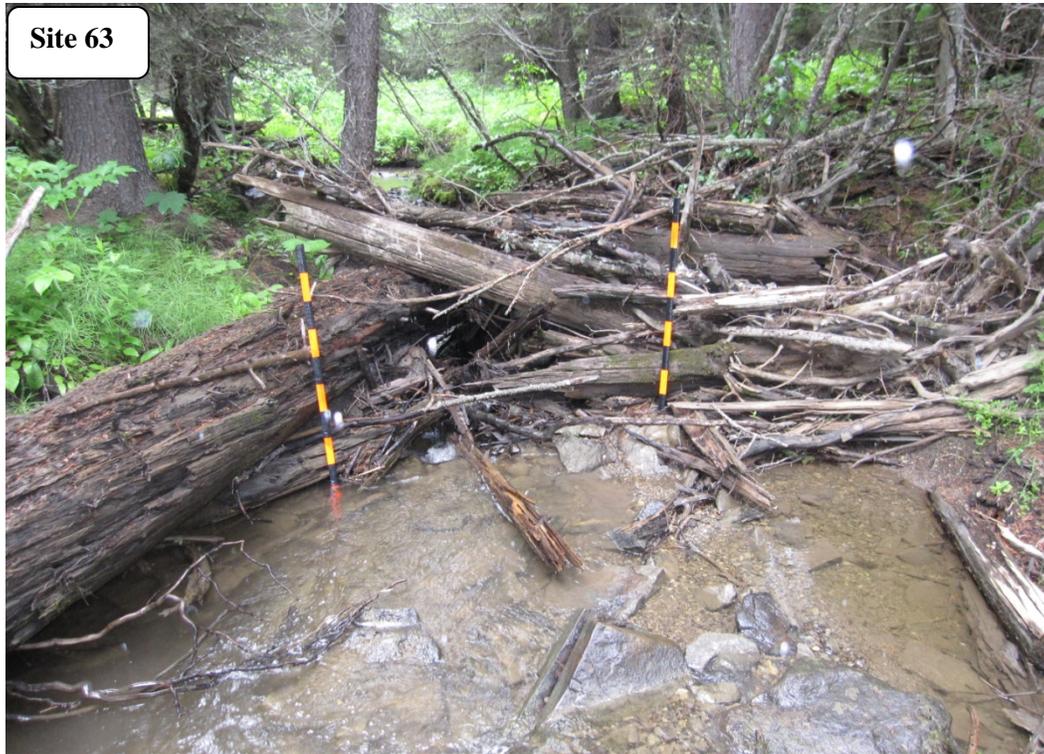
Figure E-8: A photo looking downstream towards an example of a dam in Corolla Creek.

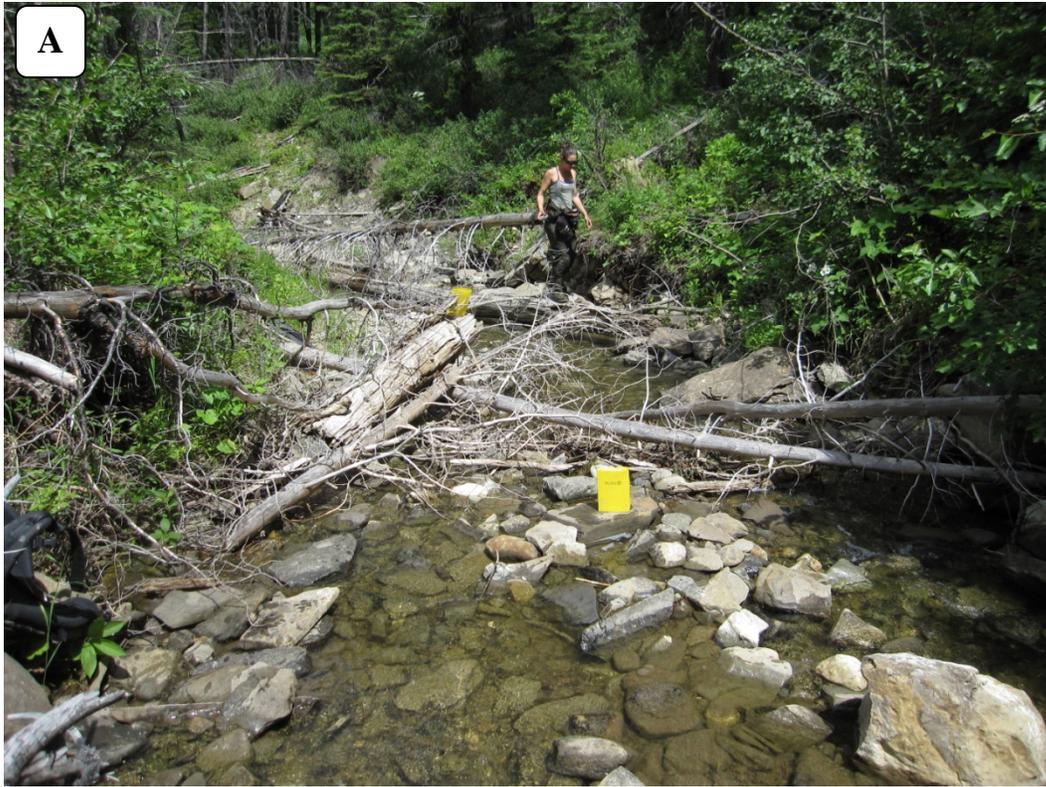
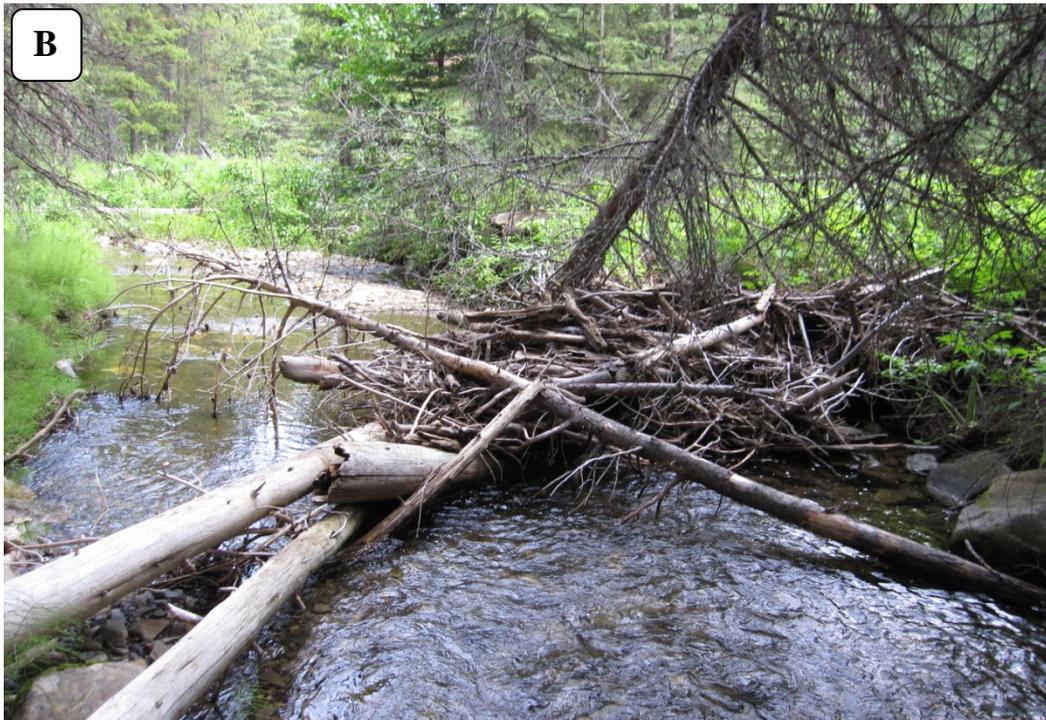
Figure E-9: Photos illustrating the variation in jam complexity found in Corolla Creek. This dam is formed as the channel narrows, constricting the transport of wood downstream. The two orange and black meter sticks showing 10cm intervals provide scale.

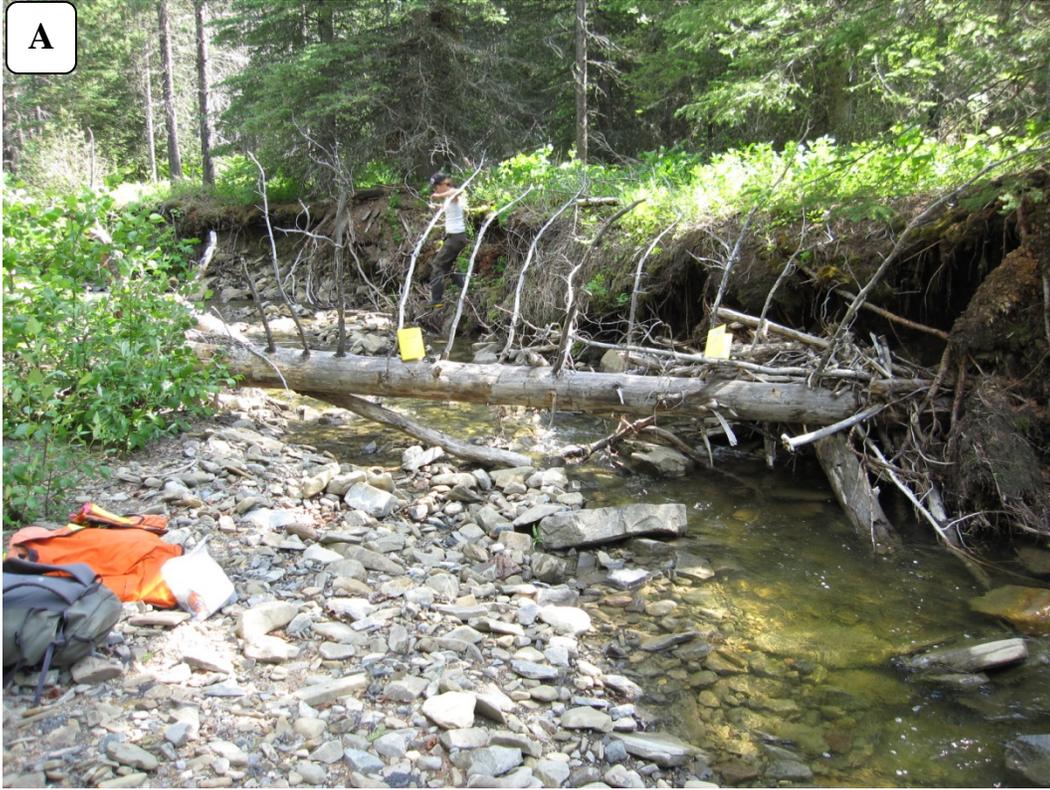
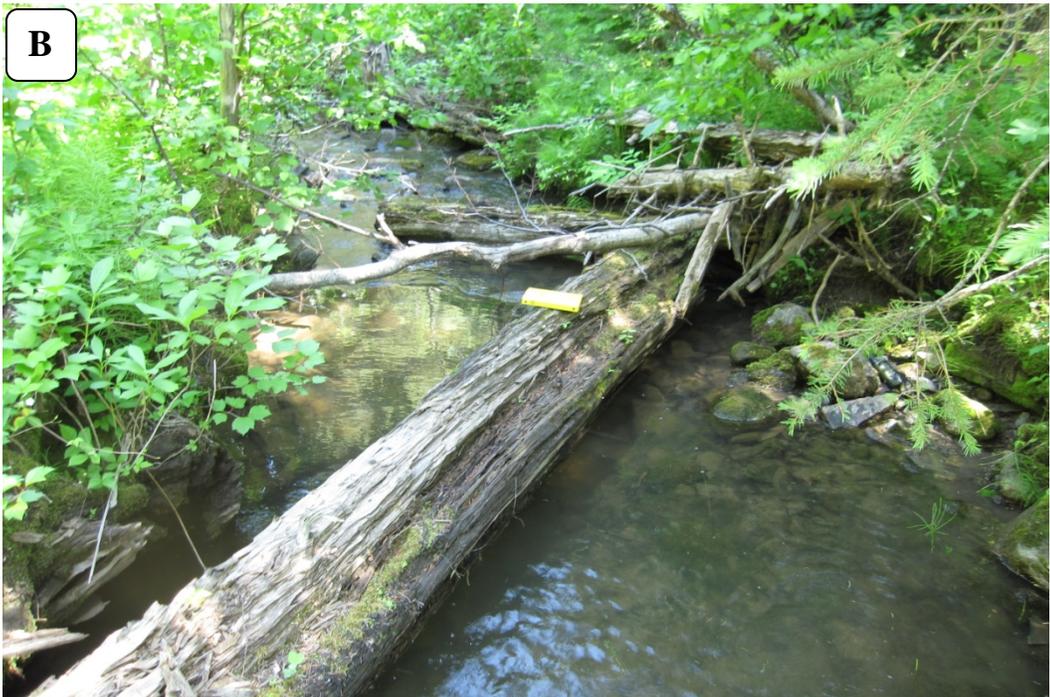
Figure E-10: Photos showing examples of simple jams within the lower reach (A) and upper reach (B) in Corolla Creek.

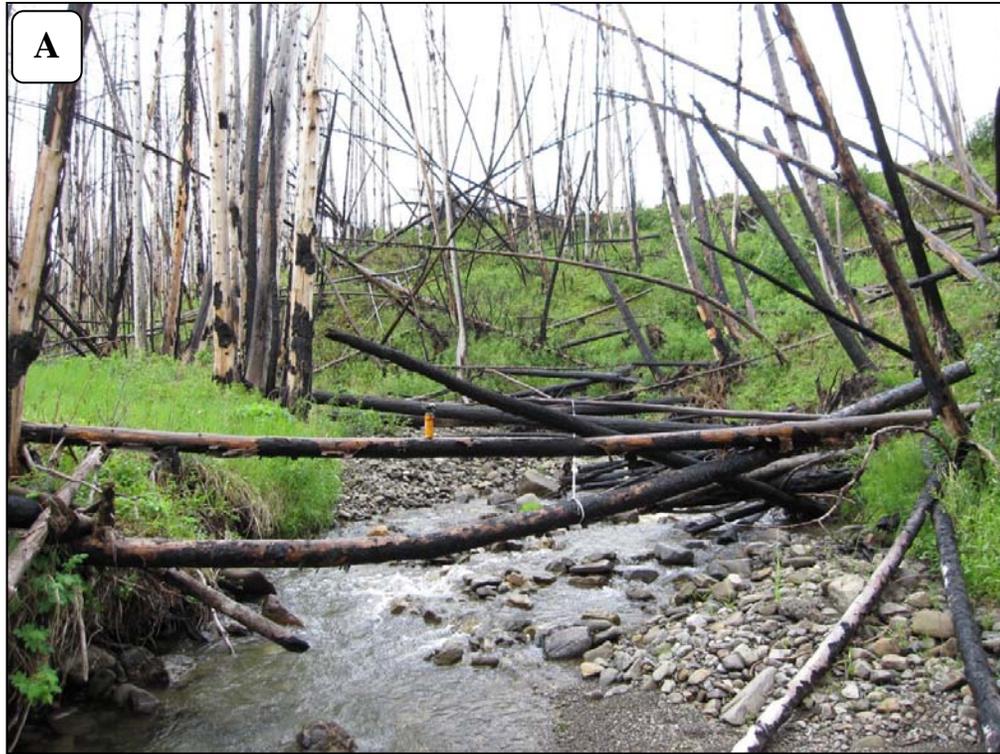
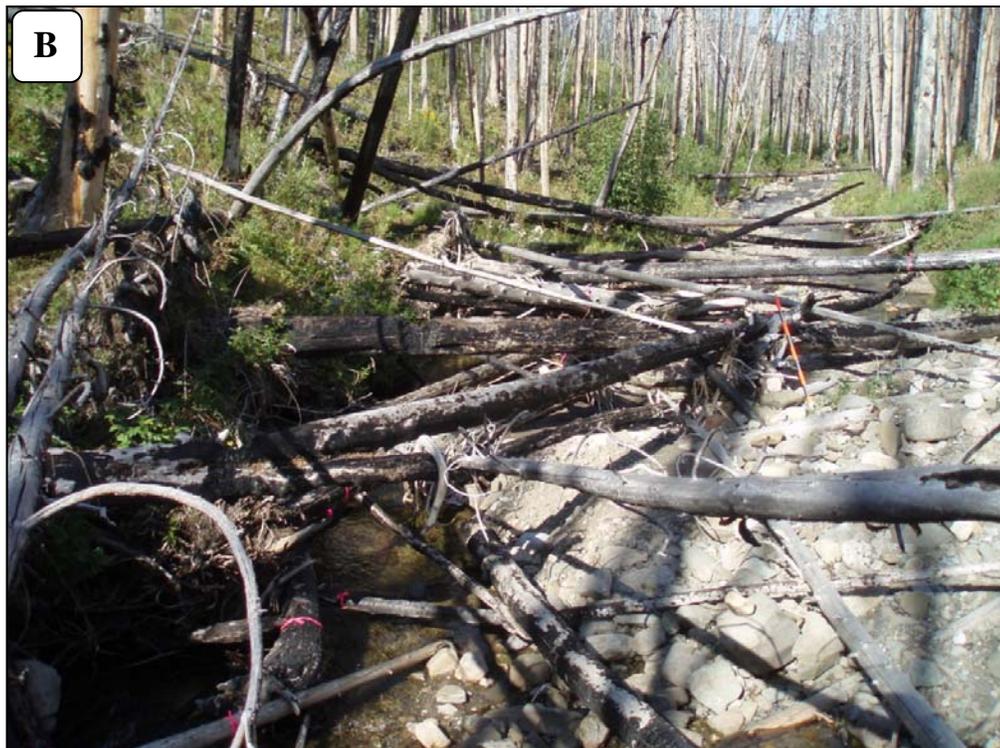
Figure F-1: Lyons East site 10 looking upstream (A) and downstream (B) towards the jam. These photos illustrate the jam structure, wood characteristics and geomorphic features. The bear spray provides scale (A) and the black and orange meter sticks are 10cm intervals for scale (B) provides scale.

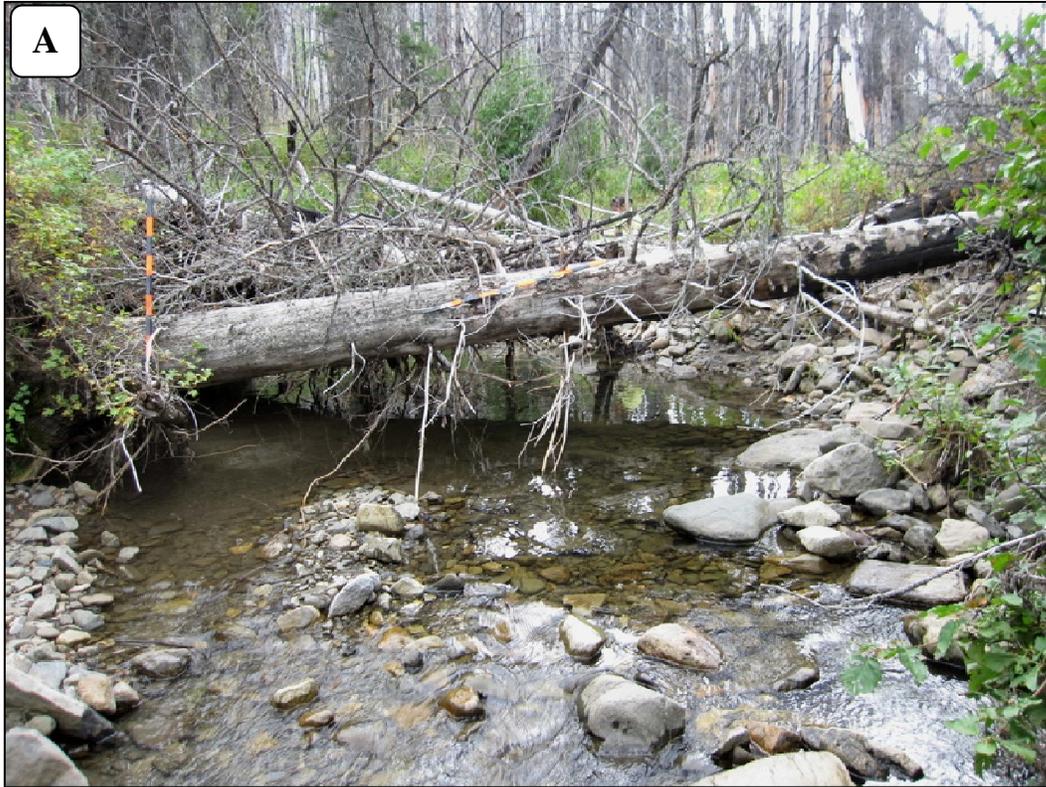
Figure F-2: Lyons East site 28 looking upstream (A) and downstream (B) towards the jam. These photos illustrate the jam structure, wood characteristics and geomorphic features. The restriction of flow has created a pool to form under the structure, with cohesive sediment stored along the left bank. The black and orange meter sticks are 10cm intervals for scale.

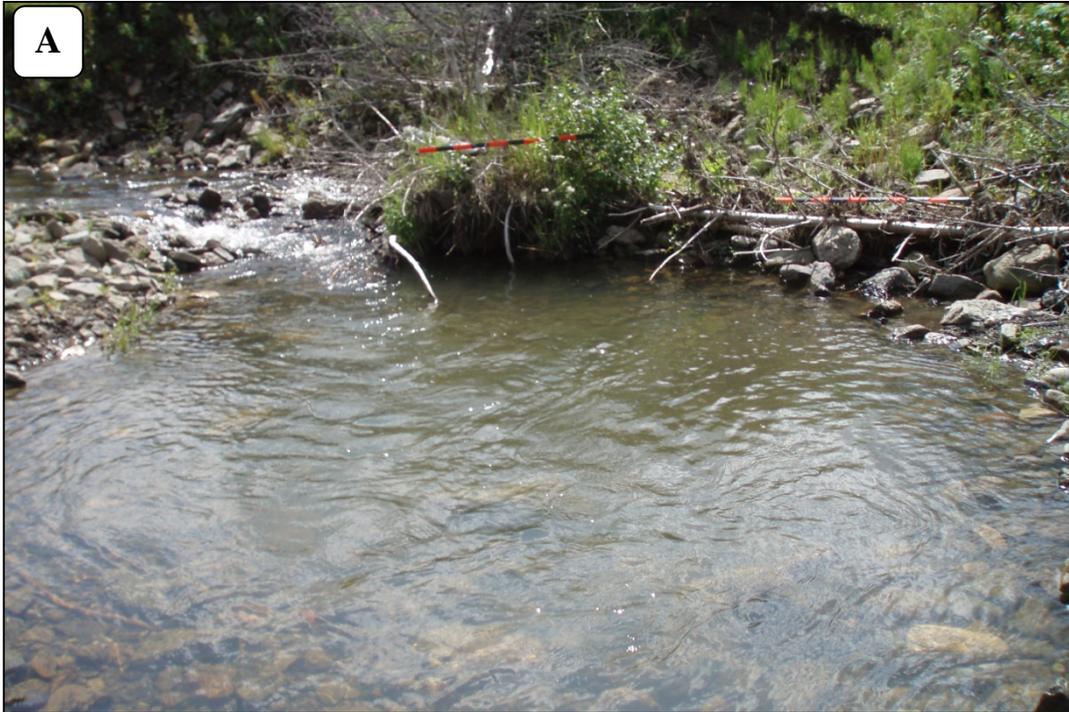
Figure F-3: Lyons East site 47 looking upstream (A) and downstream (B) towards the jam. These photographs illustrate the jam structure, wood characteristics and geomorphic features. The wood restricts flow, which has formed a pool downstream of the structure. The black and orange meter sticks are 10cm intervals for scale. The black and orange meter sticks are 10cm intervals for scale.

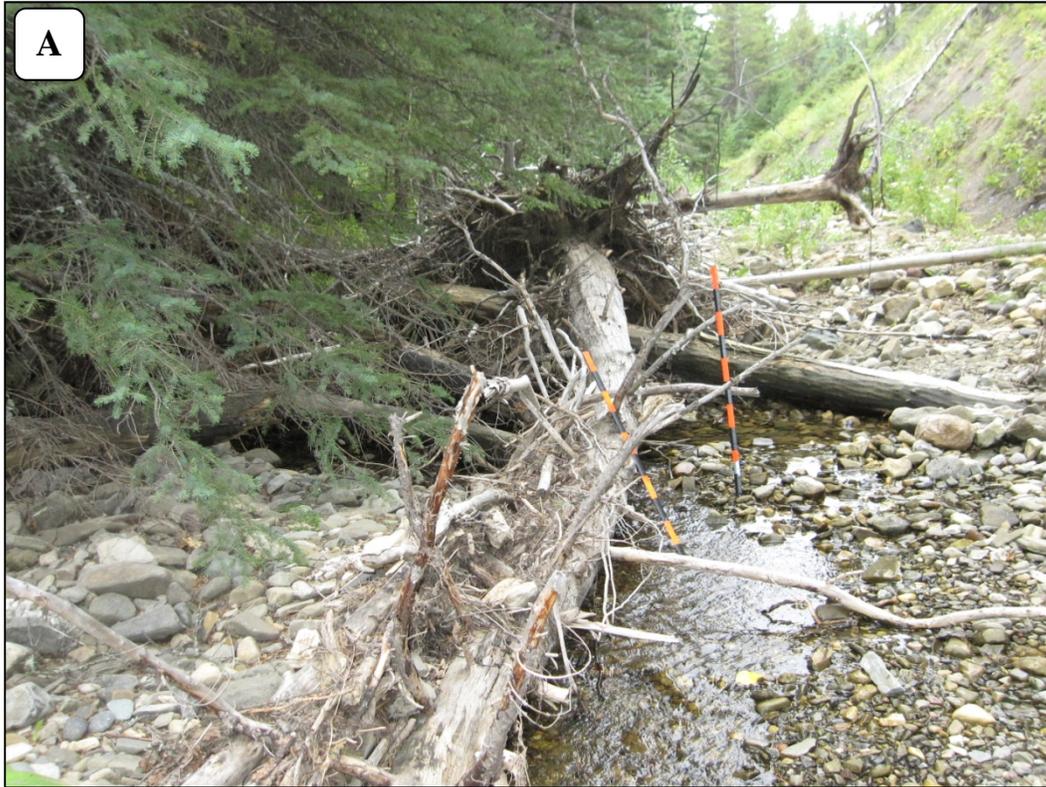
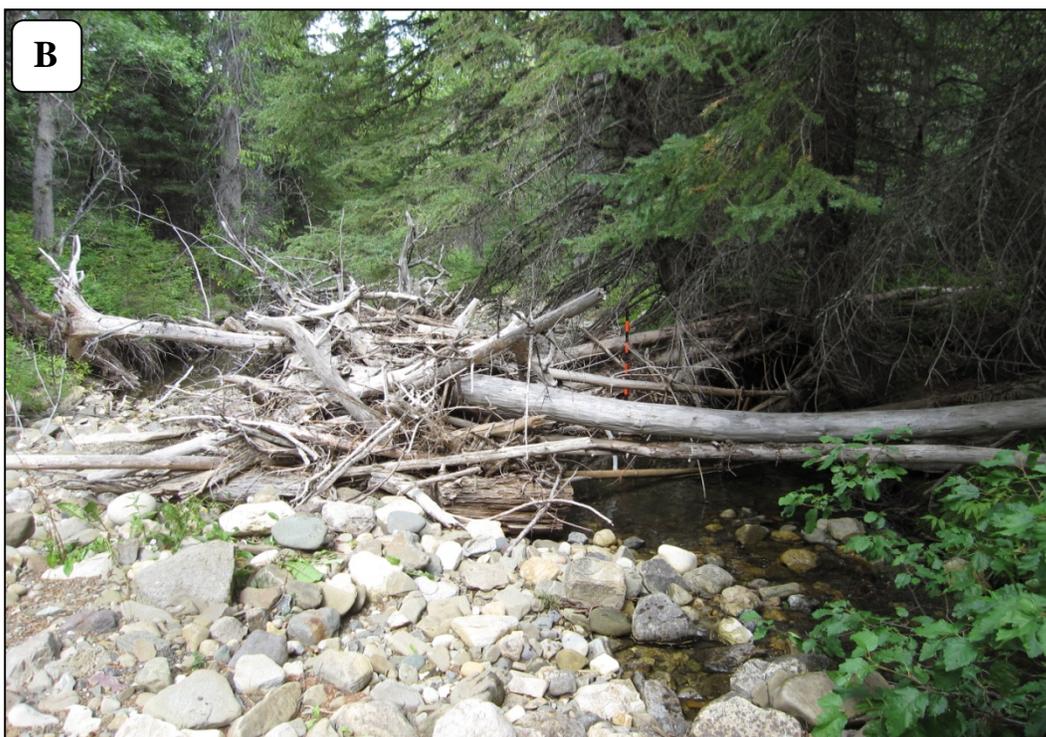
Figure F-4: Corolla Creek site 3 looking upstream (A) and downstream (B) towards the jam. These photographs illustrate the jam structure, wood characteristics and geomorphic features. The black and orange meter sticks are 10cm intervals for scale.

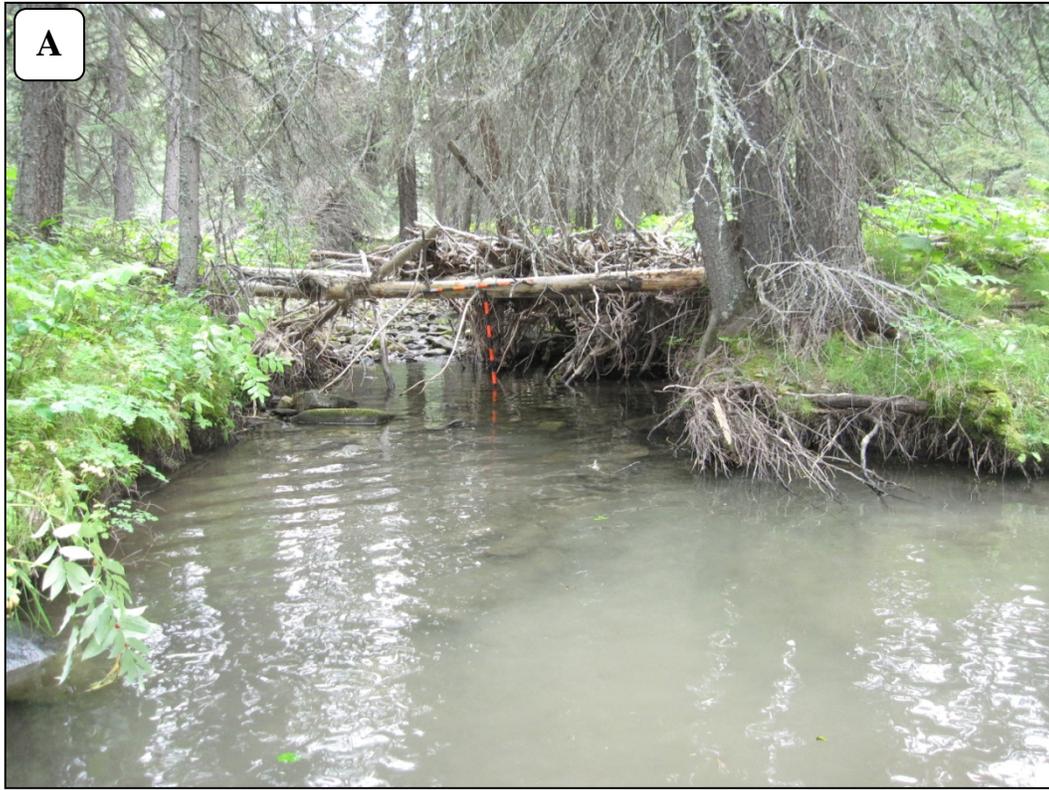
Figure F-5: Corolla Creek site 24 looking upstream (A) and downstream (B) towards the jam. These photographs illustrate jam structure, wood characteristics and geomorphic features. The murky water in “A” is due to suspended sediment from photographer’s movement in the channel. The black and orange meter sticks are 10cm intervals for scale

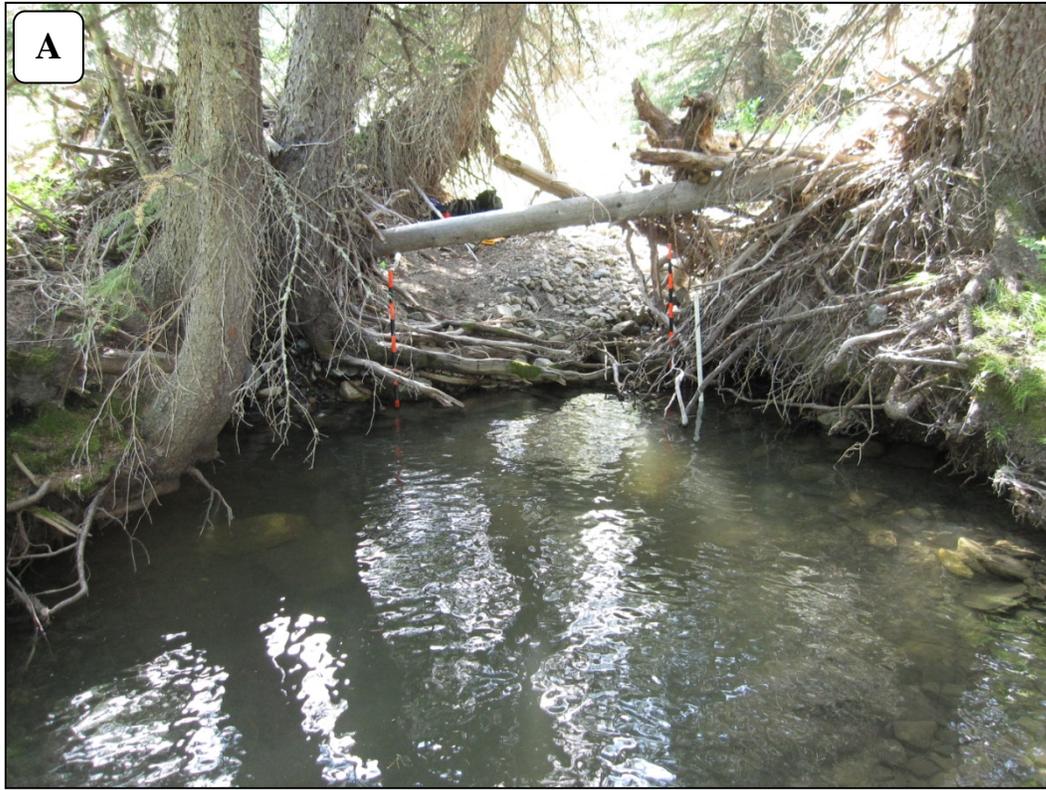
Figure F-6: Corolla Creek site 25 looking upstream (A) and downstream (B) towards the jam. These photographs illustrate jam structure, wood characteristics and geomorphic features. The black and orange meter sticks are 10cm intervals for scale.

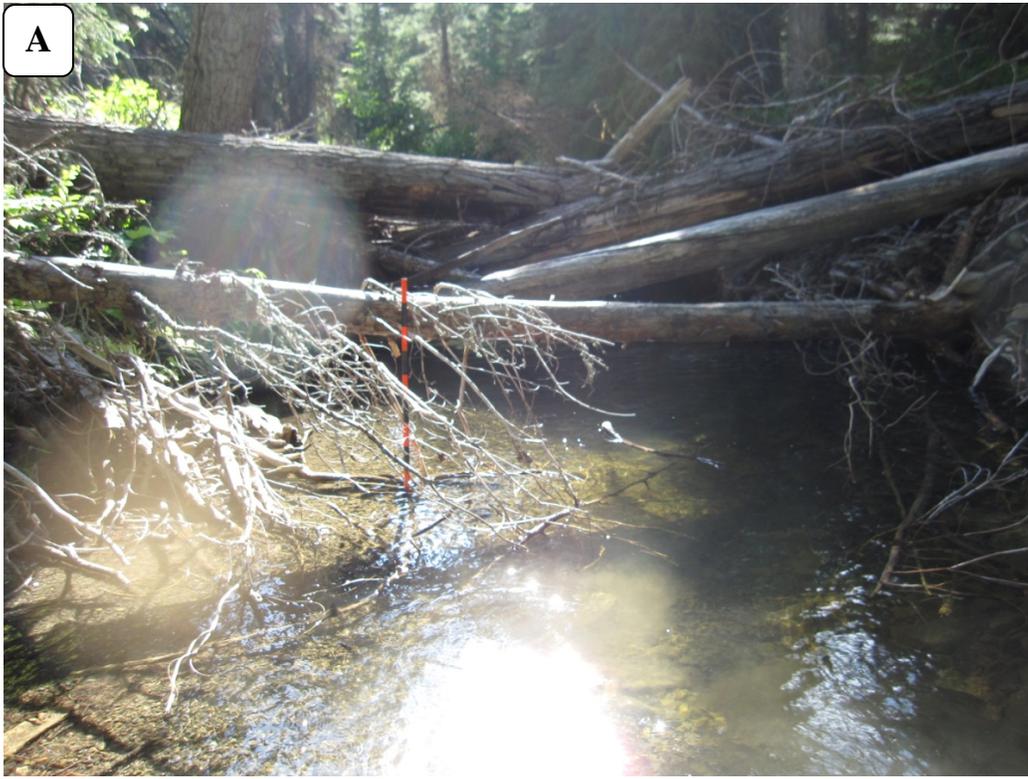
Figure F- 7: Corolla Creek site 26 looking upstream (A) and downstream (B) towards the jam. These photographs illustrate jam structure, wood characteristics and geomorphic features. The black and orange meter sticks are 10cm intervals for scale (A). The circled “Rite in the Rain” field book provides scale (B).
