Evaluation of the Performance of Pervious Concrete Pavement in the Canadian Climate

A thesis
presented to the University of Waterloo
in fulfillment of the
thesis requirement for the degree of
Doctor of Philosophy
in
Civil Engineering

Waterloo, Ontario, Canada, 2012

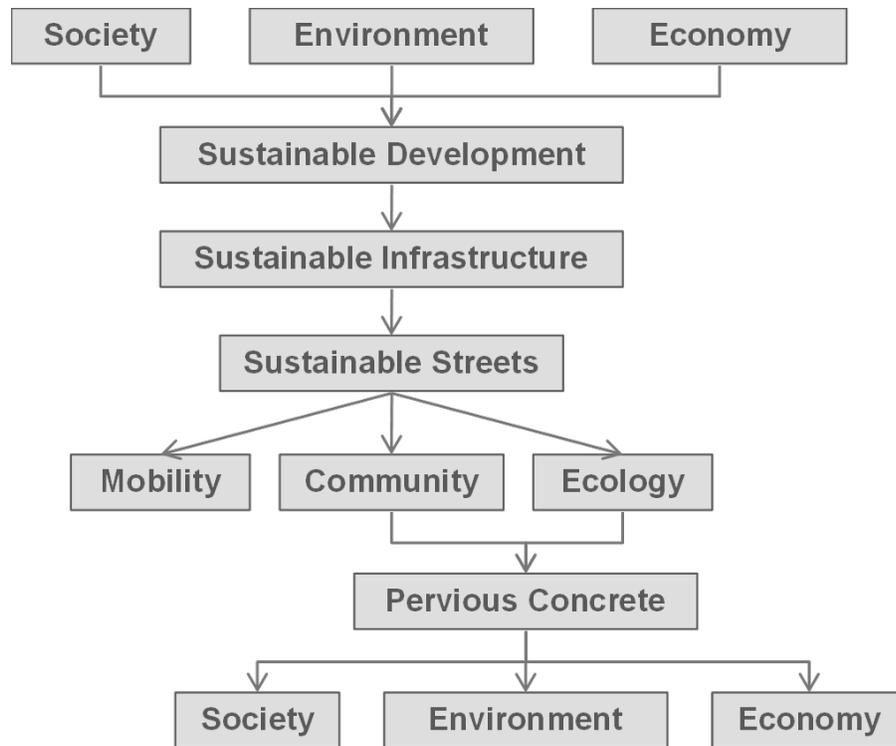
Figure 1-2: Pervious Concrete Pavement Sustainability Flow Chart (Henderson & Tighe, 2011)

The introduction of pervious concrete pavement to cold weather climates, specifically Canada, was initiated by the sustainable benefits it offers. Figure 1-2 demonstrates how pervious concrete pavement can be involved in sustainable development and sustainable streets.

Pervious concrete pavement offers many benefits when integrated into urban areas. The ability for pervious concrete to drain water from the surface offers benefits which span various sectors including the environment, society and economy. Figure 1-2 described the relationship between sustainable development and pervious concrete pavement. The relationship demonstrated in Figure 1-2 is unique to pervious concrete pavement as not all pavement or stormwater management alternatives would fulfil the presented features. In all three aspects of sustainability, the benefits that can be achieved from the use of pervious concrete pavement are often immediate as well as long term and connected.

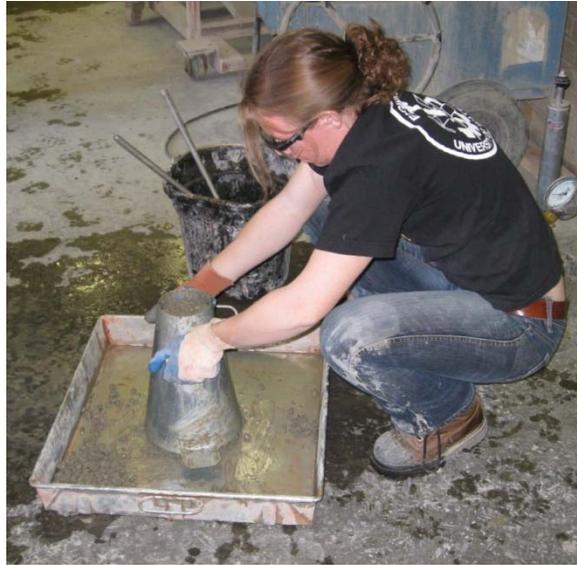
Figure 3-1: Slump Testing

Figure 3-1 shows slump testing being performed in the laboratory at the University of Waterloo.

Following the procedure in CSA A23.2-5C the slump cone or mould is moistened and placed on a flat non-absorbent surface (CSA, 1996). The cone is then filled in three layers, with each layer consisting of enough concrete mix to fill approximately one third of the volume of the mould. Each layer is rodded 25 times, with the rodding being distributed evenly across the layer. The final layer should be filled over the top of the cone, so that after the 25 rods are complete there is still excess material and it can be rolled off with the rod and the concrete is left flush with the top of the cone. The cone is then lifted off the concrete, at a steady rate, that is performed in close to five seconds. The cone can then be placed, upside down beside the concrete and the difference in height between the concrete and mould can be measured. This measured value is the “slump” of the mix. As Figure 3-2 shows, pervious concrete generally has a low slump, often 0 mm.

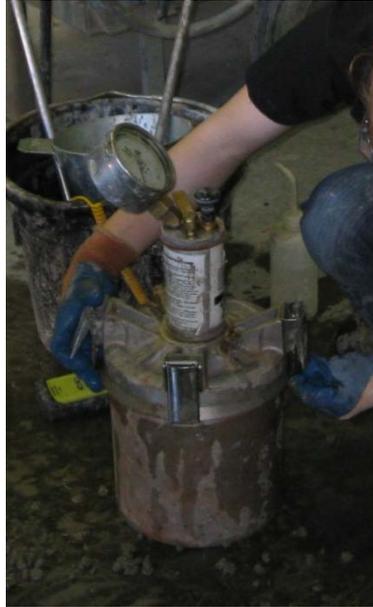
Figure 3-3: Air Meter Bucket

bowl, by 3 mm is optimum. The top of the bowl is then struck off using a strike off bar. The exterior of the filled bowl is then cleaned with a damp cloth to remove any excess material. The lid to the air meter can then be attached. Figure 3-3 shows an air meter bucket with the lid attached.

At this point the air meter should be filled with water through the holes in the lid of the air meter until water is flowing out and is clear. The holes are then closed and using the air valve, the air meter should be pumped with air to the calibration value. The air meter pressure is then released and the air entrainment content can be read off the dial.

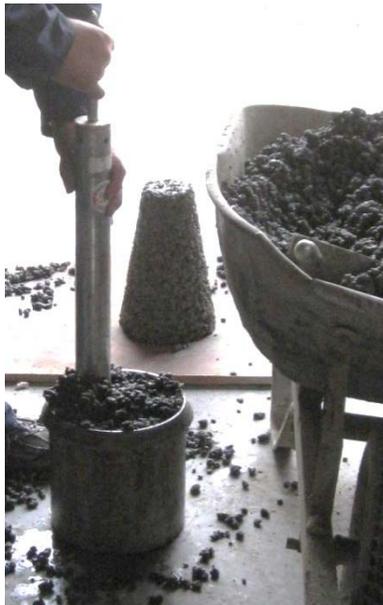
Figure 3-4: Proctor Hammer Compacting Pervious Concrete for Density Testing

In this method a cylindrical container, such as an air meter bucket, with a diameter to height ratio of 0.75 to 1.25 should be used. Pervious concrete should be placed in the container in two layers, with the layers being approximately equal in volume. When each layer is placed in the container the pervious concrete should be distributed throughout the bowl. Each layer is then compacted using a Standard Proctor Hammer. The Proctor Hammer should be dropped 20 times per layer with the drops being distributed across the layer. Figure 3-4 shows the Proctor Hammer being used to compact the pervious concrete during density testing.

After compacting the second layer the pervious concrete should be overflowing the container, ideally by 3 mm. If after ten Proctor Hammer drops on the second layer it does not appear that the pervious concrete will be overflowing following the total 20 drops then more pervious concrete should be added. After the 20 drops are completed the excess pervious concrete should be removed by striking off the surface. The pervious concrete should be level with the top of the container. All excess pervious concrete on the exterior of the container should be removed with a damp sponge. The pervious concrete and container can

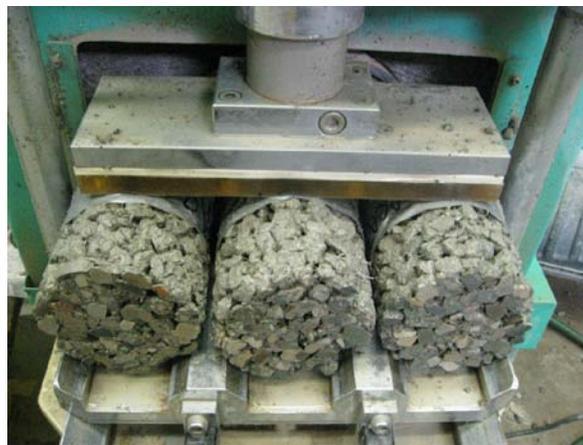
Figure 3-5: Cylinder Sample End Preparation by End Grinding

In general the cylinders were tested for compressive strength at 7 and 28 days of age. The ends of the cylinders and cores were prepared for compressive strength testing using an end grinder which is shown in Figure 3-5. In Rizvi 2009 end preparation techniques including end grinding and sulfur capping were evaluated (Rizvi, Tighe, Henderson, & Norris, 2009). The results proved end grinding produced samples that provided consistent data and the preparation was much easier to carry out without damaging the samples.

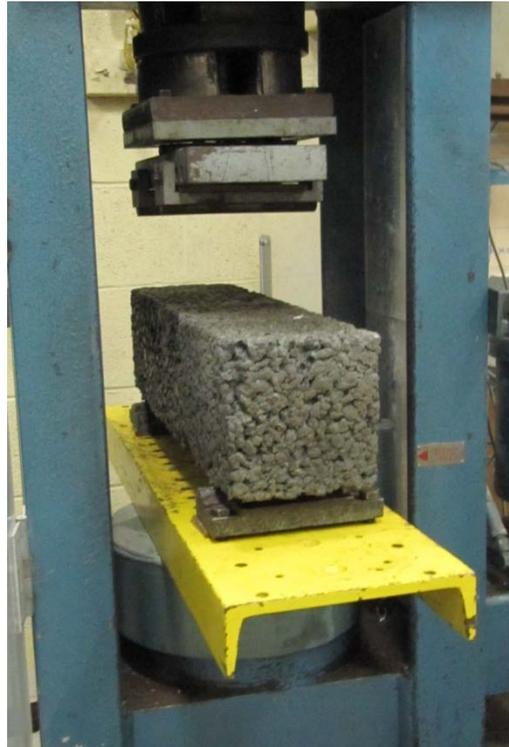
Figure 3-6: Flexural Beam in Testing Frame

3-6, with the bottom support blocks being L width apart. In the case of the beams prepared in this project L was at minimum 465 mm as the height of the beams was 155 mm. The load applying blocks were one third of L apart and centered over the beam. The beam was then loaded until rupture occurred.

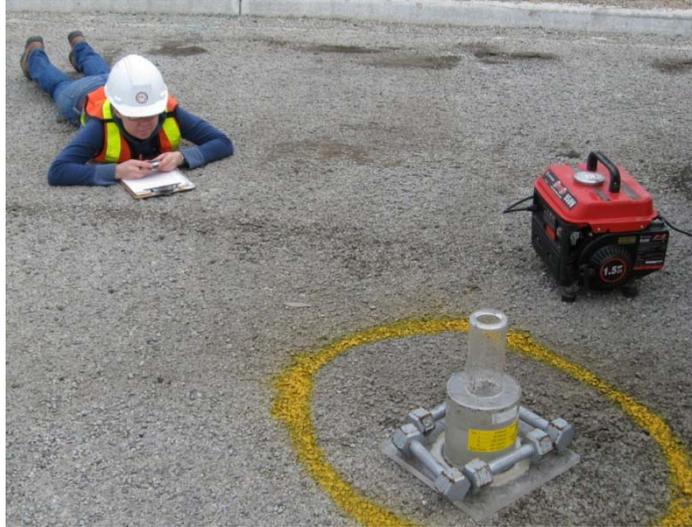
Figure 3-7: Gilson Permeameter

The permeameter is sealed to the pervious concrete surface. This is done by applying a thick (approximately 25 mm) ring of plumber’s putty to the bottom of the permeameter. The permeameter is then placed on the surface and pushed into the surface to move the putty into the pervious concrete voids around the edge. By sealing the permeameter to the surface the water is then forced to enter the pervious concrete during testing and not drain along the surface. After sealing the permeameter to the surface, four weights are placed along the base to ensure that leaks do not develop due to the pressure of the water if the permeability rate is low.

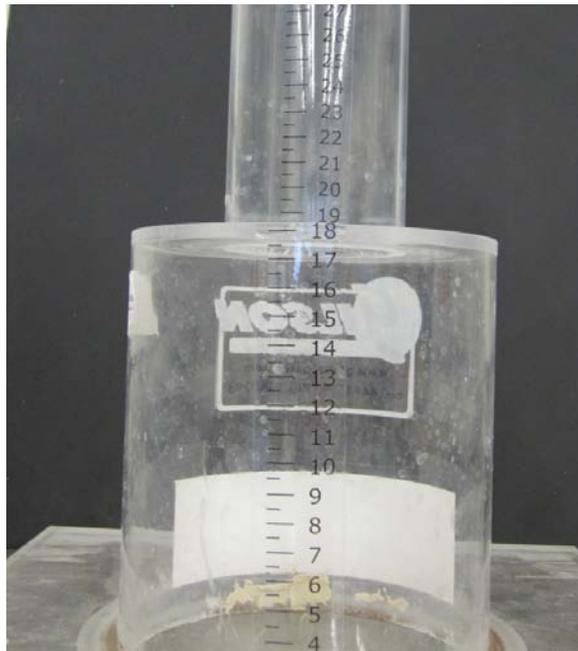
Figure 3-8: Graduated Measurement Markings on Permeameter

One evaluator lies flat on the ground so that their eyes will be level with the water in the permeameter. While the second evaluator then pours water into the permeameter. The person who is lying on the ground will record the time required for the water level to drop from one mark to another. Figure 3-8 shows the graduated marks on the permeameter. Both the initial and final points need to be within one tier.

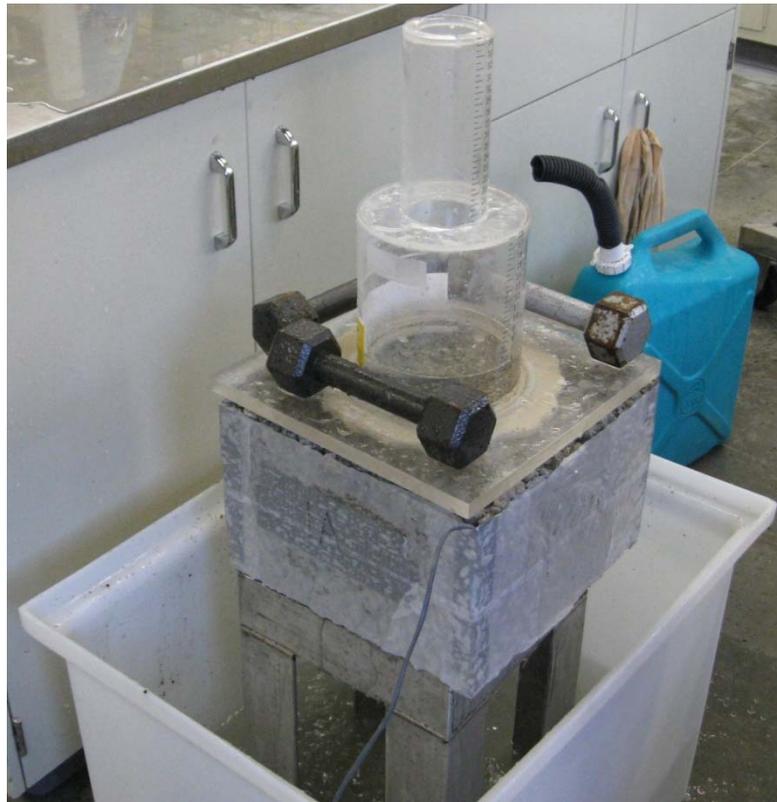
Figure 3-9: Permeability Testing of a Slab in the Laboratory

When slabs are tested in the laboratory the procedure is the same as it is at the field sites. Figure 3-9 shows a pervious concrete slab being tested in the laboratory.

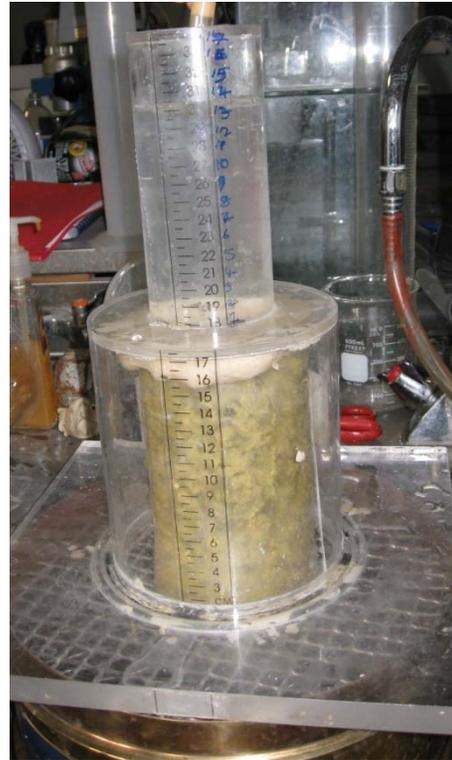
Figure 3-10B – 100mm Diameter Core

The same permeameter is used for testing 100 mm and 150 mm cores and cylinders that is used for the slabs and field sites. The cores and cylinders are wrapped in a latex sleeve to minimize and ideally eliminate drainage out of the sides of the samples. In the field it is anticipated that drainage occurs both horizontally and vertically however, it is not predicted that there are any channels that provide as little resistance as the edges of a cylinder does. Therefore the latex sleeve is used to provide pressure to the open voids and reduce free flowing water out of those voids. The industrial putty is used along the rim of the permeameter and pressed into the top of the cylinders to seal the testing equipment. Figure 3-10 shows a 100 mm sample and a 150 mm sample being tested for permeability.

As Figure 3-10B shows, the 100 mm samples fit inside the larger tier and are sealed to the smaller top tier. The cores and cylinders are then tested in the same manner as the field sites and slabs with the permeameter being filled with water and timed between two points. In all cases, Equation 3-3 is used to determine the permeability of the pervious concrete.

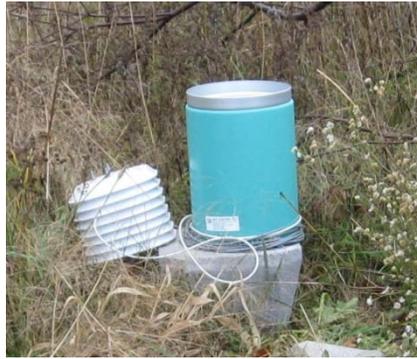
Figure 3-11: Weather Station at a Field Site

Each field site includes a weather station that records air temperature and the quantity of rainfall in each event. An example of a weather station is shown in Figure 3-11.

Each of the weather stations includes a PVC tipping bucket rain gauge and a HOBO Pendant Event and Temperature Logger. The logger records rain events in the tipping bucket as well as temperature readings of the air. The temperature readings are taken from within the white housing shown in Figure 3-11, which is a solar radiation shield. The weather stations provide information regarding the weather activities occurring at each field site. It was intended that the data collected from these weather stations would be used to compliment and better understand other data collected in this project. Examples of such are the timeline of moisture movement through the pavement structure and the temperature of pervious concrete pavement structures in comparison to the air.

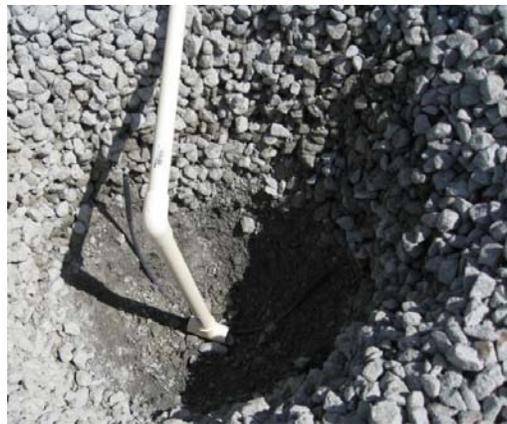
Figure 3-14: Temperature Probes Being Installed

Temperature probes, model 109B, supplied by Campbell Scientific, were included in the subgrade of some of the field sites. The inclusion of this instrumentation was a necessity in order to interpret data recorded by the moisture gauges. Figure 3-14 shows a temperature probe during installation at the construction of a field site.

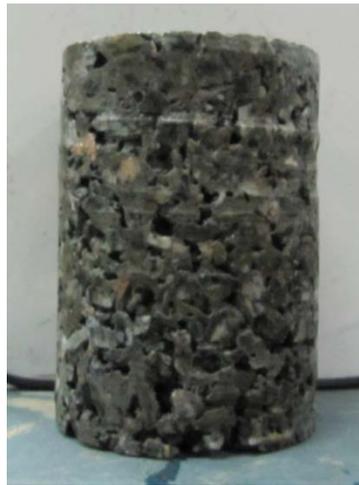
Figure 5-1: Varying Density in a Core from Site 5

It has been noticed in some cores extracted from the field sites that the top of the core appears denser, therefore visually appearing to have fewer voids than the bottom of the core. This is anticipated to be a function of the mix design and the construction method. Some of the cores were cut into slices in order to measure the voids in these various areas. Void contents of cores from Sites 1 and 3 are provided in Table 5-1. Cores from Sites 2 and 4 did not visually show variable densities. Cores from Site 5 also showed varying densities. However, were not sliced for testing as they were used in other types of analysis.. Figure 5-1 shows an example of a core from Site 5 and the visible differences in density.

Table 5-1 shows that the differences in void content within one core ranged from 2.7 % to 20.8 %. The cores from Site 3 labeled 1U# are from the entrance portion of the field site (3A) and those labeled 2U# are from the exit portion (3B).

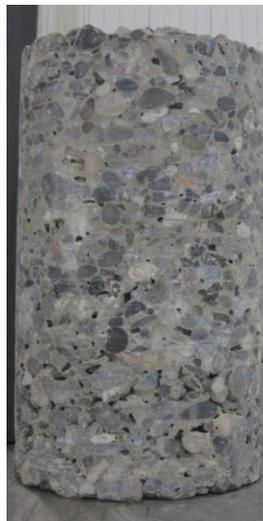
Figure 5-2: Core 2U1 from Site 3

Figure 5-2 shows a photo of one of the cores from Site 3. Unfortunately the permeability of neither portion of Site 3 has remained adequate and it is anticipated that the

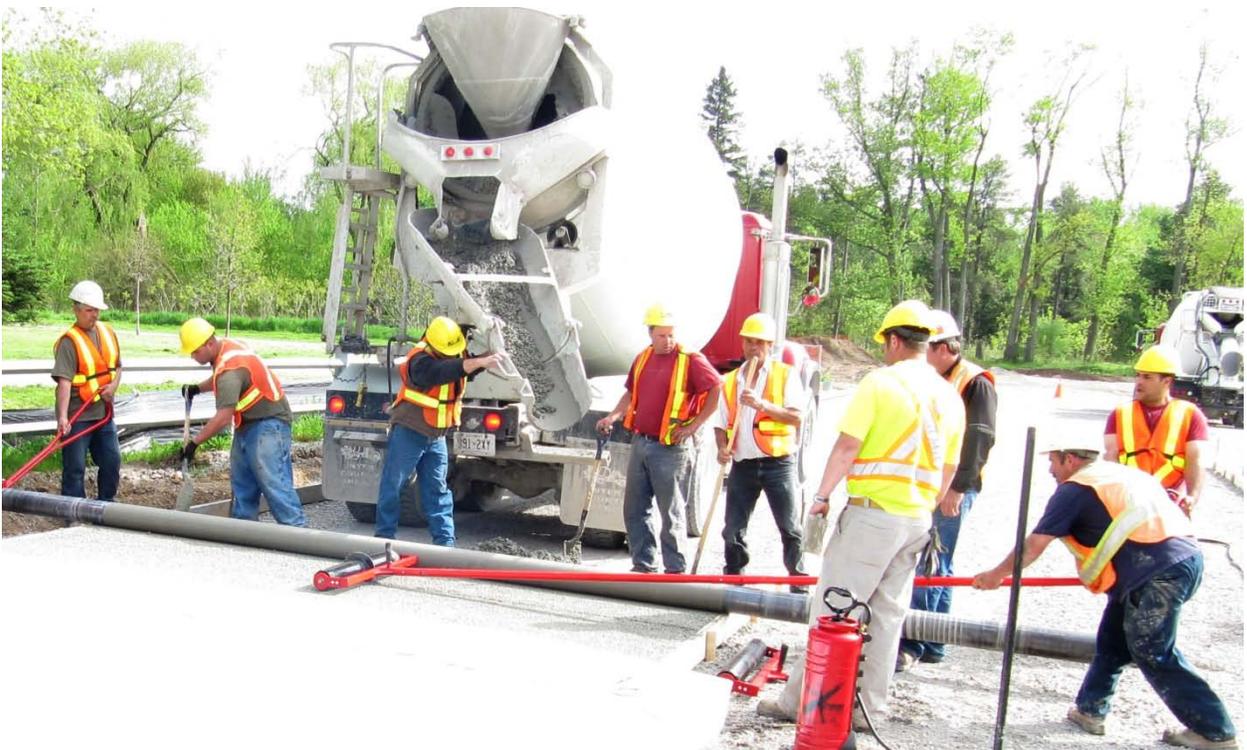
Figure 5-3: Joint Former

Joints that were formed were done so using a joint former, also referenced as a “pizza cutter”. Figure 5-3 shows a joint former in use.

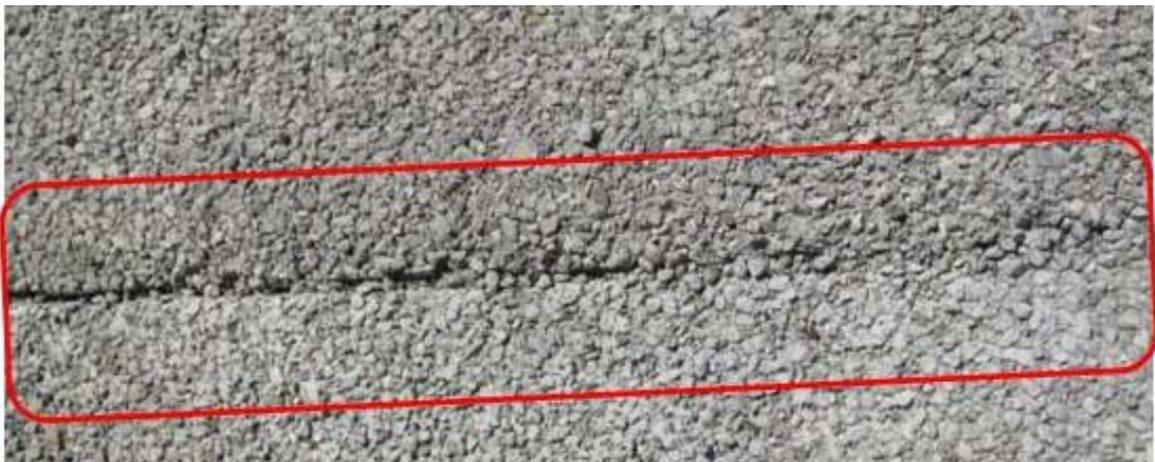
Figure 5-5: Formed Joint August 2009 Site 1 (26 Months)

Figure 5-4 to Figure 5-7 show the performance over multiple years of joints that were formed during construction at Site 1.

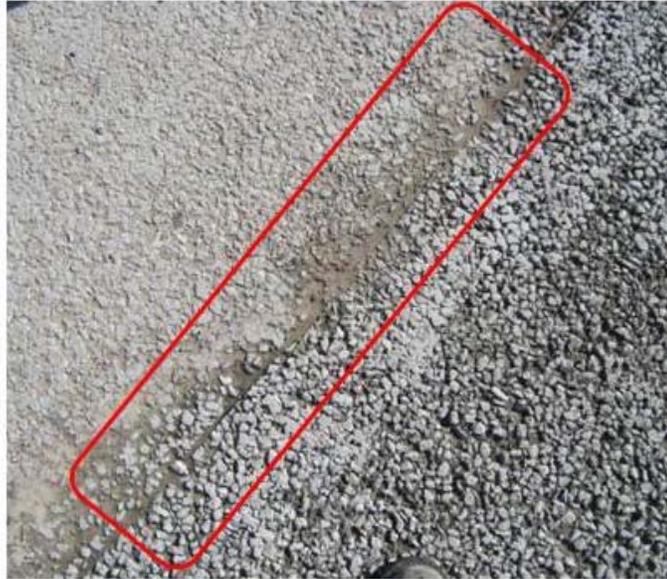
Figure 5-10: Saw Cut Joint Site 5 June 2011 (32 Months)

When a joint is saw cut the aggregate is cut with the blade of the saw to create an open space. Disturbance is experienced by the aggregate and bond between surrounding aggregates due to the forces created from the saw blade. However, no aggregates are moved as is done when the joint is formed. In order to minimize damage to the pervious concrete the joints are not cut until the pervious concrete has had adequate time to cure and gain strength. It is important though, to sawcut the joints before cracks develop in the pervious concrete due to shrinkage. If cracks have already initiated development then the joints will not serve their intended purpose, to provide a location for cracking. Joints were saw cut at Site 5 and at some locations at Site 2. Figure 5-8 to Figure 5-10 show the performance of the saw cut joints at Site 5.

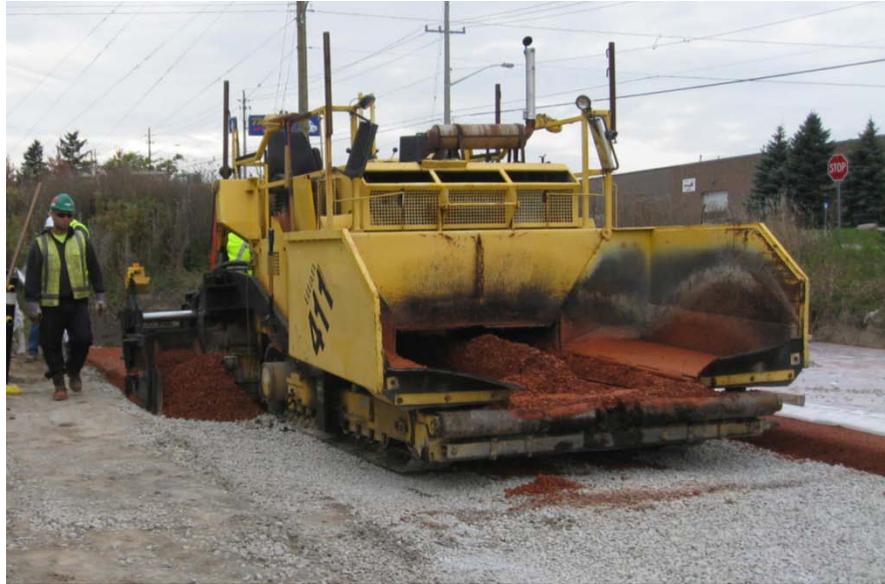
Figure 5-11: Construction of Site 4

At Site 4 an ABG asphalt paver was used to place the pervious concrete and was followed by a vibratory plate compactor. The observations from each of the field sites based on the construction method used are described below. Finally, the performance and characteristics of the pervious concrete pavement related to the various construction methods is presented.

Figure 5-11 shows the construction of Site 4 and Figure 5-12 to Figure 5-14 show the performance of the construction joints.

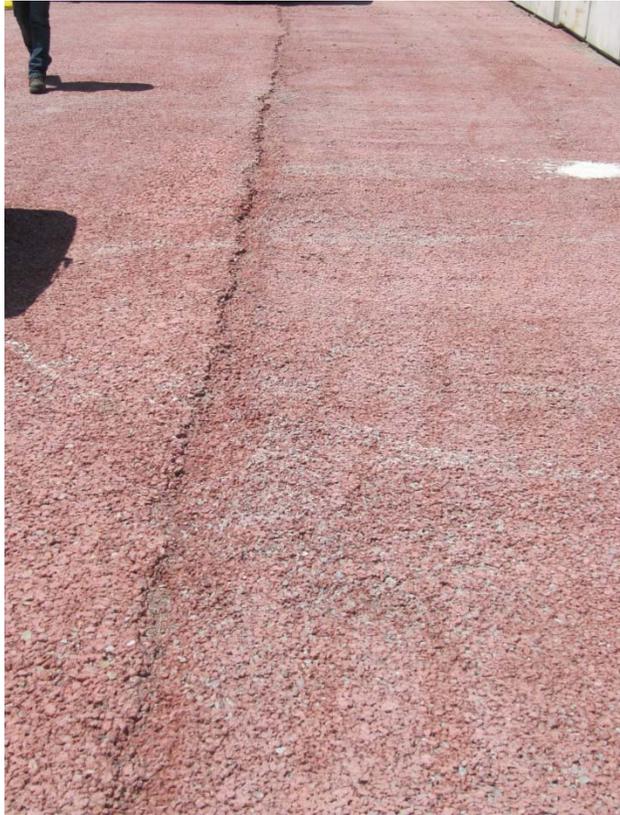
Figure 5-13: Construction Joint A/B at Site 4 June 2010 (20 Months)

As is seen in Figure 5-12 to Figure 5-14 the performance of the construction joints continues to deteriorate with time. While it is possible that only the upper most portion of the pervious concrete layer was disturbed by the adjacent pass being constructed it is evident from the results in Section 5.2 that uniform compaction is not always achieved throughout the depth of the pervious concrete pavement layer. Therefore, as deeper portions of the pervious concrete layer become exposed they are more likely to ravel as the strength of the bonds between the aggregates is lower due to less compaction during construction. The cores did not show a visible difference in density between the top and bottom, so the compaction at Site 4 could be uniform throughout the pervious concrete layer.

By placing the adjacent pervious concrete pass before allowing for curing the pervious concrete from the previous pass was weak and vulnerable to disturbance. Disturbance to the edge of the prior pass was inevitable as the intent was to place the next pass flush against the edge. This scenario was repeated at the construction joint B/C as well.
