Mitigation of Climate Change Impacts on Runway Friction

Kuujuaq Airport

A thesis

Civil Engineering

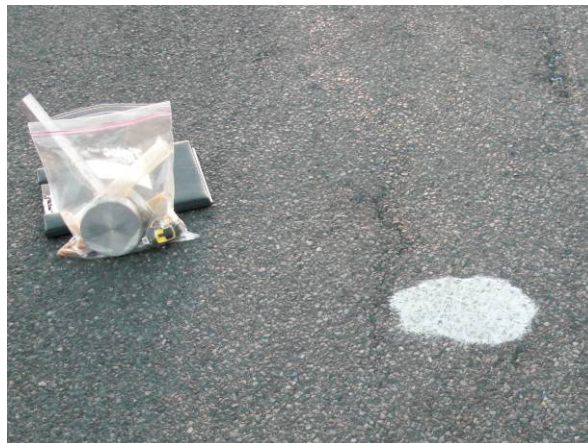
Figure 2.9 Sand Patch test (Field site visit, 2012)

The test consists of spreading a known volume of a material on a clean and dry pavement surface, measuring the area covered and subsequently calculating the average depth between the bottom of the pavement surface voids and the tops of the surface aggregate particles (ASTM, 2006a). A photograph of a sand patch test is shown in Figure 2.9.

This test method is suitable for field tests and is used to determine the average macrotexture depth of a pavement surface. Pavement macrotexture depth is used to characterize the pavement surface texture. When used in conjunction with other physical tests, the macrotexture depth values obtained from this test method may be used to determine the pavement skid resistance (ASTM, 2006a).

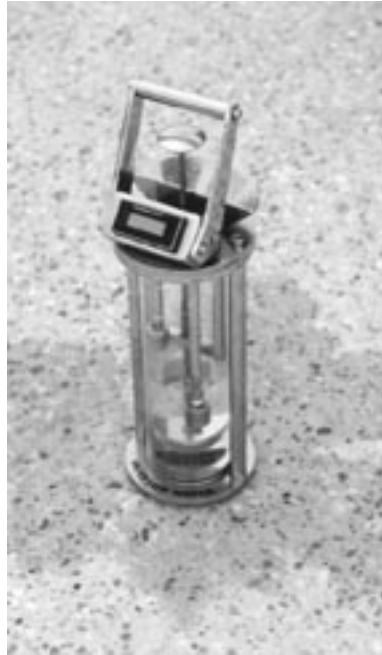
The Outflow Meter apparatus consists of a transparent vertical cylinder that rests on a rubber annulus placed on the pavement, as shown in Figure 2.10. A valve on the bottom

of the cylinder is closed and the cylinder is filled with water. The valve is then opened and the time required for a specified volume of water to flow through the system is measured and called the outflow time (OFT). It provides an indication of pavement surface macrotexture characteristics (ASTM, 2005a).

Figure 2.10 Typical Outflow Meter apparatus (National Driller, 2001)

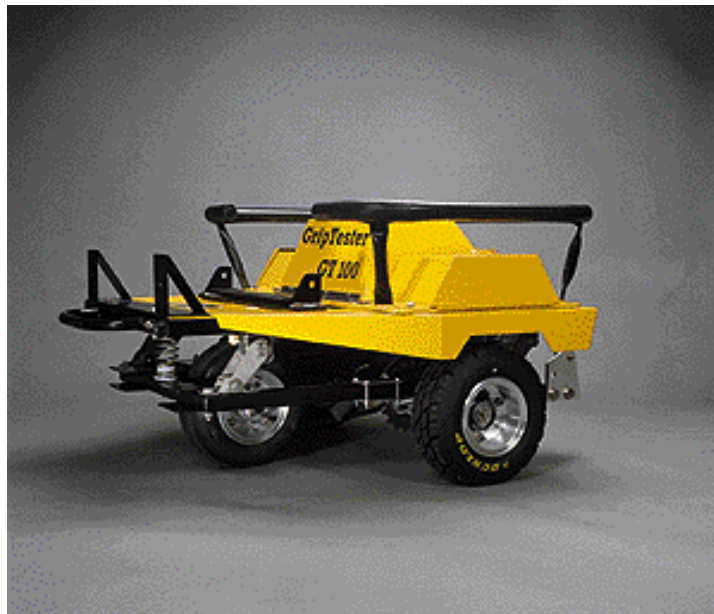
The GripTester is a friction measuring instrument (shown in Figure 2.11) that measures the longitudinal skid resistance coefficient of a pavement continuously and dynamically, and results are expressed as Grip Number (GN) or GripTester Friction Number. Skid resistance is obtained from the friction force which exists between a partially locked wheel and the wet pavement surface (*Skid Resistance (Surface Friction) Tester*, n.d.).

Figure 2.11 Typical GripTester (*Skid Resistance (Surface Friction) Tester, n.d.*).

Specified by ICAO and covered by BS7941-2:2000, the GripTester is the most widely used runway surface friction tester in the World. With over 450 units currently in operation worldwide, the GripTester provides users with the flexibility to undertake the level of runway surveys, which is most appropriate for the volume of air traffic handled (*Skid Resistance (Surface Friction) Tester*, n.d.).

As specified in the Transport Canada Aerodrome Safety Circular ASC 2004-024, the friction test tire which is used on the GripTester should be manufactured to meet the requirements of ASTM E1844. The pressure of the tire is specified at 138 +/- 3 kPa, and the vertical load on the friction test tire is 205 N. The test speed should be held constant at 65 +/- 5 km/h. The test tire is to be continuously braked during testing and should have a constant slip ratio of 10-20 percent. Testing is to be completed when the ambient air temperatures are above 0 degrees Celcius, and the pavement is dry or no more than “damp” prior to testing. “Damp” is when the pavement surface appears to be moist but a water thickness cannot be determined. The depth of water placed in front of the test tire by the self-wetting system should be 0.25 mm in thickness. Alternative water depths of 0.5 and 1.0 mm in thickness may also be used. Friction measurements should be taken on tracks parallel to the runway centerline, at left and right offsets of three meters for runways serving narrow body aircraft (Transport Canada, 2004). Other offsets such as 5 m, 10 m, 15 m may be tested to determine the friction at select locations away from the centreline.

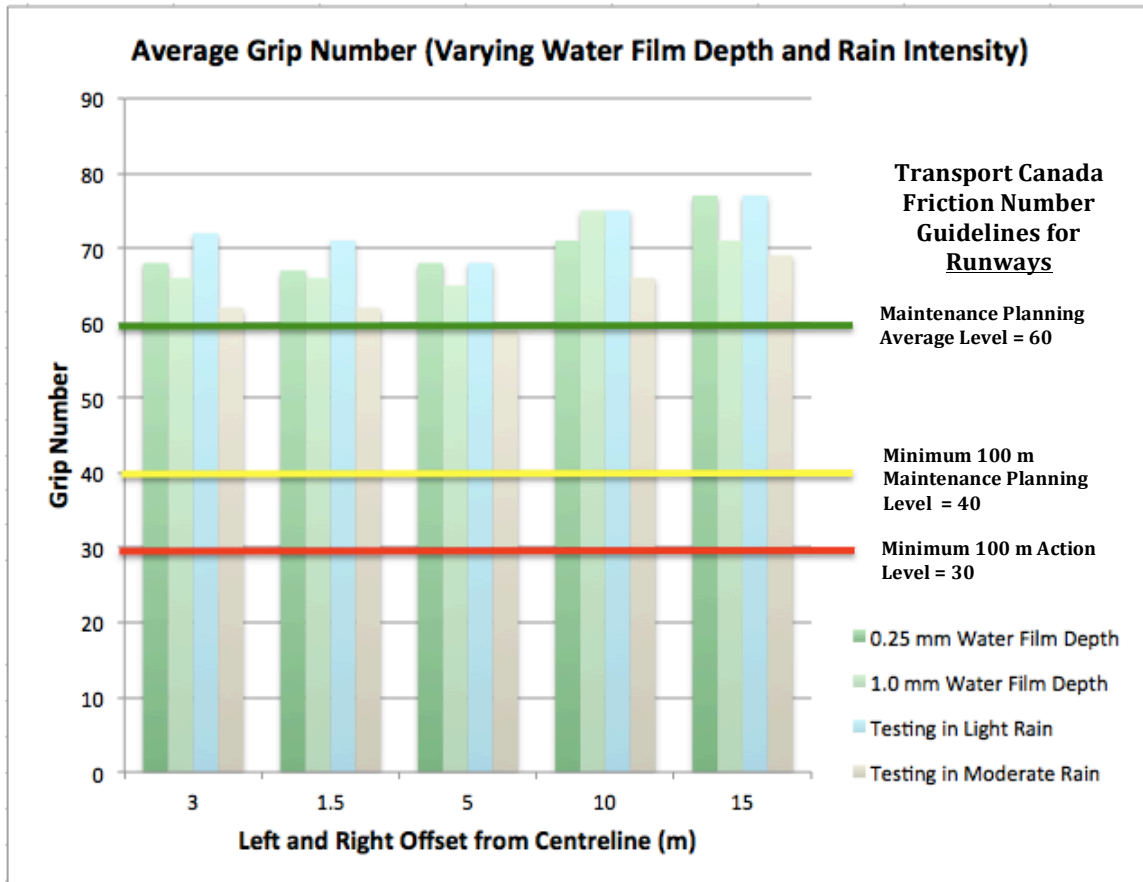
Figure 3.1 Average Grip Number measurement results under controlled self watering and varying rain conditions

Summaries of the results are presented in Figures 3.1 and 3.2.

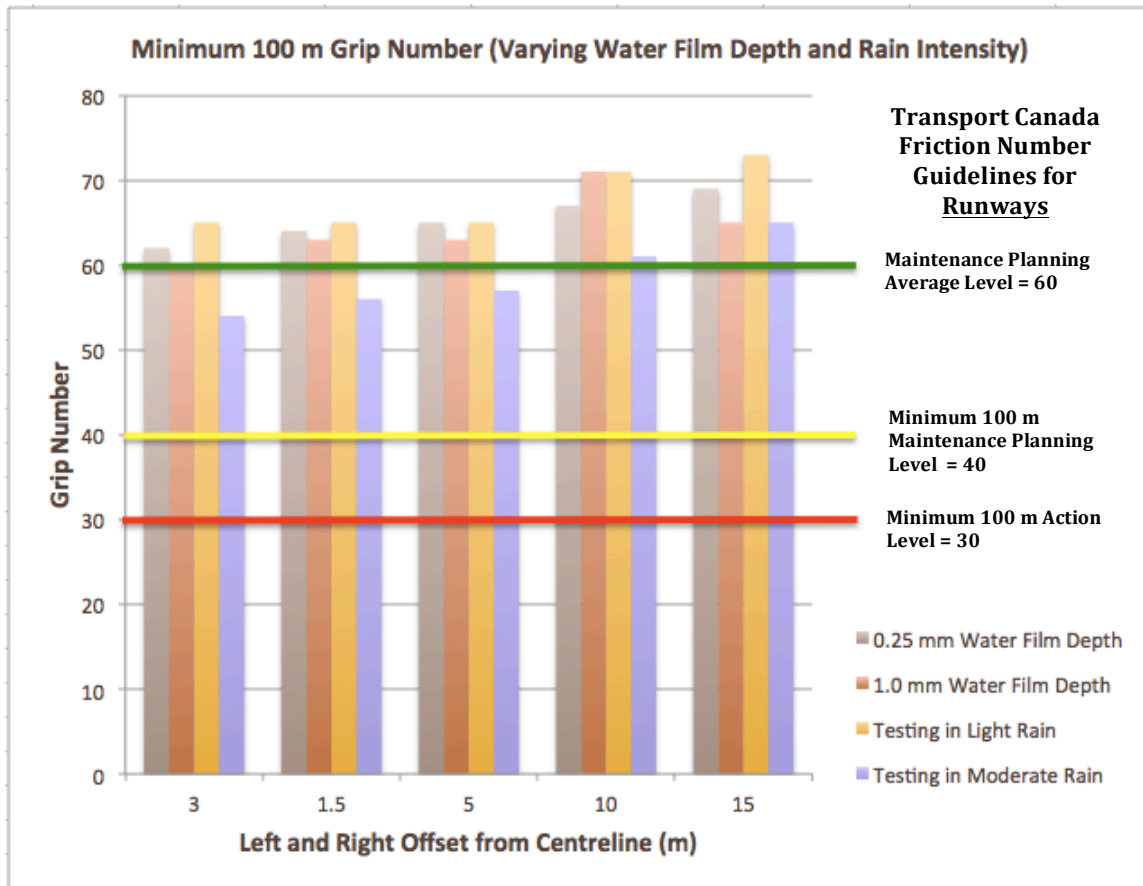
Figure 3.2 Minimum 100 m Grip Number measurement results under controlled self watering and varying rain conditions

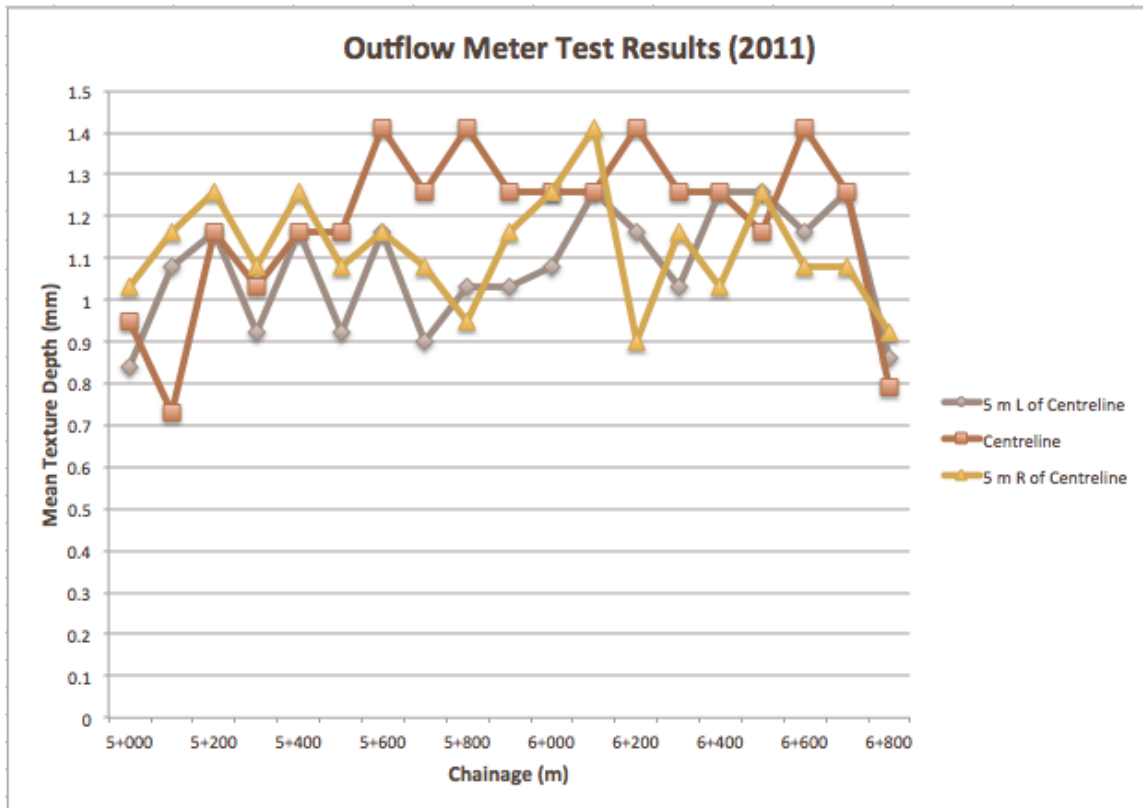
Figure 3.3 2011 Outflow Meter results (mean texture depth)

As part of this study, a survey of the runway surface texture was also conducted, using an Outflow Meter according to ASTM Standard Test Method E2380-05. Figure 3.3 shows a plot of the survey results. Testing was completed at 5 m left and right offsets from the centreline, as well as along the centreline.

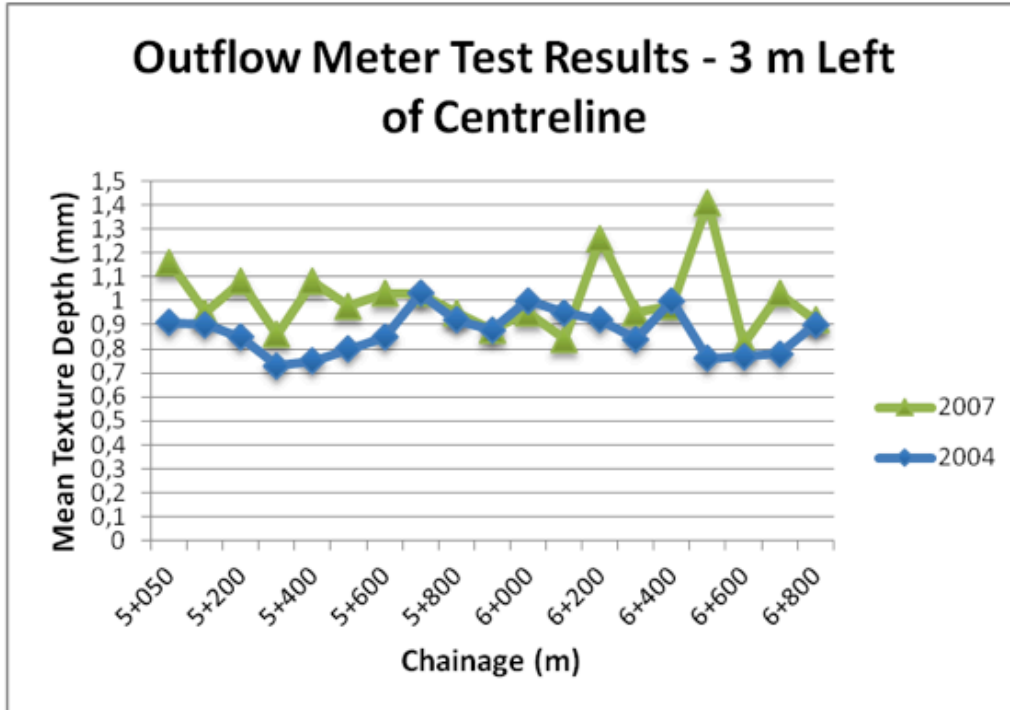
Figure 3.4 Mean texture depth, 3 m left of runway centreline

Texture surveys using the Outflow Meter test were also completed at 3 m left and right offsets from the centreline along the runway in 2004 and 2007, and a comparison was made. Figures 3.4 and 3.5 display how macrotexture has changed from 2004 to 2007. As shown by the graphs, macrotexture has generally increased from 2004 to 2007 along the length of the runway. This is likely due to the pavement surface undergoing aging by weather and winter maintenance activities such as brooming.

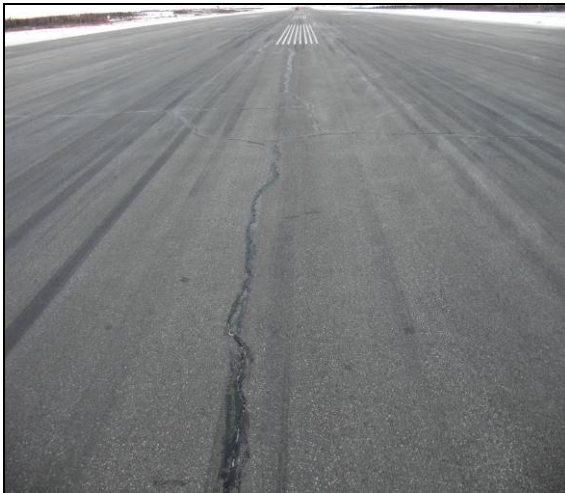
Photograph 1: Touchdown zone near the end of runway 07; location of first sand patch test

Figure 3.6 shows photographs from the December 2012 site visit showing sand patch testing and winter maintenance equipment operating on the runway.

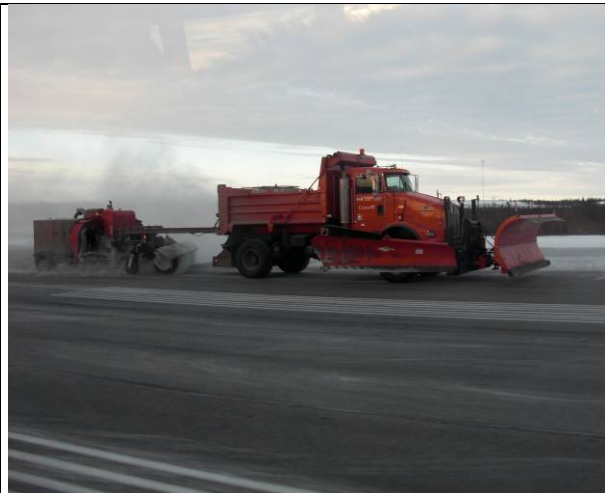
Photograph 2: Runway brooming operations

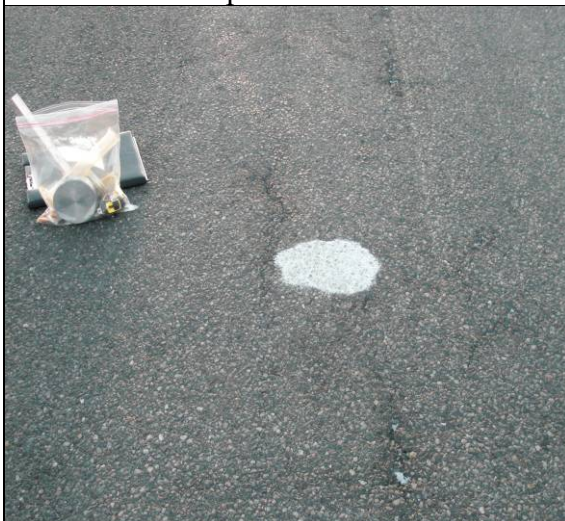
Photograph 3: Sand patch test in area of fatigue cracking on runway

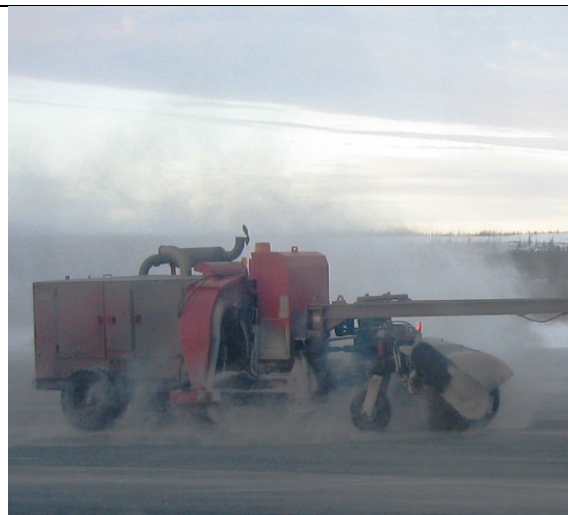
Photograph 4: Close up of brooming equipment

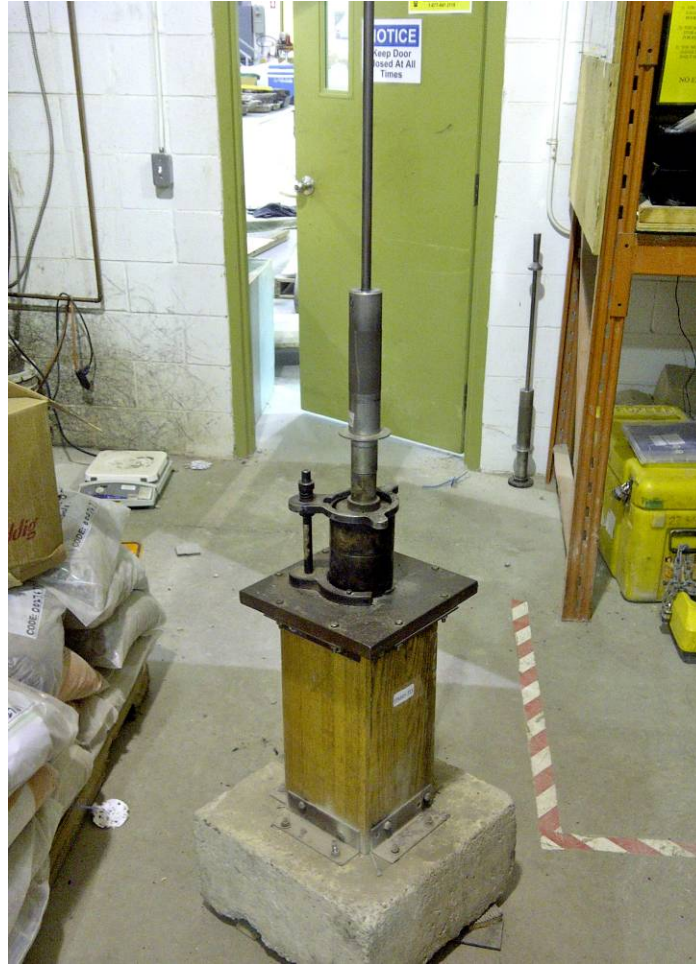
Figure 4.1 Marshall compaction hammer (LVM Toronto laboratory, 2013)

Figure 4.1 shows the Marshall Compaction Hammer used to compact the specimens.

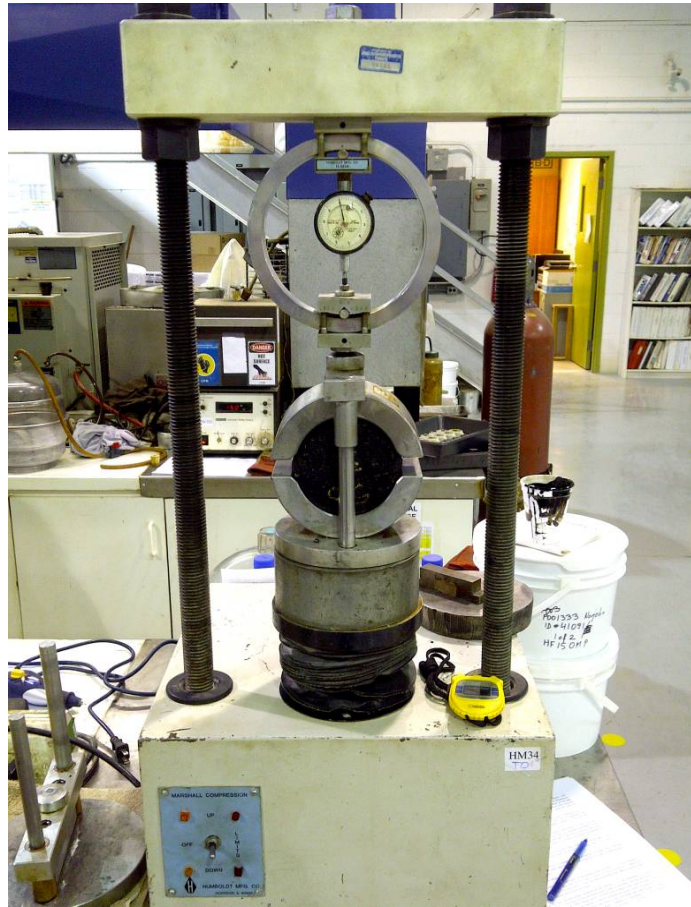
Figure 4.2 Marshall Stability machine (LVM Toronto laboratory, 2013)

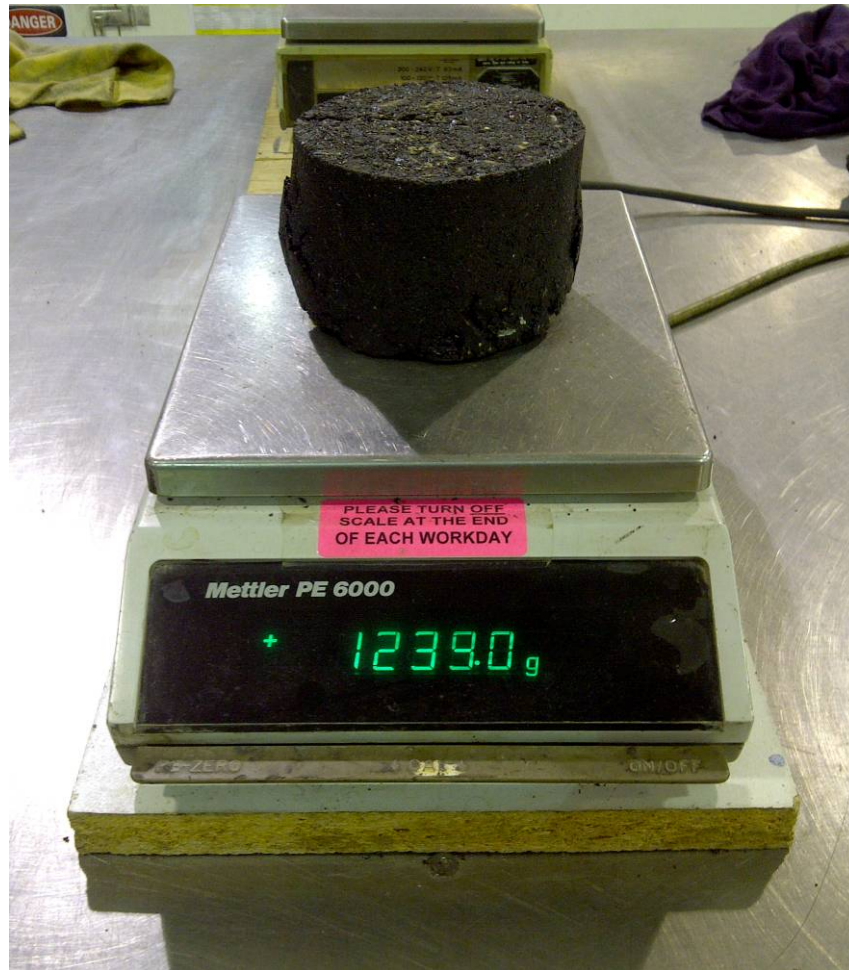
During this test, the specimens (prepared as per Section 4.3.1) are immersed in a water bath at 25°C. The mass of the specimen under water is recorded, and the specimen is then weighed in air (after being quickly blotted with a damp cloth) and recorded. The difference between the two masses is used to measure an equal volume of water at 25°C. The mass of the thoroughly dried specimen is also recorded, and specific gravity (and density) is calculated using these values. Density is calculated by multiplying the specific gravity of the specimen by the density of water (ASTM, 2005c).

Figure 4.3 Scale for weighing specimens (LVM Toronto laboratory, 2013)

Figure 4.3 shows the scale used to record the weight of the specimens.

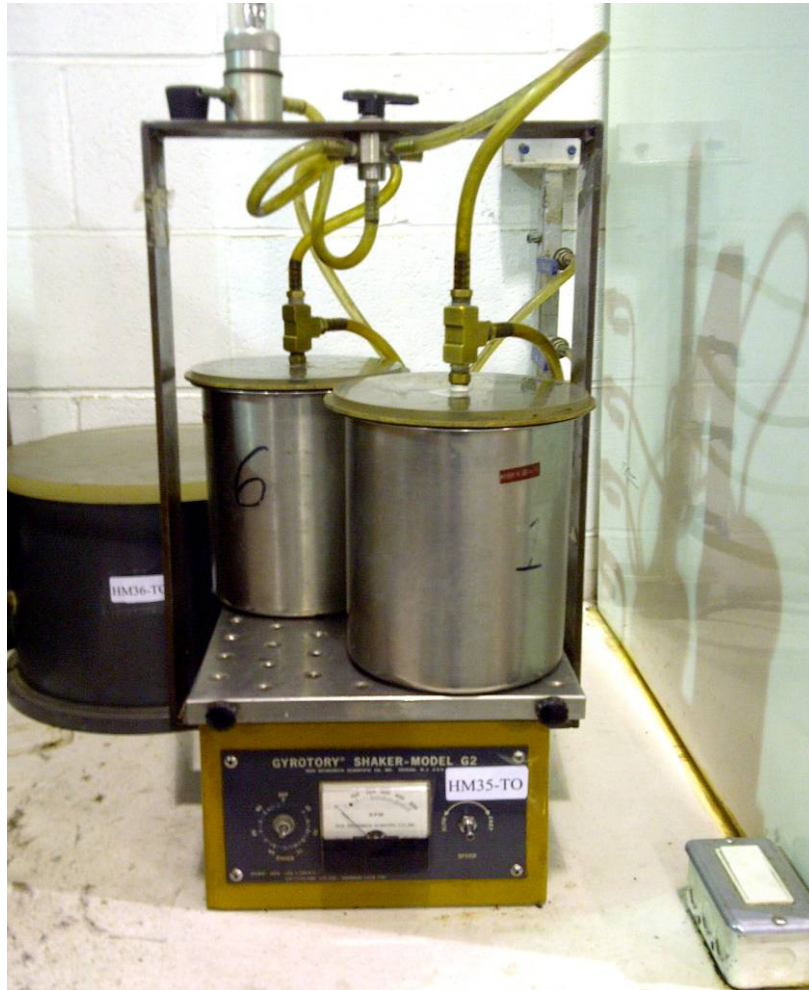
Figure 4.4 Maximum Relative Densometer tester (LVM Toronto laboratory, 2013)

Figure 4.4 shows the Maximum Relative Densometer machine used to apply the vacuum to the vessel.

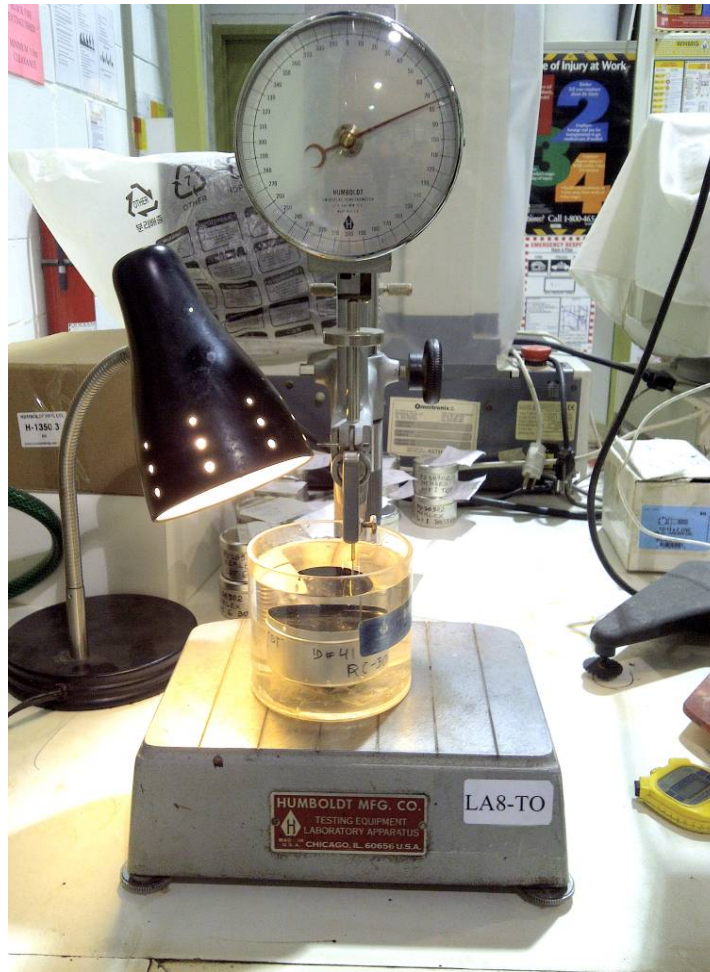
Figure 4.5 Penetration test equipment (LVM Toronto laboratory, 2013)

To complete this test, the sample was melted and cooled under controlled conditions. The penetration was measured with a penetrometer (a standard needle applied to the sample under specific conditions). The penetration test is used to measure consistency; higher penetration values indicate a softer consistency (ASTM, 2006c). Figure 4.5 shows the penetration test equipment.

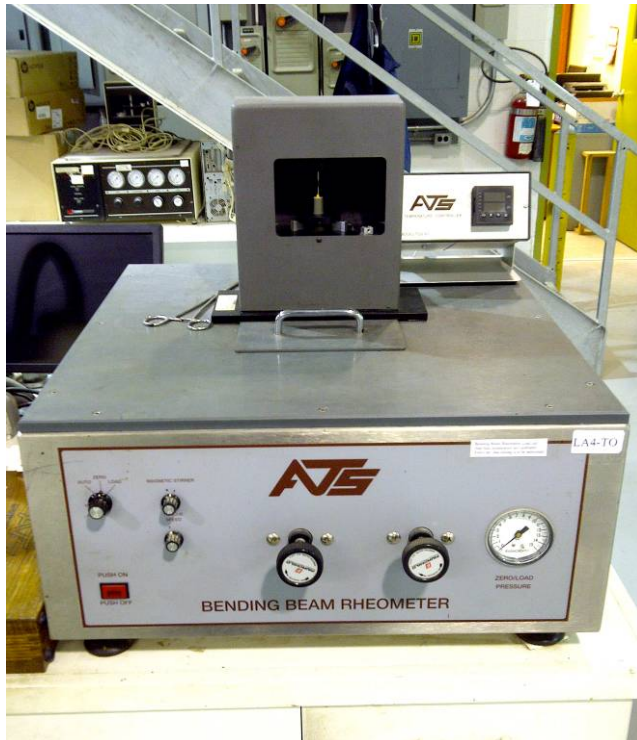
Figure 4.6 Bending Beam Rheometer (LVM Toronto laboratory, 2013)

The procedure consists of melting and cooling the asphalt binder into a container of specified dimensions. A needle is penetrated into the sample under the following conditions: 25°C temperature, 100 g load and a penetration time of 5 seconds, then depth of penetration is recorded. The depth of penetration is measured in units of 0.1 mm and reported in penetration units (for instance, if the needle penetrates 8 mm, the asphalt penetration number is 80). The Bending Beam Rheometer and Dynamic Shear Rheometer machines were used to obtain the information required to classify the asphalt binder. Figures 4.6 and 4.7 show the machines.

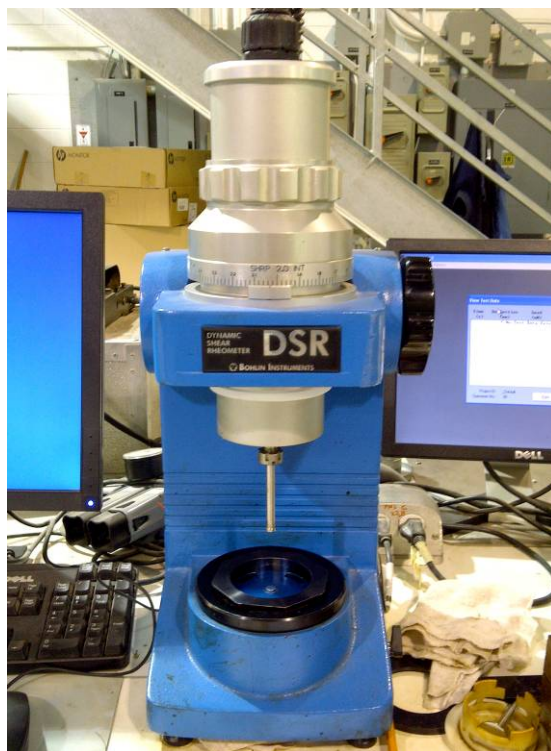
Figure 4.7 Dynamic Shear Rheometer (LVM Toronto laboratory, 2013)

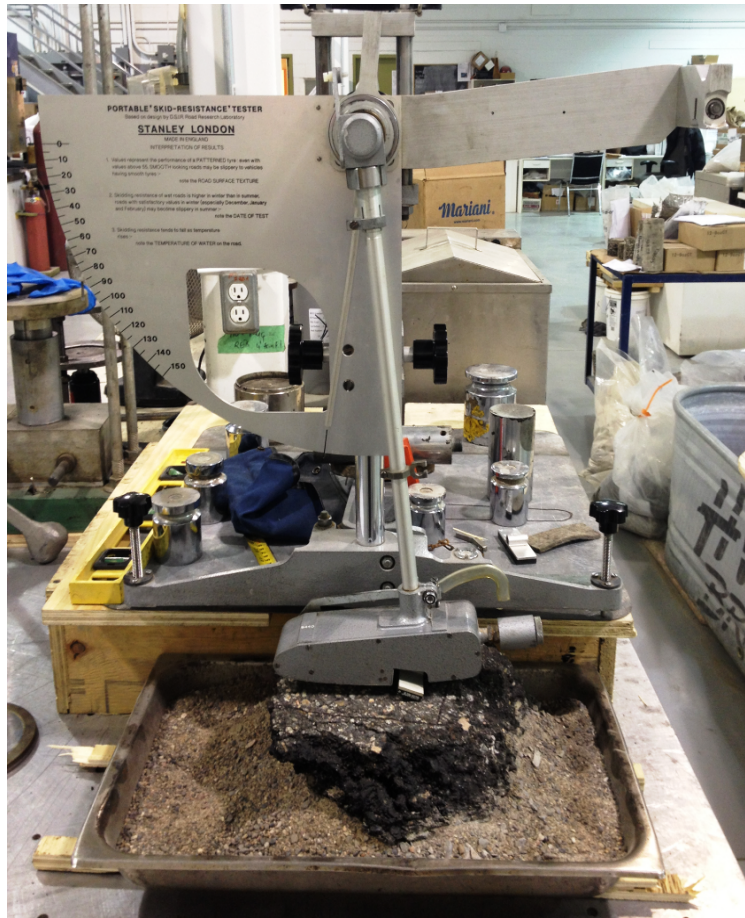
Figure 4.8 British Pendulum Tester (LVM Toronto laboratory, 2013)

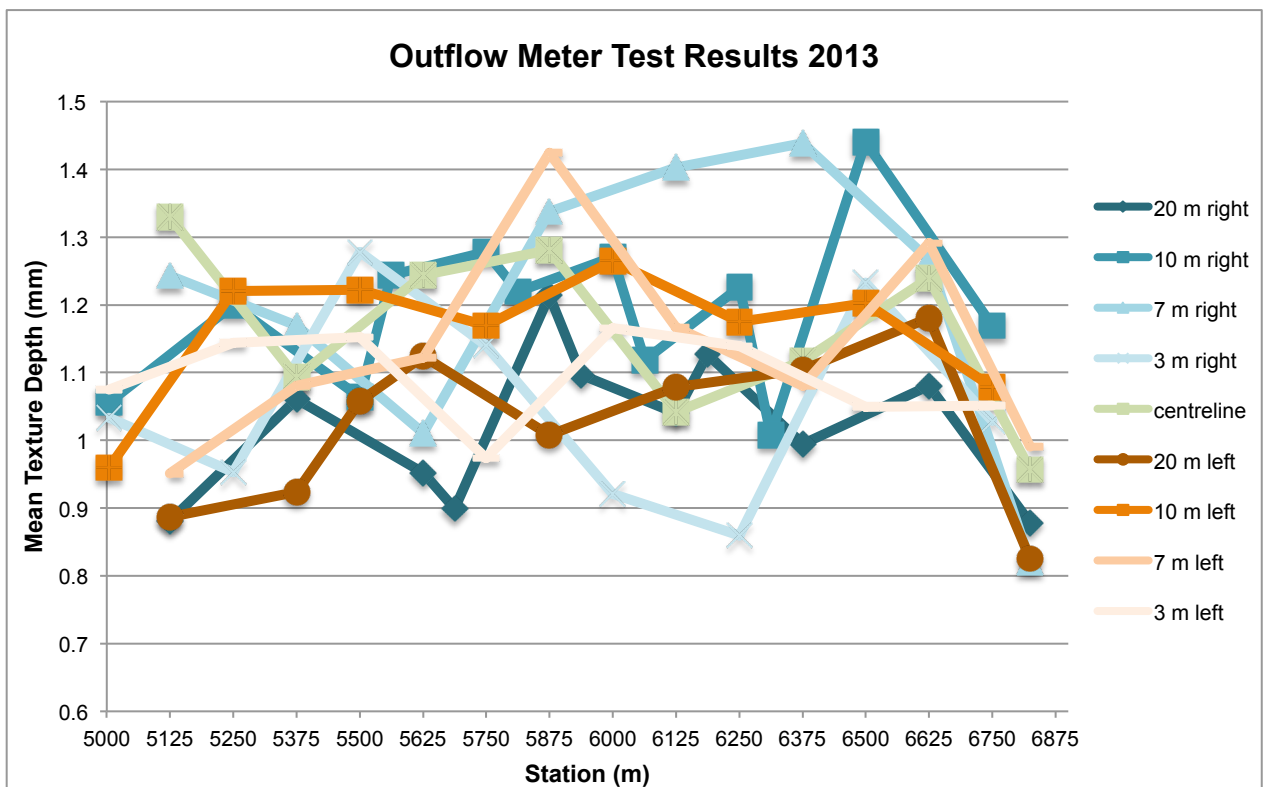
Figure 5.1 2013 Outflow Meter test results

Figure 5.1 shows the distribution of the 2013 Outflow Meter test results over the area of the runway. In addition, a contour map showing the distribution and ranges of macrotexture on the runway pavement surface from Outflow Meter testing is presented in Appendix B.

When compared to the above mentioned FAA guidelines, the macrotexture on Runway 07-25 measured in 2013 is above the requirements for action and thus macrotexture improvements at this point are not necessary.

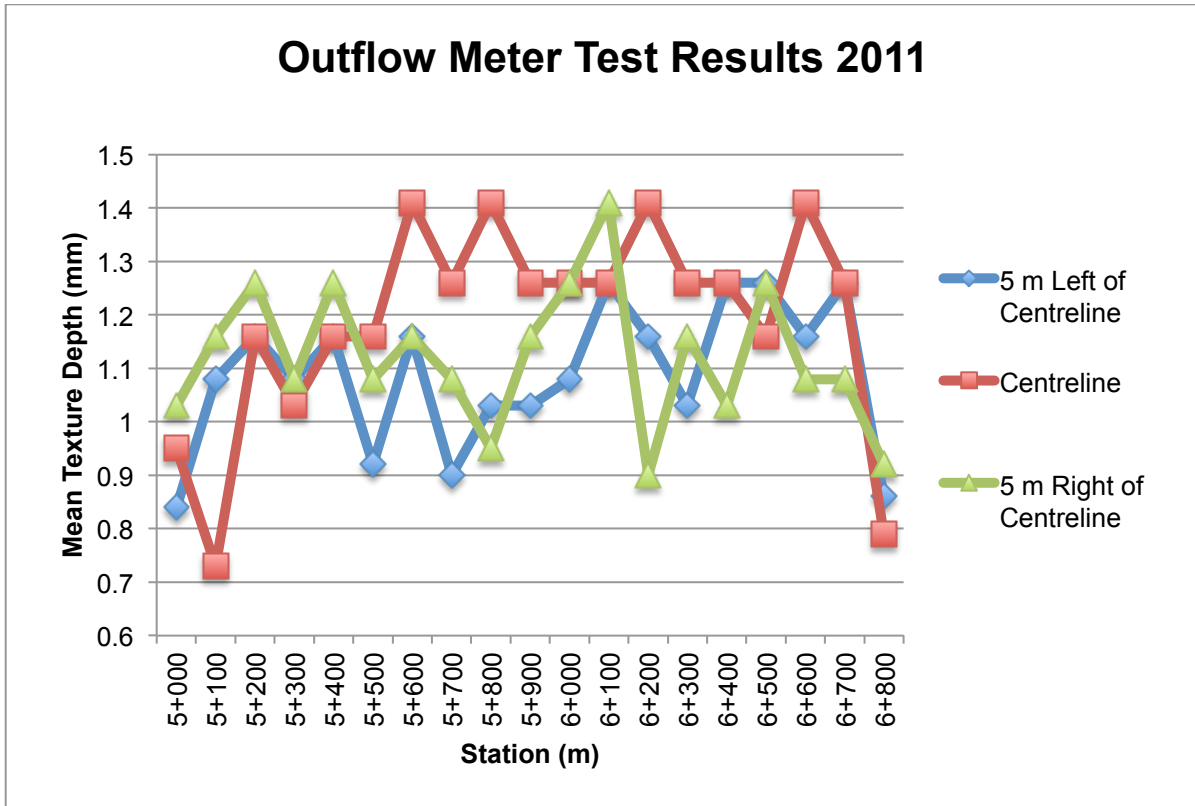
Figure 5.2 2011 Outflow Meter test results

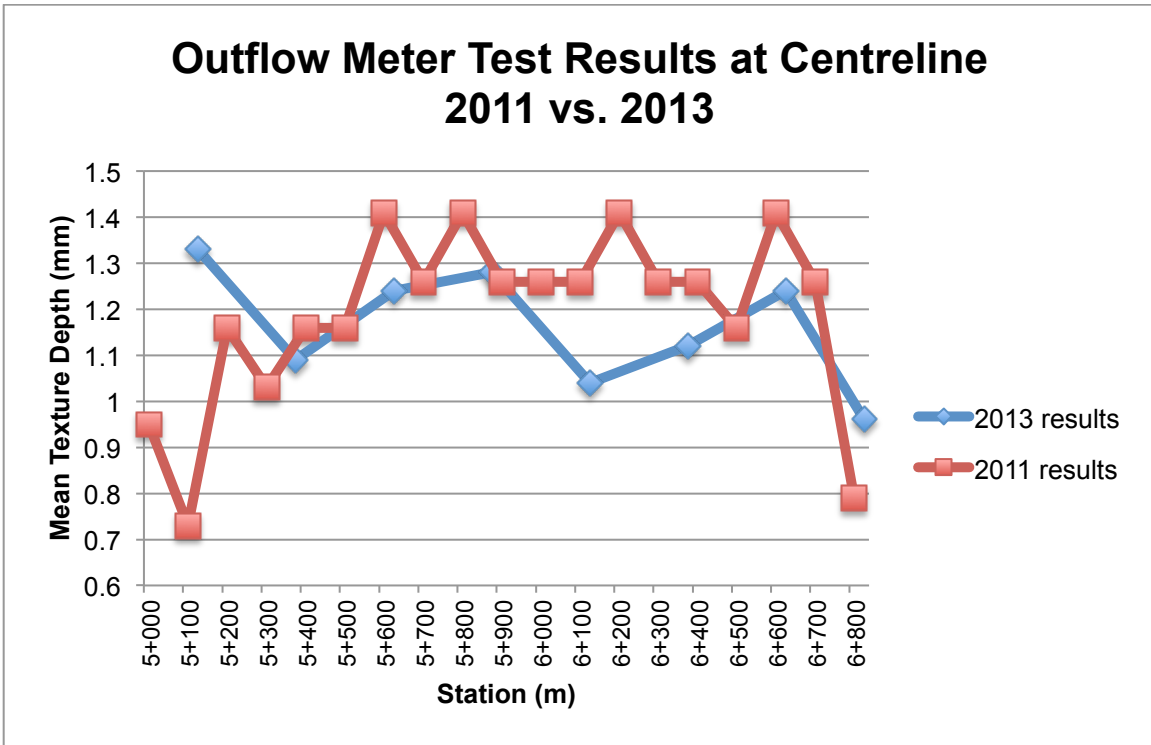
Figure 5.3 2011 vs. 2013 Outflow Meter test results at centreline

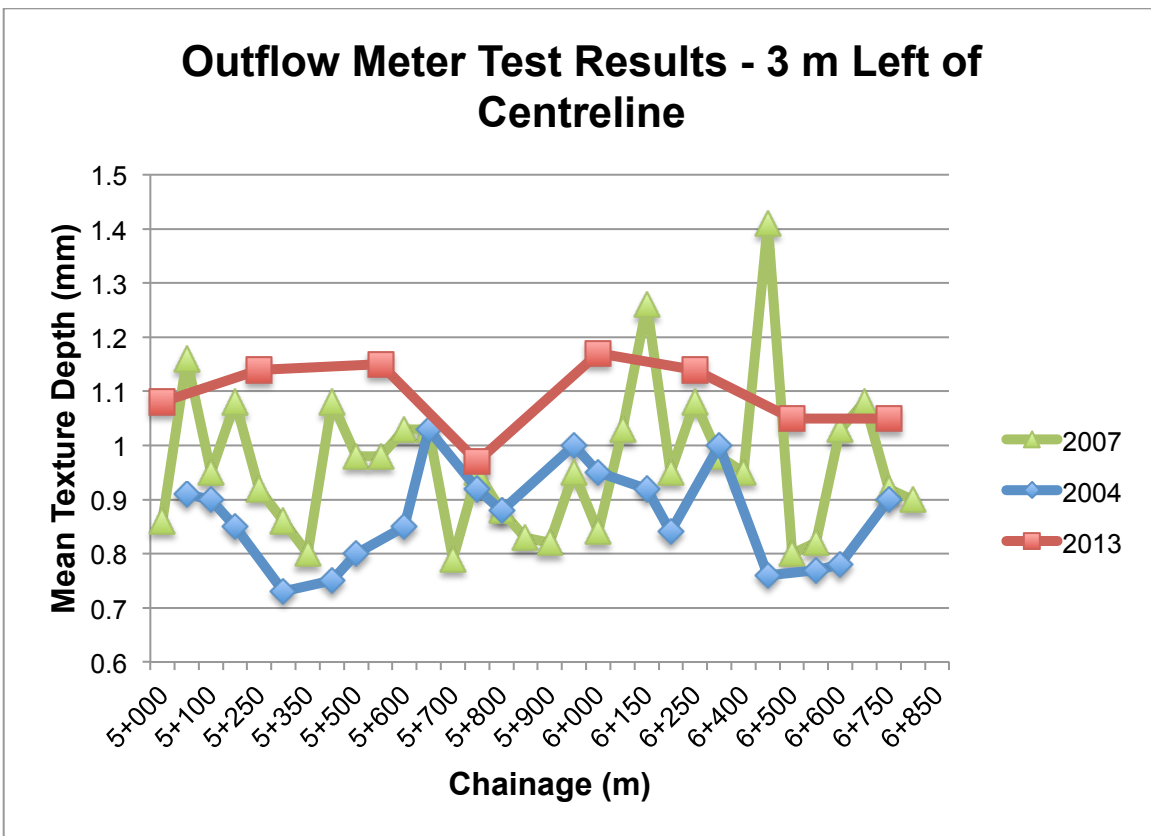
Figure 5.4 Outflow Meter test results at 3 m left of centreline at various years

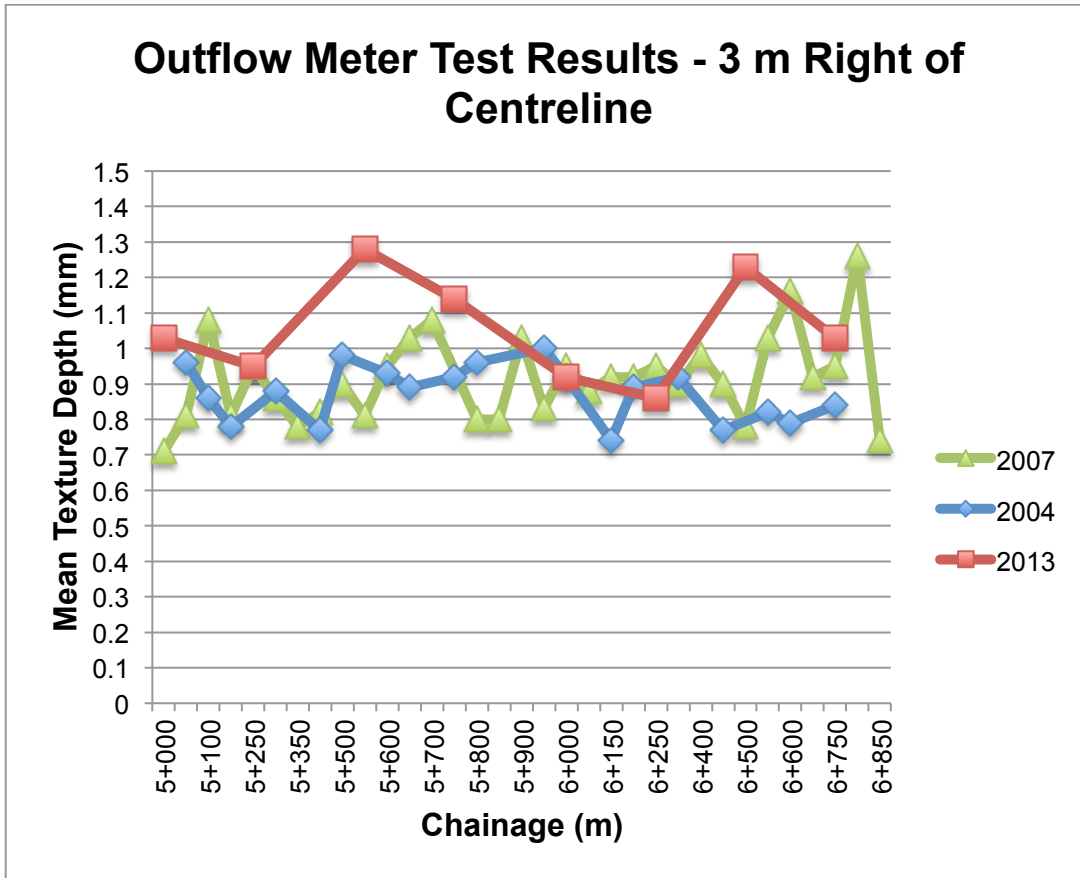
Figure 5.5 Outflow Meter test results at 3 m right of centreline at various years

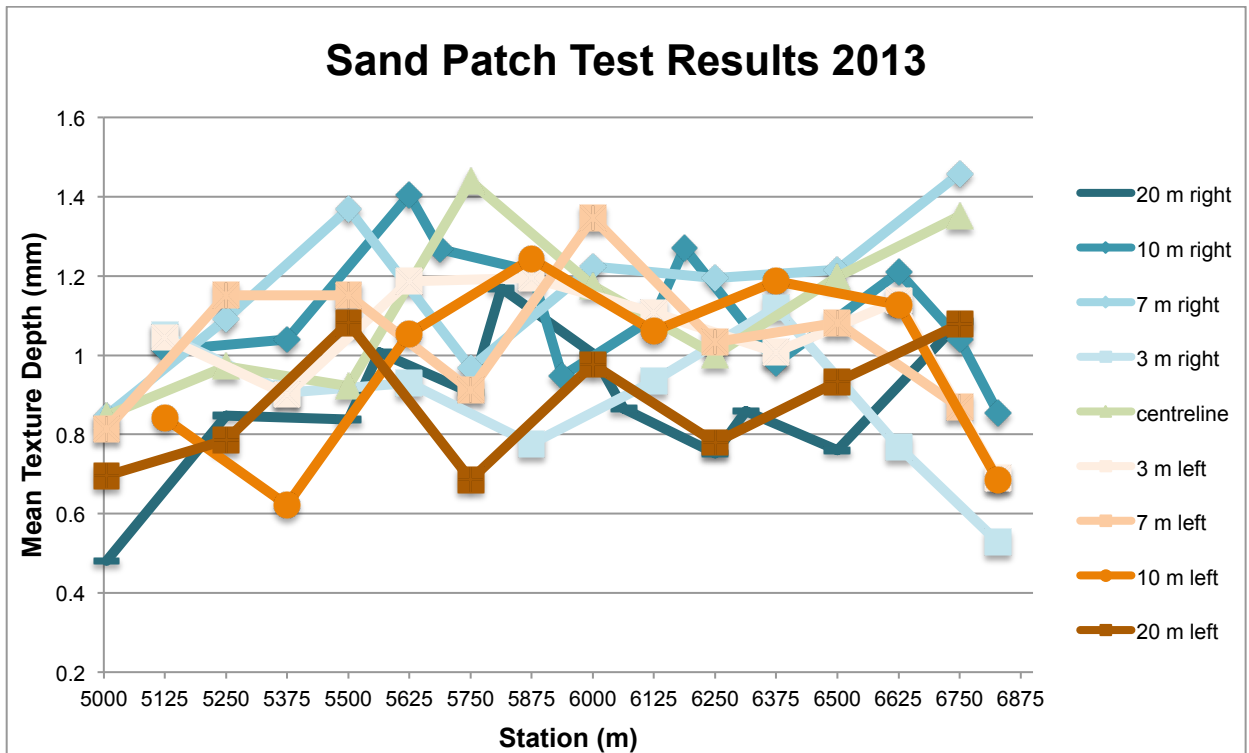
Figure 5.6 Sand Patch test results

Figure 5.6 shows the distribution of Sand Patch test results over the area of the runway. In addition, a contour map showing the distribution and ranges of macrotexture on the runway pavement surface from Sand Patch testing is presented in Appendix B.

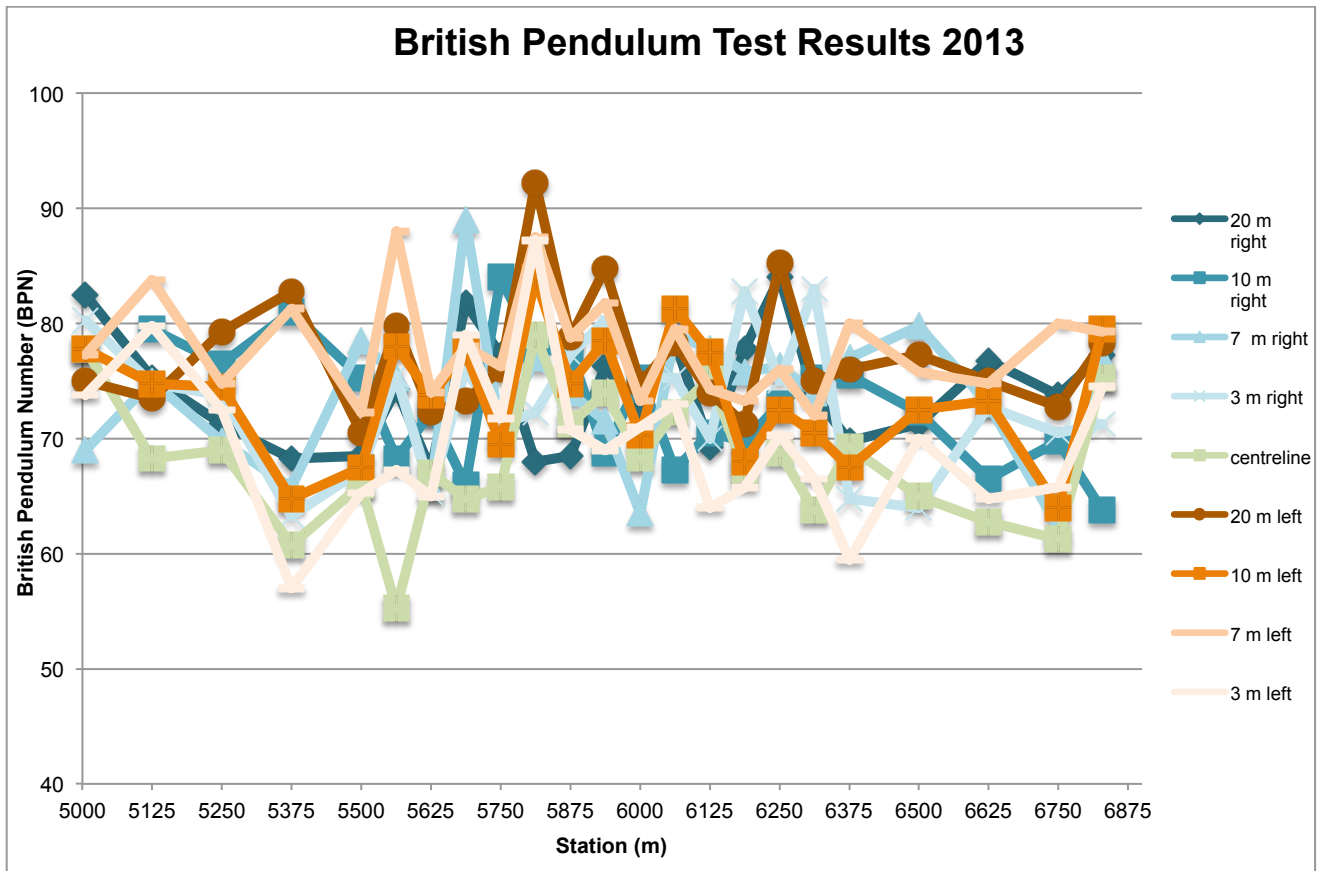
Figure 5.7 British Pendulum test results

Figure 5.7 shows the distribution of British Pendulum test results over the area of the runway. In addition, a contour map showing the distribution and ranges of microtexture on the runway pavement surface in terms of BPN is presented in Appendix B. Table 5.2 shows a summary of BPN numbers for the various lines of testing.

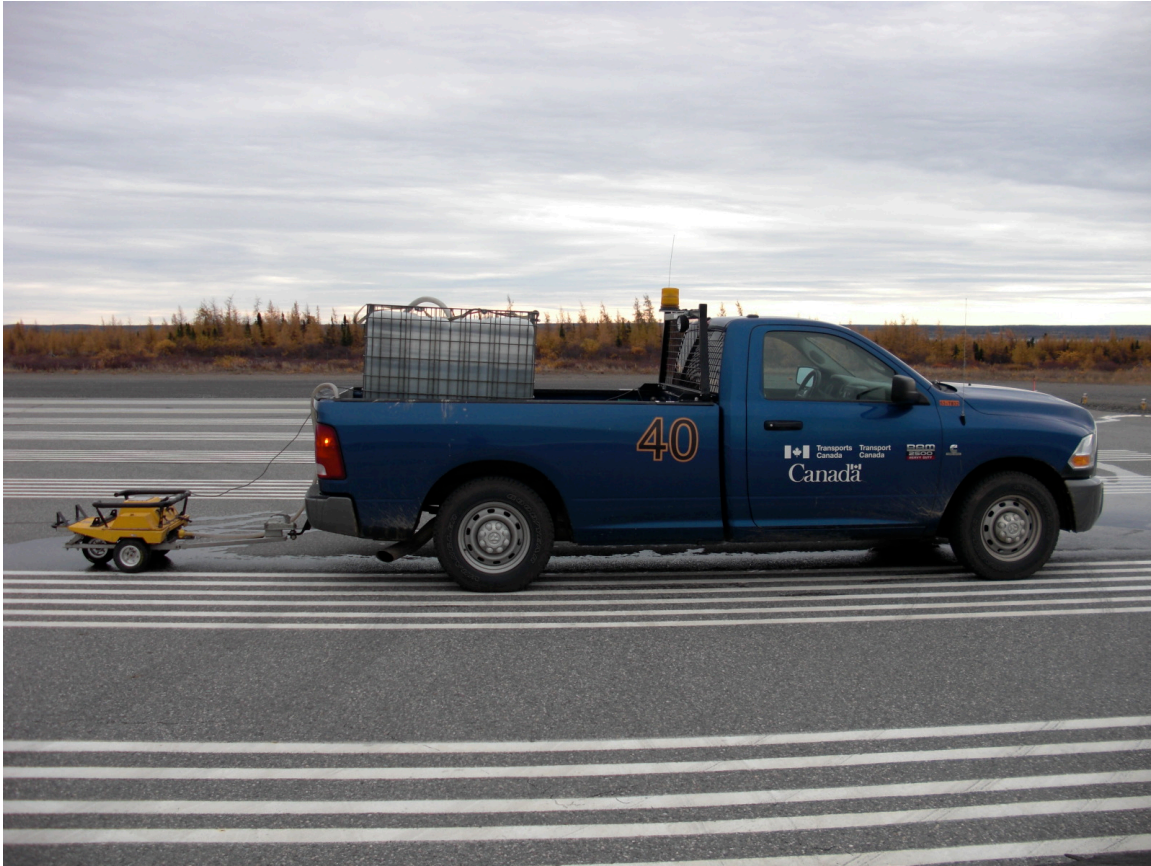
Figure 5.8 2013 GripTester operations (Field Testing, 2013)

In September 2013, a series of friction tests were completed by LVM using the GripTester instrument (manufactured by Findlay Irvine Ltd. of Scotland) between stations 5+200 and 6+600 along the runway. Testing was completed as per current standard test specifications for the GripTester equipment (ASTM E2340 *Standard Test Method for Measuring the Skid Resistance of Pavements and Other Trafficked Surfaces Using a Continuous Reading, Fixed-Slip Technique*); testing speed of 65 km/h using a smooth-tread ASTM test tire at 140 kPa inflation pressure, under self-watering conditions of 0.25 mm water film depth, at 3 m left and right offsets from the centerline. Additional tests were completed at 1.5 m, 5 m, 10 m and 15 m left and right offsets from the centreline, at varying water depths (0.25 mm, 0.5 mm and 1.0 mm) and rain intensities (light and moderate rain) for additional analyses of the runway surface. Prior to testing, the GripTester was calibrated in order to verify the specifications and ensure optimal performance. A photograph of the testing is shown in Figure 5.8.

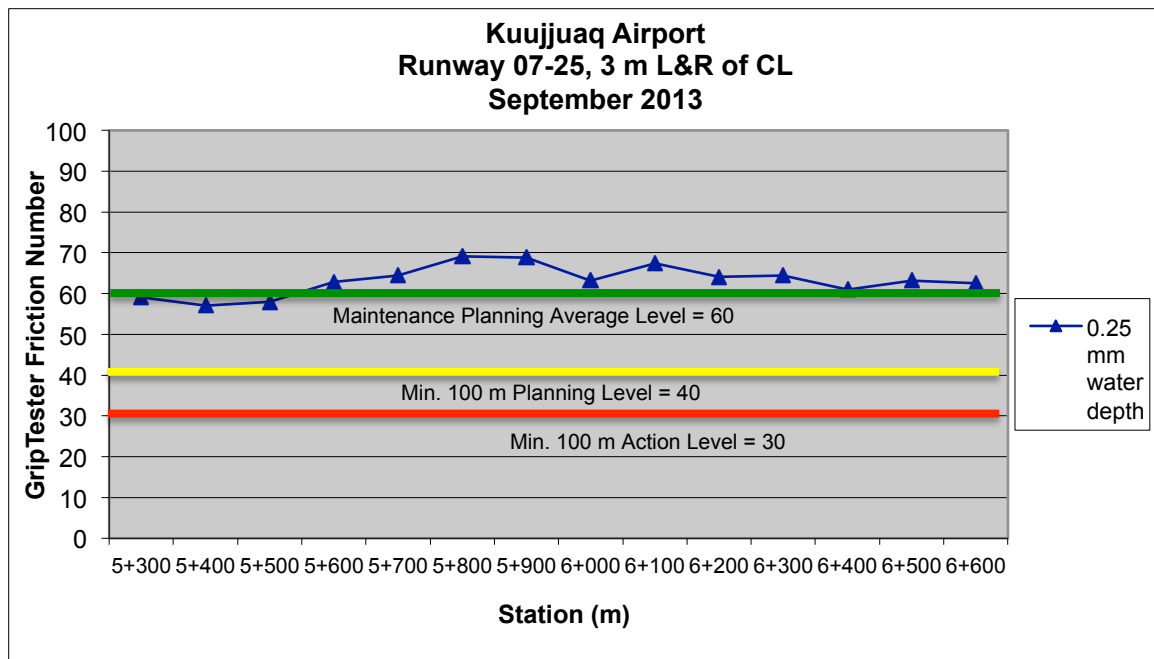
Figure 5.9 Friction testing results at standard test conditions

Figures 5.9 to 5.11 show various graphical representations of the 2013 friction testing data. Figure 5.12 shows a graphical comparison between the 2013 and 2011 data at standard test conditions. A full set of graphs containing all of the friction measurements from 2013 and 2011 are included in Appendix A. As previously noted, on all of the graphs the Transport Canada guidelines are shown in green, yellow and red, as per Table 3.1.
