Mitigation of Climate Change Impacts on Runway Friction

Kuujuaq Airport

A thesis

Civil Engineering

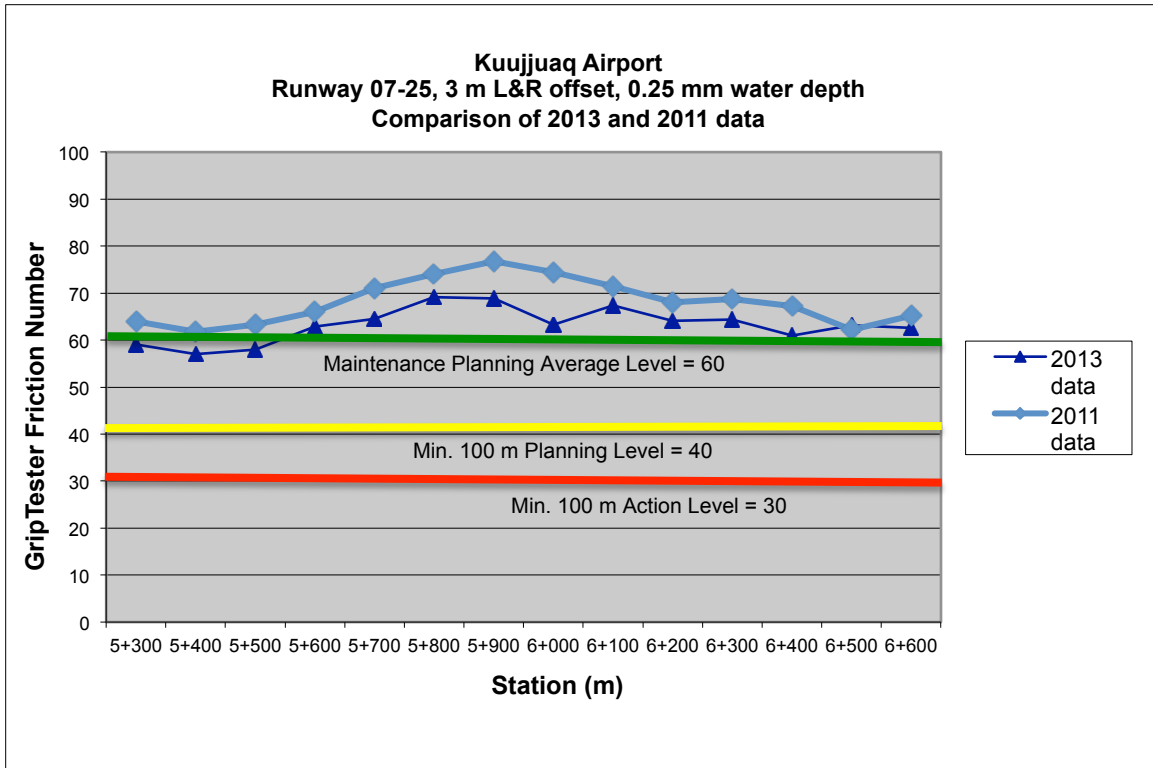
Figure 5.12 Friction testing results at standard test conditions from 2011 and 2013

Figures 5.9 to 5.11 show various graphical representations of the 2013 friction testing data. Figure 5.12 shows a graphical comparison between the 2013 and 2011 data at standard test conditions. A full set of graphs containing all of the friction measurements from 2013 and 2011 are included in Appendix A. As previously noted, on all of the graphs the Transport Canada guidelines are shown in green, yellow and red, as per Table 3.1.

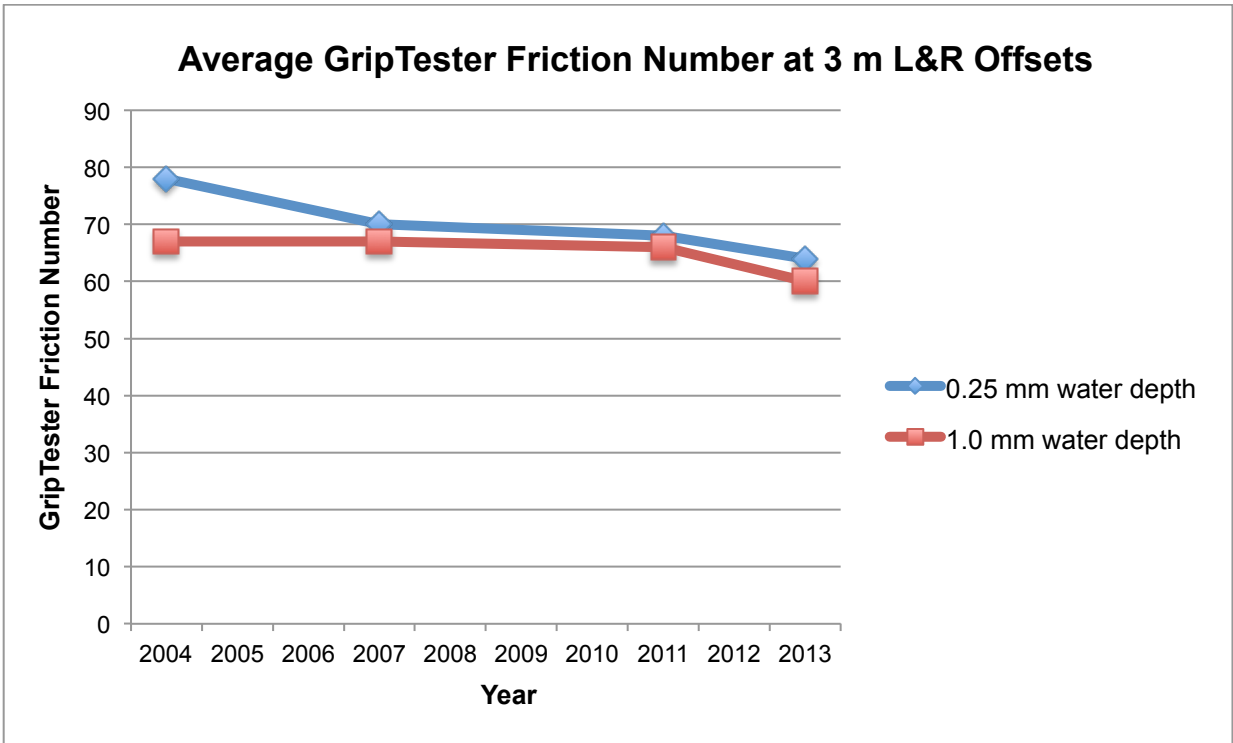
Figure 5.13 Friction testing results from multiple years

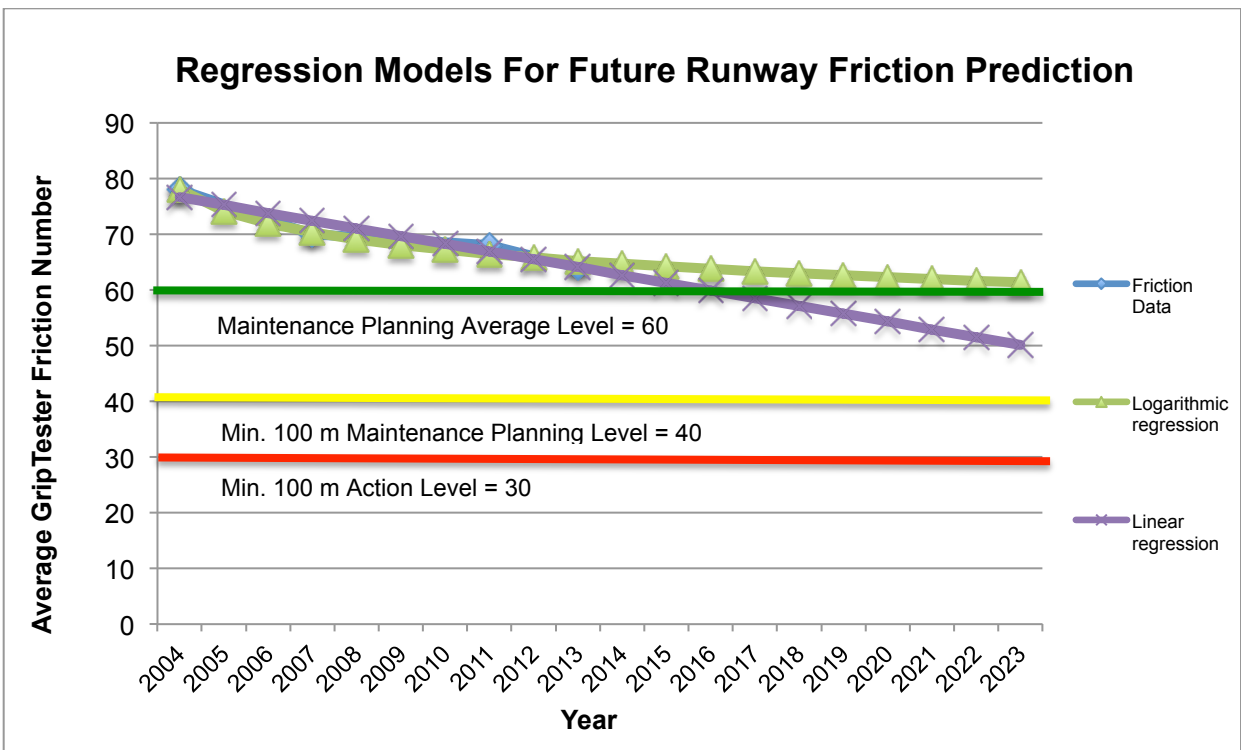
Figure 5.14 Regression models

This linear regression model for past and future years is graphically shown in Figure 5.14 (purple line). Based on this linear regression model, it would appear that in 2016, the Average Friction Number would be 60, and in 2017 it would fall below 60 to 58. At this point, the Transport Canada Guideline would be reached (Friction Number of 60 corresponds to maintenance planning). This may be confirmed by friction testing which should be carried out in 2015. It would be expected that runway maintenance planning activities be undertaken in 2016 and executed within the year in order to improve the runway friction to a level greater than 60. Friction testing by GripTester is recommended to be carried out every 2 years until 2017 at which point friction would be expected to be increased if maintenance/rehabilitation is completed; and friction testing could be carried out at less frequent intervals thereafter, provided that the friction restoring activities improved the friction to a desirable level. Various methods of friction restoration are discussed in chapter 6.

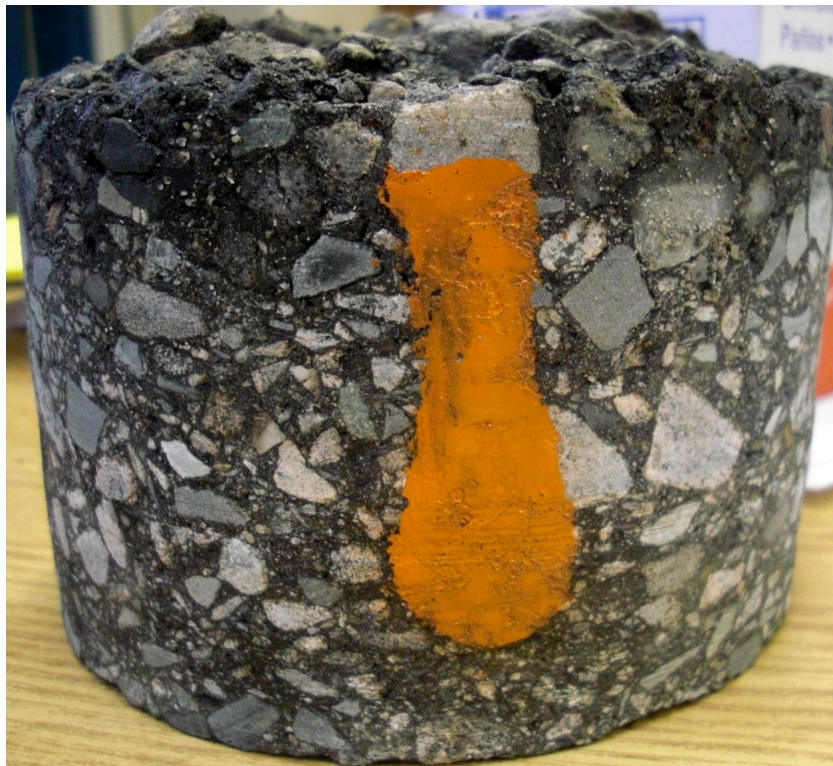
Figure 5.15 Core 1, 3 m left of centreline at station 5+250 m

The asphalt concrete was observed to be in good condition based on the visual examination of the cores. Additionally, the aggregate in the asphalt mix appeared to be crushed and durable. Based on a site inspection of the surrounding areas of the runway, it was evident that this locally sourced aggregate observed in the asphalt concrete was also used on a gravel service roadway, where the gravel appeared to be durable and in very good condition.

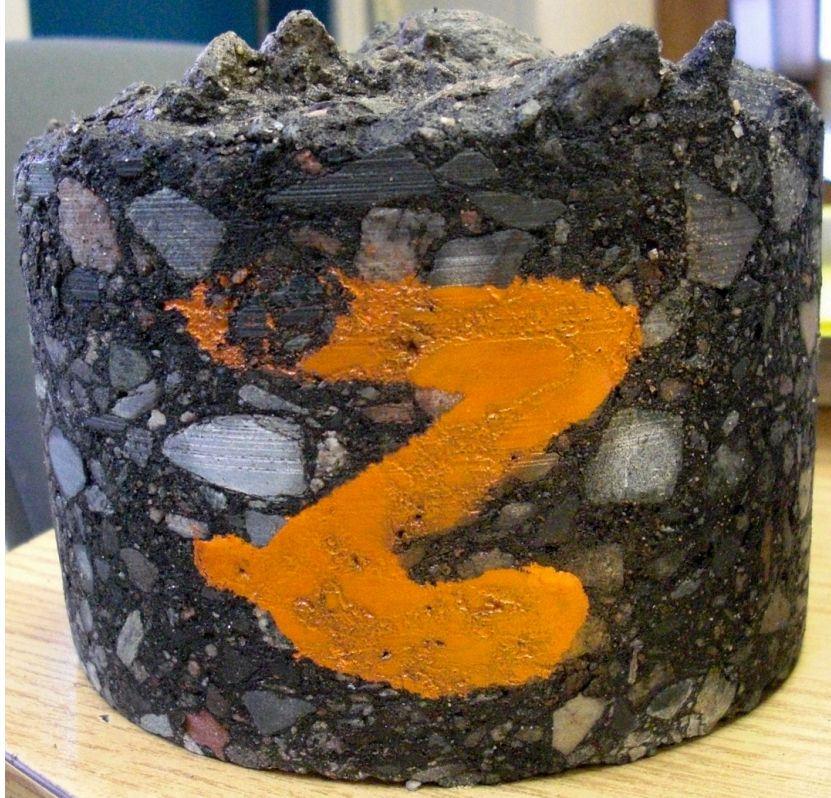
Figure 5.16 Core 2, 10 m left of centreline at station 5+375 m

A coring investigation was completed at the same time as the surface texture and friction testing program in the fall of 2013. Various cores of the asphalt concrete were obtained using a 150 mm diameter core barrel equipped with diamond drill bit along the length of the runway at various offsets from the centreline. Figures 5.15 and 5.16 show photographs of two core samples. The cores were obtained for visual examination only as it was not possible to complete laboratory testing.

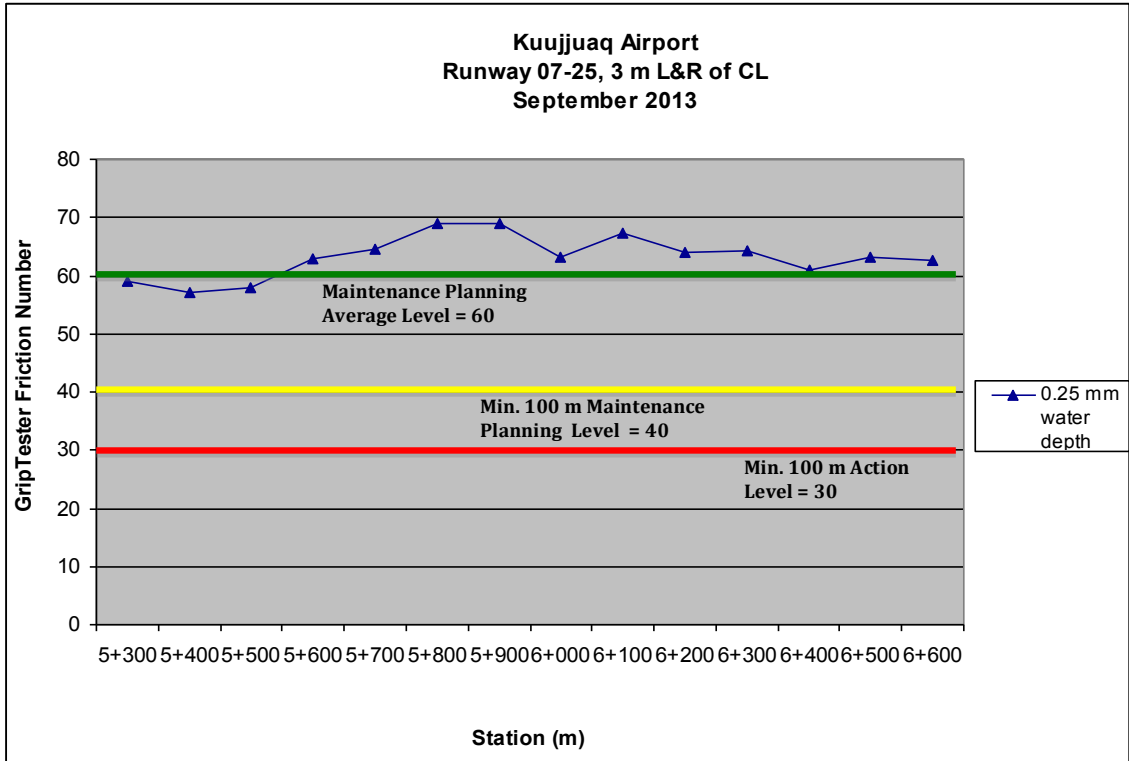
Figure A.1 2013 GripTester friction results, average of 3 m L&R offsets, 0.25 mm water depth

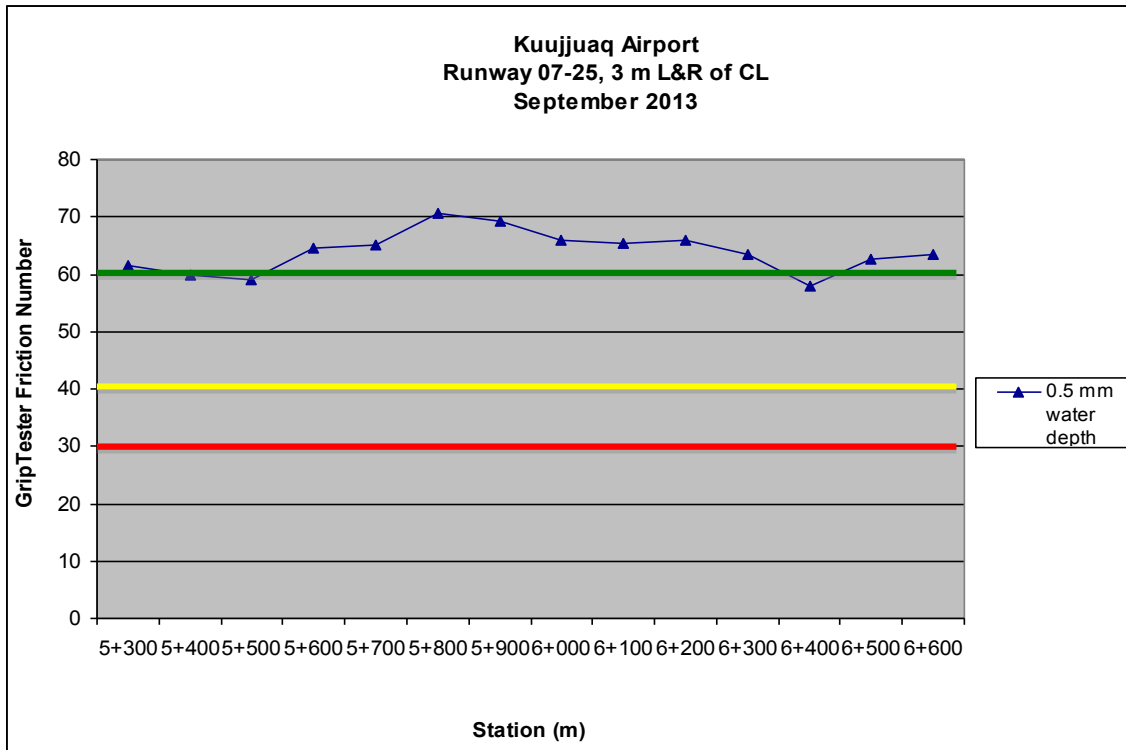
Figure A.2 2013 GripTester friction results, average of 3 m L&R offsets, 0.5 mm water depth
