Evaluation of Cold Weather Performance of Rubber Modified Asphalt Placed in Ontario

A thesis
presented to the University of Waterloo
in fulfillment of the
thesis requirement for the degree of
Master of Applied Science
in
Civil Engineering

Waterloo, Ontario, Canada, 2014

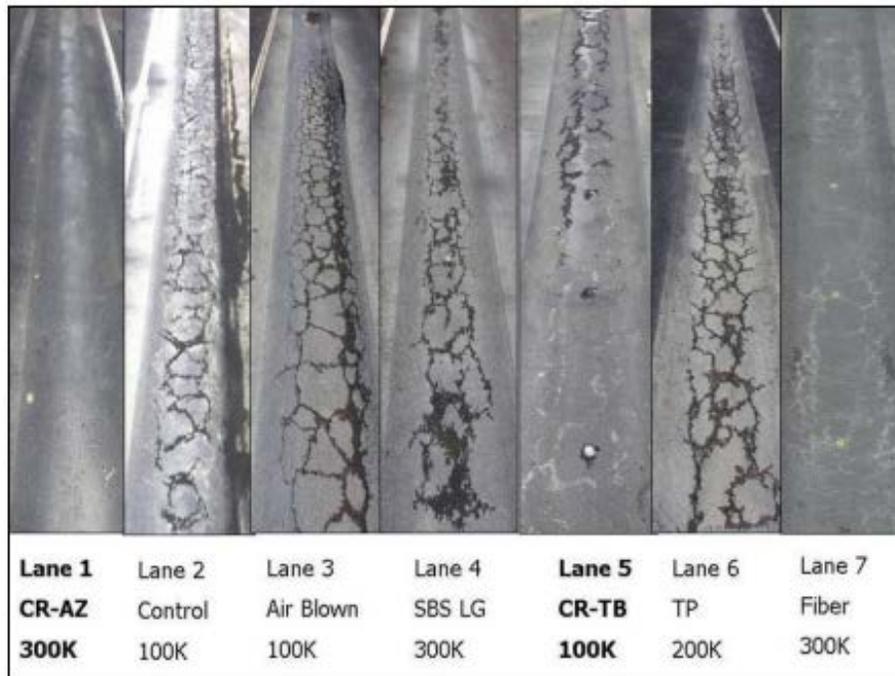
As shown in Figure 2.1, the asphalt rubber section survived 300,000 passes of the loaded rolling tire with no cracking, while the conventional pavement had 90 m of total length of cracking only after 100,000 passes [Takallou 2011]. This shows the resistance asphalt rubber has to cracking, as a core was taken from that section, and showed that the 50 mm of conventional mix under the rubber pavement had been cracked; yet the surface had no cracking. The asphalt rubber had not only out-performed the conventional pavement, it had performed much better than all the other modified pavements in the ALF.

Figure 2.1 Sections Tested at the ALF (Source: [Takallou 2011])

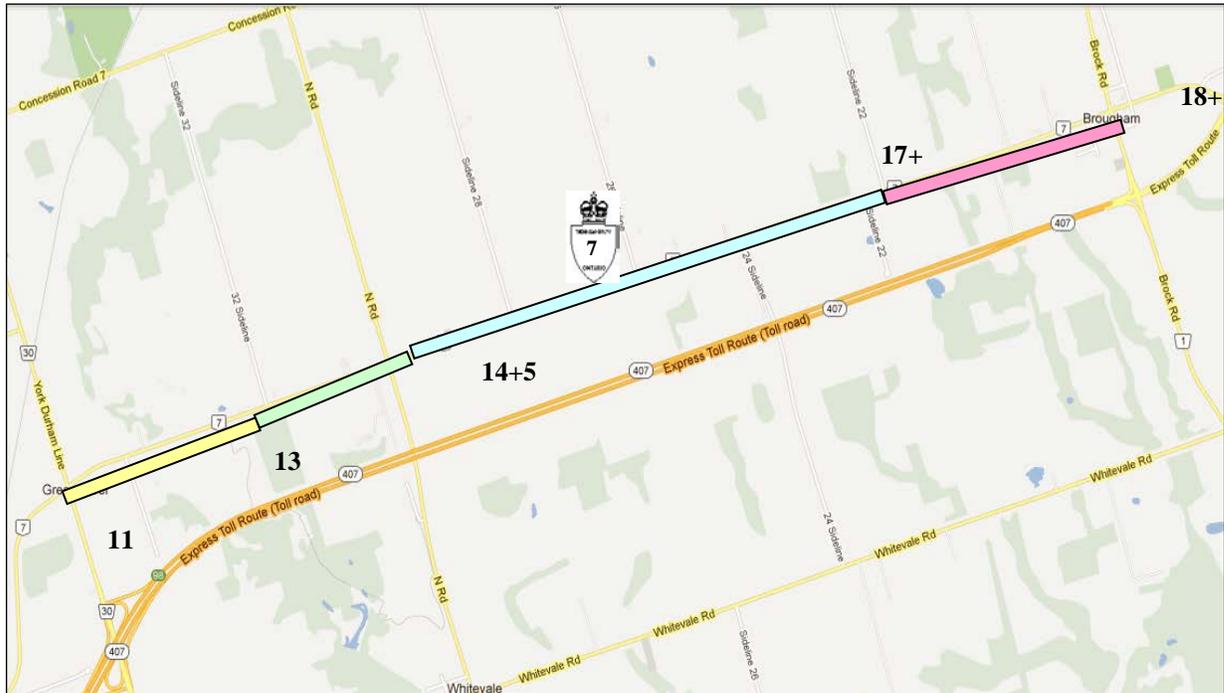
summarized in Figure 3.1. It should be noted, though, that this section's SP9.5 R Gap Graded section (the field blend RMA) was paved at a thickness of only 30 mm as opposed to the remaining sections being paved 40 mm thick.

Figure 3.1 Section Layout for Highway 7 [Hegazi 2013] Map [Google Maps 2014]

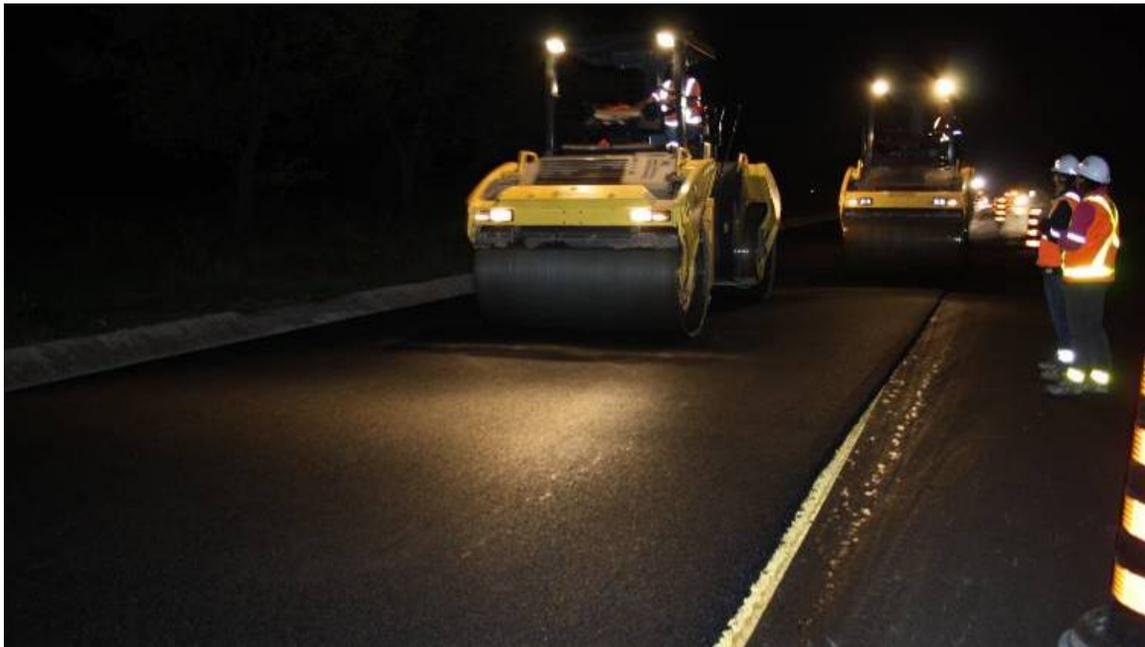
Figure 3.2 Steel Drum Rollers Used During Paving

This section was placed with two pavers and a Materials Transfer Vehicle (MTV). Three steel drum rollers were used on the project, and a rubber tire roller was not used based on the recommendations received by experts in the US. Rubber tire rollers can potentially result in pickup from the rubber in the asphalt mix. Figure 3.2 shows the steel drum rollers operating close together. Also, can be seen from Figure 3.2 is the paving was conducted at night.

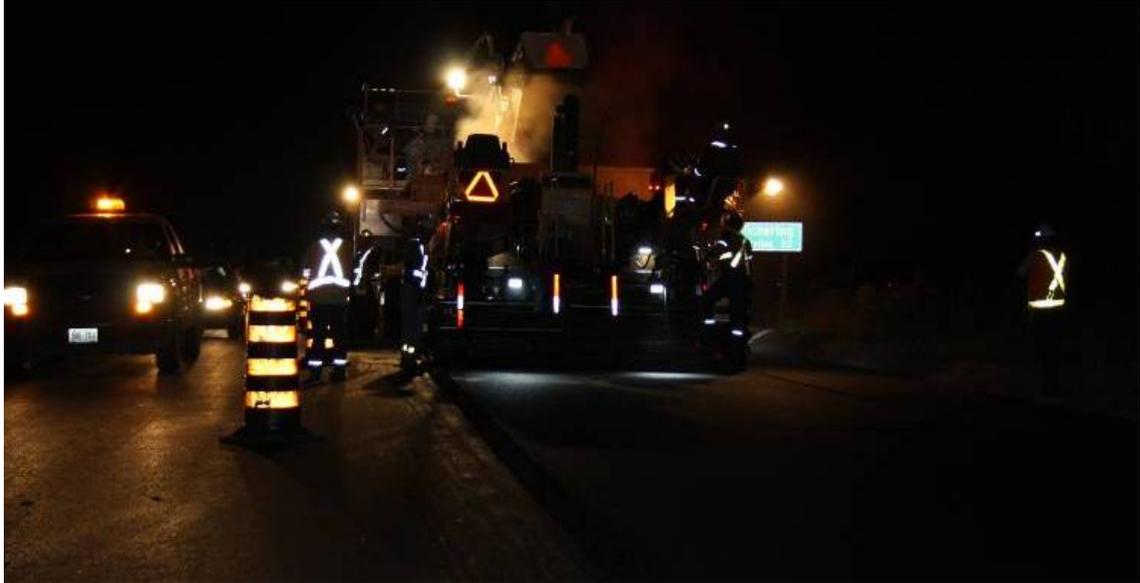
Figure 3.3 Paver and Smoke from Paver During Night Paving

Some smoke was visible from the paver during the paving operation. The smoke is visible in Figure 3.3, which was taken during the paving of the highway. Although there was visible smoke, the fumes did not pose any immediate health risks above and beyond what exists with conventional HMA paving [Burr et 2001].

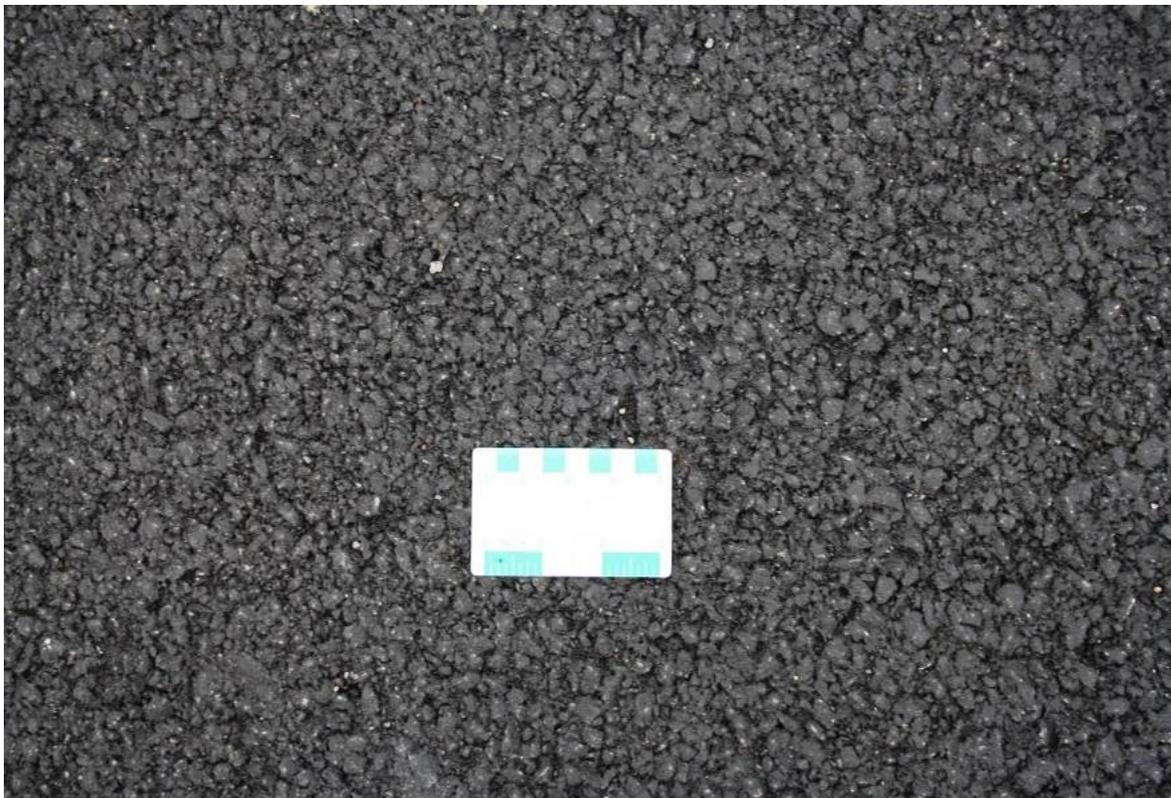
Figure 3.4 Finished RMA Surface

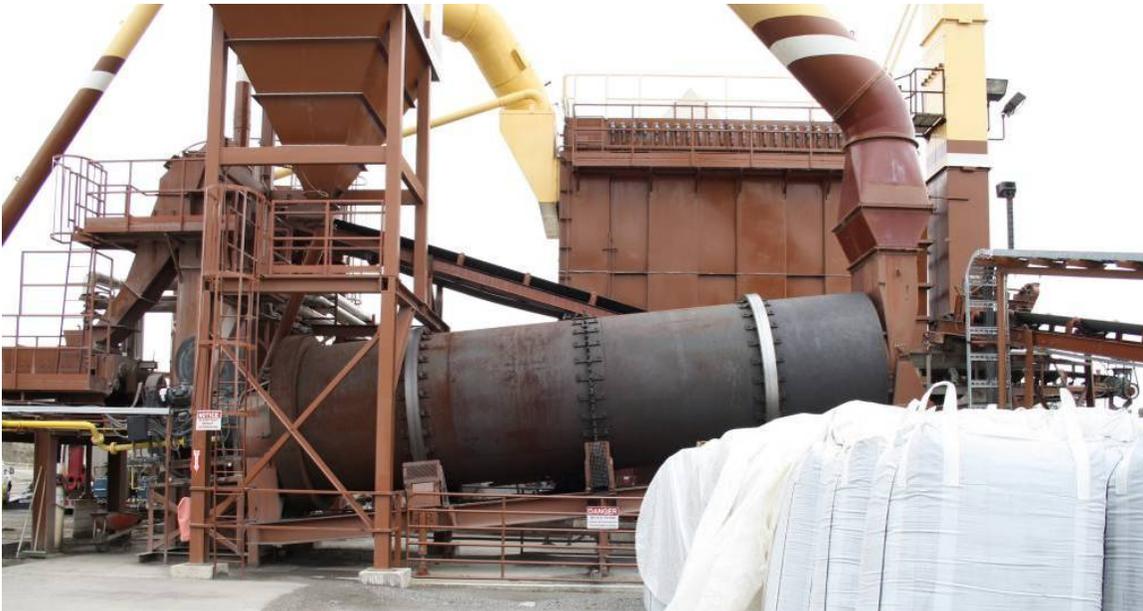
Figure 3.6 Asphalt Plant Used for Production of Highway 35 Mixes

- The plant had to be modified to allow for the field blending unit to connect to directly into the system. Figure 3.6 shows the plant which was modified to allow for the connection of the blending unit. The oil tanks at the plant were modified to feed the AC to the rubber asphalt cement blending unit, and a valve was added to feed the plant the rubberized asphalt cement to produce the RMA.
- Additional smoke was detected at the plant and some odor was present, yet the surrounding community did not complain about any odor and it was deemed a non-issue.
- The blending unit was producing at a rate of 150 tons per hour while the plant could handle anywhere between 180 to 200 tons per hour. It was slower than capacity due to the rubberized asphalt cement being more viscous and therefore more difficult to work with than the conventional asphalt cement.

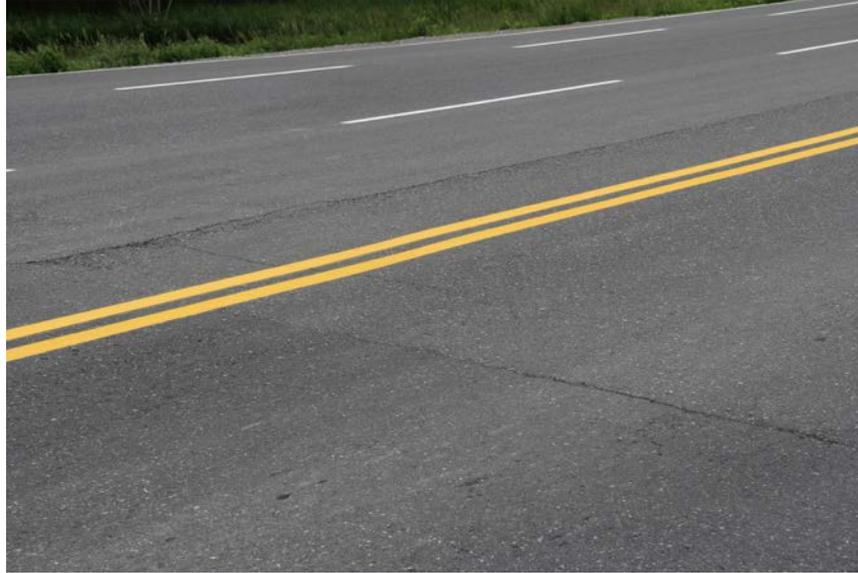
Figure 3.7 Site Visit Photo

The conventional HMA section on this project has performed well, yet with some pavement distresses present and fatigue starting to show. Moderate transverse cracking is visible and evident on the pavement that occurs every 1.5 to 2 metres. This cracking is fairly consistent throughout the section, and ranges from slight to moderate severity, with few that can be considered severe transverse cracks. Also evident in the section is centerline joint cracking that runs through most of the section. Edge cracking is also present occurring only a few times and with very low severity. The ride quality of this road is moderate, with the transverse cracking causing some slight discomfort in the ride.

The RMA section overall was performing better than the conventional HMA section. The pavement visually differs from that of the conventional HMA in that it looks gap-graded. Transverse cracking is still present in this section, yet it is less severe and less frequent than on the conventional HMA pavement. There is also centreline joint cracking, but again it is of very slight severity and few in frequency. The ride quality is greatly improved over the conventional HMA section, yet still some discomfort exists due to the transverse cracking on the highway.

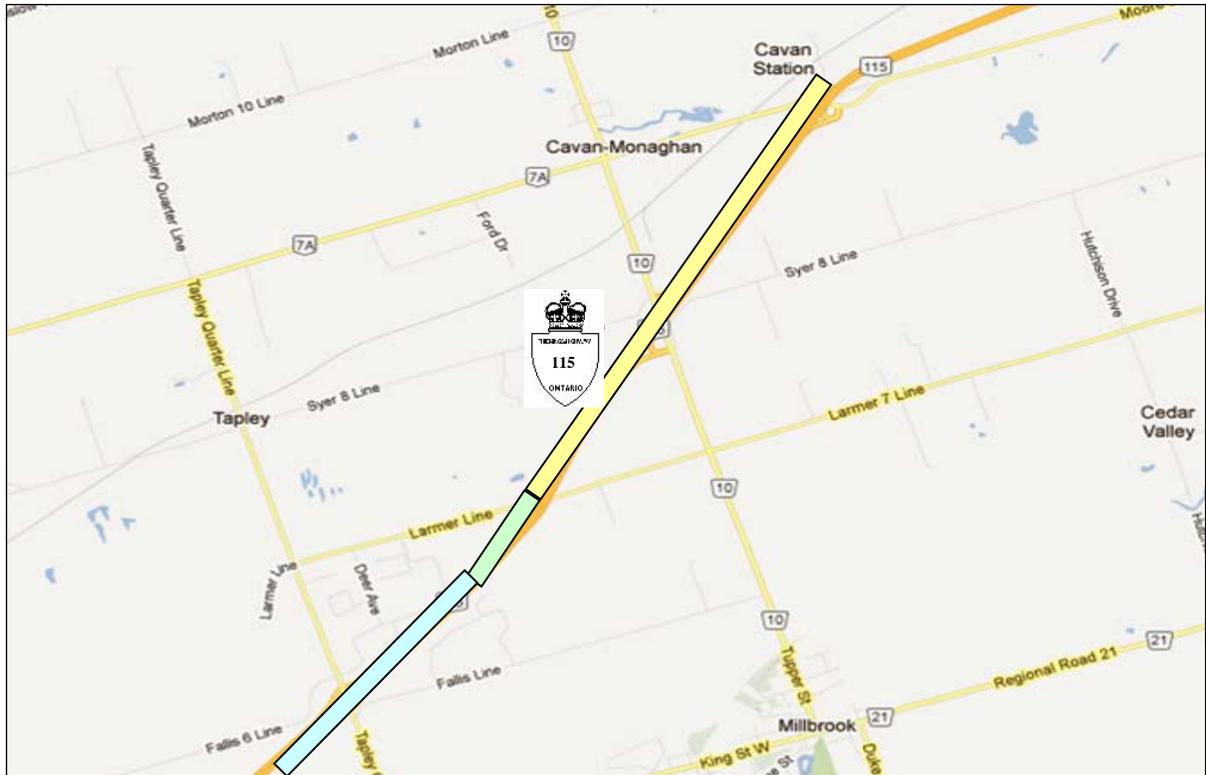
Figure 3.9 shows the configuration of the sections for Highway 115. There are three different sections paved. Starting from the north, the first section involves paving a 50 mm overlay of SP12.5FC2 R Gap Graded Surface Course. The second section is a 50 mm overlay paved with an SP12.5FC2 Surface Course. The third section is also a 50 mm paved overlay involving an SP12.5FC2 Surface Course, but as noted in the figure, this section will be outside the scope of the experiment as the underlying pavement was in worse condition than any of the other sections. With the underlying conditions being in the state it was in, it would be unwise to include this section as a control section for comparing the performance of the mixes.

Figure 3.9 Configuration of the Mixes for the Sections of Highway 115 [Hegazi 2013]. Map [Google Maps 2014]

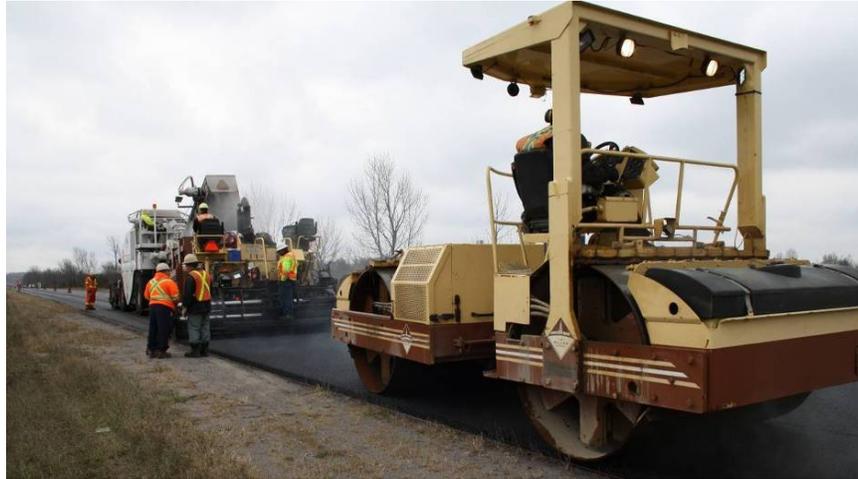
Figure 3.10 Steel Drum Roller Following Closely to the Paver on Highway 115 Construction

One paver and one MTV were used on this paving project. Three steel drum rollers were used for compacting, two of them on vibratory mode and the third in static mode. The drum rollers were following in close proximity of the paver to ensure proper compaction temperatures, as shown in Figure 3.10. There were less hauling trucks for this project than the others.

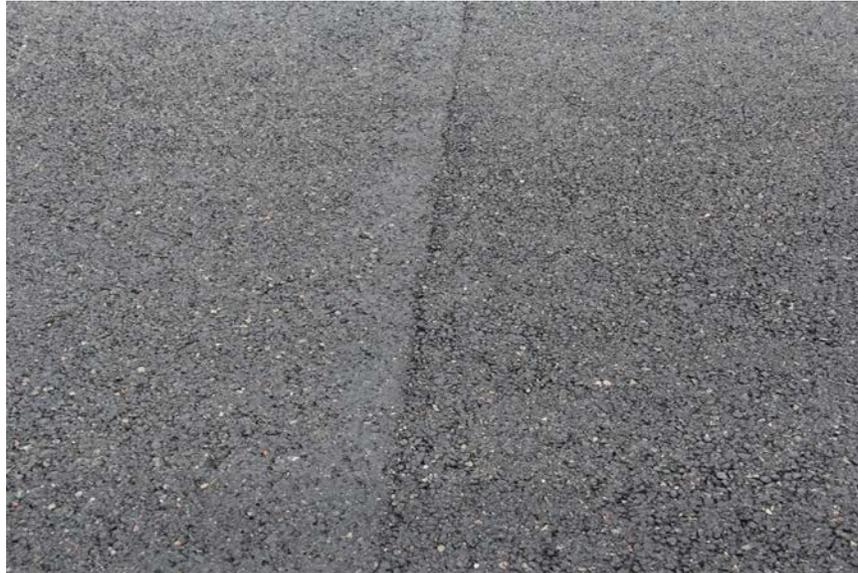
Figure 3.11 Highway 115 SP12.5 Dense-Graded Conventional HMA

The conventional HMA section is performing well, although there are many transverse cracks that exist on this pavement. The transverse cracks are fairly severe, and occur frequently. It was noted that the northbound lane was performing worse compared to the southbound lane. The section continues to be performing well, as the ride quality on the road is still very good.

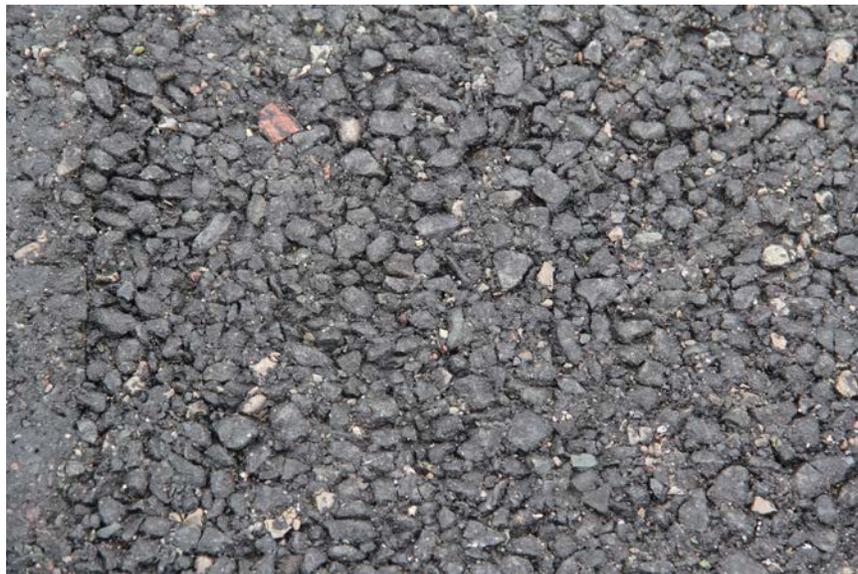
Figure 3.12 Highway 115 SP12.5 Gap-Graded Rubber Mix

The RMA section on this highway shows some sign of distress, but it is few and very minor. There is evidence of some low severity transverse cracking, which do not occur

very often, and some centerline joint cracks that are evident yet not severe. While the pavement is starting to show slight cracking, the ride quality is still excellent, and again, the RMA section seems to have a better ride quality than that of the conventional HMA section.

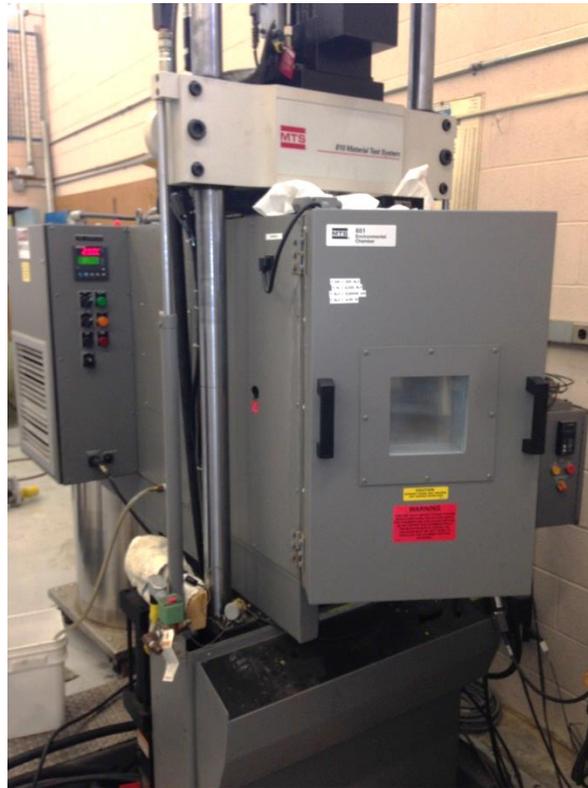
Figure 4.1 Material Testing System 810 with Environmental Chamber

The laboratory testing that was carried out for this research was done on the Material Testing System (MTS) provided by CPATT. The MTS consist of an environmental chamber, a load frame, hydraulic power supply, and a control panel all controlled through the MTS computer software. Figure 4.1 below shows the MTS 810 that was used for the TSRST testing.

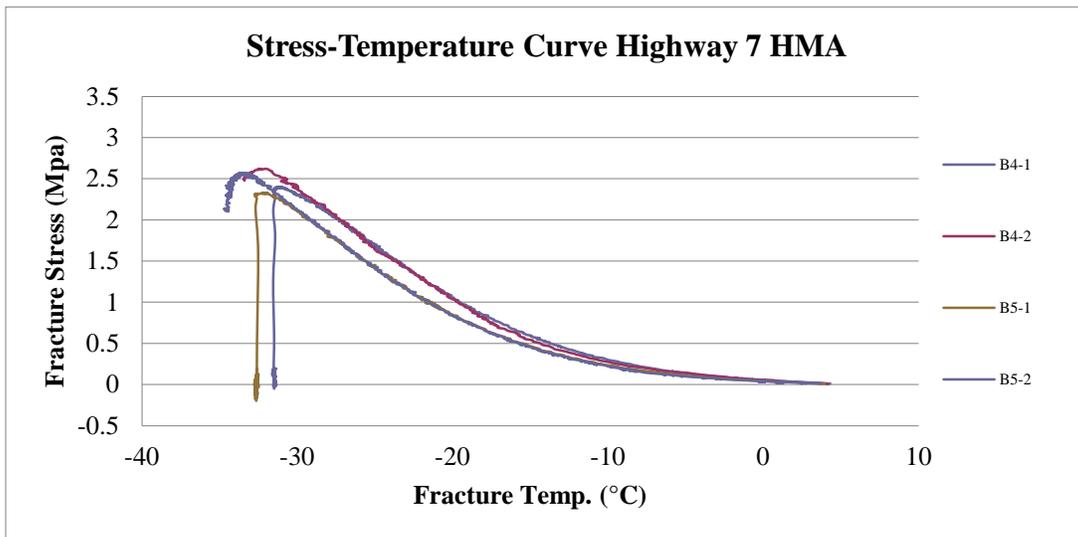
Figure 4.2 Highway 7 HMA Stress-Temperature Curve

The figures for the stress temperature curves for Highway 7 HMA in Figure 4.2 exhibit typical TSRST results. The temperature decreases at a rate of 10°C per hour until the failure at approximately -33°C. Immediately following this, the curve shows a decrease in stress. At the peak of the curve is the fracture temperature and stress, and as can be seen in Figure 4.2, the curve is consistent for all four of the tests.

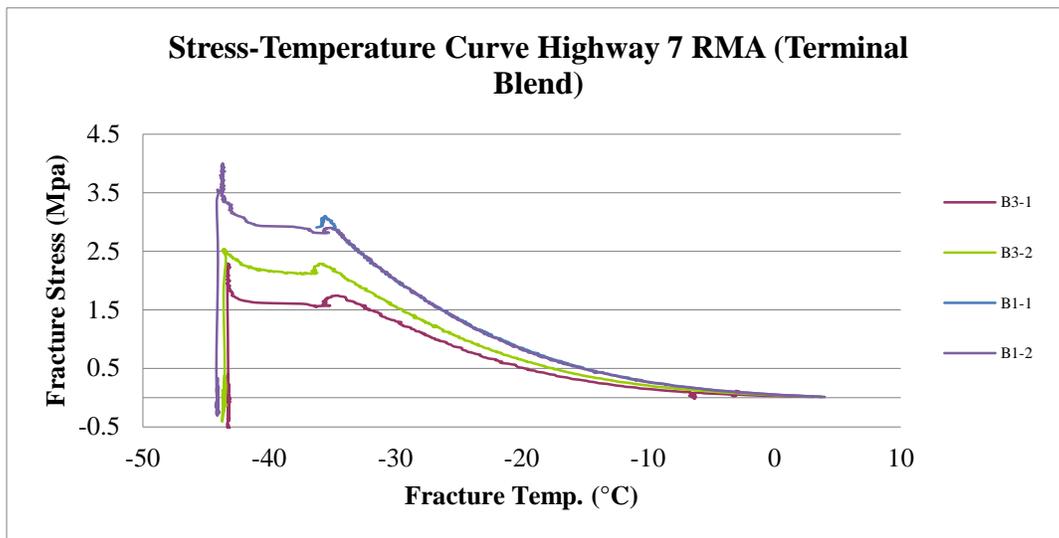
Figure 4.4 Highway 7 RMA Terminal Blend Stress-Temperature Curve

When observing the stress-temperature curves for the specimens, it is evident that the fracture of the RMA mixes occurs at a lower temperature than the HMA mixes, yet they behave in the same manner when cooled at a rate of 10 degrees per hour. Figure 4.2 below shows the stress temperature curve for the Highway 7 SP12.5 Dense Graded HMA mix, Figure 4.3 shows the curve for the Highway 7 SP9.5 R Gap Graded (Field Blend) RMA mix, and Figure 4.4 shows the curve for the Highway 7 SP12.5 R Dense Graded (Terminal Blend) RMA mix.

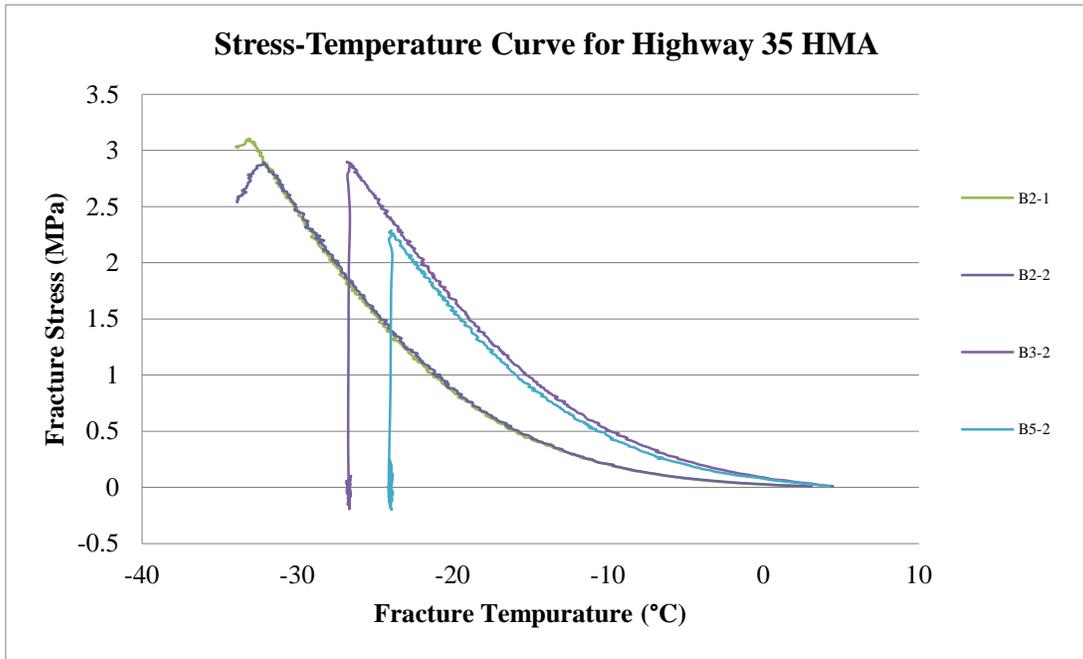
Figure 4.5 Highway 35 HMA Mix Stress Temperature Curve

Figure 4.5 and Figure 4.6 show the stress-temperature curves for Highway 35 HMA mix RMA mix, respectively. The same pattern is observed for the Highway 7 mixes, where the conventional HMA mixes and the RMA mixes behave similarly, yet fail at different temperatures and stress values. Figure 4.5 (Highway 35 HMA mix) shows the mix being cooled until it fails at approximately -30°C average, where the curve shows failure. Although the mix is specified to be a -28°C mix, beam B3-2 and B5-2 performed under the specification for the mix. The fracture stress of this HMA mix averaged at a very high 2.85 MPa.

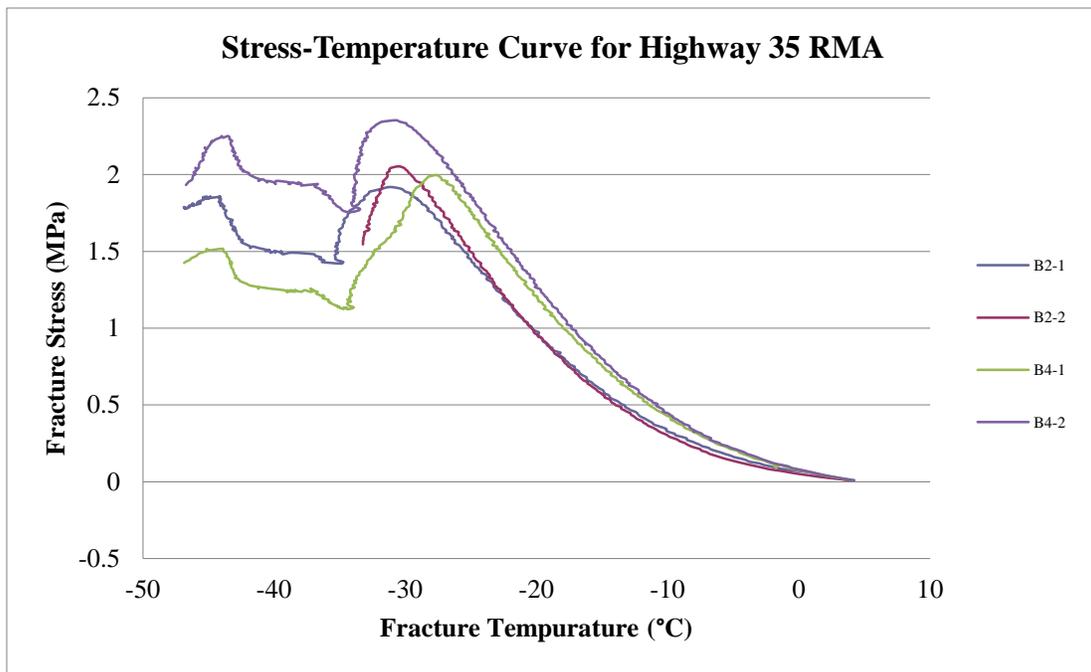
Figure 4.6 Highway 35 RMA Mix Stress-Temperature Curve

Comparatively, the Highway 35 RMA mix fractures at a slightly lower temperature than that of the conventional HMA mix. The fracture stress is also much lower on the RMA mix than the conventional mix. This mix is also exhibiting a recovery type behavior as the stress decreases but the sample is able to withstand additional temperature decreases until brittle failure.

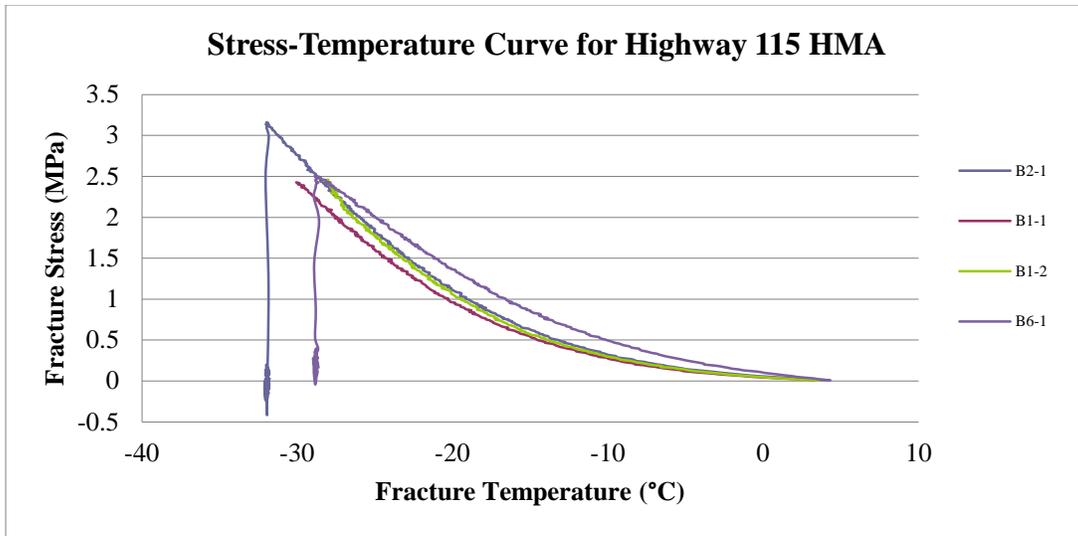
Figure 4.7 Highway 115 HMA Mix Stress-Temperature Curves

Figure 4.7 and Figure 4.8 show the stress-temperature curves for Highway 115 Conventional HMA and RMA, respectively. The conventional HMA mix for the Highway 115 section again behaves similar to the conventional HMA mixes in the previous sections. The mix is cooled until approximately -30 degrees at a failure stress of approximately 2.68 MPa. The area of concern with this mix is that the mix is underperforming, as the PG grade of the mix is PGAC 64-34. The mix is failing at a

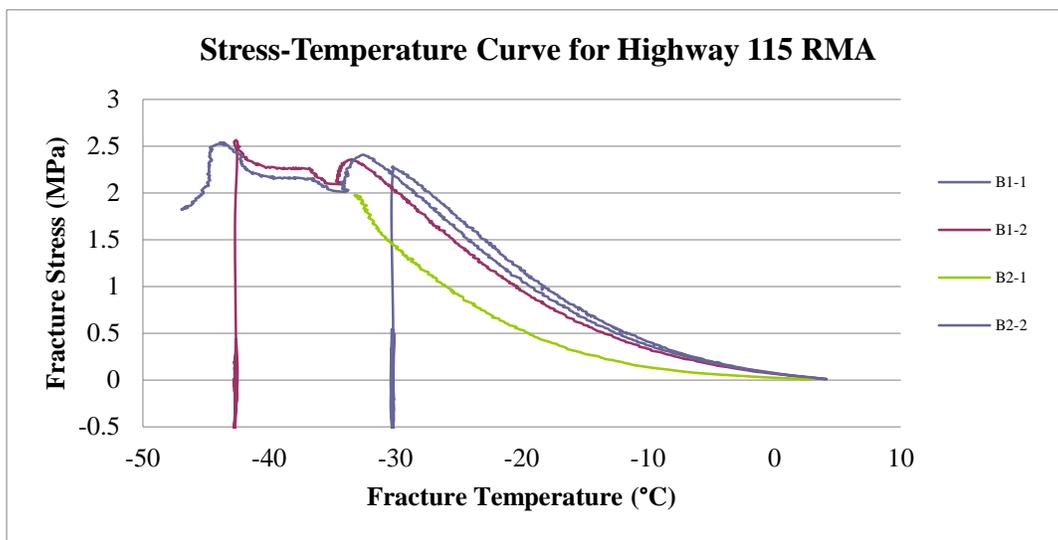
Figure 4.8 Highway 115 RMA Mix Stress-Temperature Curves

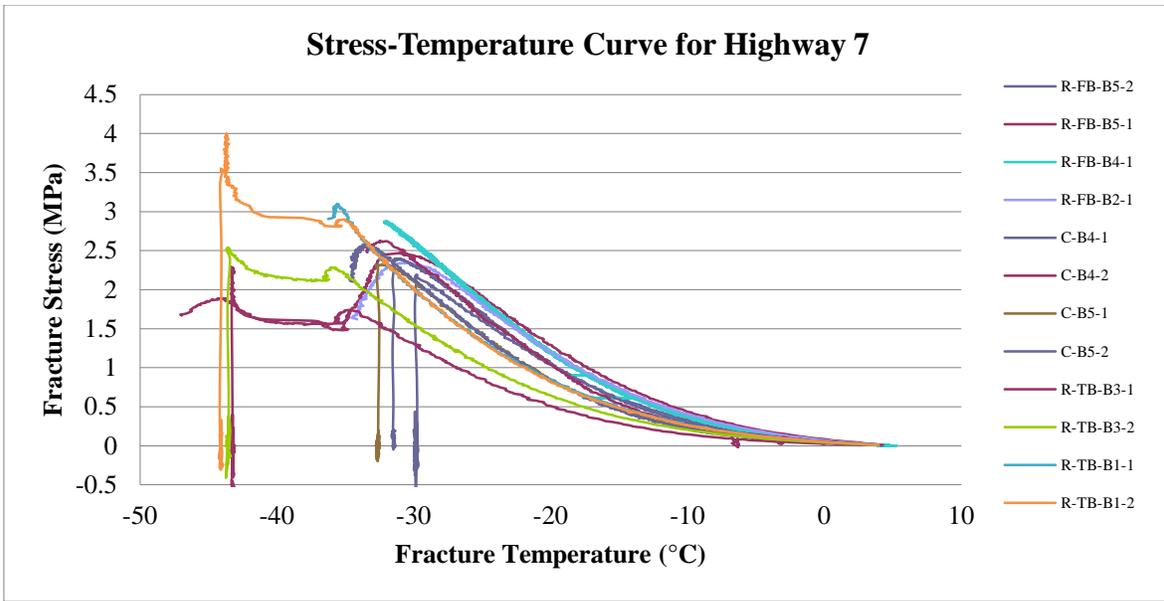
The comparison of the three mixes present on the section of Highway 7 is evident in Figure 4.9. The RMA field blend mixes show very similar performance to that of the conventional HMA mixes in this case. The RMA field blend mixes do fail at a slightly lower stress and lower temperature, but it is not significant as compared to the conventional HMA. One of the differences between the Highway 7 RMA field blend mixes and the other RMA mixes on the remaining highways is the fact that it is the only mix that is a 9.5 mm nominal size mix. While this may not attribute fully to the fact that the mix is not outperforming the conventional HMA mix, but it may be a contributing factor, as other RMA mixes have outperformed the HMA mixes. While there may be other factors, it is suspected that the fact that Highway 7 uses SP9.5 mix for the RMA while the other highways use SP12.5 mixes may contribute to the performance.

Figure 4.9 Stress Temperature Curves for All Highway 7 Mixes

The behavior of the RMA terminal blend mixes was more interesting, as it displayed a strange pattern when compared to that of a normally observed TSRST result. This phenomenon occurs with only the rubber blends, as in Figure 4.9 for the Highway 35 mixes, it exhibits the same behavior in the rubber field blend mix.

Evident in Figure 4.9 to Figure 4.11 is the pattern displayed by the rubber mixes, whereas the rubber causes the mix to withstand lower temperatures then fails suddenly after a flat line in the stress value. It is suggested that this phenomenon is due to the strength of the rubber in the matrix of the mix. It seems that the initial dip in the stress in

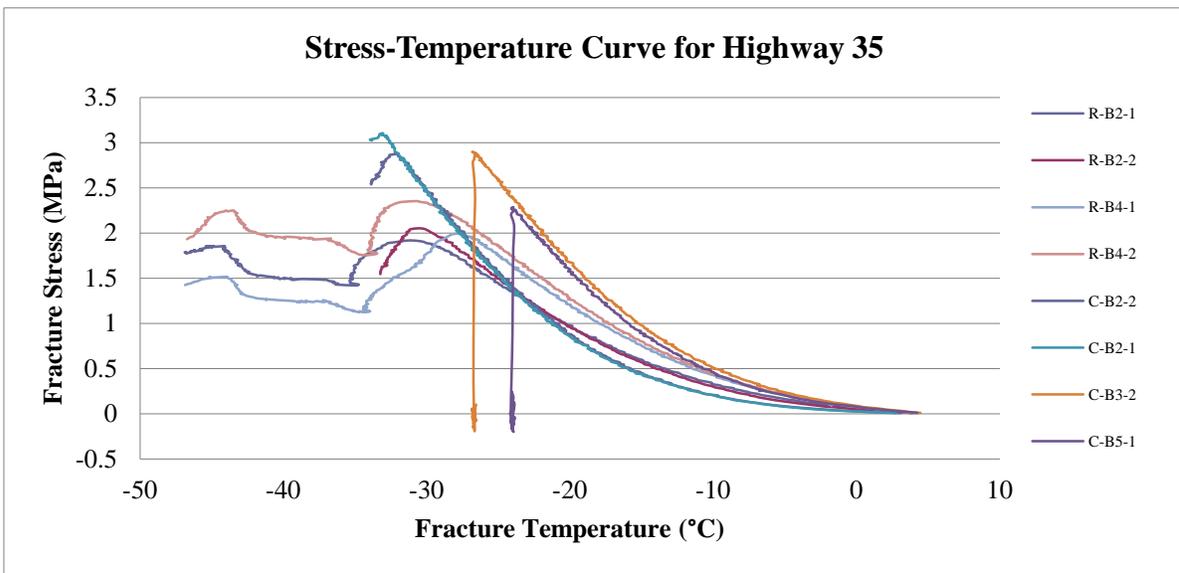
Figure 4.10 Stress-Temperature Curves for all Highway 35 Mixes

Figure 4.10 shows the comparison between the RMA field blend mix and the conventional HMA mix for Highway 35. The most evident difference between the mixes is the RMA's ability to perform at very low temperatures. As mentioned previously, the RMA mix is exhibiting a strange behavior when it approaches temperature of -35°C and lower. Although it exhibits this behavior, it is evident that the rubber mix is able to withstand lower temperatures, while keeping the internal stresses on the beam lower than that of the conventional HMA.

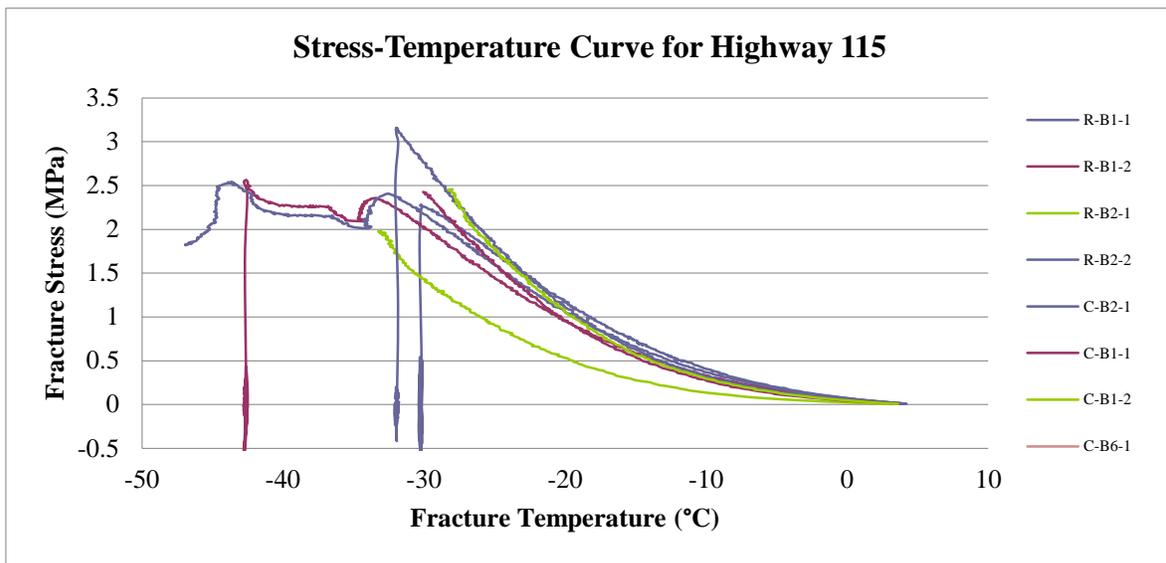
The behavior of the rubber mix is evident also in the Highway 115 mixes for RMA shown in figure 4-11. The stress-temperature curves for highway 115 shows the variation between the conventional HMA and the RMA mixes. The conventional HMA mixes go through a large stress before failure close to a temperature of -30°C . The RMA mixes exhibit the strange behavior of a drop in stress and withstanding lower temperatures until a brittle failure.

Figure 4.11 Stress-Temperature Curves for All Highway 115 Mixes

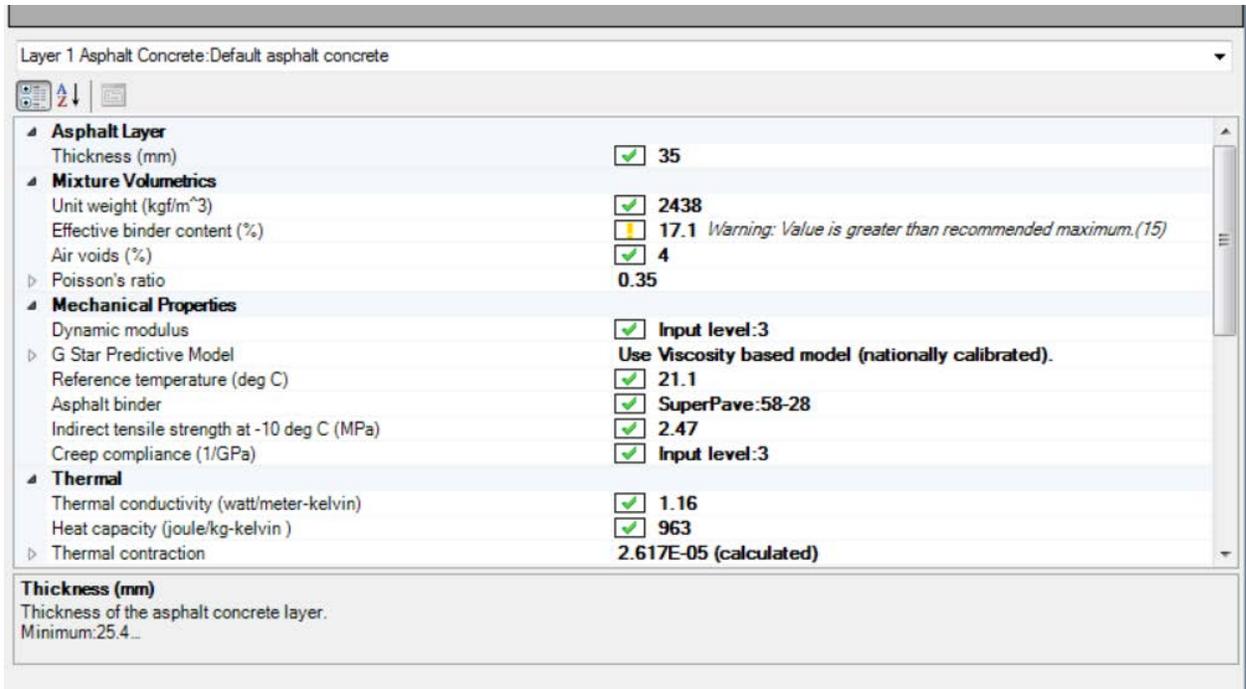
Figure 5.1 shows the RMA layer input for Highway 7. The Figure shows a screenshot from the AASHTOWare software input screen, where the parameters for the specific layer is inputted to be able to carry out the analysis.

Figure 5.1: Layer Parameter Inputs for Asphalt Layer 1 (RMA Layer)

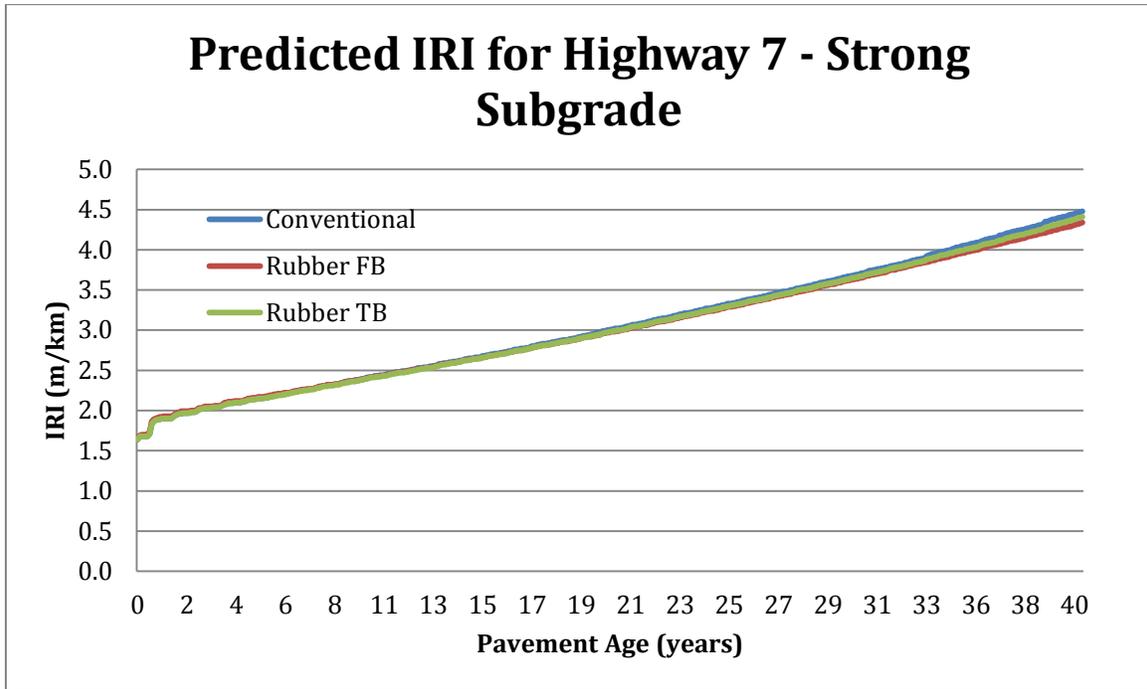
The results from the analysis for the Highway 7 sections are presented in Figure 5.7 through Figure 5.10. These graphs show the predicted IRI, total rutting (or permanent deformation), bottom-up cracking, and thermal cracking for the design life of the pavement for the mixes used on Highway 7.

Figure 5.7 Predicted IRI for Highway 7 - Strong Subgrade

Observing the performance of the pavement mixes in terms of IRI, Figure 5.7 shows the performance of all three mixes for this section is identical when considering the structure of the pavement along with the mix properties. The rubber mixes are, at the very least, performing similar to the conventional mixes, yet the AASHTOWare software is not showing similar performance expectations for the RMA.

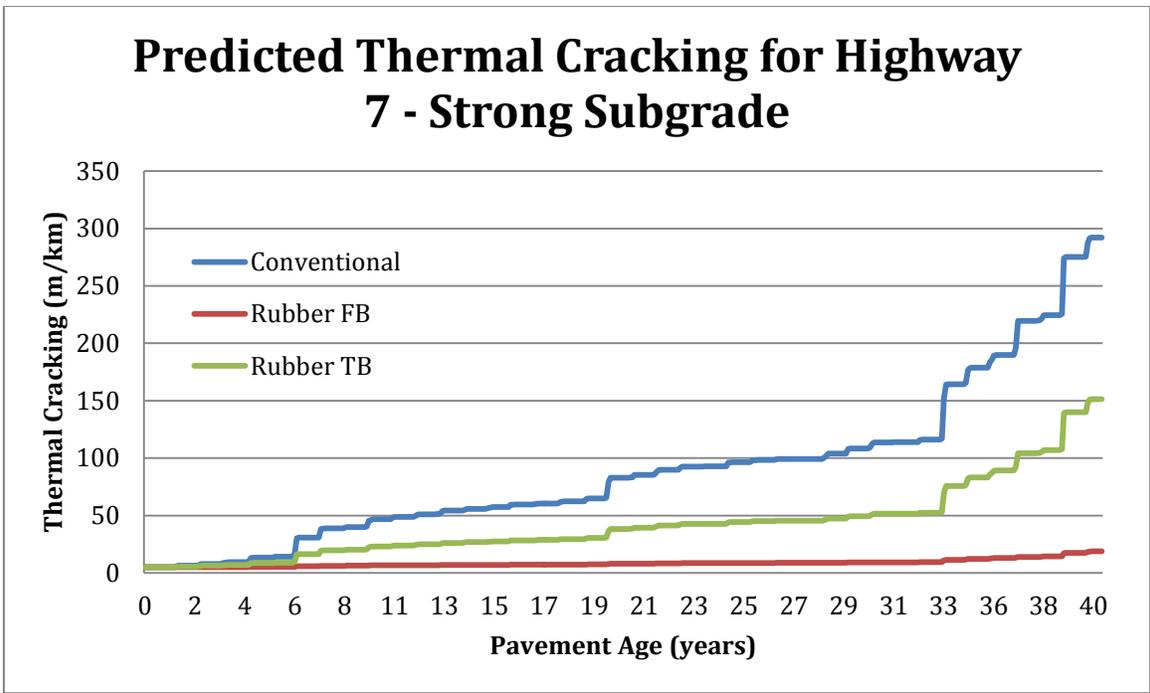
Figure 5.9 Predicted Thermal Cracking for Highway 7 - Strong Subgrade

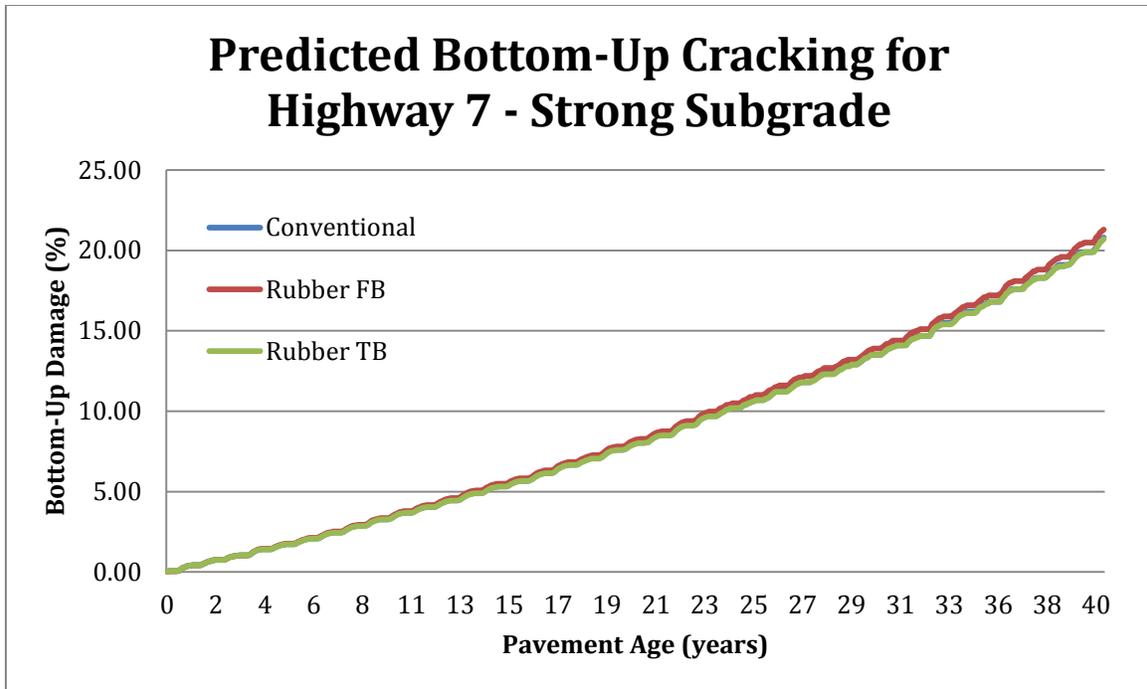
Figure 5.10 Predicted Bottom-Up Cracking for Highway 7 - Strong Subgrade

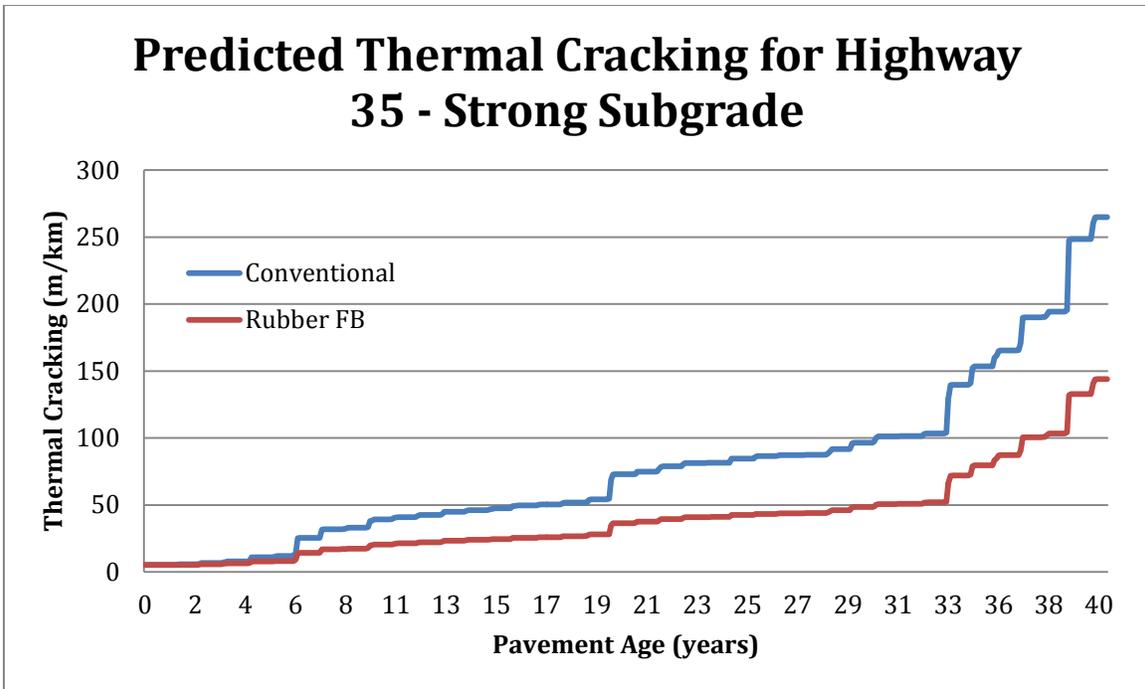
Figure 5.13 Predicted Thermal Cracking for Highway 35 - Strong Subgrade

Figure 5.13 shows the comparison of the predicted thermal cracking for the Highway 35 mixes. It can be observed that the rubber field-blend mix shows less thermal cracking during the design life of the pavement, and therefore is more resistant to surface cracking than the conventional HMA mix. The result shown in Figure 5.13 is consistent with the results obtained from the TSRST testing that was carried out on the mixes, showing that the rubber mixes, being able to withstand colder temperatures, can also resist thermal cracking, more so than the conventional HMA.

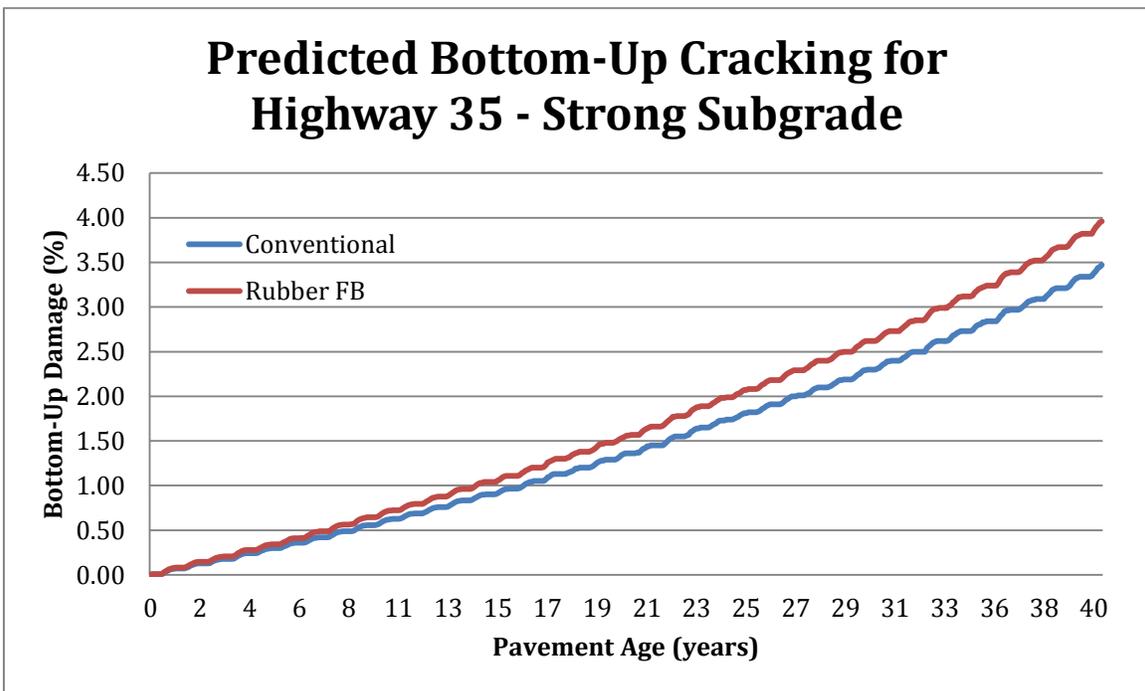
Figure 5.14 Predicted Bottom-Up Cracking for Highway 35 - Strong Subgrade
