Evaluation of Cold Weather Performance of Rubber Modified Asphalt Placed in Ontario

A thesis
presented to the University of Waterloo
in fulfillment of the
thesis requirement for the degree of
Master of Applied Science
in
Civil Engineering

Waterloo, Ontario, Canada, 2014

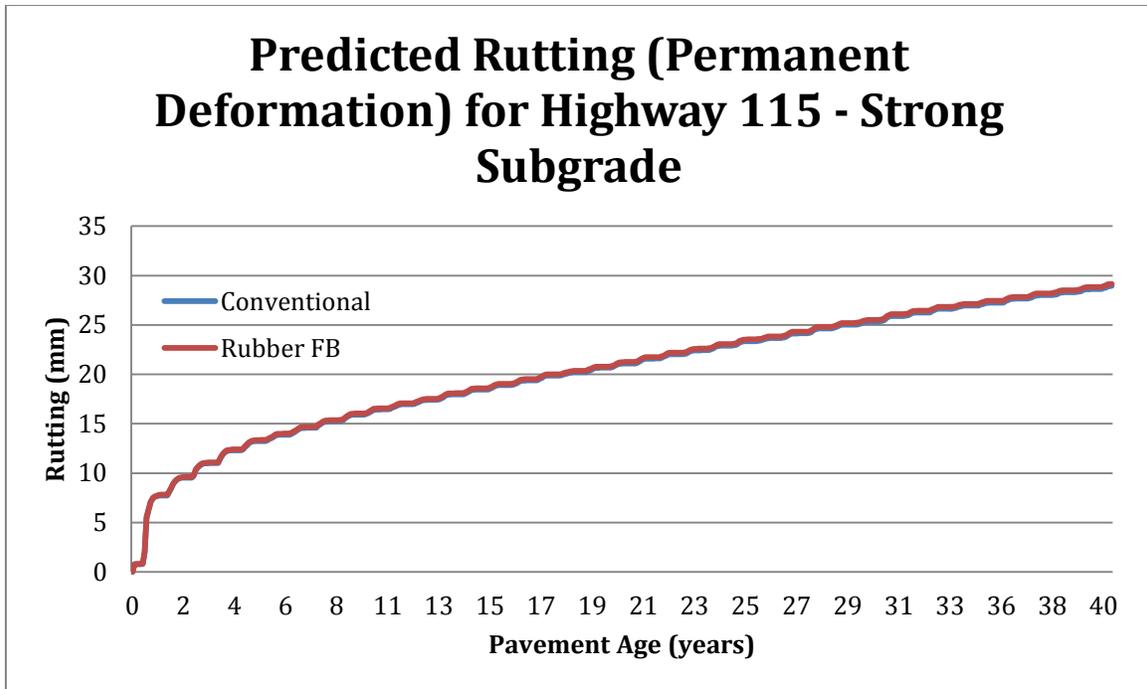
Figure 5.16 Predicted Rutting (Permanent Deformation) for Highway 115 - Strong Subgrade

The predicted IRI and predicted permanent deformation (rutting), shown in Figure 5.15 and Figure 5.16 are shown as being approximately the same for the design life of the pavement, with the IRI having a value of approximately 4.3 m/km and the predicted rutting having a value of approximately 30 mm for both mixes. Similar to Highway 7 and Highway 35, the IRI performance and rutting performance of the rubber mix is observed as being equal with the performance of the conventional mix, however, the added properties of the rubber in the mix are not accounted for due to the limitations of the AASHTOWare software.

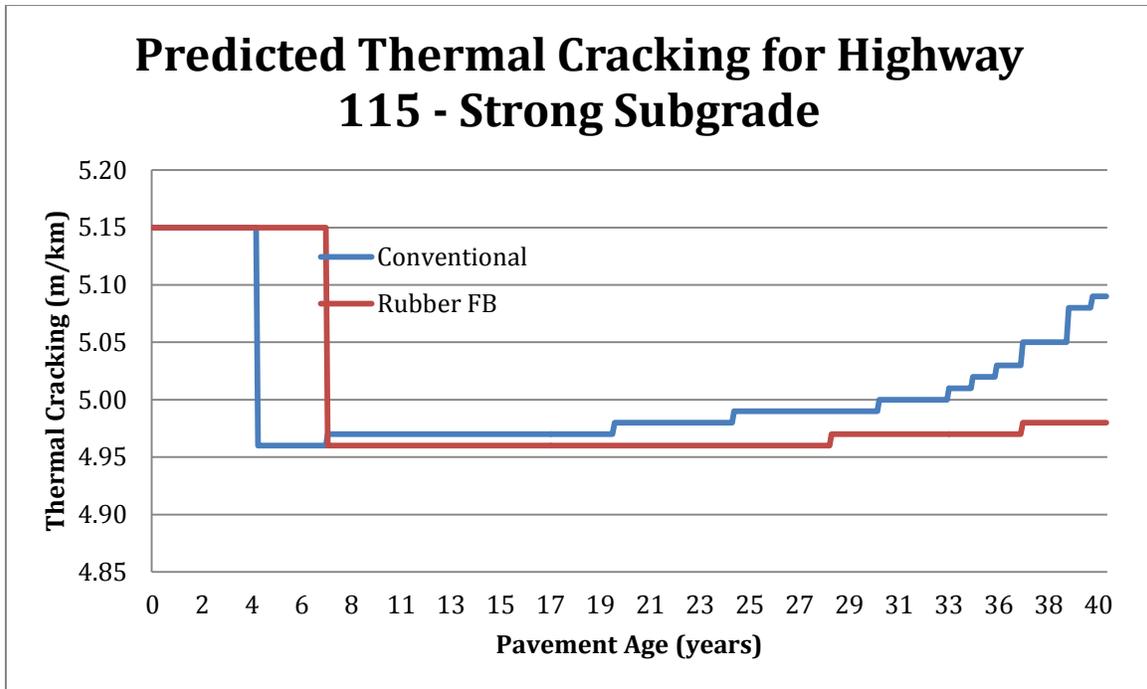
Figure 5.17 Predicted Thermal Cracking for Highway 115 - Strong Subgrade

Figure 5.17 shows the predicted thermal cracking for Highway 115. The thermal cracking graph shows a limitation of the AASHTOWare software as it seems to not be able to accurately predict the initial cracking extent, as evidenced by the drop in thermal cracking at approximately 4 years for the conventional HMA mix, and 7 years for the rubber mix. A sudden drop in the graph indicates a decrease in the amount of cracking per kilometre, which cannot be the case unless maintenance was carried out on the pavement. Although this may show a problem, the remainder of the graph follows the typical curve for thermal cracking that has been observed in Highway 7 and Highway 35 with regards to the rubber mix exhibiting less thermal cracking than the conventional HMA mix. Although the graph looks similar to the Highway 7 and Highway 35 mixes, the thermal cracking values are much lower than the mixes used on the other highways, reaching values of approximately 5.1 m/km and 5.0 m/km at the 40 year design life for the conventional HMA and rubber mixes, respectively.

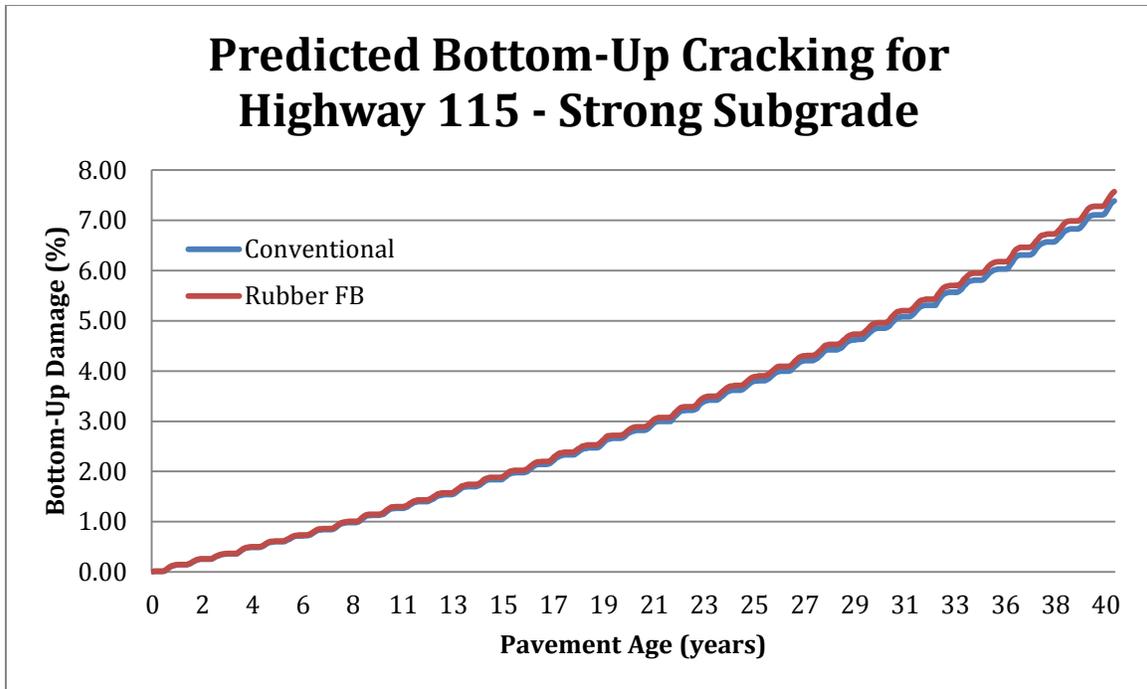
Figure 5.18 Predicted Bottom-Up Cracking for Highway 115 - Strong Subgrade

Figure 5.18 shows the percentage of bottom-up cracking on the pavement throughout the design life. Both the conventional HMA and the rubber mixes show approximately a 7.5% of bottom up damage at the 40 year design life. It can be concluded from this Figure that the rubber mix performs equally as well as the conventional HMA. Although the graph shows the rubber field blend exhibits slightly higher percentage of bottom-up cracking, the increase is in the order of 0.1%, which is minimal when looking at the pavement on a larger scale.

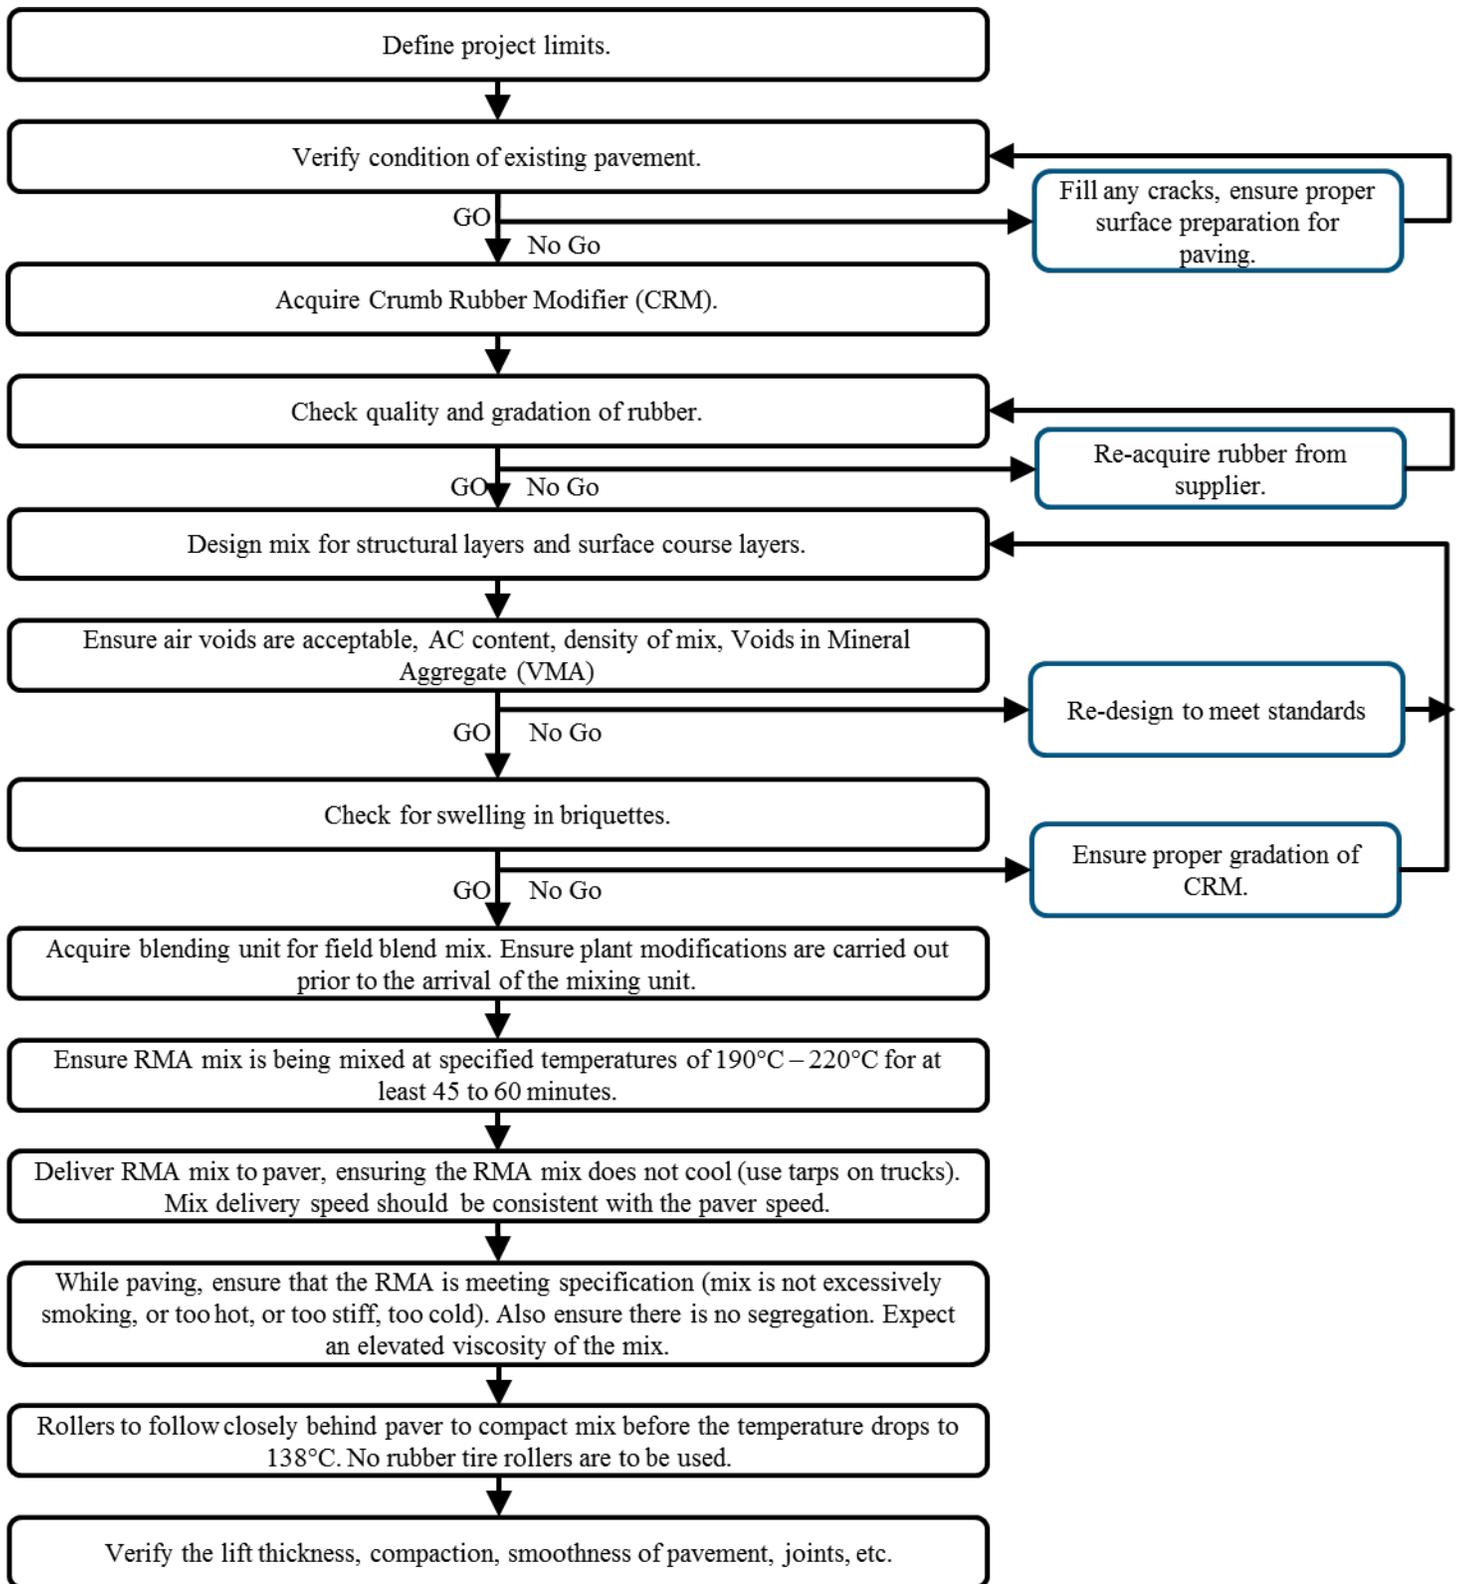
When choosing to pave with RMA, Figure 6.1, developed as part of this research, provides a workflow for the paving of RMA. While the workflow presented does not include every detail of the process, it does serve as a checklist of important guidelines to abide by when paving with RMA.

Figure 6.1: RMA Guidelines Workflow
