**Landslide damming in Western Sichuan
Province, China,
with special reference to the 1786 Dadu River
and 1933 Diexi events**

A thesis

Earth Sciences

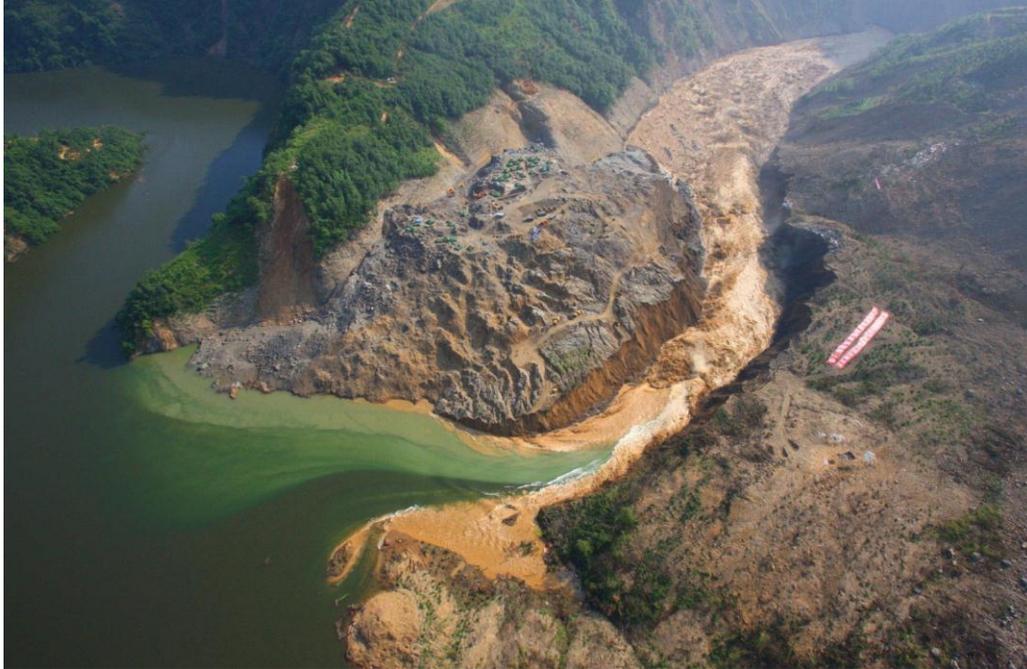
Figure 1.5. Tangjiashan landslide-dammed lake during controlled breach on June 10, 2008. Note the enlarged spillway caused by water incision over the landslide body (Photographed by Prof. Liu Ning. Figure 10.14 from Cui et al. 2011).

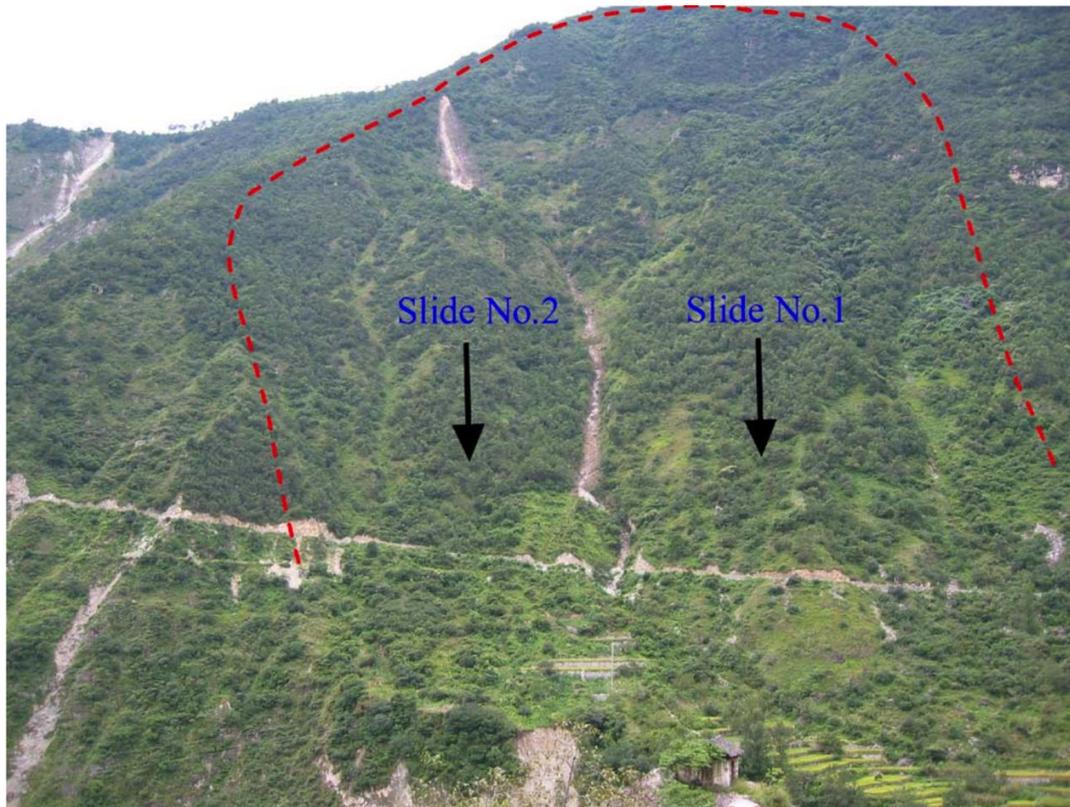
Figure 2.1. Landslide that formed the 1786 lake, located on the right bank of the Dadu River (coordinates: 29.6314N, 102.1608E) according to Dai et al. (2005). The red dashed line indicates the landslide boundary. (Figure 6 from Dai et al. 2005, photograph facing west)

Dai et al. (2005) proposed two adjacent landslides, with volumes of 6Mm^3 and 5Mm^3 , respectively (Figure 2.1). Based on the estimation of Dai et al. (2005), the dammed lake caused by the landslides reached an elevation of 1,180 m asl. At this pool elevation, the lake was 6.8km in length, 1.7km^2 in area, and 50Mm^3 in volume. It is doubtful a dam breach of this limited scale could cause such catastrophic damage downstream. Meanwhile, the reservoir proposed by Dai et al. (2005) cannot match most of the historical descriptions. Moreover, it is found that the total volume of water that is impounded by the dam in 9 days is far larger than the proposed reservoir volume, which means that in Dai's case, the dam would have no reason to hold such a long time. Therefore, it is considered that the landslides and its dammed reservoir proposed by Dai et al. (2005) are unlikely to have caused the 1786 dammed impoundment or the volume necessary for the documented downstream catastrophe.

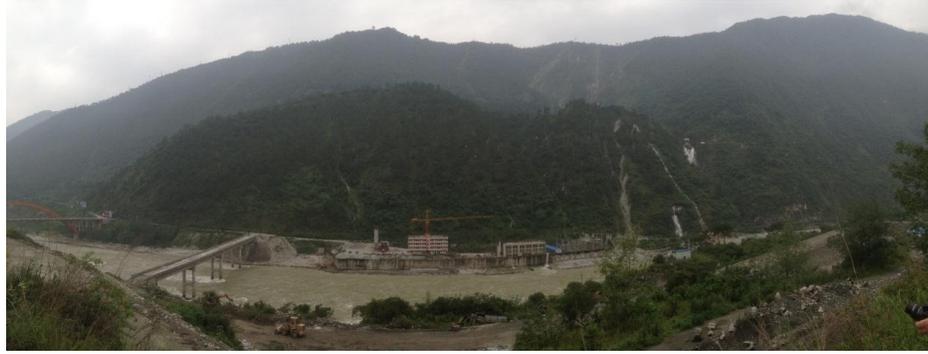
Figure 2.3. Photograph of the Mogangling Landslide, located on the right bank of the Dadu River (coordinates: 29.6237N, 102.1578E). Photograph taken on 18/07/2014, on the left bank, facing west.

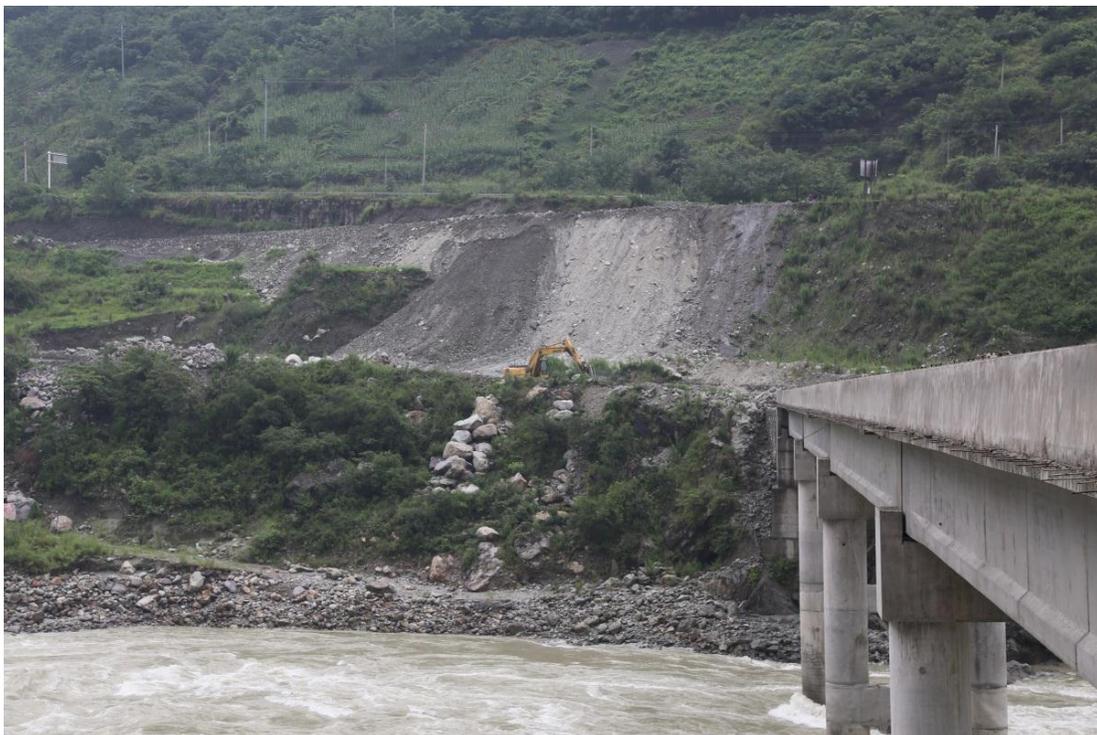
Figure 2.5. Alluvial deposits on left bank of the Dadu River, photo taken on 18/07/2014.

Lithology of the area mainly consists of granite and diorite, with diabase in some parts (Wu et al., 2013). Quaternary colluvial deposits can be found on the rear edge of the landslide. Alluvial deposits are also found near the river channel, which is shown on Figure 2.5.

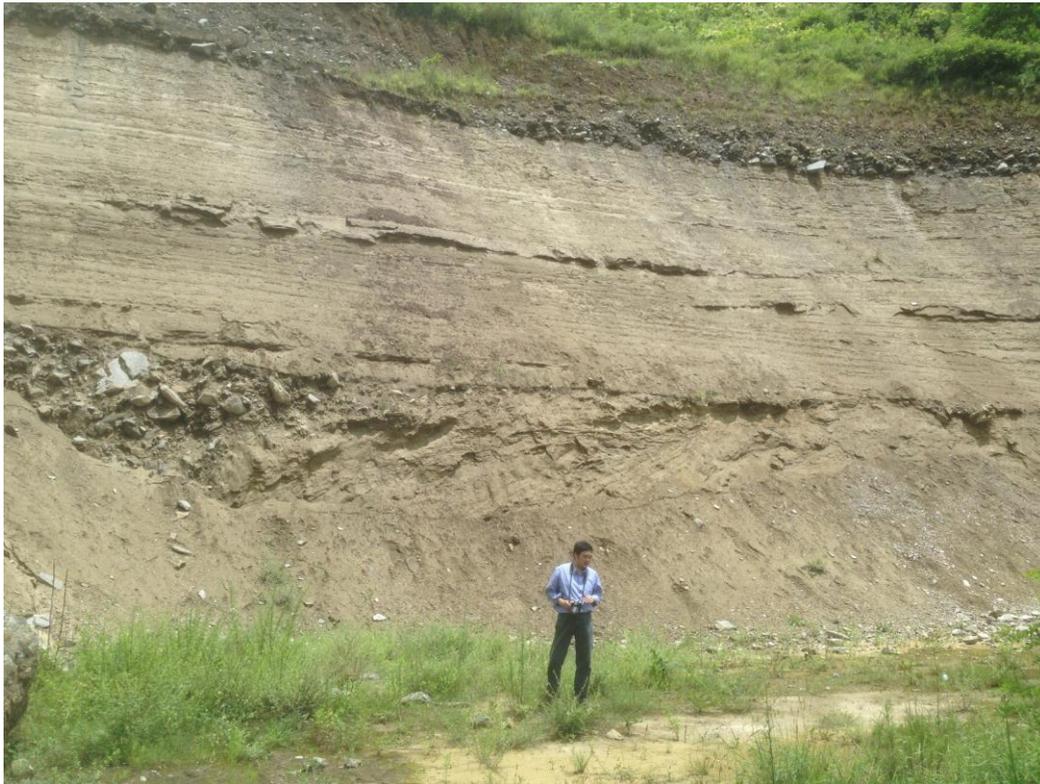
Figure 3.2. Lacustrine deposits of the “Ancient landslide-dammed lake of Diexi”. Photo was taken near the reservoir tail of the present Da Lake (taken on 12/07/2014).

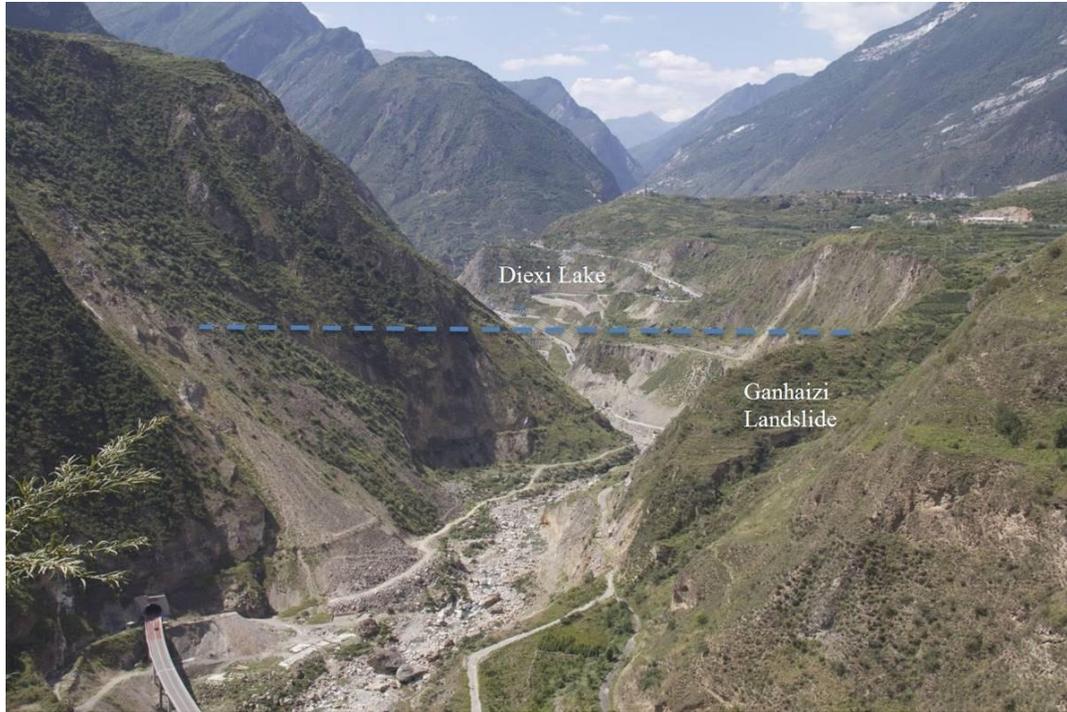
Figure 3.6. Photograph of the remnant dam of Diexi Lake, which was formed by the Ganhaizi landslide and the Diexi landslide (taken on 17/08/2013).
