**Investigation and Propagation of Defects in the
Membrane Electrode Assembly of Polymer Electrolyte
Membrane Fuel Cells: Quality Control Analysis**

A thesis

presented to the University of Waterloo

Chemical Engineering

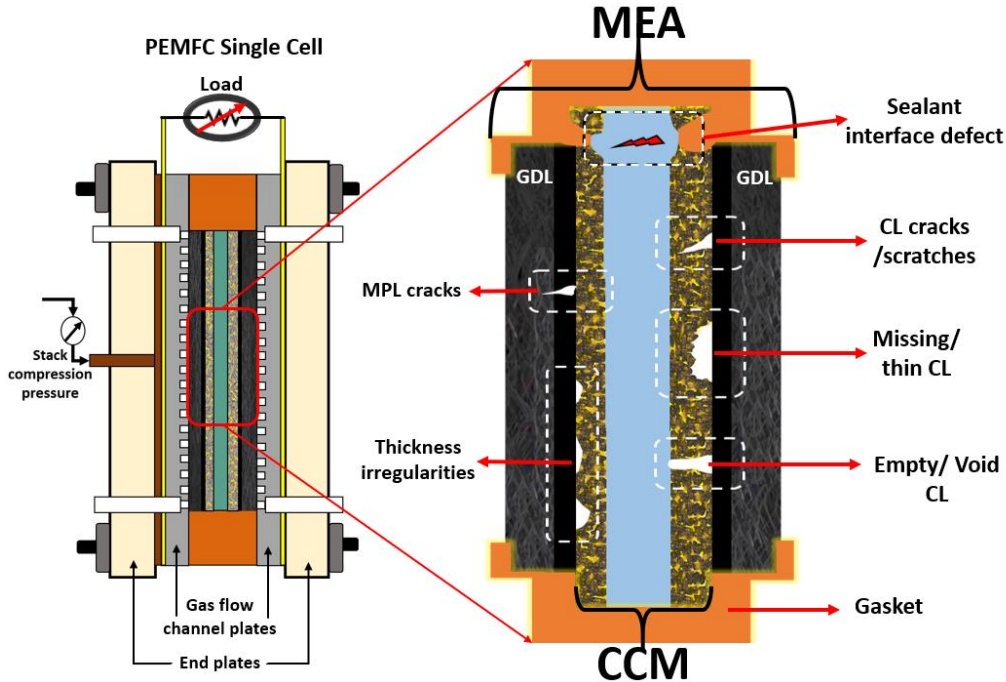
Figure 1-1: Various defects observed in CCM/MEA components during the fabrication process.

CCMs and GDLs are two major components in an MEA. The defects in CCM/GDL are defined as imperfections, irregularities or non-uniformities in the thickness of the catalyst layers and MPL that can cause losses in PEMFC performance. These defects include cracks, missing/empty catalyst, catalyst agglomerates, scratches, voids, delaminated portions, uneven thickness coatings and membrane pinholes. Examples of MEA defects are shown in Figure 1-1. As defects grow larger in size, shape and extent, failure becomes more likely [7,8]. More precautions should be taken specifically during the fabrication of CCMs to produce defect-free electrodes since it is expected that manufacturing defects grow at a faster rate than defects that form during the subsequent operation due to chemical, mechanical and thermal degradation [8,9]. Although advances in CCM fabrication technology have enabled PEMFCs to operate at higher power densities in recent years, operation at these higher rates can leave the CCM more prone to develop electrode defects that lead to catastrophic failure. Once defects such as pinholes become large enough, the direct reaction of the fuel and oxidant can produce hydroxyl and hydroperoxyl radicals that accelerate the chemical degradation of the polymer membrane [9,10]. The research presented here has attempted to gain a better understanding of the origin and evolution of various defects in CCMs and GDLs, classify defects according to the physical characteristics, correlate these defects with PEMFC performance loss under different operating conditions and develop a quality control system for improving MEA technology.

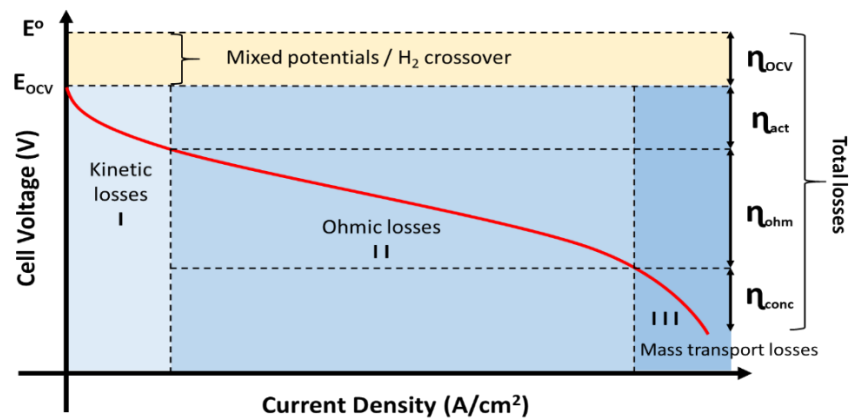
Figure 2-2: Schematic of polarization curve indicating the major cell voltage losses: mixed potential/open circuit (η_{ocv}), activation overpotential (η_{act}), ohmic overpotential (η_{ohm}) and concentration overpotential (η_{conc}).

Typically, a polarization curve is considered to be the main measure of fuel cell performance. A polarization curve depicts the dependence of cell potential or voltage on the current density. Three regions which mark the onset of the voltage losses due to electrode kinetics (activation), ohmic resistance and mass transfer can be identified on these curves, as shown in Figure 2-2.

The actual cell voltage is less than the cell potential determined from the Nernst equation during fuel cell operation. This is due to the losses shown in Eqn (2.5): open-circuit voltage (η_{OCV}), activation/charge transfer losses (η_{act}), ohmic losses (η_{ohm}) and concentration/mass transfer losses (η_{conc}). As the current density increases, the magnitudes of the last three voltages increase

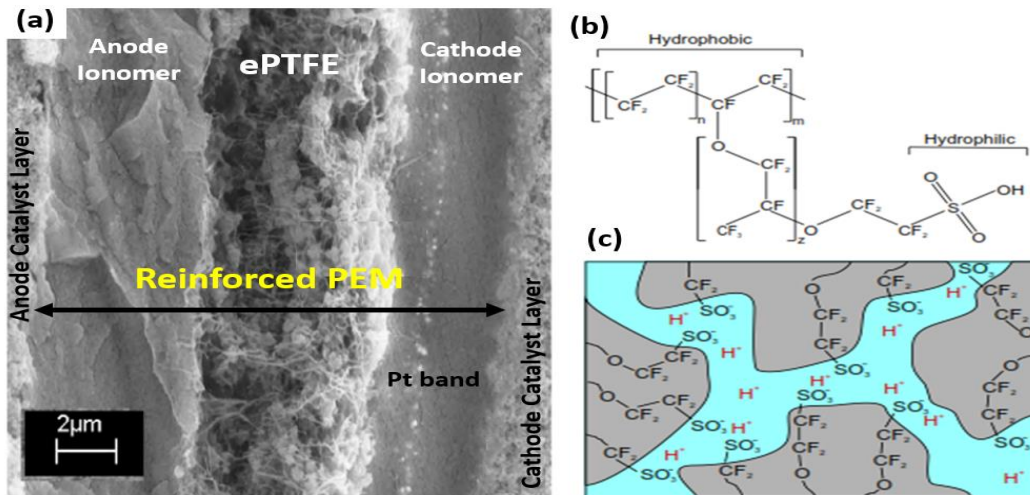
Figure 2-3: (a) Cross-sectional view of reinforced membrane [41]. (b) Chemical structure of the Nafion polymer and (c) microscopic structure of Nafion membrane [44].

Figure: 2-3a shows the cross-sectional view of a membrane where the ePTFE layer is reinforced between the anode and cathode ionomer layers, while Figure 2-3b shows the chemical structure of PFSA membrane which is amphiphilic due to the presence of hydrophobic and hydrophilic side

chains. Short hydrophilic chains made of sulfonic acid groups connect long hydrophobic chains of polytetrafluoroethylene. The sulfonic acid groups increase the proton conductivity. The amphiphilic nature of the PFSA membrane causes the polymer phase to separate into clusters and leave behind a proton conductive network, as shown in Figure 2-3c. The proton conductive network is provided by water (blue) which fills the hydrophilic phase [44].

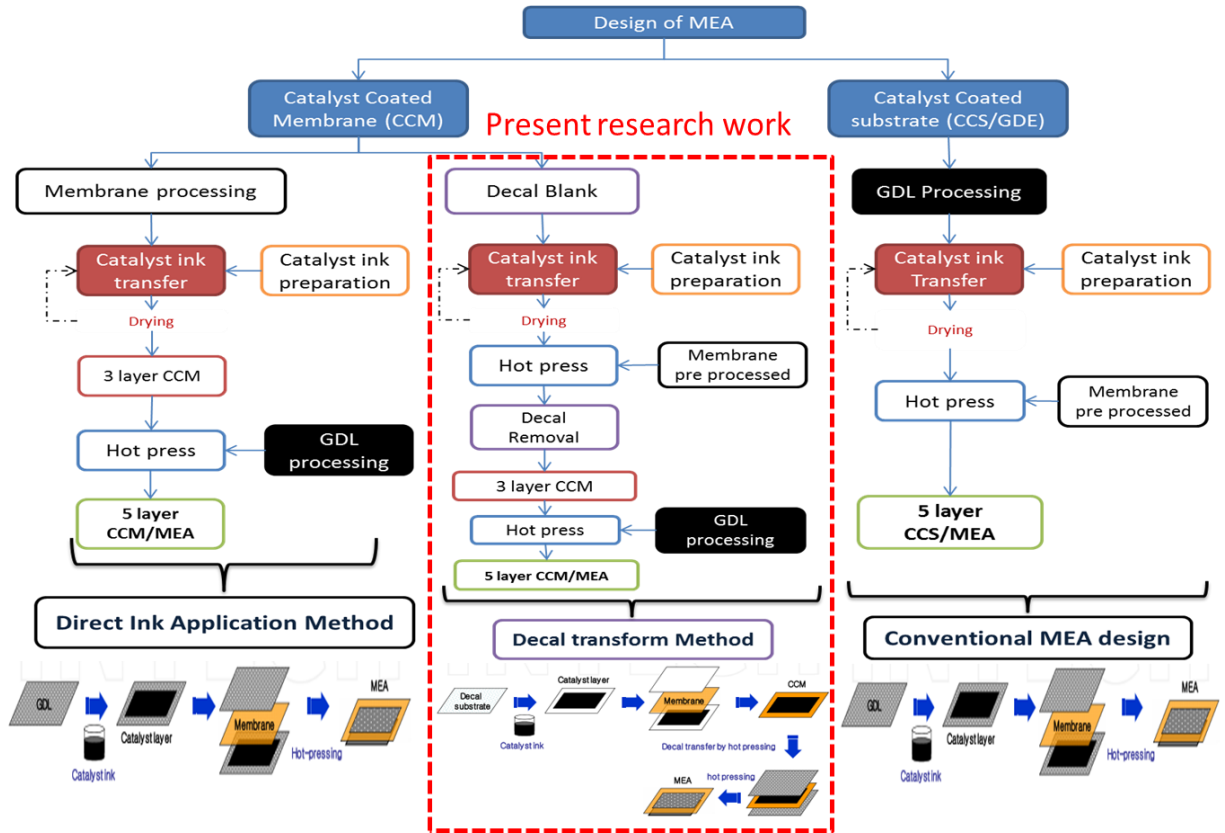
Figure 2-4: MEA fabrication methods [54].

The research in this PhD project will focus on the CCM-fabricated DTM technique. This technique involves loading the catalyst layer ink uniformly onto the decal substrate as shown in Figure 2-4 (indicated in red dotted rectangle). The CLs of both electrodes are then transferred from the decal substrates to the Nafion membrane by hot pressing at 100 to 120 kg cm⁻² loaded pressure and temperatures of 110°C-140°C for a specific amount of time. The decal substrates are then peeled away from the CCM to leave behind the catalyst layer on the membrane, yielding a three-layer CCM. Finally, teflon-treated GDL or GDE (MPL + GDL) is then added to the CCM by hot-pressing, as mentioned earlier [54].

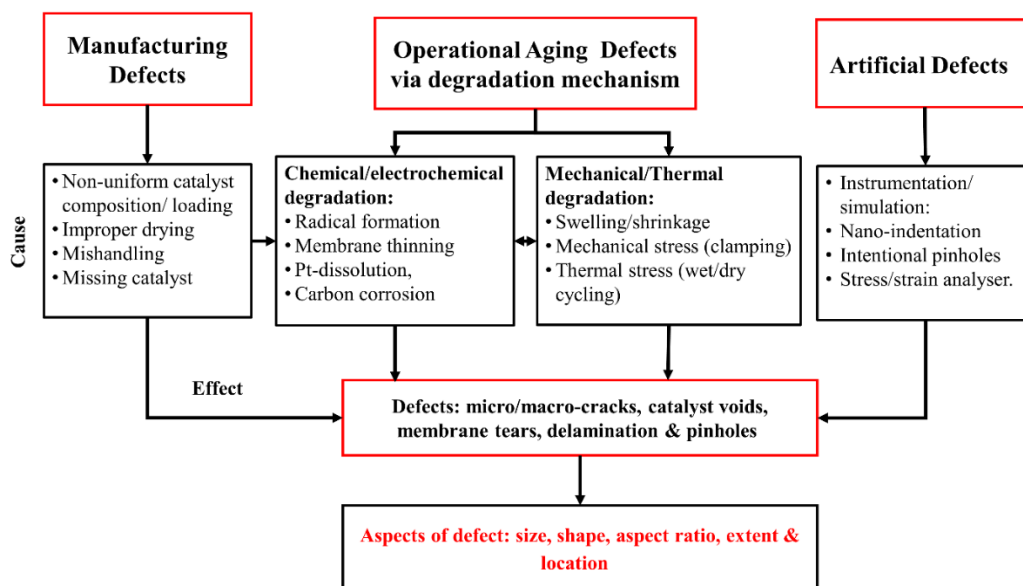
Figure 2-5: Categorization, cause and effect of defects formed in PEMFC components.

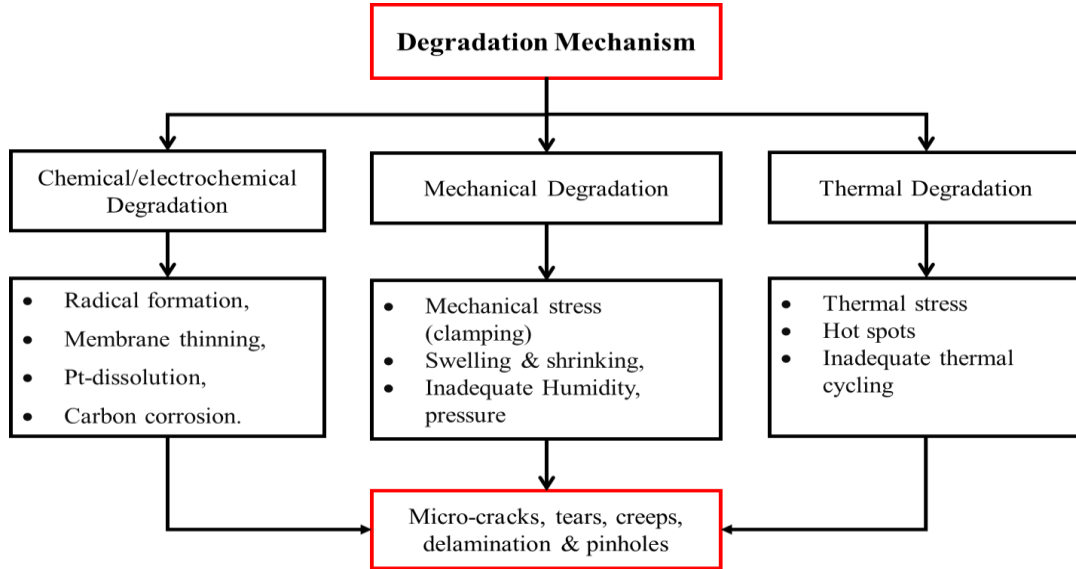
Figure 2-7: Degradation mechanism of defect formation in MEA components

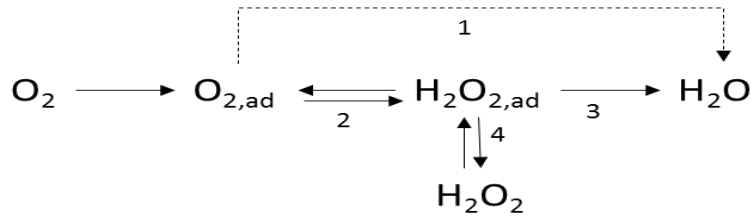
Figure 2-8: Oxygen reduction reaction on metals.

the cathode or in the core of the membrane [41]. Figure 2-9 shows four chemical/electrochemical processes that cause hydrogen peroxide formation in the fuel cell CCM. In process I, the incomplete reaction of electrons and H^+ (step 4 in Figure 2-8) forms hydrogen peroxide, which is generated electrochemically by the two-electron reduction of oxygen at potentials below 0.695 V shown in Eqn. (2.12). This is catalyzed by both platinum particles and the carbon support. LaConti et al. proposed that radicals are initially generated by the formation of H_2O_2 through the addition of a proton to an incomplete water structure as shown in Figure 2-8. The four-electron reduction reaction of oxygen to form water as product at the cathode is shown in Step 1 and Eqn. 2.11. This overall process likely does not occur all at once. H_2O_2 can form according to steps 1 and 2 via two-electron reduction and then go onto form water in step 4 or desorb from the catalyst surface into the bulk in step 3 [79].

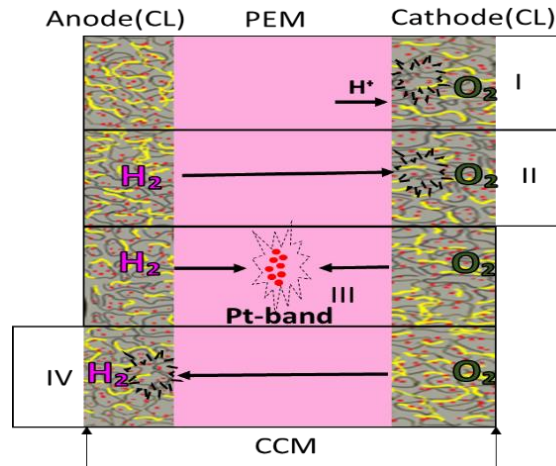
Figure 2-9: Schematic illustration of four different mechanisms of hydrogen peroxide formation.

Due to the permeable nature of the membrane, gas crossover of hydrogen from the anode to the cathode and oxygen cross-over from the cathode to the anode can occur (processes II and IV in Figure 2-9). In both cases, gases can react chemically to produce hydrogen peroxide in the cathode catalyst layer (II) and the anode catalyst layer (IV). This can reduce the proton conductivity of the ionomer and weaken the mechanical strength of the catalyst layer and polymer membrane [79]. One way to estimate the rate at which the polymer degrades is to measure the concentration of fluoride ions in the effluent water from the fuel cell [41]. In process III (Figure 2-9), the removal of the carbon support structure in the CL can promote the agglomeration or dissolution of Pt nanoparticles. The free Pt nanoparticles can migrate and become embedded in the membrane to form a Pt band which can promote pinhole formation and enhance peroxide generation in the

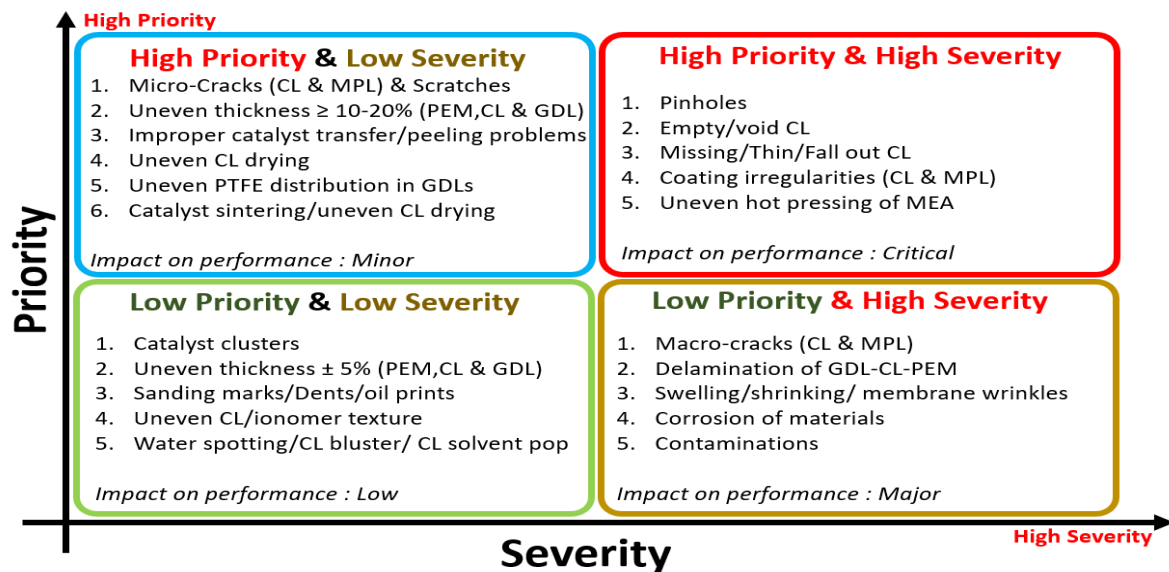
Figure 2-11: Categorization of defects based on severity and priority.

Defects can be categorised based on their severity and priority. Defect severity refers to the impact on fuel cell performance and can be categorized as being critical, major, minor and low. Defect severity is an important characteristic because it is directly related to functionality [89]. If a pinhole develops in the membrane, the MEA can no longer function in a stack and would thus be classified as a defect of critical severity [71]. Hu and Cao analysed the evolution of pinhole growth affecting the long-term stability of MEA [90][33]. On the other hand, priority represents the attention which should be paid to the defect and is classified as being immediate, high, medium, and low. For example, micro-cracks have little immediate effect on overall performance but have the potential to propagate into a defect that does require immediate attention. Thus, they are classified as defects of high priority [91][92]. Figure 2-11 shows a detailed categorization of various defects based on their severity and priority.

High severity and high priority: A defect that falls in this category will cause the failure of a fuel cell. This defect completely damages or changes the structure of the electrode to the point where operation can no longer continue [89]. Other examples of high severity and high priority defects are pinholes and empty catalyst layers. Pinholes result in the failure of the fuel cell, while the presence of empty catalyst layers which do not promote the electrochemical reactions can lead to large pressure, concentration and thermal gradients and non-uniform heat distributions during operation that can lead to the development of pinholes, particularly at high current densities [93]. These gradients also tend to facilitate gas crossover and enhance radical formation which further decomposes the polymer in the membrane.

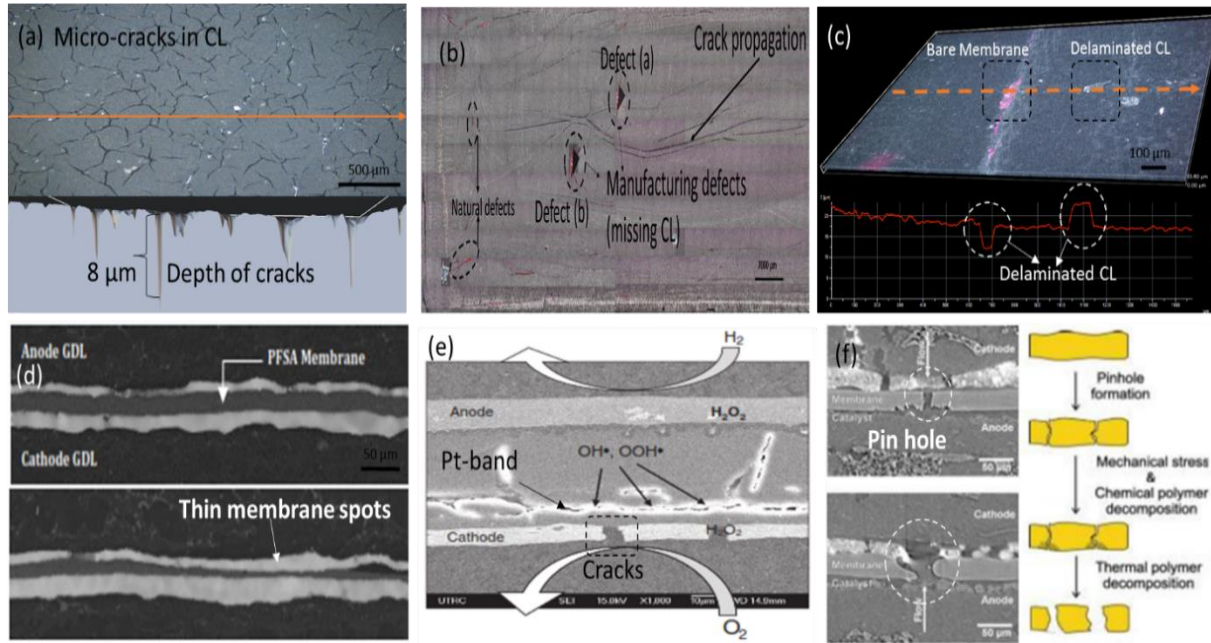
Figure 2-12: (a) Top and side views of CL showing distribution, length and depth of cracks. (b) Missing catalyst regions/thin catalyst area (manufacturing defects) in CCM; the dark line indicates major cracks in CL due to expansion of membrane. (c) Delamination of CL leaving bare membrane. (d) Membrane thinning. (e) Pt band formation in membrane causing radicals. (f) Mechanism of pinhole formation caused by chemical, mechanical and thermal degradation.

Defect type	Material affected	Impact of defect in CCM
Cracks (Fig. 2-12a)	Catalyst layer: separation of catalyst layer without breaking of membrane. Membrane: creeping or tearing inside the solid polymer.	<ul style="list-style-type: none"> • Breaking of catalyst layer • Defect propagation through mechanical stress • Non-homogeneous current distribution • Areas subject to free radical attack • Increased resistance in catalyst area • Growth of defect to a pinhole
Voids (Fig. 2-12b)	Catalyst layer: areas where no catalyst is loaded or missing catalyst regions	<ul style="list-style-type: none"> • Improper catalyst transfer onto the membrane • Increase in surface resistance of CL • Higher chance of water flooding
Delamination (Fig. 2-12c)	Catalyst layer/membrane: separation of catalyst layer from PEM	<ul style="list-style-type: none"> • Separation of CL due to mechanical changes of the PEM • Higher chance of water flooding • Partition of CL and membrane across micro-crack and pinhole areas • Increase in activation losses

Membrane thinning (Fig. 2-12d)	Membrane: variations in CCM thickness	<ul style="list-style-type: none"> • Mechanical weakness of polymer structure inside the PEM • Areas with high radical concentration • Variation of resistance at different locations • Areas of high gas crossover
Platinum dissolution [58] (Fig. 2-12e)	Membrane: separation of Pt nanoparticles and Pt band within membrane	<ul style="list-style-type: none"> • Formation of thin Pt-band within the membrane • Loss of ECSA over entire active area • Damage due to carbon corrosion • Slow catalytic activity affecting long-term stability
Pinholes (Fig. 2-12f)	Membrane: void spaces within membrane that are larger than 10 microns allow gas crossover of fuel and oxidant.	<ul style="list-style-type: none"> • Major effect on performance loss in CCM • Exothermic reaction between H₂ and O₂. • Areas where chemical, mechanical and thermal stresses combine • Instant electrode short-circuits • Develops at flooded areas

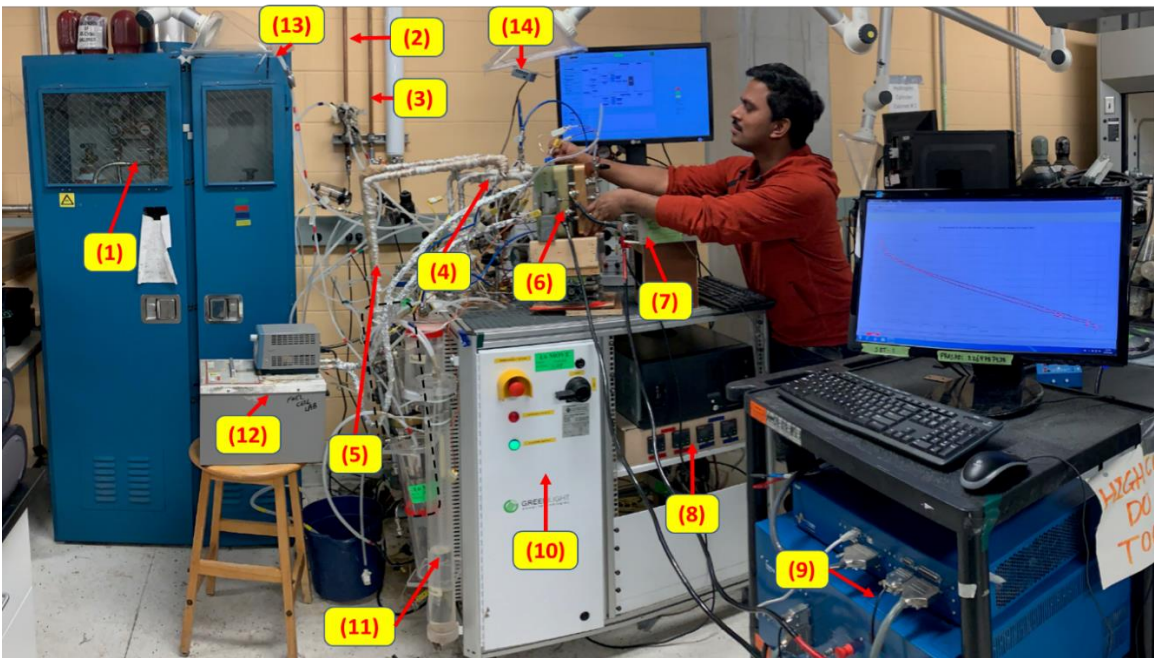
Figure 3-1: G50 fuel cell test station and ancillary components for PEMFC testing. Refer to the text for identification of the numbered components.

All experiments in this research study were conducted using a G-50 fuel cell test station to investigate PEMFC performance. The test station contained the following components (refer to

numbered items in Figure-3-1): 1. hydrogen fuel tanks (99.9995% purity), 2. air supply line, 3. nitrogen supply line, 4. anode and cathode inlet gases from internal humidification bottles (wet), 5. anode and cathode inlet gases from external humidification bottles (dry), 6. FCAT cell (see schematic of single cell in Figure 1-1), 7. external power supply (5 V, 120 A) connected in parallel to the FCAT cell and external electrical RBL 232- TDL load box (Note that the load box was located below the computer monitor), 8. Temperature controllers for humidification bottles, 9. BioLogic Science VMP3 potentiostat with HCP-1005/100A booster and EC lab V10.39 software, 10. Greenlight model fuel cell control chamber (G-50), 11. water outlet bottles to collect condensed water from the fuel cell stack for fluoride ion release analysis. 12. water bath to maintain the stack temperature at 90°C, 13. hydrogen outlet connected to fume extractors, 14, hydrogen sensor to detect any H₂ leaks from the stack.

Prior to assembly in the FCAT cell, each MEA was examined using IR thermography to identify BOL defects, as discussed later in section 3.2.2.1.2.1. Once the MEA was incorporated into the cell, a leak test was performed to confirm that the assembly was properly done. If any leak was observed, the cell was re-assembled with new silicone gaskets, Swagelok fittings or bipolar flow plates until the leak test was passed. Once this was accomplished, the FCAT cell was carefully connected to the inlet and outlets gas streams to the G-50 test station shown in Figure 3-1. Hot deionised water was supplied to the stack water inlet port from the external water bath (12) to heat the cell to 90 ± 5 °C.

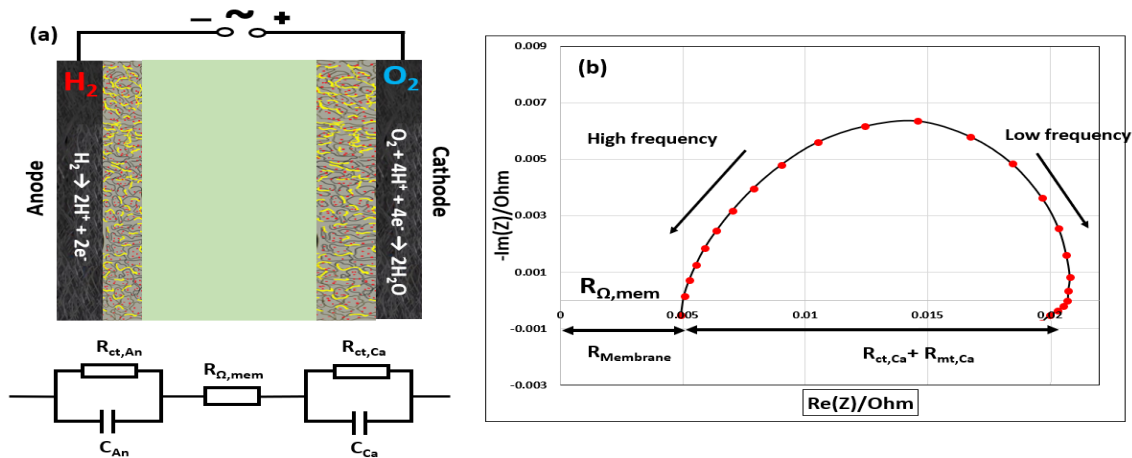
Figure 3-2: (a) Equivalent circuit of electrochemical processes occurring in PEMFC. (b) Nyquist plot (EIS) of PEMFC showing how the membrane resistance $R_{\Omega, mem}$, cathode charge transfer resistance $R_{ct, Ca}$

and cathode mass transfer resistance $R_{mt,Ca}$ are determined. The charge transfer resistance of anode is neglected due to the fast kinetics of the hydrogen oxidation reaction (HOR).

and mass transfer resistance of a PEMFC. Functionally, the membrane of an MEA acts as a resistor, while the anode and cathode CLs act similarly to capacitors in a circuit consisting of the cathode working electrode and anode counter electrode. Figures 3-2a and b show the equivalent circuit describing electrochemical processes and a typical Nyquist plot, respectively, of the PEMFC. Each of the anode and cathode catalyst layers can be modelled as an R-C element with capacitor C and a resistor R_{ct} in parallel. R_{ct} represents the charge transfer resistance in the catalyst layer and C represents the capacitance of the electrochemical double layer at the electrode/electrolyte interface. The two R-C elements are connected in series to $R_{\Omega, mem}$ which represents the membrane resistance. Since the anode reaction is notably faster than the cathode reaction, the cathode reaction is rate controlling and of greater interest.

The factors contributing to the voltage loss can be quantified by determining the characteristic parameters of the equivalent circuit. The capacitors in the circuit act as ideal conductors at high frequencies, resulting in the elimination of the imaginary components of the impedance. Since $R_{\Omega, mem}$ is the only element limiting the flow of current in the equivalent circuit at high frequencies, the resistance of the membrane can be determined by the point of intersection of the impedance curve with the x-axis (real impedance) at the high frequency end. The capacitors can be assumed to be perfect insulators at low frequencies. Therefore, the voltage drop across the single cell MEA is determined by the sum of the remaining resistors. Similar to the membrane resistance, the total resistance of the cell is obtained from the intersection of resistance with the real impedance axis (x-axis) in the low frequency region [120].

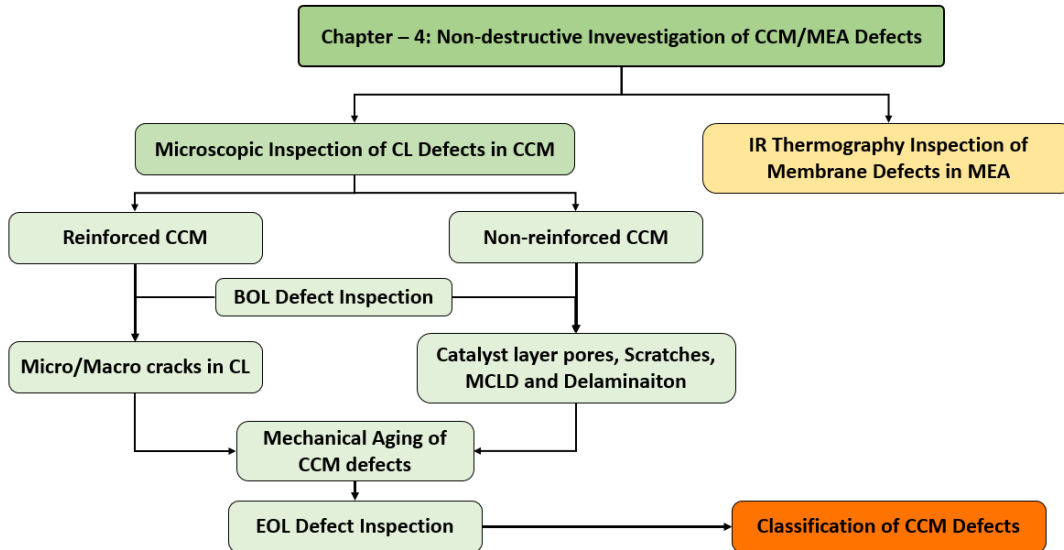
Figure 4-1: Framework for CCM defect analysis followed in this part of study.

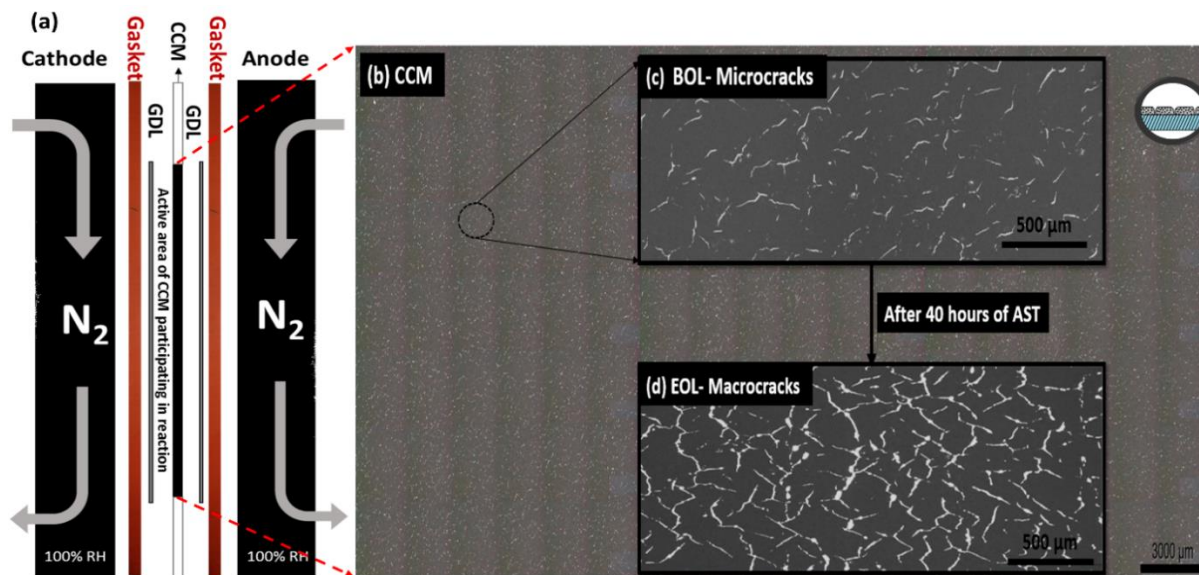
Figure 4-4: (a) Orientation of CCM in test cell jig showing gas flow directions and gasket sealants in contact with the GDLs. (b) Single large stitched image of a reinforced CCM in the BOL state of the cathode. Magnified image of an individual block of the stitched image captured at 5x magnification showing (c) BOL cracks and (d) EOL cracks aged for 40 hours.

Figures 4-4b-d show optical microscopy images of the cathode catalyst layer of a reinforced CCM at BOL after long-term storage (i.e., BOL_{LTS}) and later at EOL (i.e., EOL_{LTS}) after being subjected to the AST described in section 4.3.6. This AST was repeated three times on different reinforced CCM samples, as noted previously. Very similar results were obtained from these triplicate experiments. Figure 4-4b shows a single large image of an entire reinforced CCM in the BOL_{LTS} obtained by stitching 252 higher resolution optical images captured at 5x magnification. Figure 4-

To investigate the effect of aging on crack propagation, the reinforced CCM discussed in section 4.4.2.1 was subjected to an AST in the custom-built test cell jig (Figure 4-4a) for 40 hours according to the conditions listed in Table 4-1. At the end of the 40-hour AST, the CCM was re-examined to characterize its crack structure. Figure 4-6a shows an image of the EOL cracks in a portion of the EOL-LTS. In order to provide a closer view, we show the encircled area in Figure 4-6a at 50x magnification in Figure 4-6b. The bottom half of the graph (Figure 4-6c) gives a cross-sectional view of the cracks penetrating into the CL as one moves along the blue line shown in Figure 4-6a. The corresponding Z-profile along the blue arrow in Figure 4-6b is presented in Figure 4-6d to show the depth of the main cracks that are intersected in this region. The larger of the two cracks shown is measured to have a width of $\sim 20 \mu\text{m}$ and depth of $\sim 7 \mu\text{m}$. Since the nominal thickness of the cathode CL is $8 \mu\text{m}$, this crack essentially penetrates through the full depth of the CL and exposes the bare membrane below. Cracks that penetrate through the CL provide preferential water transport pathways and inhibit mass transport of the reactant gases [134]. As the defect area grows, the severity of the defect increases gradually and would be expected to reduce PEMFC performance [80,121].

BOL such as cracks in the CL (i.e., reinforced CCM) exhibit higher voltage loss compared to the non-reinforced CCM with no cracks in the CL. The OCV of the reinforced CCM shown in Figure 4-4b decreases by 102 mV from 928 mV to 826 mV, whereas the OCV of the non-reinforced CCM shown in Figure 4-11a drops by 45 mV from 942 mV to 897 mV. The OCV drops as a result of mixed electrode potentials arising mainly due to hydrogen gas crossing through the defective areas and then being oxidized at the cathode where oxygen is present. These results are consistent with that of the optical image analysis in sections 4.4.1.1 and 4.4.2.3 which reveals that cracks grow in both length and width and that the defect (crack) area in the reinforced CCM increases by 8.1% from BOL to EOL. One would expect cracks to have grown in both dimensions in order for the amount of gas crossover through the membrane to rise significantly. On the other hand, no significant growth of BOL defects (Figures 4-9 and 4-10) is observed in the non-reinforced CCM indicating that it is still intact. The 45 mV drop could be due to the single large crack that has formed on the cathode CL (Figure 4-11). Small portions of the CL appear to be delaminated inside the cracked area, which could also contribute to this loss in OCV.

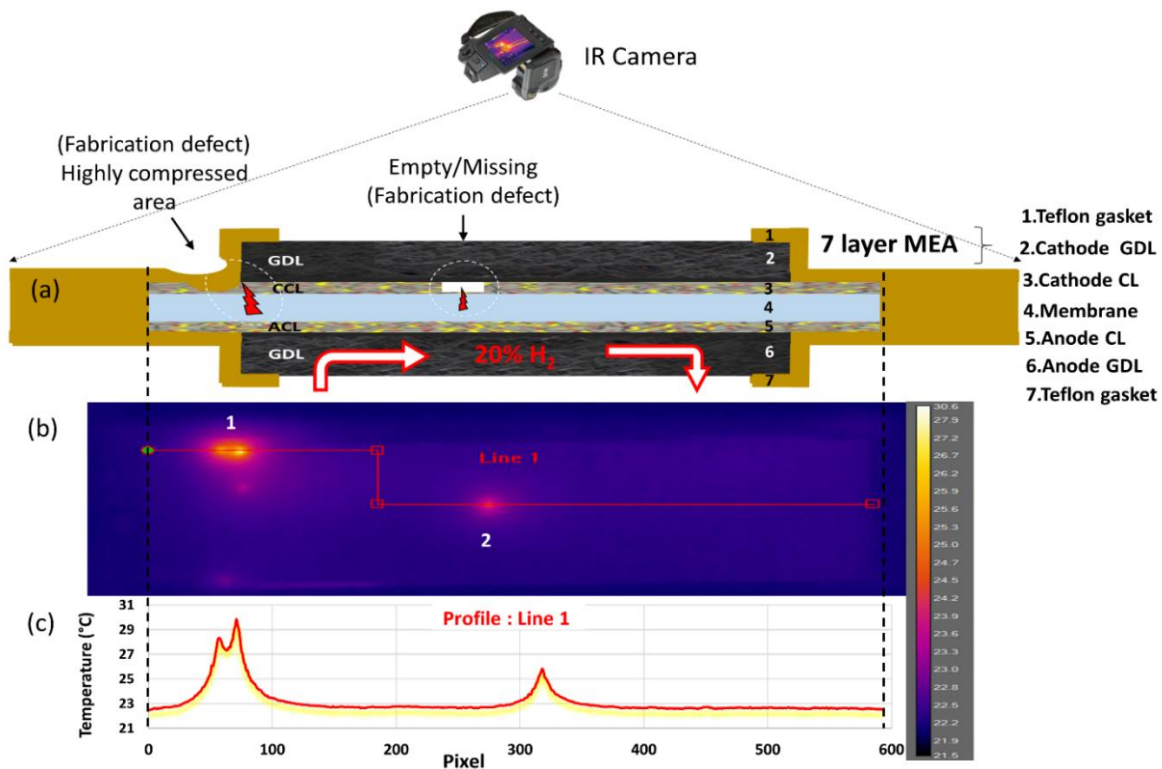
Figure 4-5: (a) Schematic diagram of the side view of MEA and location of defects in non-reinforced CCM at BOL; (b) thermal image of defected MEA viewed on cathode side (c) temperature profile along the red line shown in Figure 4-5b. Note that 590 pixels along x-axis correspond to a length of 12 cm.

Some of the defects formed during fabrication can be caused by uneven pressure/stress on the component layers after hot pressing or can include missing catalyst regions in the CCM. Such defects facilitate hydrogen crossover, leading to a large drop in the OCV and even to pinhole formation [69]. Monitoring defects in the CCM within an MEA is complicated by the fact that it is contained within the GDL layers. In this case, IR thermography has been shown to be effective at characterizing defects [8,103]. In this study, we use IR thermography to examine the cathode side of an MEA, as shown in the schematic side view in Figure 4-5a. It should be noted that the set-up shown in Figure 4-5a examines the actual 7-layered MEA used in commercial PEMFCs (not the same as the samples examined in the set-up shown in Figure 4-4a which is used to test

CCMs alone). Thus, the CCM in this image is hot-pressed to the GDL. Although this is an unused MEA, it contains typical defects formed during fabrication. In our setup, it is perfectly sealed and aligned along the edges of the GDL with a teflon gasket. Note that the CCM is slightly larger than the GDL in this sample, but the overhang portion is sealed with the teflon gasket.

Examination of the temperature profile in Figure 4-5b suggests that larger leaks through the defect are associated with higher temperature spots in the IR image. A higher temperature in the image reflects that more hydrogen has crossed from the anode to cathode and reacted with oxygen on the platinum catalyst surface to generate heat. The heat (infrared energy emitted) produced on the cathode is detected by the infrared detector of the IR camera and converted to an electrical signal which is precisely measured and processed by software that can automatically quantify the infrared energy and generate a thermal image. The images acquired using the camera are converted into visible images by assigning a color to each IR energy level to yield a false-color image called a thermogram. In this way, hotspots across pinholes and thin or empty portions of the CL can be determined using IR thermography.

An IR image of the top view of the non-reinforced MEA in the BOL shown in Figure 4-5b and the temperature profile along the two horizontal line segments drawn on the thermal image are combined along one line are shown in Figure 4-5c. The temperatures in this IR image span a range from 21°C (dark blue) to 31°C (pale yellow). This image reveals the presence of two hotspots. One hotspot is found near the upper edge of the MEA. The location of this fabrication defect is not surprising since the area between the active area, GDL and gasket (elliptical region indicated by the dashed lines in Figure 4-5a) is prone to developing defects at the edge of the MEA due to the large pressure and stress on the CCM applied by the GDL during hot pressing. The temperature profile across this hotspot shows peaks at temperatures of 30.6°C and 28.2°C. The second hotspot which reaches 26.1°C is located near the center of MEA and presumably is caused by missing catalyst or thinning of the catalyst. Missing or thinned catalyst can be caused either by the improper laying down or lift-off of a small portion of the CL during the decal transfer step or by the direct intrusion of carbon fibers from the GDL. Based on the maximum temperatures reached in the profile, defects due to missing CL appear to be less harmful than those near the edge of the MEA. The gas crossover in the defected MEA is measured to be 1.2 mL min⁻¹ at BOL. Although suppliers of CCMs are aware of such defects, their effects as well as their growth during fuel cell operation have not been studied. Therefore, it is important to quantify the amount of missing CL that has occurred prior to MEA fabrication. These IR results shows that these defects are also significant and should be of concern prior to MEA assembly. Although the hotspot defects do not initially appear to affect performance, they can potentially grow during cell operation and eventually cause shutdown of the PEMFC [69,103].

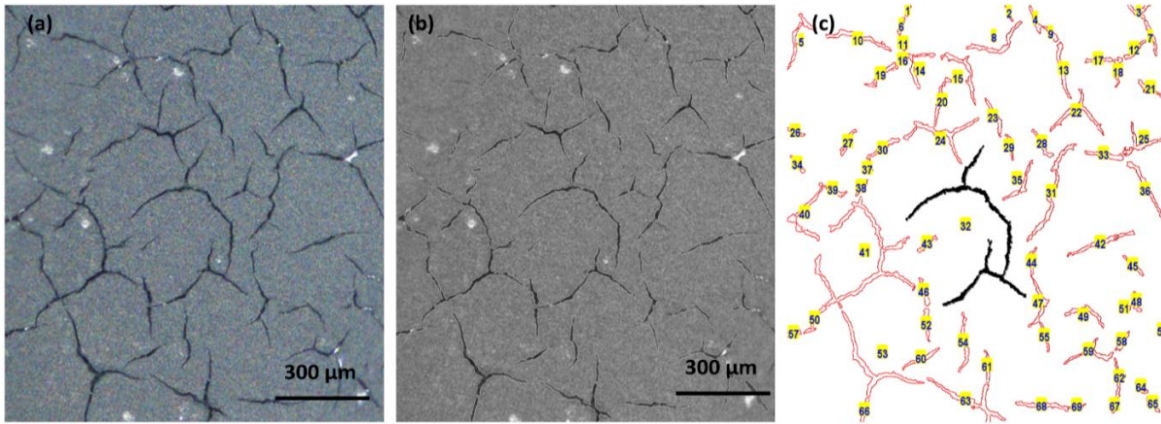
Figure 4-7: Section of cracked area selected from Figure 4-4a (spatial resolution of $1.83 \mu\text{m}$ and $5\times$ magnification) to demonstrate the boundaries of cracks, (a) RGB microscopic image, (b) 8-bit (black & white) image, where dark areas indicate cracks and white areas indicate dents, (c) boundaries of cracks corresponding to Figure 4-7b, where crack number 32 represents the larger area ($8570 \mu\text{m}^2$) of the crack.

The degree of crack propagation in the catalyst layer is investigated using the open-source imaging software ImageJ. The RGB (red, green and blue) microscopic image in Figure 4-7a is converted to an 8-bit (black and white) image shown in Figure 4-7b for easier detection of cracks. To eliminate distortions (shading or smoothing) in the image, a FFT-bandpass filter is applied to better visualize the image contrast. To analyze the length and areas of the cracks, the scale bar is firstly calibrated from the image with a known distance. Secondly, a threshold is adjusted by sliding the intensity bar so that all the cracks of interest are selected with respect to crack boundaries, as shown in Figure 4-7c. Resolution of the image has a major impact in this process by affecting the detection of some defect/crack details. The image resolution which is directly related to magnification of the microscope is an important and challenging factor that can influence the fine details of the smaller defect/micro-cracks. Accordingly, we have been careful to account for these effects in the image analysis. The spatial resolution r of the images is $1.83 \mu\text{m}$ obtained from the expression $r = 0.5\lambda/N.A$, where wavelength $\lambda=550 \text{ nm}$ and numerical aperture $N.A = 0.15$. The crack boundaries may cross smaller or newly generated cracks ($< 5 \mu\text{m}$) which may influence the number of cracks. However, the total area of defects is not significantly influenced. Thus, since the determination of the number of cracks is a complicated process at lower magnification, we have chosen to characterize the severity of defect on the basis of the total damaged areas in the CL. Finally, crack dimensions are obtained by selecting the Analyze Particle command in the ImageJ software, which

gives overall information on number, length and area of the cracks. The results of the overall crack analysis are discussed in section 4.4.2.3.

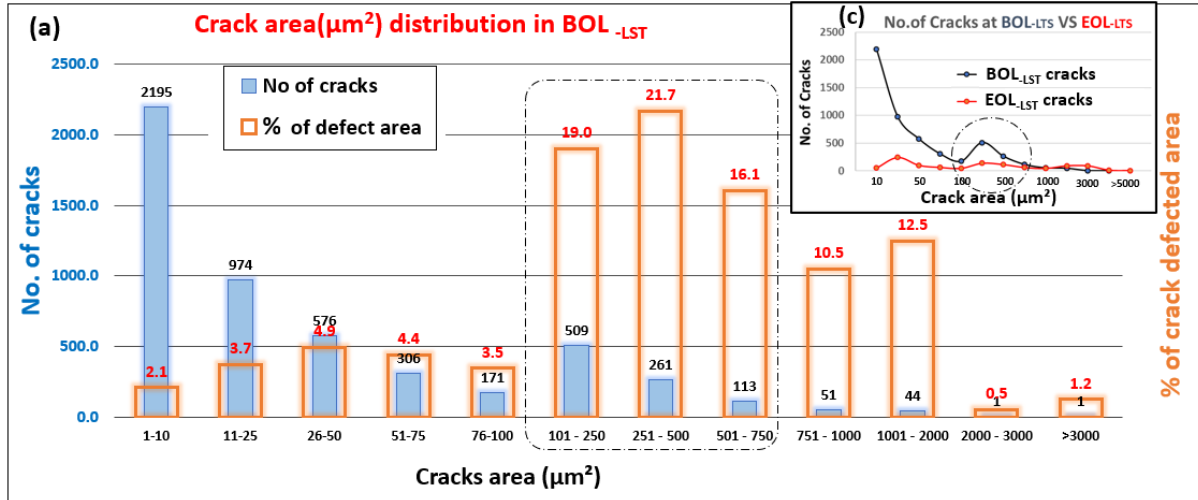
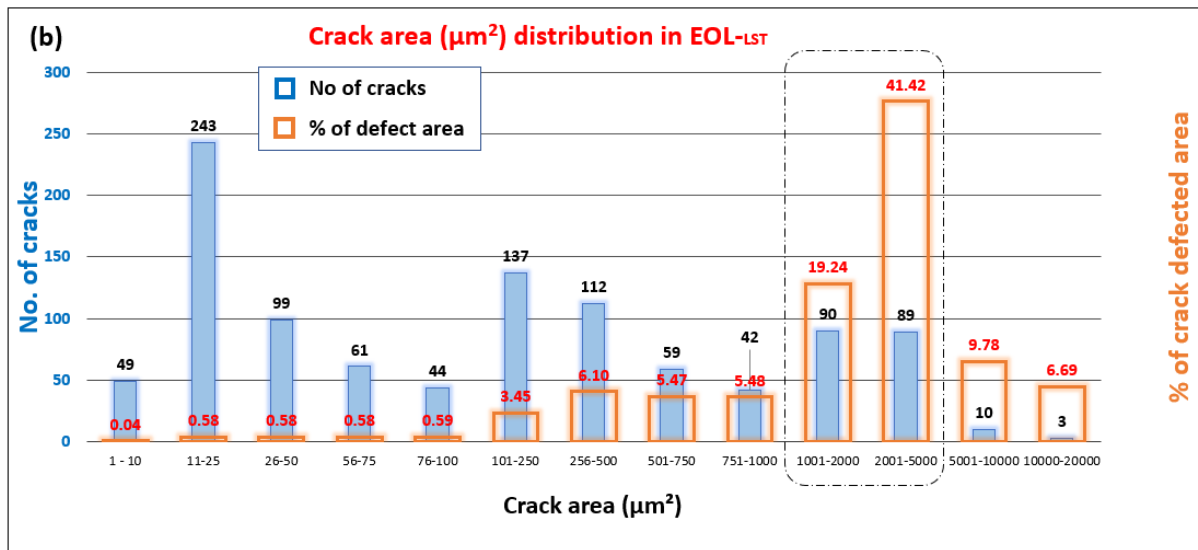
Figure 4-8: (a) Distributions of number of cracks and percentage of the total defect area covered by BOL-LST cracks, (b) distributions of EOL-LST cracks after aging for 40 hours and (c) comparison of BOL and EOL crack distributions.

The distributions of the cracks and defect area percentage of the BOL-LTS and EOL-LTS analyzed using the Image J software are presented in Figures 4-8a and 4-8b, respectively. The non-uniformity of the crack distribution increases sharply on going from the BOL-LTS state to the EOL-LTS state. The blue bars indicate the number distribution of cracks with respect to the area from $1 \mu\text{m}^2$ to above $10000 \mu\text{m}^2$ that they cover, while the orange bars show the distribution in terms of the percentage of the total defect area. It should be noted that these data are obtained over the entire 1 cm^2 active area of CCM. On the basis of numbers alone, these data reveal that the smallest cracks occur most frequently in the CCM when it is in the BOL-LTS state. However, medium-sized cracks from 100 to $750 \mu\text{m}^2$ dominate in terms of the area, covering $\sim 56.8\%$ of the total defect area (enclosed in the yellow dashed region in Figure 4-8a).

When the CCM is aged, the plastic deformation of the membrane during hydration and dehydration causes the surface cracks in the BOL-LTS to grow downward into the CL and horizontally along its surface [135]. When undergoing dehydration, the membrane shrinks, causing cracks to close or migrate toward each other in the CL. When the membrane becomes more hydrated, compressive stress is developed in the membrane and pressure is released through the propagation of the macro-cracks. Table 4-2 shows the overall summary of defects found in the reinforced CCM from its BOL-LTS to EOL-LTS. After aging the sample, the density of cracks (both BOL and EOL) decreases significantly from $\sim 27613 \text{ cm}^{-2}$ to $\sim 10515 \text{ cm}^{-2}$ in its EOL state ($\sim 61.9\%$ decline). The blue curve

in Figure 4.8c presents the distribution of BOL cracks with respect to crack area, while the red curve shows the distribution of EOL cracks. Since many fewer cracks remain at EOL than at the start of aging, it appears that many BOL cracks have merged to form larger cracks after 40 hours of the AST. As much as 60.7% of the defected area is made up of cracks between 1000 and 5000 μm^2 in area after aging (represented by yellow dotted line in Figure 4-8b). A number of measures of the crack dimensions provide evidence of the dramatic growth in their size during aging. The total defect area has increased significantly from $\sim 2.4\% \pm 0.10$ (BOL-LTS) to $\sim 10.5\% \pm 0.04$ (EOL-LTS), while the maximum crack length has grown from 280 to 700 μm and width from 100 to 250 μm . Interestingly, the aspect ratios of the defects do not significantly change, indicating that the length and width of the cracks grow at similar rates. This fact suggests the cracks tend to merge isotropically rather than anisotropically and is consistent with the side-by-side comparison of the reinforced CCMs in Figure 4-4c and 4-4d which shows that the cracks tend to have a more branched structure at EOL than at BOL. This effect is clearly evident in the crack network in Figure 4-7c where the branches of crack 32 are extended and merged to adjacent cracks with an area of 8570 μm^2 . If new cracks form during aging, one would expect that the EOL distribution would include a large number that are $\sim 50 \mu\text{m}^2$ or less in area, similar to that observed in the BOL samples. However, as shown in Figures 4-8b and 4-8c, very few cracks smaller than 100 μm^2 are observed after aging. This strongly suggests that most of the cracks that grow are those that already appear at BOL-LTS, reflecting the importance of minimizing crack and defect formation during the manufacturing process or storage conditions of the CCMs. This is also confirmed by our direct observation of the entire CCM surface at BOL and EOL with the optical microscope.

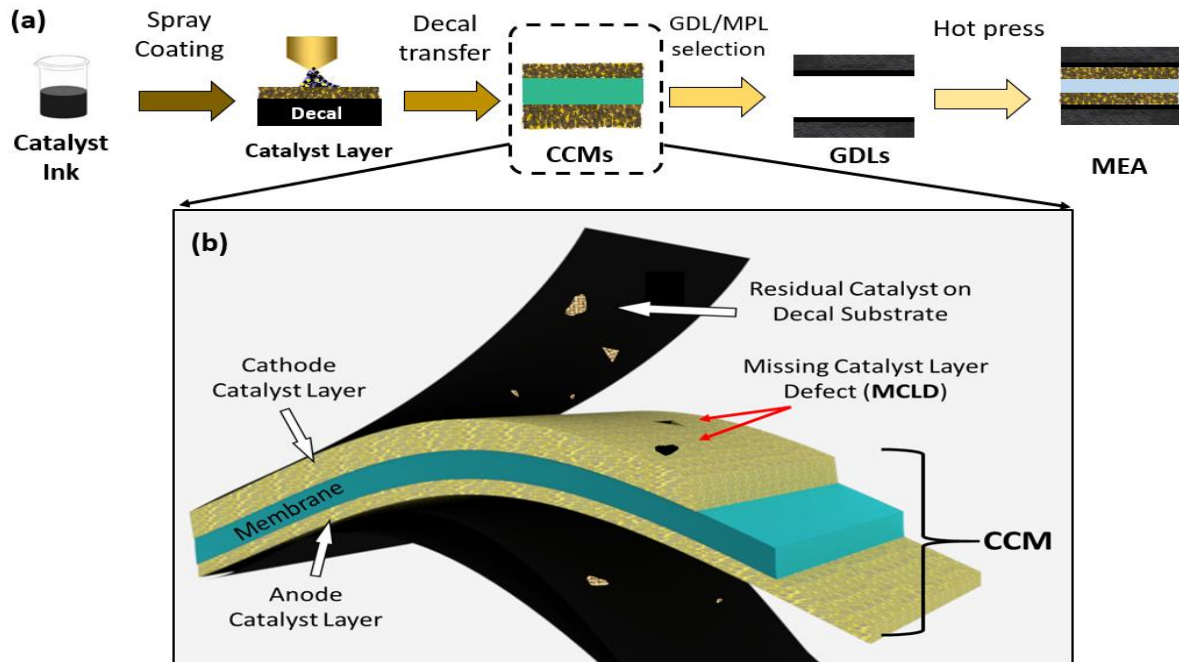
Figure 5-2: (a) Steps involved in fabrication of CCM/MEA. (b) Schematic showing missing catalyst layer defects (MCLD) in the CCM fabricated using the decal transfer method.

It is well known that the CL is a key component of the cathode in a PEMFC. The steps by which the CL is fabricated and incorporated into the MEA is presented schematically below in Figure 5-2a. The catalyst layers are made by mixing a Pt/C catalyst diluted with deionized water and ethanol mixed with ionomer binder solution. The catalyst ink is spray-coated onto a decal substrate

followed by drying at 80°C. The catalyst layer on the decal substrate is then transferred onto a PFSA Nafion membrane using the decal transfer method in a hot press at 140°C for 5 mins. During the decal peeling process, tiny portions of catalyst can be left over on the decal substrate, forming a catalyst irregularity defect on the catalyst layer. These defects are defined as missing catalyst layer, thin catalyst layer or zero catalyst layer.

The MCLDs are one of the most common defects that form during the mass production of CCMs. An example of how such a defect can form during the decal transfer of the CL is shown schematically in Figure 5-2b. The red arrows on the image indicate two MCLDs formed on the CCL during the decal removal process when catalyst has not been transferred from the decal substrate to the CCL. For example, the catalyst transfer ratio of the catalyst layers from the decal onto the membrane in the CCMs investigated in this study were ~90 - 95%. Saha et al [63] reported catalyst transfer rates of 60%, 80%, 90% and 99% using the DTM technique. No research work to date has focused on investigating MCLDs and their impact on PEMFC performance. Therefore, the primary focus of the research is to investigate the behaviour of these catalyst layer defects during aging, which is a high priority topic in the fuel cell industry.

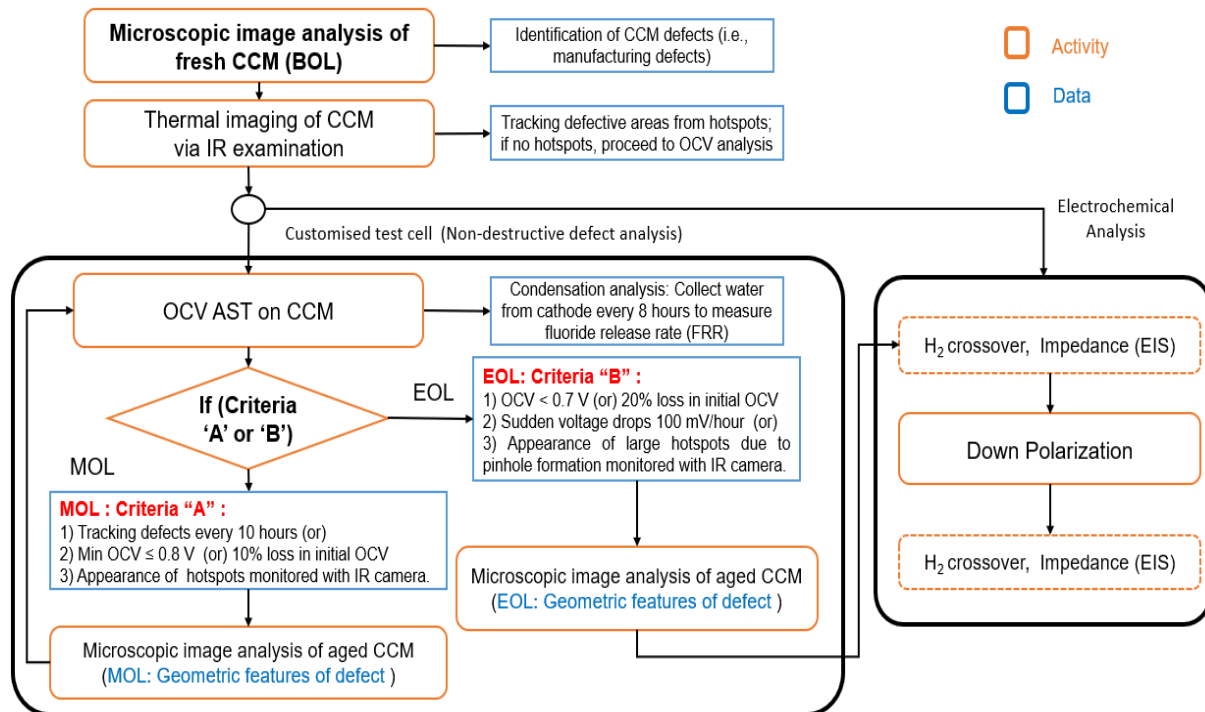
Figure 5-3: Non-destructive CCM defect analysis framework combined with electrochemical analysis.

Figure 5-3 depicts the new framework for investigating real catalyst layer defects that would benefit the quality control procedure used by fuel cell manufacturers. This framework is novel because it provides manufacturers with a non-destructive CCM defect analysis tool. The details of this framework are discussed in this section.

Figure 5-3 shows the flowsheet of the various steps to monitor and characterize the aging of CCMs and the formation and growth of defects. As discussed in section 4.3.2, defects were identified using reflected microscopy at BOL in pristine CCMs. IR thermography of the sample was captured before the start of OCV analysis to confirm that no pinholes or leak spots were present at BOL, as discussed in Section 4.3.3. Only pinhole-free CCMs were allowed to proceed to the OCV-AST. DOE-recommended protocols were used for this OCV-AST operation [141][108]. MCLD defective CCMs were aged using the custom-designed test cell described in section 4.3.4. Operation of the CCMs in the test cell enabled the user to investigate defect propagation at MOL and EOL. During the OCV analysis, two criteria (A and B) were set to investigate the evolution of defects in the membrane.
