**Investigation and Propagation of Defects in the
Membrane Electrode Assembly of Polymer Electrolyte
Membrane Fuel Cells: Quality Control Analysis**

A thesis

presented to the University of Waterloo

Chemical Engineering

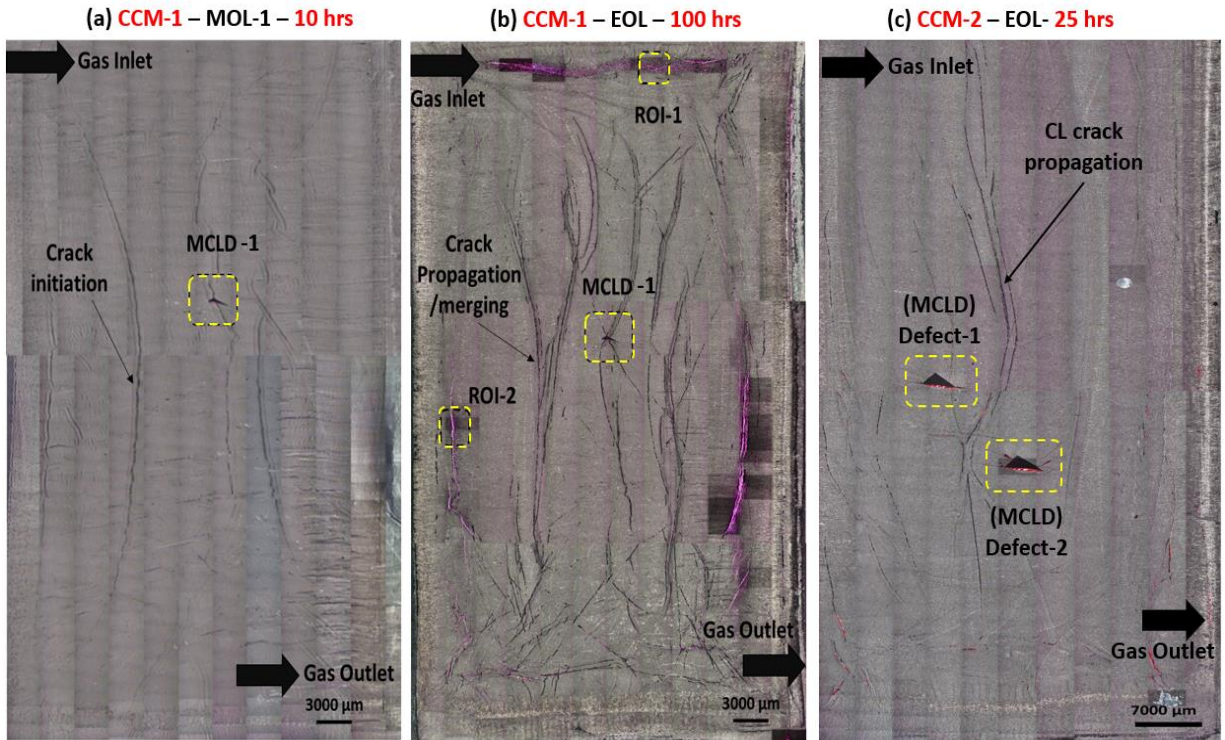
Figure 5-4: Stitched optical microscopic image of CCL of defected (a) CCM-1 showing 1 MCLD observed after (a) 10 hours (MOL-1) and (b) 100 hours of OCV-AST (EOL); regions ROI-1 and ROI-2 are specifically selected for further investigation of crack propagation and delamination of CL. (c) CCM-2 showing 2 MCLDs (Defect-1 and Defect-2)

Once inspected at BOL, CCMs to be aged proceeded to the OCV-AST conducted in the test cell discussed in section 4.3.4. The microscopic image analysis follows the procedure described in the flowchart/framework in Figure 5-3. The entire 48 cm² stitched active areas of the CCL of CCM-1 and CCM-2 are shown in Figure 5-4. The stitched optical images of CCM-1 after 10 and 100 hours aging by the OCV-AST appear in Figures 5-4a and b, respectively, while the image of CCM-2 after 25 hours of OCV-AST is presented in Figure 5-4c. The gas inlet and outlet directions are indicated at the top left and bottom right of the image. Three major changes were observed during the aging process:

Similar results (green curve in Figure 5-5) are observed for CCM-2 that contained two MCLDs in the CCL at BOL, as shown in Figures 5-4c. Over the course of the AST, the OCV degrades by 66 mV at a very high average rate of 2.98 mV/h. However, due to the formation of a hot spot in the location of MCLD -2 in Figure 5-4c (see IR thermograph in Appendix section 10.3), the sample met the EOL criteria after only 25 hours of AST. Obviously, the rapid decline in the OCV can be attributed to the severe physical damage of the membrane.

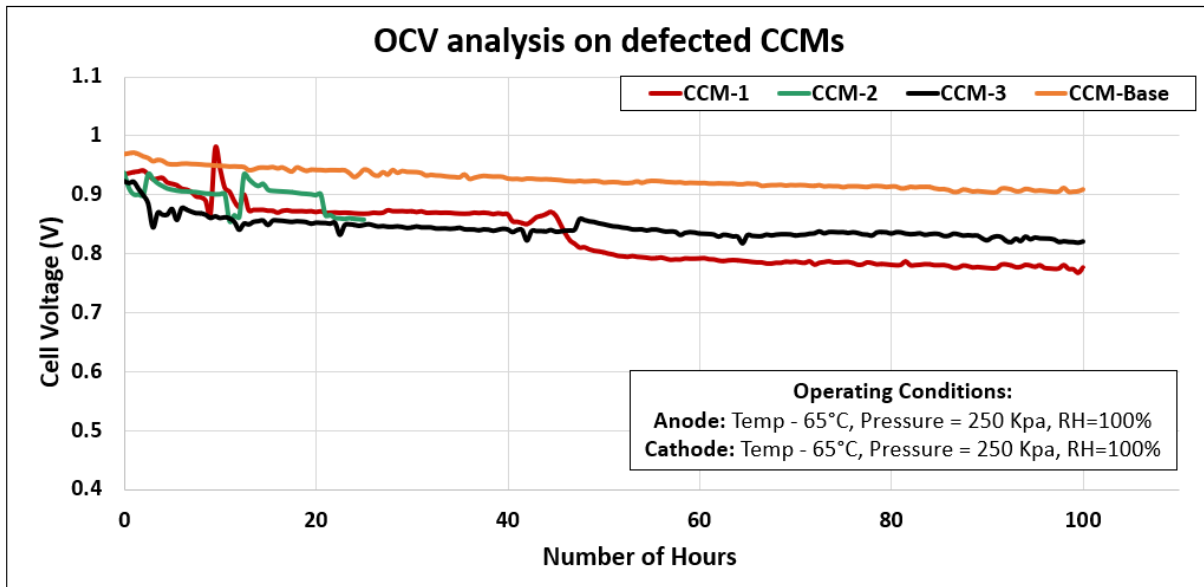
Figure 5-5: OCV test results of CCM-1, CCM-3 and CCM-baseline operated in the test cell over a duration of 100 hours. The green curve represents the OCV decay curve of CCM-2 which was operated for only 25 hours due to pinhole formation inside the MCLD defect.

chapter. The OCV curves obtained using these CCMs over the course of their ASTs are presented in Figure 5-5. The OCV-AST was stopped at MOL in the case of CCM-1 (after 10 hours and again after 50 hours) and CCM-2 (after 12 and 25 hours) based on the criteria given in Figure 5-3 to examine the evolution of the MCLDs with the optical microscope. Although CCM-3 and CCM-baseline did not reach their EOL at the end of 100 hours, the experiments were terminated at this point in order to compare their rates of OCV degradation with that of CCM-1. CCM-2 was stopped due to hotspot identified across the defect-2 after 25 hours.

The red curve in Figure 5-5 shows that the CCM-1 OCV is more severely affected over the course of the AST than CCM-3 and CCM-baseline – decreasing from 935 mV to 776 mV at an average rate of 1.6 mV/hr. On the other hand, the OCV of CCM-3 degrades from 923 mV to 820 mV at an average rate of 1.03 mV/hr. Two observations related to the voltage loss in CCM-1 were made:

A primary focus of this study is to investigate the relation between the evolution of the MCLD and its loss in OCV as the CCM ages. As shown in OCV curves in Figure 5-5 (red line), CCM-1-MCLD experiences a noticeable voltage degradation of 7.4% over the first 10 hours of operation as its voltage decreases from 935 mV to 865 mV. Particularly noticeable is the abrupt voltage drop of 36 mV from 901 mV to 865 mV between the 9th and 10th hours of the AST. To determine whether this loss in performance can be correlated to a change in the MCLD, we have carried out an image analysis of the CCM after the 10th hour (i.e., MOL-1). Further image analysis is conducted on the CCM after aging for 50 hours (MOL-2) and 100 hours (EOL) over which period the OCV is observed to have dropped by a cumulative amount of 10.1% and 17.8% with respect to its initial voltage. Figure 5-7a shows the areal growth of the MCLD (black curve) and degraded catalyst area inside the MCLD (pink curve) during the OCV AST. Prior to OCV testing, the pink area inside the MCLD detected is negligible (Figure 5-6a), as expected. As the AST proceeds, the catalyst in defect areas undergoes washout that leaves behind bare membrane or thin catalyst layer spots due to non-uniform bonding of catalyst across the defect. The cumulative area of the MCLD (dark triangular region in Figure 5-6) increases by 5.4% from BOL to MOL-1(10 hours), 11.25% between MOL-1 and MOL-2 (40 hours) and 1.58% between MOL-2 and EOL (50 hours) (Figure 5-7a). The pink area in Figures 5-6a-d drastically increases by a factor of ~ 17.7 over the 100 hours of the experiment. As a result, the voltage degrades at a rate of 1.6 mV/h over this duration. For

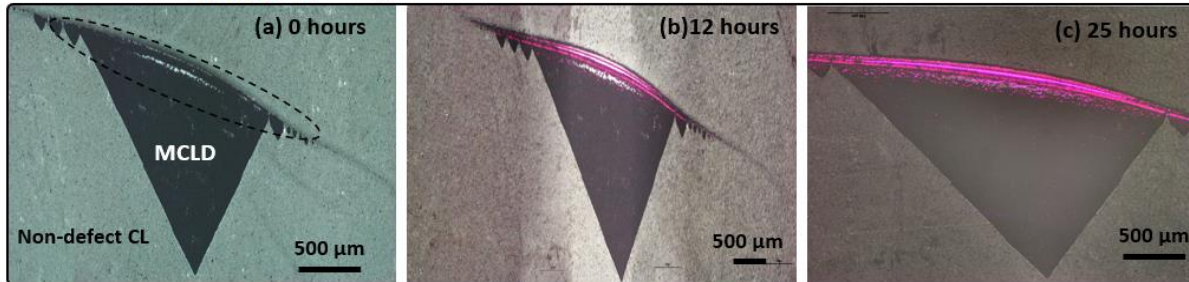
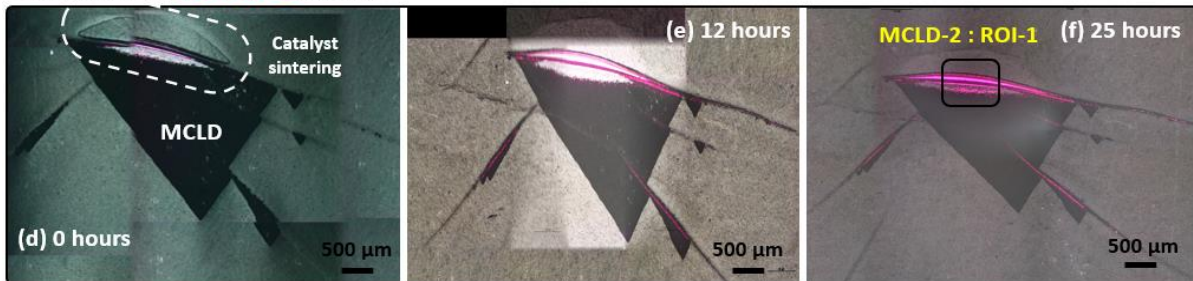
CCM-2: Cathode : **Defect – 1 (MCLD)**

CCM-2: Anode : **Defect – 2 (MCLD)**

Figure 5-8: Microscopic image of defect growth of MCLD in CCM-2 (see the location of defect in Figure 5-4c): defect -1 on cathode captured at (a) 0, (b) 12 and (c) 25 hours; defect-2 on anode at (d) 0, (e) 12 and (f) 25 hours of OCV AST.

Figure 5-8 depicts a surface view of the morphological changes of defect-1 and defect-2 in CCM-2 on cathode at 0 hours, 12 hours and 25 hours of OCV-AST. Defect-1 is located on the cathode side, while defect-2 appears on the anode side in the locations indicated in Figure 5-4c over the entire $\sim 48 \text{ cm}^2$ area. The region in defect-2 designated as ROI-1 in Figure 5-8f is shown at higher magnification in Figure 5-9. The plots in red at the bottom of Figures 5-9 correspond to Z-profiles along the blue arrows indicated in the microscopic images in Figures 5-9a and b. Although CCM-2 was tested for only for 25 hours, the trend in the defect growth is similar to that of CCM-1. The bare membrane inside defect-2 in CCM-2 likely facilitates gas leakage through the membrane and the rapid decrease of the OCV at a rate of 2.95 mV/h. The aerial view and depth profile in Figure 5-9b reveals the presence of a micro-pinhole on a portion of this bare membrane. The proposal that gas has leaked through the bare membrane (via these micro-pinholes) is supported by the IR thermograph for this sample (see Appendix section 10.3) which reveals the presence of hotspots in the same region where the micro-pinholes appear. The pink area inside the MCLD increases by 942% due to catalyst washout, whereas the total area occupied by the MCLD increases by only 5.5% after 25 hours. The significant loss of the OCV is likely due to the formation of micro-pinhole or membrane cracks, as shown in Figure 5-9b. Once electrodes develop pinholes or leak zones, the criterion for EOL is met and the experiment is terminated. The following two additional observations can be made from this microscopic inspection of defect-2 in CCM-2.

1. By closely inspecting defect-2 at BOL from both the cathode and anode sides, a catalyst sintering area is found across the MCLD as represented by the white dotted circle in Figure 5-8d. Since the catalyst sintering is observed at BOL, it is expected that this defect presumably formed during the hot press ($\sim 140^\circ\text{C}$) of decal substrate and polymer membrane. As a result of the high temperature and pressure during the hot press across the defect-2, a small section of the catalyst layer is completely missing in the area denoted as ROI-1 in Figure 5-8f and Figure 5-9. Catalyst sintering presumably causes polymer melting in the membrane that might lead to cracks and pinhole in the membrane as shown in Figure 5-9b. A magnified surface view of ROI-1 in Figures 5-9a and 5-9b clearly shows a strip of bare membrane that would be exposed to the reaction gases during cell operation.

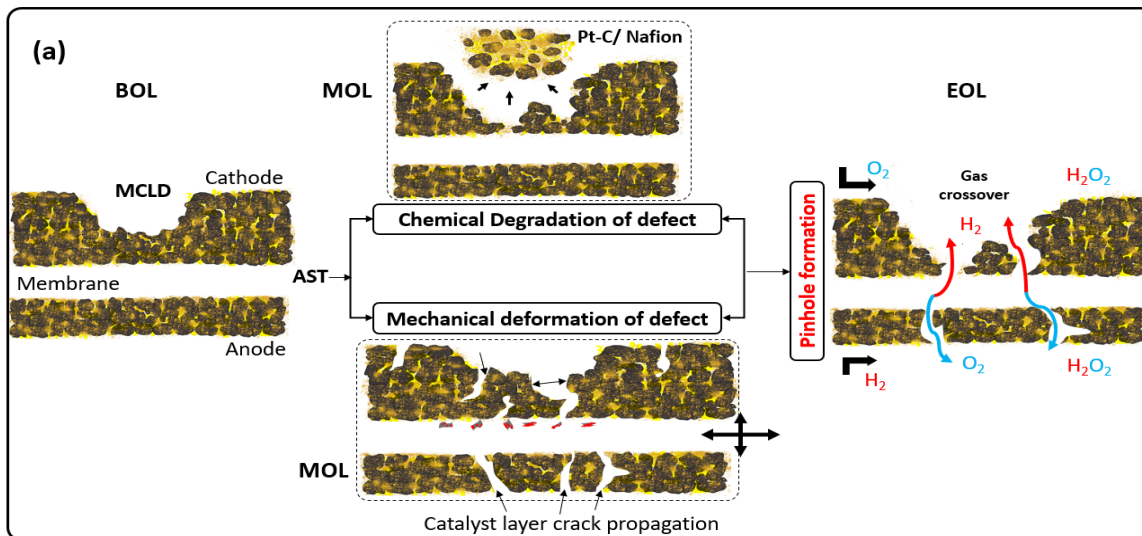
Figure 5-11: Schematic showing the possible ways that defects in the cathode layer can propagate via chemical and mechanical degradation and eventually lead to gas crossover through pinholes.

Electrode failure is intrinsically linked to degradation of both the catalyst layer and membrane, where one event may lead to occurrence of another event and also exacerbate other problems. The present study focused on events leading to electrode failure that occur through propagation of CCM defects. Figure 5-11 is a schematic showing the influence of chemical and mechanical degradation on catalyst layer defects and their effects on developing pinholes. As seen from the previous section, chemical degradation inside the catalyst layer defects (MCLD) is non-homogeneous due catalyst erosion/washout that leads to thinning/zero catalyst. The mechanical deformation of membrane during hydration/dehydration leads to wider crack opening/propagation in the catalyst layers in both anode and cathode. Both events cause structural damage to the catalyst layers.

5-9b). Since the gas permeation rate depends on the size of these defects, defects tend to grow at different rates under the same operating conditions. As depicted in Figure 5-11, more decomposition of ionomer occurs on the cathode side than the anode side [68]. First, due to its smaller size, H₂ can permeate faster from the anode side to the cathode than O₂ can in the opposite direction. In addition, since the platinum loading on the cathode is higher than it is on the anode, more reaction between O₂ and crossover H₂ occurs on the cathode side than between H₂ and crossover O₂ on the anode side. Two products of this reaction are H₂O₂ and heat, both of which promote polymer decomposition.

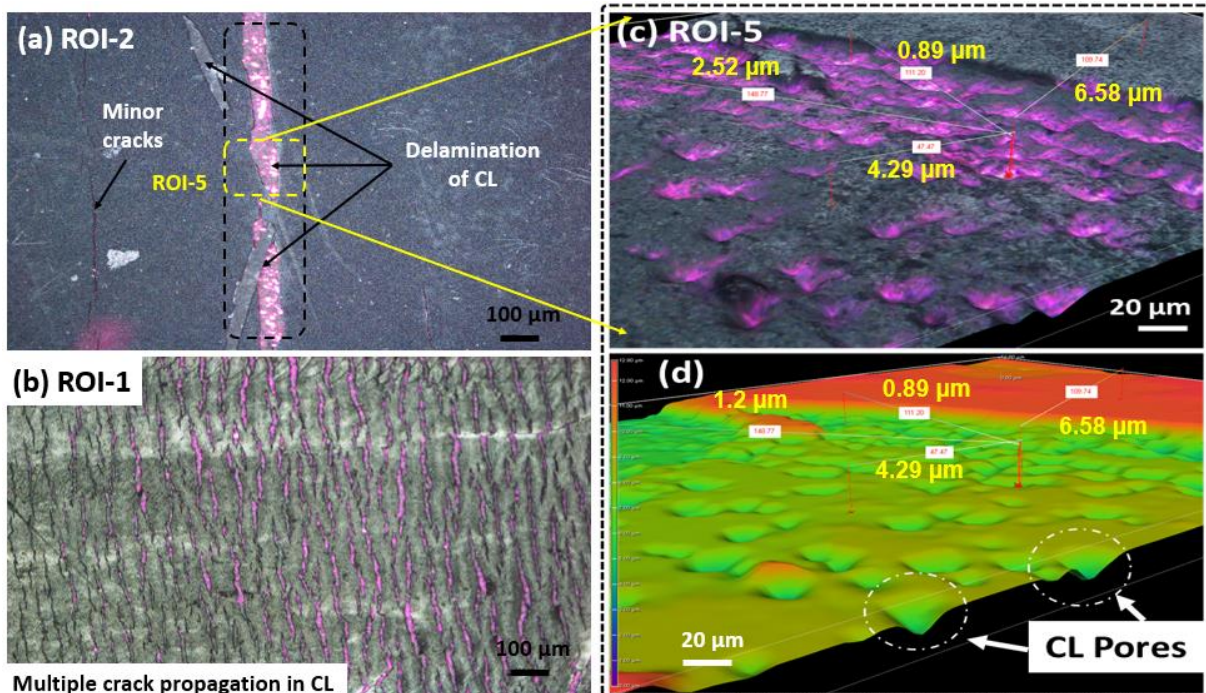
Figure 5-12: Microscopic images of crack propagation on the CCLs at EOL: (a) delaminated catalyst layer at ROI-2, (b) multiple crack propagation at ROI-1; the pink area in the image represents the thinnest region, (c) 3D enlarged view of delaminated and degraded catalyst layer at ROI-5 and (d) color mapping of delaminated area at ROI-5 showing catalyst layer pores.

Crack formation is affected not only by electrode thickness but also by uniform and linear hygrothermal expansion of the membrane due to water retention and swelling [96]. To demonstrate the effect of hygrothermal expansion, we select regions ROI-1 and ROI-2 from Figure 5-4b for further analysis. These regions are useful for this purpose because they are located at different distances from the gas inlet where water from the humidified reaction gases tends to accumulate. ROI-1 is closer to the gas inlet than ROI-2 and so would be expected to contain more water and undergo more hygrothermal expansion and subsequent mechanical deformation. Analysis of the images in Figure 5-12 confirm this expectation. Many more cracks appear at ROI-1 which has a higher water concentration (Figure 5-12b) than at ROI-2 which contains less water (Figure 5-12a).

Even after 100 hours of OCV-AST operation, it is observed that cracks have not propagated significantly in the vertical direction (i.e., with respect to their depth) and penetrate ~ 50% - 70% of their thickness in Figure 5-12a. (Note: The depth profile of delaminated catalyst layer in CCL was discussed in section 4.4.3.3). Closer examination at 100x magnification has been conducted on a specific delaminated region labelled ROI-5 within ROI-2 (Figure 5-12a). A view of ROI-5 is illustrated in Figure 5-12c and 5-12d showing that a portion of the catalyst layer has detached from the surface crack. The numbers on the image represent the catalyst layer thicknesses remaining on the membrane at different locations after delamination has occurred. Several Z-profile measurements have been done across the delaminated areas on the CCM (inlet, middle and outlet areas) to estimate the remaining thickness. This analysis reveals that the average thickness of delaminated CLs varies from 2 μm to 6 μm (some of these regions are shown in Figure 5-12a). As noted previously, the pink areas in Figure 5-12c represent the thinnest areas where the transmitted light can pass through the damaged portions. These damaged areas are also associated with pores or openings that form at the surface of the CL. It should be noted that pores are not intentionally introduced into this type of CL by manufacturers during fabrication. The particular color scheme

shown in Figure 5-12 is also used for the MCLD in Figure 5-6. The orange areas represent the non-defected catalyst, while the green areas correspond to defected catalyst remaining after delamination. The possible causes for the surface delamination may be traced back to hot pressing step during fabrication. The uppermost catalyst surface that is first exposed to the hot plates during CCM fabrication presumably has a strong and uniform contact bond with Pt/C catalyst particles and ionomer composite in the catalyst layers [147]. When the heat penetrates to the lower portions of the catalyst layer, the ionomer network in the catalyst layer will also develop strong bonds with the ionomer in the electrolyte membrane [22][139]. At the interface between the lower catalyst layer and membrane, some portions of the ionomer migrate into the membrane and leave behind large pores in the lower catalyst layer. This is also consistent with the idea that CCMs strongly interact with the CL and polymer membrane to reduce the contact resistance between adjacent layers [7]. When the membrane becomes humidified, it swells and experiences stress. This sets up a pressure difference between the upper and lower portions of the catalyst layer that can lead to delamination in the middle of the catalyst layer. The delamination occurs depending on the ionomer network in the catalyst layers. Some of the factors that influence delamination are CL thickness, membrane swelling and ionomer concentration in the CL. On the cathode, the maximum delamination is observed to remove 70% of the catalyst layer thickness. However, on the anode, delamination is rarely observed. If the ACL were delaminated, it would likely be completely removed since it is very thin. The differences in delamination between the cathode and anode can be attributed to their individual catalyst layer thicknesses. The dotted circles in Figure 5-12d indicate damaged area that appears as pores in the catalyst layer after delamination. To investigate the size distribution of these features, image analysis is conducted on non-defected and defected area (delaminated areas). The diameters are measured to be $\sim 1 - 2.5 \mu\text{m}$ in non-defected areas, whereas they are more than 5 times as large with diameters of $\sim 5 - 25 \mu\text{m}$ in defected areas. Large pores are not favourable for fuel cell operation because they act as dead zones where less catalyst is available for an electrochemical reaction to occur and facilitate gas crossover and water flooding. From our overall examination of CCMs at BOL, MOL-1, MOL-2 and EOL, catalyst erosion is observed only in the defected areas i.e., inside MCLDs and inside delaminated catalyst layers. No evidence of erosion is found on non-defected areas. These observations are particularly important for the development of catalyst coatings and integrity of catalyst layer fabrication. Although

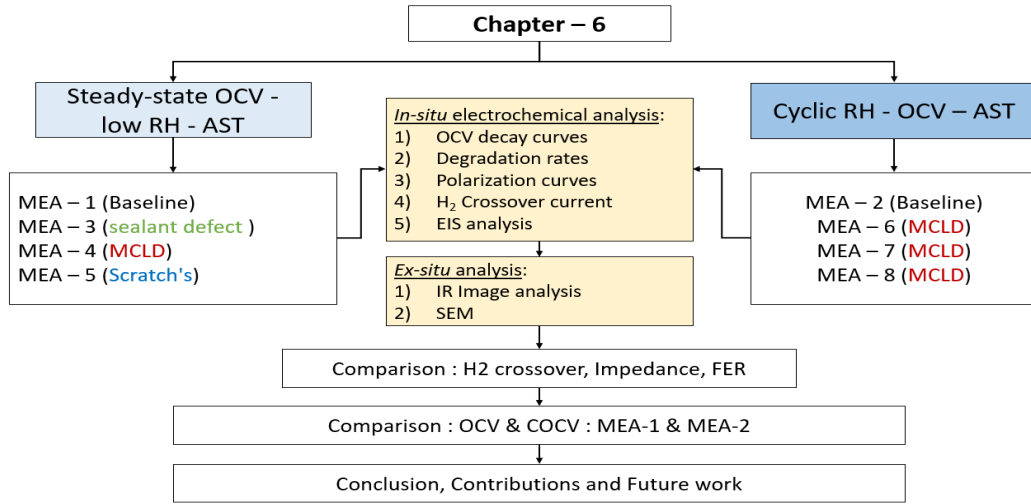
Figure 6-2: Framework for MEA analysis followed in this part of study.

Although studies showed that chemical and mechanical ASTs are useful for screening the overall durability of MEA, the role of pre-existing electrode defects is still not clearly understood. Thus, a research gap exists in understanding how BOL manufacturing defects affect the overall cell performance and propagate during typical fuel cell operation at high temperatures and variable humidity conditions. In this chapter, case studies of 3 defects are analysed as a part of MEA quality control: (1) missing catalyst layer defects (MCLD), (2) gasket/CCM interface defects (sealant pinhole defects), and (3) scratches/cuts in the CCM. Among the various CCM defects discussed in Chapter 4, these defects are chosen since they have been commonly recognised by electrode manufacturers during CCM fabrication. The durability of MEAs with and without defects are tested under two OCV-AST conditions: (i) steady-state low RH and (ii) cycles of low/high RH at a high stack temperature of 90°C. The extent of chemical and mechanical degradation of electrode defects and information regarding MEA component failure mechanisms can be gleaned from these ASTs and visual inspection of defects. The AST protocols developed in this work are based on the standard DOE procedures and feedback from our industrial partner. Details of the research framework are shown in Figure 6-2 and the step-by-step AST procedure used for MEA analysis is shown in Figure 6-3.

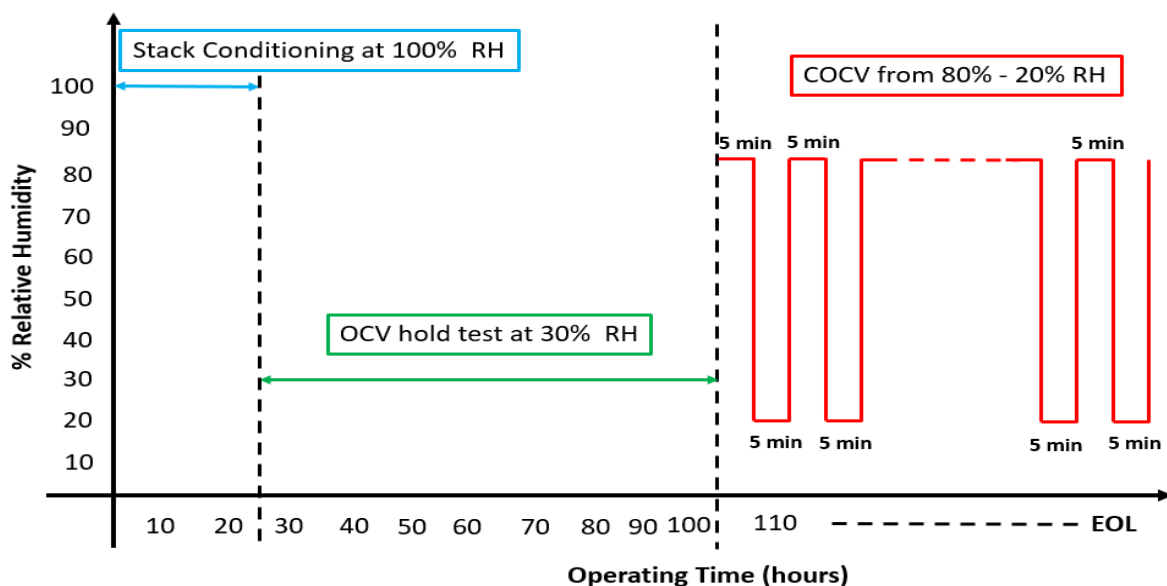
Figure 6-4: Schematic of various RH cycles used during electrode/stack conditioning (blue-100%RH), steady-state OCV (green-30%RH) and RH cycling (red – 80% - 20% RH).

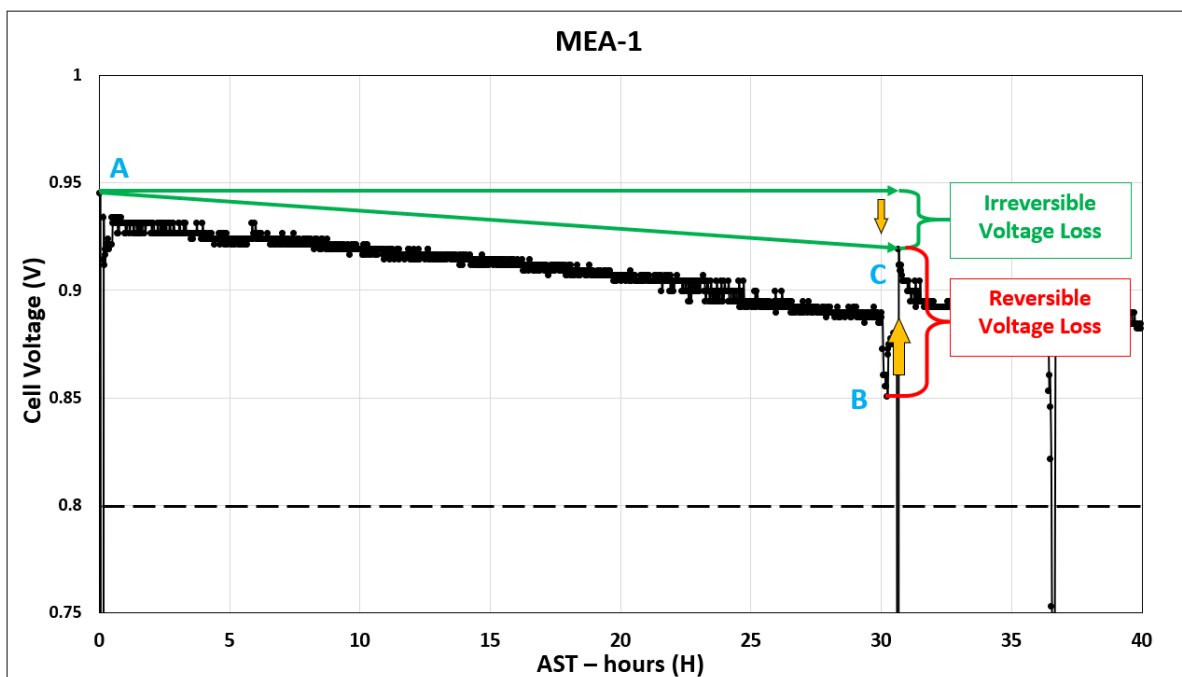
Figure 6-6: Analysis of the OCV curve for MEA-1 during the first period (MOL-1) to differentiate the reversible and irreversible losses. The irreversible voltage loss is indicated in green (A to C) and the reversible loss in red (B to C).

It is interesting that the initial OCVs of these MEAs at BOL are essentially the same, with an average value of ~ 0.945 V. Thus, the initial OCV is not a good indicator of the state of MEA in these cases. As shown in Figure 6-5, a sharp drop in the OCV is observed when the AST is interrupted at MOL for electrochemical characterization to obtain polarization curves and EIS spectra and measure H₂ crossover, but then recovers when the AST is resumed. Close analysis of the change of the OCV during this interruption period is very informative and enables the reversible and irreversible losses of the electrode to be distinguished. The OCV degradation rates measured in this study are commonly reported in the literature. For instance, Kundu et.al.[111] and Mehmood et.al.[154] reported similar degradation rates during cell interruption. To explain in more detail, the period (MOL-1) in the OCV curve of MEA-1 from 0 hours up to the first interruption at 30 hours is shown as an example in Figure 6.6. The overall degradation rate during the first 30 hours is measured to be ~ 3.16 mV h⁻¹. The irreversible voltage loss is indicated in green (from A to C in Figure 6-6), while reversible loss is indicated in red (from B to C in Figure 6-6). Each interruption is characterized by two sharp downward spikes when the AST is interrupted and one upward spike when it is resumed. It should be noted that the upward spike reaches a voltage higher than the OCV measured just prior to the interruption. The irreversible losses are estimated from the difference between this spike and the OCV at t=0 and are attributed to permanent degradation of MEA components such as the membrane and catalyst layer (from A to

C in Figure 6-6). The reversible voltage loss is estimated from the difference between this upward spike and the first downward spike where the OCV just before the AST is interrupted (from B to C in Figure 6-6). The reversible voltage loss can be attributed to such phenomena as catalyst surface oxidation and water flooding in the MEA, that are completely or partially undone when the AST is interrupted and the MEA undergoes electrochemical characterization. The reversible voltage loss can be attributed to such phenomena as catalyst surface oxidation and water flooding in the MEA, which are completely or partially undone when the AST is interrupted and the MEA undergoes electrochemical characterization. The total degradation rate corresponds to the sum of reversible and irreversible decay rates. However, it is important to distinguish between these two types of OCV loss and estimate the irreversible voltage decay because it is directly associated with membrane thinning and loss of active catalyst surface area.

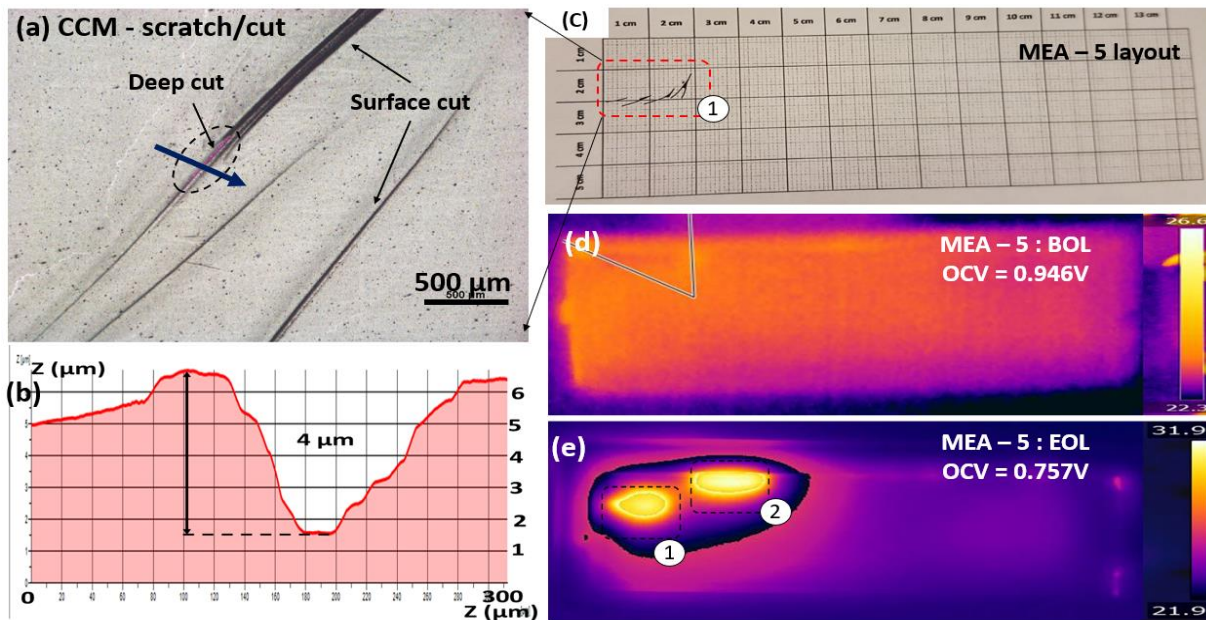
Figure 6-13: MEA-5 (a) Optical image showing scratches on the catalyst layer; the dotted circle area indicates a deep cut, while the dark line denotes a surface scratch; (b) Z-profile across the blue arrow in (a) showing a deep scratch with depth of $4\mu\text{m}$; (c) layout of MEA-5 showing location of defect in CCM; IR images of MEA-5 at BOL (d) and EOL (e) showing two pinholes 1 and 2.

MEA-5 is a 3rd case study focusing on catalyst layer defects such as scratches or cuts in the CCM. An example of scratches with deep cuts and surface cuts are shown in Figure 6-13a and Appendix Figure 10-5. The graphical view of MEA-5 showing the location of this defect is shown in Figure 6-13c. Two types of scratches are commonly observed on cathode catalyst layers: (i)

surface cuts and (ii) deep cuts. From our previous investigations (see section 4.4.3.1 of chapter-4), surface scratches have very little/negligible impact on defect propagation due to lower variability in defect thickness $\pm 0.5\mu\text{m}$. The thickness of the surface cut is found to be approximately $\sim 1.2\mu\text{m}$. On the other hand, deep cuts in catalyst layer are concerning and require more attention in selecting high-quality CCMs. The dotted circle in Figure 6-13a shows a deep cut, with the deep cut region in the catalyst layer (magenta colour) that directly exposes bare membrane to the gases. The Z-profile in Figure 6-13b taken along the blue arrow in Figure 6-13a shows that the cut penetrates to a depth of $\sim 4\mu\text{m}$. Manufacturers should be aware of this type of scratch and the extent to which they affect PEMFC performance. If CCMs rolls are investigated with a reflected microscope, the operators should inspect the range and severity of scratches by varying the transmitted light between 5% and 20% during analysis. The higher the reflected light intensity inside the defect, the more critical is the defect.

IR examination of MEA-5 prior to the OCV-AST does not reveal any hotspots (Figure 6-13b), indicating that no gas should leak across the membrane at the outset. During the AST, the OCV of MEA-5 degrades at a rate of 1.85 mVh^{-1} until it reaches EOL after 110 hours. The AST is

The polarization curves for MEA-5 in Figure 6-14b show that 50.3% of the cell voltage is lost over the current density at 1.5A/cm² where mass transfer is dominant. Increase in mass-transfer losses is most likely caused by the propagation of damaged areas (region-1 and region-2 in Figure 6-13e) that do not contribute to any electrochemical reaction and facilitate water accumulation at higher current densities. The EIS results also confirms the growth of membrane resistance from 3.67 mΩ (BOL) to 5.44 mΩ (EOL), respectively, as shown in Figure 6-14d and Table 6-6. The IR results strongly support the conclusion that the irreversible loss of OCV in MEA-5 originates primarily in the catalyst layer and CCM/gasket interface defects. Although these

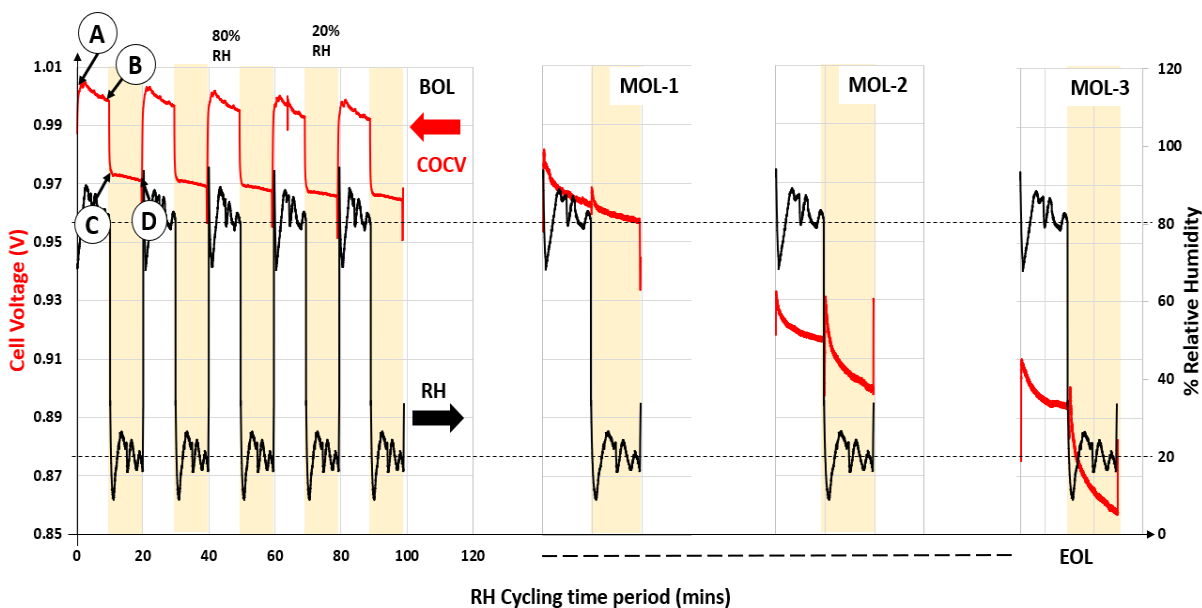
Figure 6-15: RH cycle waveform (black) and OCV response (red) of MEA-2 (baseline) during AST.

When MEA-2 is hydrated to 80% RH (point A in Figure 6-15), it takes up water and swells, resulting in large in-plane compressive stress. During the wet-hold period at 80% RH (A to B), the in-plane compressive stress relaxes with small variation of the water content in the membrane, this leads to fairly minor deviations in OCV during this part of the cycle from BOL to EOL [169]. The switch from 80% to 20% RH (B to C) reduces the water content in the membrane and significantly decreases the in-plane compressive stress.

The switch from 80% to 20% RH (B to C) reduces the water content in the electrode both in catalyst layer and electrolyte membrane. This leads to faster decay of the OCV that appears throughout the AST. During the dry-hold period at 20% RH (C to D), the membrane shrinks and reduces its thickness, enabling more H₂ crossover to occur. The change in OCV correlates with the dynamic changes of the hygro-expansion and elongation of Nafion membrane as a function of RH reported by Lai et. al. [159]. Majsztrik et. al. found that Nafion expands 14% from its original

The voltage curves shown in Figure 6-17 are isolated voltage curves shown in Figure 6-15 to show declining voltage behaviour of under 80% RH and 20% RH. The black curves in the plots represent the OCVs recorded during wet conditions, i.e., 80% RH, where the membrane is saturated with water providing good ionic conductivity, with less mechanical and chemical stress. The red curve represents the voltage during dry conditions, i.e., 20% RH, when the membrane shrinks and experiences high in-plane mechanical stress. In each of the cases shown here, the difference in the OCVs measured under wet and dry conditions is relatively small at the outset of the AST, but begins to grow at a later stage. It is likely that the decrease in OCV is caused by degradation of the membrane [83]. The shaded regions in Figure 6-17 highlight when the voltage difference between wet/dry conditions becomes larger. The blue arrows indicate the onset of material degradation leading to early failure of the electrode that is further investigated using FER measurements. The green arrows represent the EOL caused by material degradation that accelerates gas leakage through damaged areas/electrode defects.

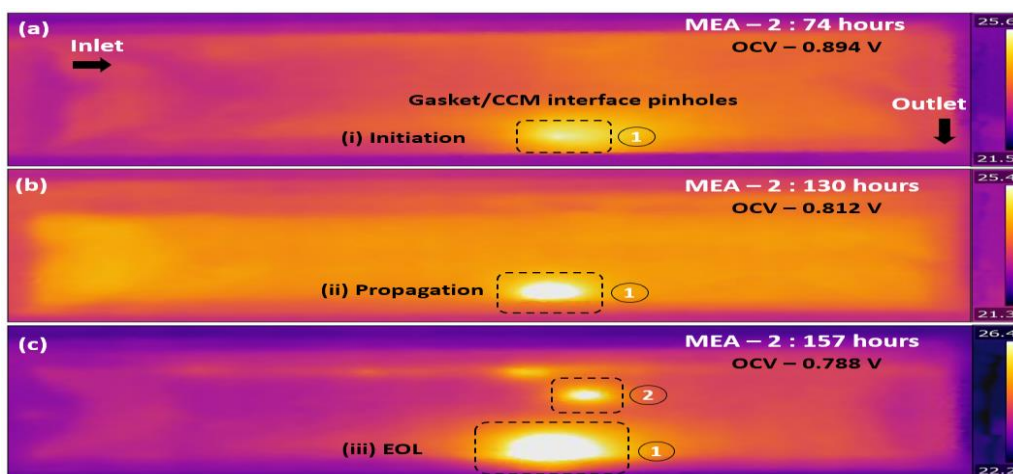
Figure 6-19: MEA-2 IR thermographs captured at (a) 74, (b) 130 and (c)157 hrs of AST.

The IR thermographs in Figure 6-19 indicate that hydration and dehydration during RH cycling at a high temperature initiates mechanical membrane failure particularly near the gasket/CCM interface (region-1). With the increase in dry time at 92 hours, the defect in region-1 continues to grow. By the time the AST reaches EOL, a second pinhole in region-2 has appeared at the center of the MEA and the defect in region-1 has grown significantly (Figure 6-19c). Taken together, these results suggest that the life span of MEA is greatly influenced by the length of time that the membrane is in a dehydrated state.

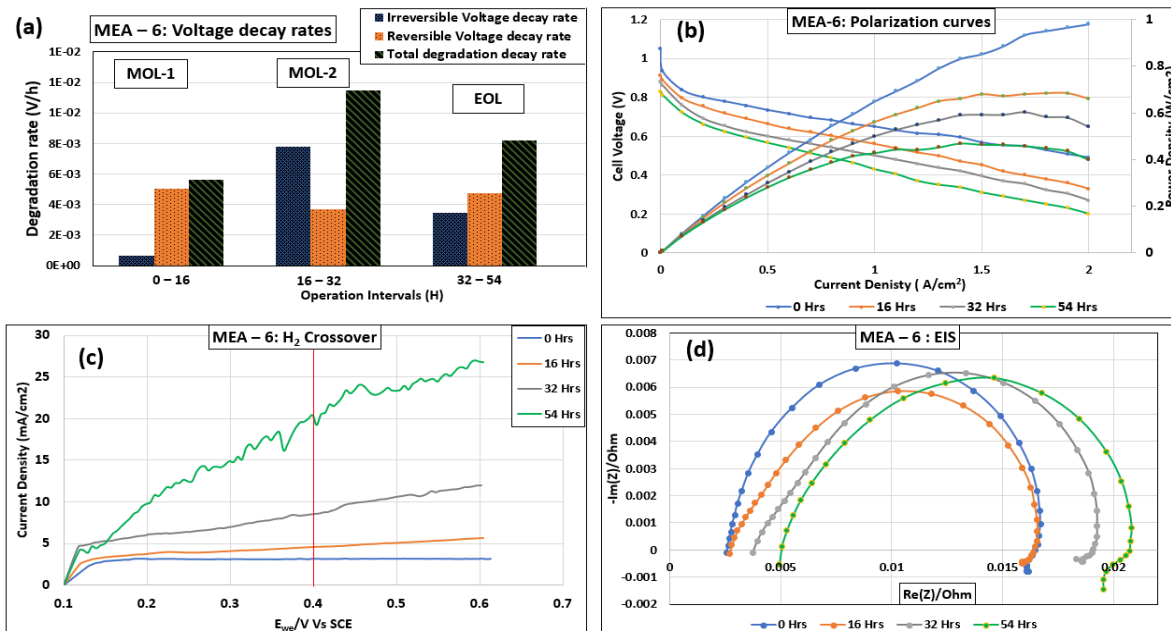
Figure 6-20: MEA-6 performance: (a) breakdown of irreversible (blue), reversible (orange) and total (green) OCV decay rates during the AST; (b) polarization curves, (c) H₂ crossover currents and (d) Nyquist EIS plots (@ 100 mA cm⁻²) obtained during aging.

RH cycles 10min/10min) is then applied to MEA-6 until it reaches EOL. As a result of the change in AST, the irreversible component of the OCV decay rate increases by ~12-fold over the period from 16 to 32 hrs (Figure 6-20a). At the end of 32 hours, the OCV reaches 0.804 V, close to the EOL. The experiment is continued for another 54 hrs (162 RH cycles) until the OCV reaches 0.752 V, with degradation rate of $\sim 4.21 \text{ mV h}^{-1}$. After the EOL, the GDLs were carefully disassembled and CCM was separated for optical analysis (see section 4.3.2) to study the effect of RH cycling on the catalyst layer and MCLD. Microscopic inspection showed that several regions in the anode and cathode catalyst layers developed cracks and delaminated. When the delamination occurs in the anode catalyst layer, it removes all of the catalyst layer to expose the membrane. This is expected since the thickness of the anode catalyst layer is 3x times thinner than the cathode. The delamination mechanism in catalyst layers is discussed in section 5.4.3.3.2. On the other hand, delamination on the cathode side removes 30 – 70% of its initial thickness. The changes of the morphology of the MCLD were also investigated after the RH cycling AST and are discussed later in section 6.5.2.1. It is also observed that the mechanical stress in MEA during RH cycling also causes excess compression under the land area where sections of the MPL are separated from the GDL and remain on the catalyst layer surface. From the entire microscopic observation on CCM, the RH cycling AST cause significant structural damage in catalyst layer through cracks and delamination.

Figure 6-20b shows the changes in the polarization curves measured at $t = 0, 16, 32$ and 54 hrs during the COCV-AST. A steady decrease is observed in the polarization performance over time. However, the drop in cell voltage in the activation region ($0.01 - 0.25$ A cm⁻²) is smaller than elsewhere in the curve. This indicates that the active catalyst in the catalyst layer is not as severely affected by the AST as other components. A larger performance loss is observed in both the ohmic region (0.25 A cm⁻² – 1.5 A cm⁻²) (i.e., 39.9% drop of the cell voltage from 0.614 V to 0.369 V at a current density of 1.2 A cm⁻²) and mass-transfer region (1.5 A cm⁻² – 2 A cm⁻²) (i.e., 50% drop of the cell voltage from 0.401 V to 0.201 V at a current density of 2 A cm⁻²). It is expected that these losses are most likely due to structural and interfacial changes in the catalyst layer and electrolyte membrane due to cracks and delamination during RH cycling. The combined chemical and mechanical stress during RH cycling leads to propagation of catalyst layer cracks and defected areas (e.g., MCLD) and delamination of the catalyst layer. It is expected that catalyst layer cracks and propagation of MCLD increase the ohmic losses in MEAs.

The H₂ crossover currents in Figure 6-20c show good agreement with the trends observed for the irreversible OCV decay and IR thermographs Figure 6-21. From 0 to 16 hrs during the AST, the

crossover current density remains below 5 mA cm^{-2} . After 32 hours, the crossover current density increases to 8.58 mA cm^{-2} at 0.4V (red line in image 6-18) and the irreversible OCV decay rate increases ~ 7 -fold. At EOL, the crossover current has increased to 20.52 mA cm^{-2} at EOL. This is also confirmed by IR thermography results as shown in Figure 6-21. Figure 6-21(a) shows the MEA-6 before RH cycling with a small hotspot located at the MCLD. After 96 RH cycles (32 hours), a second hotspot (region 2) is developed across the sealant interface area (Figure 6-21b). After 162 RH cycles (54 hours), the hotspot in region 2 (Figure 6-21c) has grown significantly at the same time that the OCV is measured to be 0.775V and EOL is reached. This is also confirmed from EIS results, where the membrane resistance increases from $2.69 \text{ m}\Omega$ to $5.05 \text{ m}\Omega$ from BOL to EOL. The summary of OCV losses, H_2 crossover and EIS results is presented in Table 6-9.

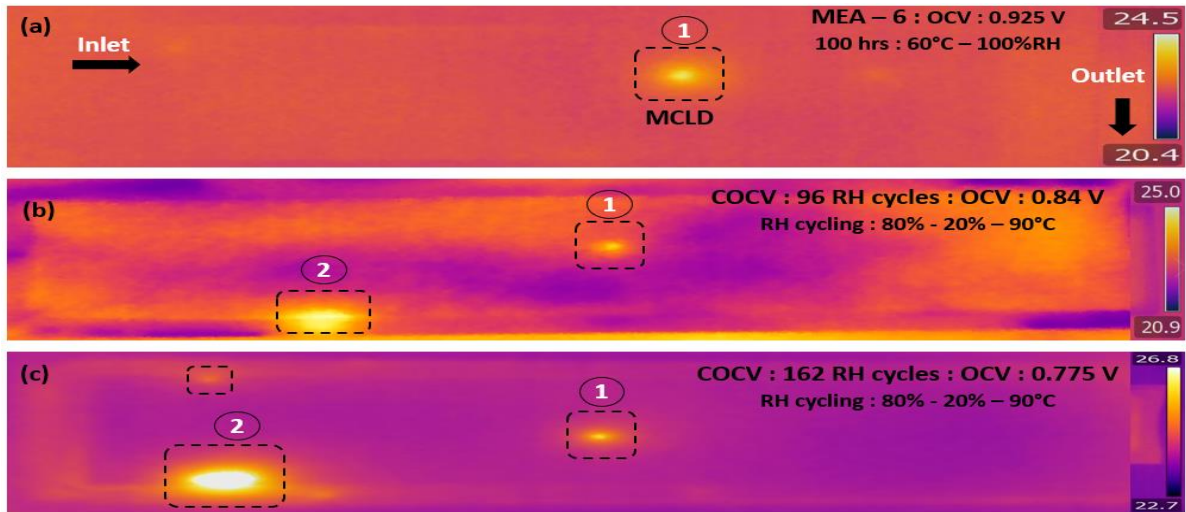
Figure 6-21: MEA-6 IR investigation captured at (a) BOL (b) MOL-1 and (c) EOL. IR thermographs of MEA-6 captured at (a) prior to COCV test, (b) after 96 RH cycles (32 hrs) and (c) after 162 RH cycles (54 hrs of AST).

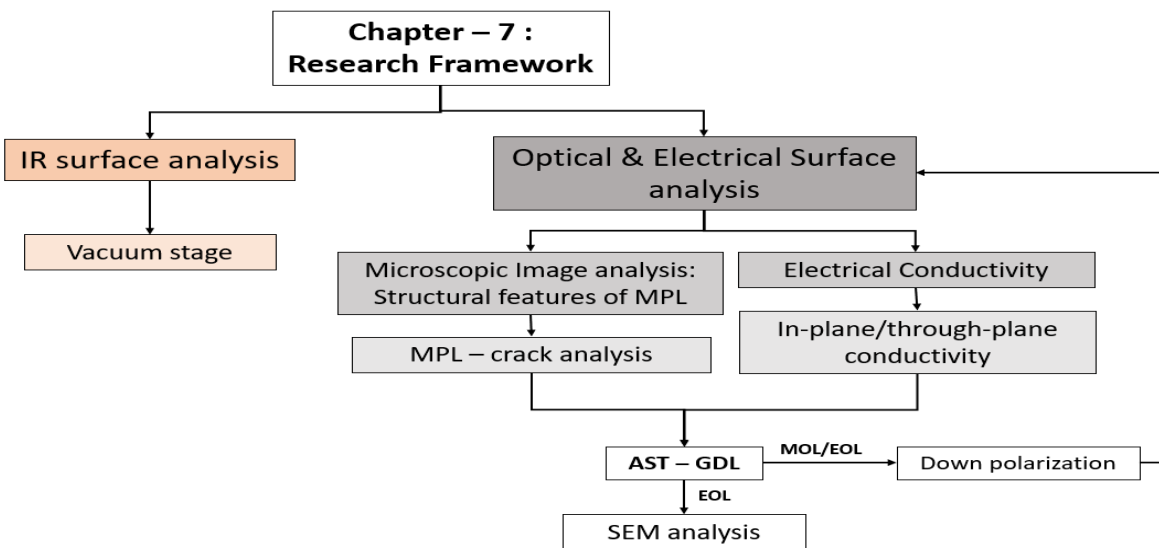
Figure 7-2: Framework for research on GDL quality control in this chapter.

Figure 7-2 shows the research framework adopted in this study of GDL quality control. The main objective of this research is to detect defects on the GDL/MPL electrode using IR thermography with DC excitation method by pulling cold air suction through defects under vacuum. This test setup is newly developed in this work and will be discussed in detail in section 7.3.1. Defects with size from $\sim 200 \mu\text{m}$ to $\sim 500 \mu\text{m}$ on the MPL can be identified using this method of inspection. As no industrial standards for common defect sizes currently exist, this size range is selected to be representative of common defects. After IR investigation, the second stage of

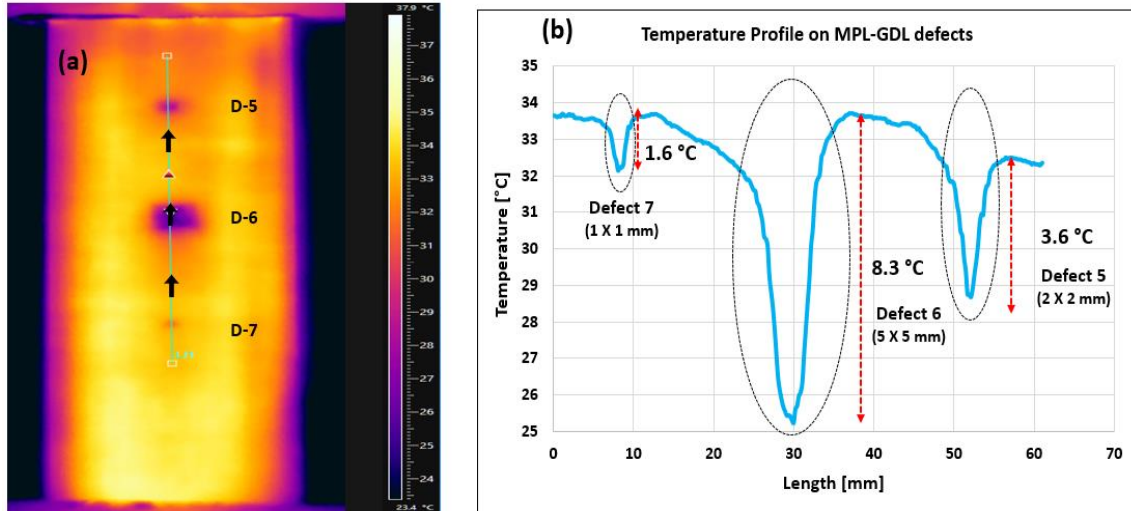
Figure 7-5: IR image of GDL showing defects D-5 to D-7. (b) Temperature line profile across the defects shown in Figure 7-5a.

Figure 7-5a shows the thermal response of the GDL shown in the digital image in Figure 7-3c. Figure 7-5b shows the temperature profile along the green line passing through D-5, D-6 and D-7 in Figure 7-5a. This plot clearly shows the drop in surface temperature at the defect. Furthermore, the larger the defect, the greater is the temperature decrease. The temperature drops across D-7 (1 mm x 1 mm), D-5 (2 mm x 2 mm) and D-6 (5 mm x 5 mm) are measured to be 1.6, 3.6 and 8.3°C, respectively. In each case, the temperature decreases from the edge to the center of the defect. This shows that the net flux of current at the center decreases as a result of loss of conductive material (i.e., defect in MPL), allowing higher permeation of gases through the GDL fibers. The temperature decrease of 8.3°C across D-6 across 5 mm square defect shows that this temperature is ~ 3 times larger than the literature value of 2.6°C [16]. Table 7-2 shows the comparison of thermal response on MPL defect to the current literature values. The IR defect detection method developed in this work takes less than 1 minute to scan a GDL surface with an active area of 30 x 20 cm.

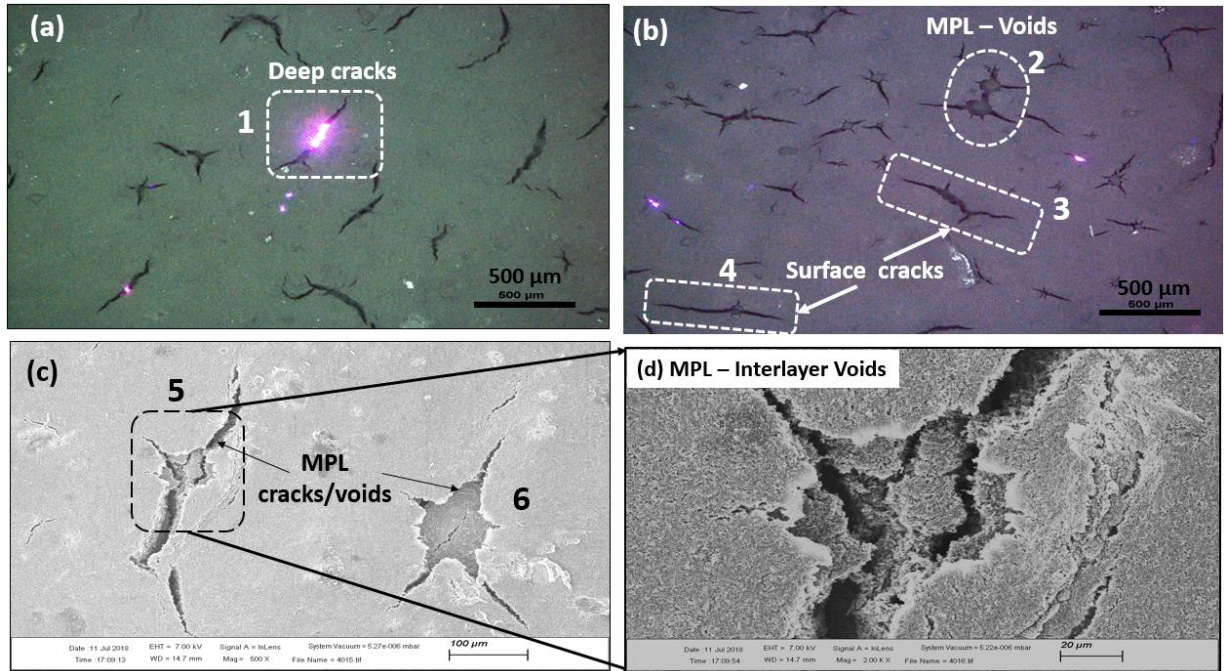
Figure 7-7: Microscopic images of MPL surface at BOL showing (a) deep cracks (through-plane crack) (b) surface cracks (in-plane cracks) (c) SEM image of MPL surface cracks (d) SEM image of interlayer inside the crack.

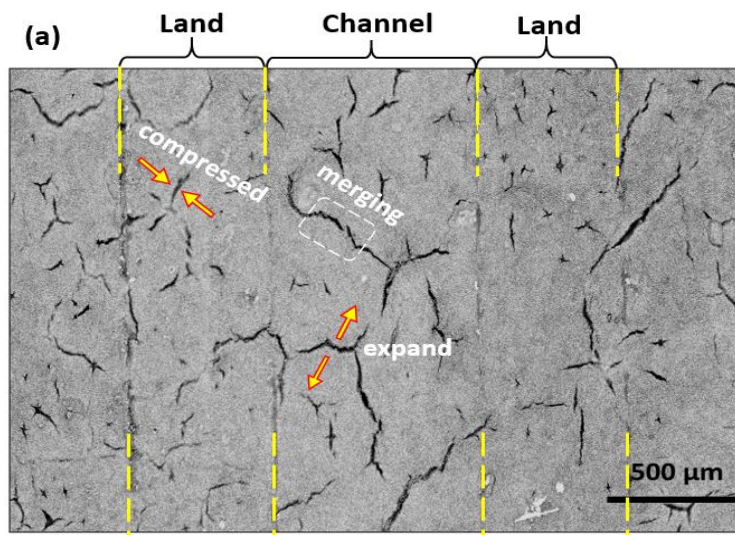
Figure 7-9: (a) Microscopic image of cracked MPL surface under channel and land regions.

are exposed to higher fuel flow velocities, rapid changes of humidity and mechanical intrusion of the GDL into the channel may result in different crack growth behavior. Figure 7-9a shows an MPL surface under both land and channel areas. It is clearly observed that the cracks under the land area are compressed and their widths tend to close. Therefore, no significant growth of the cracks is observed under the land region as shown in Figure 7-9a. On the other hand, the cracks under the channel expand both along their lengths and widths and merge with neighboring cracks. This can be attributed to higher flow rates and erosion along the crack edges due to water accumulation, which ultimately accelerates the propagation of BOL cracks in MPL surface [186]. We observe that puddle-shape cracks tend to form under the land region, and it was found that the average depth of puddle-shape cracks are around $5 \pm 1 \mu\text{m}$ with a diameter of $25 \pm 4 \mu\text{m}$. Puddle-shape cracks refers to the circular openings in the crack, an example is shown in Figure 7-7C (region 6). Generally, crack propagation on the GDL/MPL in actual fuel cell operation depends on stack compression pressure, inlet gas flowrates and membrane expansion pressure (depending on RH cycling). It is believed that the pressurized gases in flow field plate mechanically stretch the GDLs with in the channel area, this stretch causes propagation of cracks in MPL surface. Whereas cracks in MPL under the land region is confined therefore negligible propagation is observed. From close investigation of the MPL surface, several dents on the surface are also observed as bright areas although we notice no change in their area during aging. However, it is believed that dents on the MPL surface have no effect on the material properties as well as on the cell performance [42]. It is also observed that GDL fibers are visible in deeper cracks. These observations strongly demonstrate that through-plane cracks can penetrate the entire MPL thickness and reach the GDL/MPL interface. The frequency of through-plane cracks in the aged sample is not uniform over the entire surface, showing deviations from one region to another.

3. The propagation rate of cracks in MPL surface is observed to be higher under the channels than under the lands as shown in Figure 7-9a. This effect is expected since the area under the channel is fully exposed to the high flow rates of wet and dry gases and thus a higher rate of water accumulation, contributing to the erosion along with the edges of the cracks. This ultimately accelerates the propagation of cracks. A similar effect on the catalyst layer surface has been reported by Kim et al [187].
