**Investigation and Propagation of Defects in the
Membrane Electrode Assembly of Polymer Electrolyte
Membrane Fuel Cells: Quality Control Analysis**

A thesis

presented to the University of Waterloo

Chemical Engineering

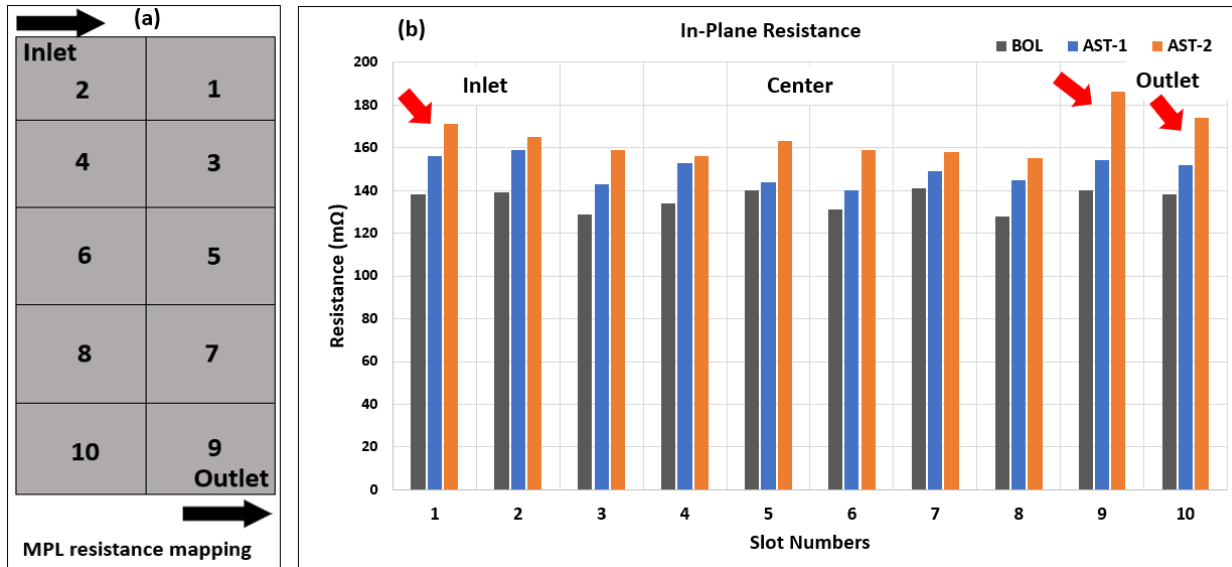
Figure 7-12: (a) Schematic of MPL surface (top view) divided into 10 regions or slots for in-plane resistance measurements, (b) In-plane resistance measurements obtained in the 10 slots using the four-point probe, the red arrows indicate the resistance at inlet and outlet.

The average in-plane resistance of fresh and aged GDLs is shown in Figure 7-12. For detailed in-plane measurements, the entire MPL surface is divided into 10 equal area regions or slots (each slot covers an active area of 2 x 1.4 cm) as shown in Figure 7-12a and the in-plane resistance of each of these slots averaged over 20 measurements is determined (200 points in total) from slot to slot as shown in Figure 7-12b. The average in-plane resistances over the entire MPL surface at BOL, AST-1 and AST-2 are 135.8, 149.5 and 164.6 mΩ, respectively. These results show that the in-plane surface resistance increases by 13.7 mΩ and 28.8 mΩ when a fresh MPL is aged according to AST-1 and AST-2, respectively. It is found that the in-plane resistance in the MOL outlet region has increased from 140 mΩ to 185 mΩ (slot-9) and 178 mΩ (slot-10), these areas also showed a noticeable crack growth under channel area. We believe that the increases in surface resistance is due to the growth of crack length and aspect ratio (length to depth). These results are also consistent with our previous microscopic observation that the area of the cracks increases significantly when sample are aged under the different RH cycles during AST-1 and AST-2. It is also observed that the local resistance under the flow channel is measured to be ~ 169 mΩ, which is higher than the value of 151 mΩ under the lands. This shows that the material loss in the channels is greater than under the lands and this is expected to increase the ohmic resistance in MEA.

The in-plane electrical resistance increases from 135.8 to 164.6 m Ω when the GDL/MPL substrate is aged under AST-2 RH cycling. The highest in-plane resistance is measured under the channels with an average of 169 m Ω for channels and 151 m Ω for lands. From these results, it appears that mechanical stress caused by RH cycling increases the electrical resistance of GDL/MPL substrates.

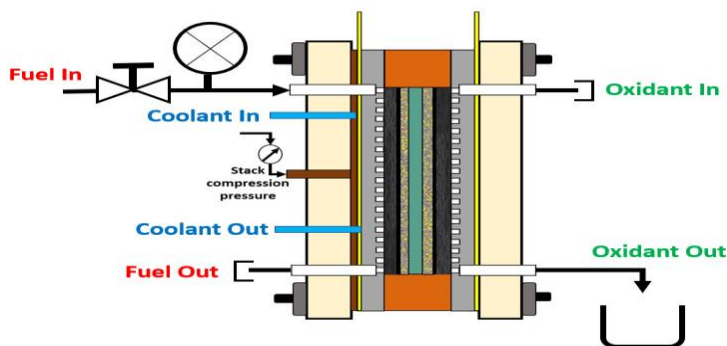
Figure 10-1: Fuel-to-oxide or hydrogen crossover leak test set-up.

The basic leak test is performed at BOL, MOL and EOL to measure the total gas leakage rate from all the sources, i.e., each coolant, fuel and oxidant port, hydrogen cross-over. A schematic diagram (Figure 7.4) below shows the set-up for the H₂ cross-over circuit leak test. The same set-up and procedure are used to test for internal and external leaks. Once the MEA is assembled in FCAT cell, the leak test is performed by slowly pressurizing the fuel cell stack to 30psi using air as a source until it is locked automatically.

For the hydrogen crossover test, the hydrogen source is connected to the fuel inlet port while the fuel outlet is closed. Tubing is connected to the oxidant inlet and then submerged in a graduated cylinder. The oxidant outlet is sealed, while the coolant inlet and outlet are locked. The amount of leakage between the fuel and oxidant circuits is obtained by measuring the volume of bubbles collected in the inverted graduated cylinder. A leakage rate of 1 ml/min or less is tolerable to pass the test. For the internal and external leak tests, a soap solution is sprayed on each of the ports, connections, across the bipolar plates and MEA to locate the leak. The appearance of bubbles indicates a gas leak, which must then be addressed. The soap solution is also sprayed on the bipolar plates due to the possibility of a leak in the gaps between the plates. Measurement of H₂ gas crossover is regularly conducted (MOL) throughout the OCV-hold test experiment to make sure it does not exceed 2 ml/min. If this value is exceeded, the test is terminated and MEA is further tested *ex-situ* to identify defects such as thickness variations and pinhole spots. Table 1 shows the breakdown of the gas volumes measured during the internal and external leak tests in a case where the entire set-up is found to pass the leak test.

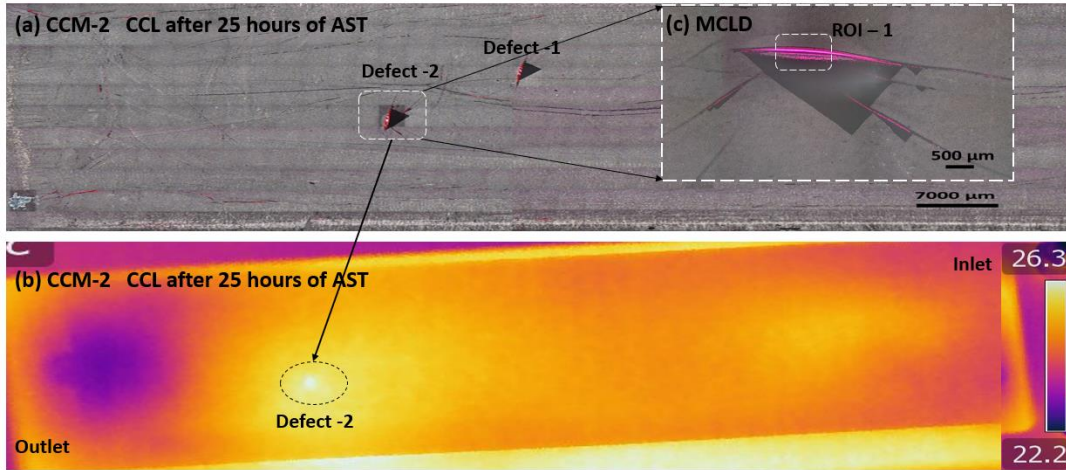
Figure 10-2: IR investigation of CCM-2 captured after 25 hour of AST: (a) digitally stitched microscopic image of CCL that has 2 MCLDs, (b) IR thermograph showing hotspot across defect-2 and (c) magnified view of defect-2.

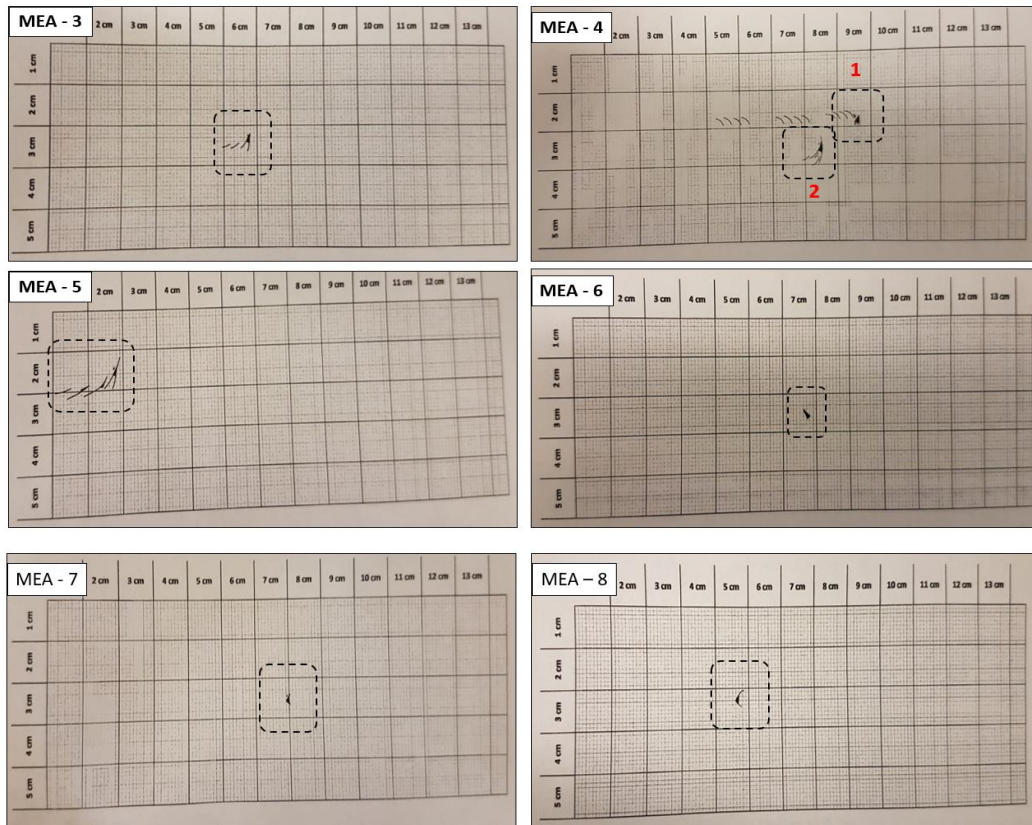
Figure 10-4: Graphical chart of CCM-used for MEAs (3 to 8), The rectangular box represents the approximate location of MCLDs on the CCL side of the CCM.

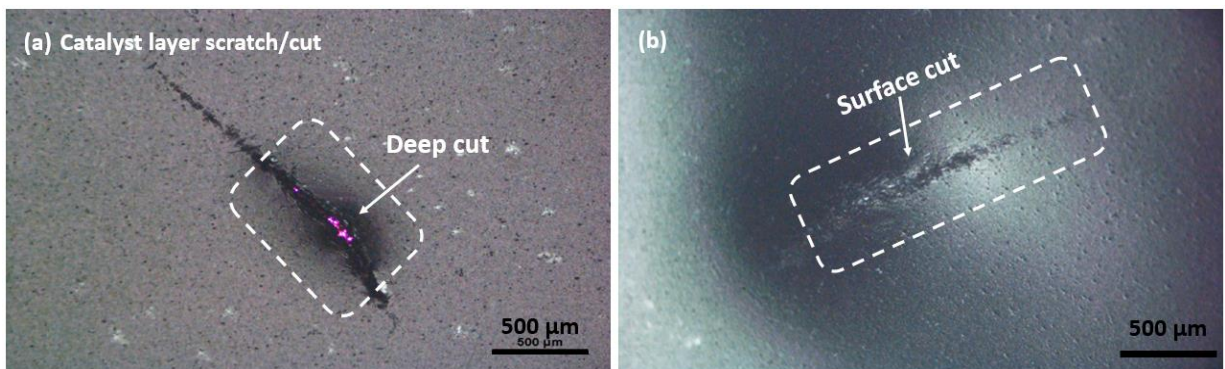
Figure 10-5: Microscopic image of scratches in the catalyst layers: (a) deep cuts and (b) surface cuts.

MEA-5 is a 3rd case study focusing on catalyst layer defects such as scratches or cuts in the CCM. An example of scratches with deep cuts and surface cuts are shown in Figure 6-13a and Appendix Figure 10-5. The graphical view of MEA-5 showing the location of this defect is shown in Figure 6-13c. Two types of scratches are commonly observed on cathode catalyst layers: (i)

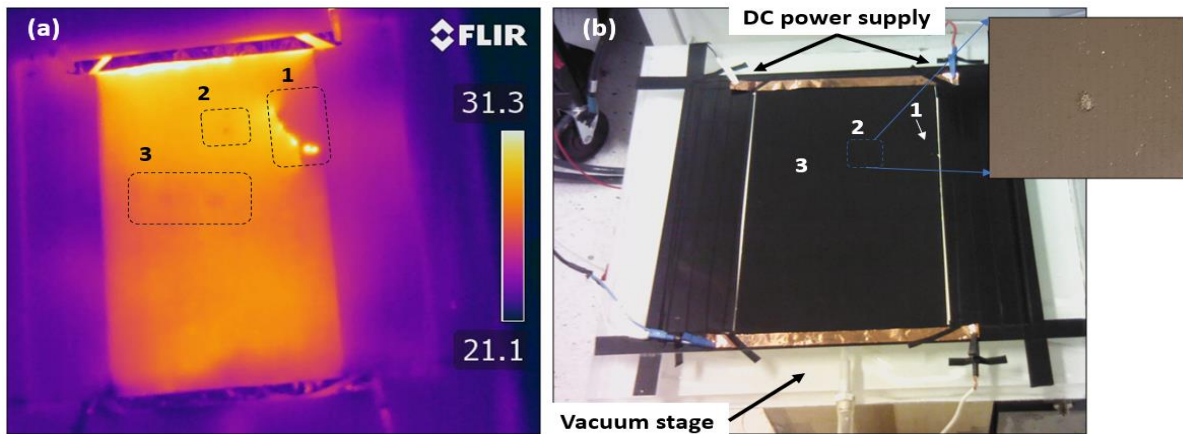
Figure 10-6: (a) Thermal response of defected GDL (30 cm X 20 cm), the corresponding digital image is shown in Figure (b), the magnified image represents the defect on the MPL (2 mm X 2 mm)

suction of air, it is expected that thinner areas in the GDL substrate offer higher gas permeability that allows more air to pass through defected areas and results in a colder surface. At a higher vacuum, the permeation rate of gases through defected areas in turn increases the local electrical resistance of the defect. This drives the flow of current across the edge of the defect and the temperature drop at the center of the defect. An example of a larger GDL area (30 cm x 20 cm) investigated using the vacuum stage method is shown in Appendix Figure 10-6.

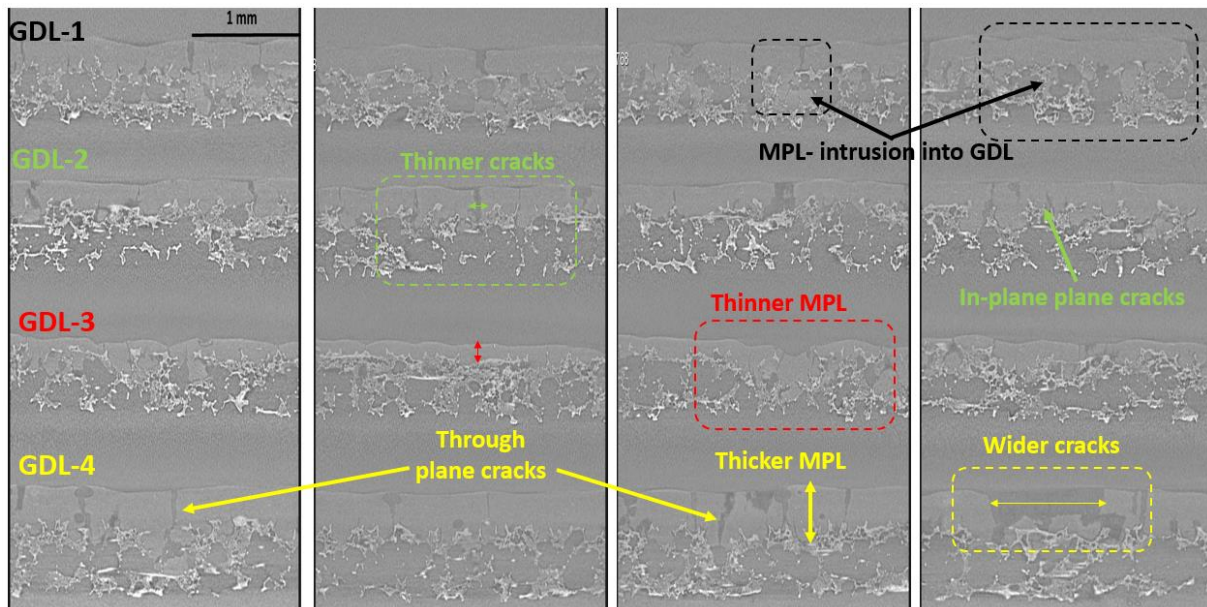
Figure 10-7: X-ray tomographic images showing variations in the MPL thickness and MPL cracks on the GDL substrate.
